ACCIDENT

Aircraft Type and Registration:	Zenair CH 701UL, G-EOIN	
No & Type of Engines:	1 Rotax 912-UL Piston Engine	
Year of Manufacture:	2000 (Serial no: PFA 187-13490)	
Date & Time (UTC):	9 May 2018 at 1230 hrs	
Location:	Lamb Holm Airfield, Orkney Islands	
Type of Flight:	Private	
Persons on Board:	Crew - 1	Passengers - 1
Injuries:	Crew - None	Passengers - None
Nature of Damage:	Damage to propeller, nose landing gear and floor panel	
Commander's Licence:	Airline Transport Pilot's Licence	
Commander's Age:	61 years	
Commander's Flying Experience:	11,850 hours (of which nil were on type) Last 90 days - 9 hours Last 28 days - 4 hours	
Information Source:	Aircraft Accident Report Form submitted by the pilot

Synopsis

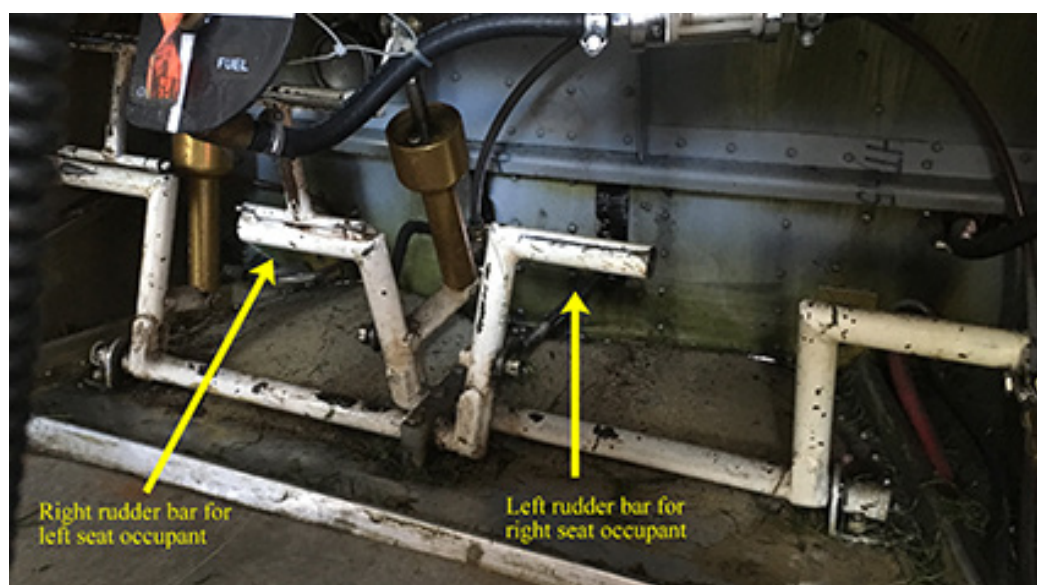
Figure 1

Post-flight inspection of the rudder bars led the pilot to believe that during the second landing, his right foot had slipped and was resting on the left rudder bar which is installed for a pilot in the right seat. Thus when he pressed with his right foot, he had moved the rudder bar in the opposite direction to that intended. All his previous SEP flying had been on types equipped with rudder pedals rather than rudder bars. On this aircraft the right rudder bar for the left seat occupant is situated close to the left rudder bar for the right seat occupant (Figure 1) and the pilot had not identified this before flight. He also noted that space in this cockpit is restricted and that his legs, being fairly long, may not have been positioned ideally.

Rudder bars in G-EOIN, with left rudder applied
