SERIOUS INCIDENT

Aircraft Type and Registration:	Morane Saulnier MS.315E D2, G-BZNK	
No & Type of Engines:	1 Rotec R3600 piston engine	
Year of Manufacture:	1932 (Serial no: 354)	
Date & Time (UTC):	5 May 2018 at 1400 hrs	
Location:	Sidmouth Beach, Devon	
Type of Flight:	Unknown	
Persons on Board:	Crew - 1	Passengers - 1
Injuries:	Crew - None	Passengers - None
Nature of Damage:	None reported	
Commander's Licence:	Private Pilot's Licence	
Commander's Age:	46 years	
Commander's Flying Experience:	493 hours (of which 12 were on type) Last 90 days - 20 hours Last 28 days - 8 hours	
Information Source:	Aircraft Accident Report Form submitted by the pilot

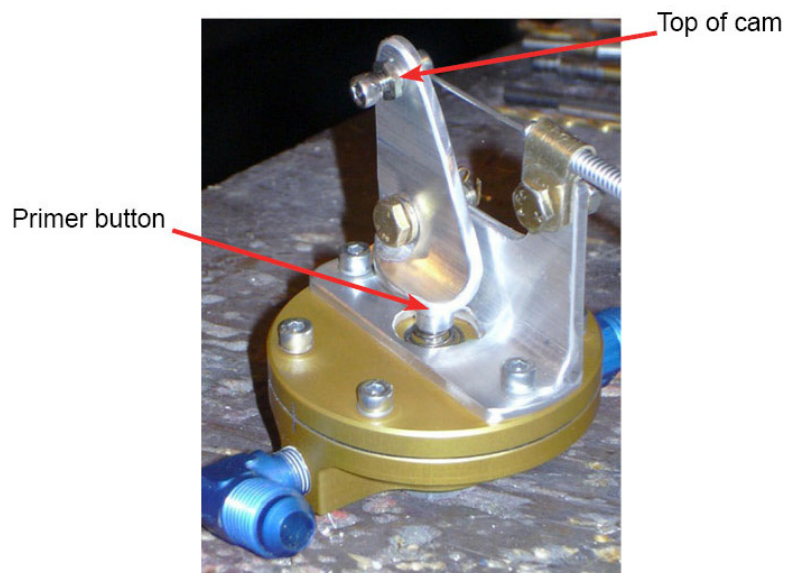
Figure 2

In this installation, fuel is supplied to the throttle body via a fuel pressure regulator that incorporates a primer button (Figure 2). When depressed, the primer button overrides the regulator and allows fuel to flow freely into the throttle body for engine starting.

Example fuel pressure regulator and primer button.
(Image produced by Rotec Aerosport Pty Ltd and used with permission)

Information provided by the LAA indicated that the engine would continue to run with the primer button depressed but with fuel consumption several times greater than in normal operation. Incomplete combustion of the excess fuel would produce black soot in the exhaust flow.
