ACCIDENT

Aircraft Type and Registration:	MBB-BK 117 D-2 EC145, G-RMAA	
No & Type of Engines:	2 Safran Helicopter Engines Arriel 2E turboshaft engines	
Year of Manufacture:	2017 (Serial no: 20166)	
Date & Time (UTC):	3 May 2018 at 1400 hrs	
Location:	Car park close to Molineux Stadium, Wolverhampton, West Midlands	
Type of Flight:	Commercial Air Transport (Helicopter Emergency Medical Service)	
Persons on Board:	Crew - 1	Passengers - 3
Injuries:	Crew - None	Passengers - None
Nature of Damage:	Damaged frangible fenestron protector and distorted undercarriage cross tube	
Commander's Licence:	Airline Transport Pilot's Licence	
Commander's Age:	45 years	
Commander's Flying Experience:	2,012 hours (of which 54 were on type) Last 90 days - 48 hours Last 28 days - 20 hours	
Information Source:	Aircraft Accident Report Form submitted by the pilot

Synopsis

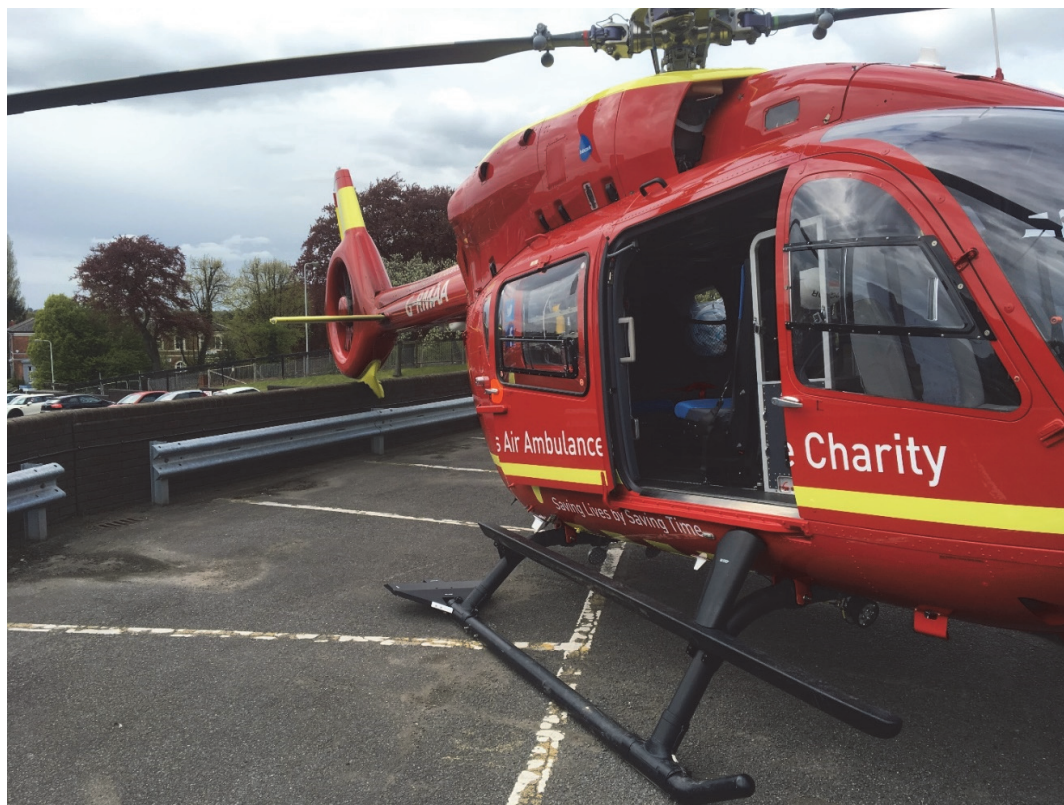
Figure 2

The pilot shut down the aircraft and the occupants were vacated, with the patient being transported to hospital by road ambulance. The helicopter had turned approximately 40° to the left from its original parked position and had moved 3 to 4 ft rearwards. The frangible section of the tail boom had contacted a low wall and the landing gear cross tube had deformed as a result of the heavy landing (Figure 2). Subsequent examination of the helicopter by the operator's maintenance organisation found no technical issue that could have caused the loss of directional control.

A review of the flight data and a video taken by an onlooker showed that the left anti-torque pedal was slightly depressed prior to lift off. It remained in this position as the helicopter lifted but remained in contact with the ground. As the helicopter became airborne it started to yaw to the left. The pilot applied right anti-torque pedal, but it was insufficient to arrest the rate of yaw.

G-RMAA after the incident with the frangible section of the tail boom in contact with the low wall

As a result of this event the operator has re-briefed all of its pilots on the possible consequences of remaining light on the skids when lifting into the hover.

The operator has also updated their ODC to reflect the most recent EASA Acceptable Means of Compliance and refer to dimensions of both the EC135 and the EC145.
