SERIOUS INCIDENT

Aircraft Type and Registration:	British Aerospace (BAe) ATP, SE-MHF	
No & Type of Engines:	2 Pratt & Whitney Canada PW126 turboprop engines	
Year of Manufacture:	1989 (s/n 2013)	
Date & Time (UTC):	3 May 2018 at 2210 hrs	
Location:	8 nm west of Milton Keynes	
Type of Flight:	Commercial Air Transport (Cargo)	
Persons on Board:	Crew - 2	Passengers - None
Injuries:	Crew - None	Passengers - N/A
Nature of Damage:	None	
Commander's Licence:	Airline Transport Pilot's Licence	
Commander's Age:	54 years	
Commander's Flying Experience:	4,277 hours (of which 2,169 were on type) Last 90 days - 54 hours Last 28 days - 19 hours	
Information Source:	AAIB Field Investigation

Synopsis

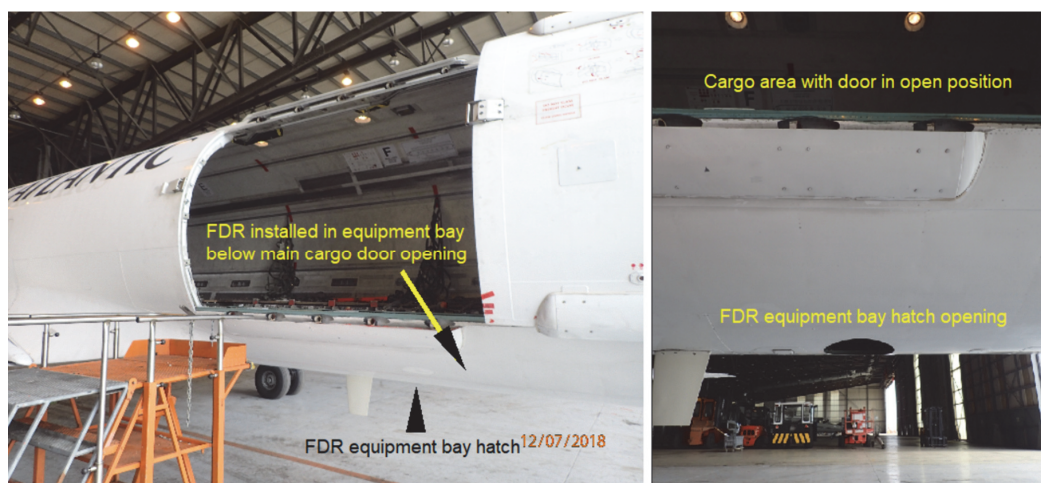
Figure 4

Location of FDR relative to LFD opening

The majority of FDRs found with moisture ingress were those that had been fitted to BAe ATP aircraft with the LFD. Discussions with engineers, and inspection of SE-MHF, indicate that rainwater can enter the cargo bay area during loading, which may then find its way into the rear equipment bay and the FDR. There was also some evidence that rainwater had dripped onto the FDR. Over time this will increase the probability of moisture entering the FDR and cause it to fail as corrosive products develop. Although tested for resistance to moisture ingress at certification, the PV1584 is not hermetically sealed and therefore moisture and liquids can easily enter the unit. Unlike later generation solid-state recorders, the unit was not required to be tested for its waterproofness or the potential effects of dripping water.

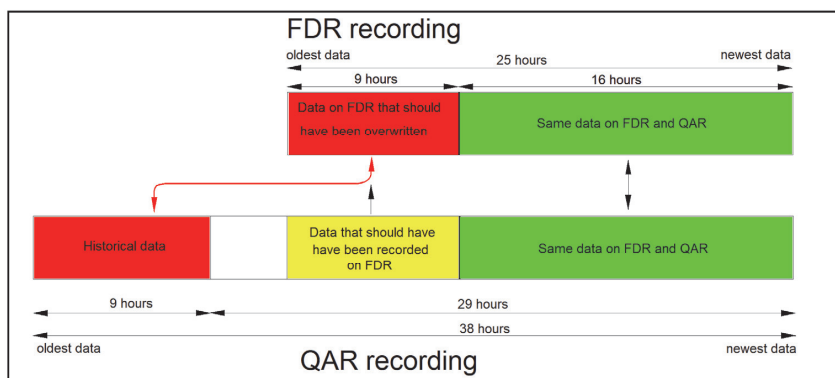
Figure 6

Pictorial time sequence of FDR recording

The PV1584 FDR fitted to SE-MHF had an intermittent fault that caused nine hours of data not to be overwritten and the loss of data during several other flights. Inspection of the FDR found evidence of moisture within the electronics module. This most likely caused the intermittent operation of the magnetic-tape recording function. The moisture may have also prevented the correct operation of the BITE as no fault was noticed during the period of incorrect operation.

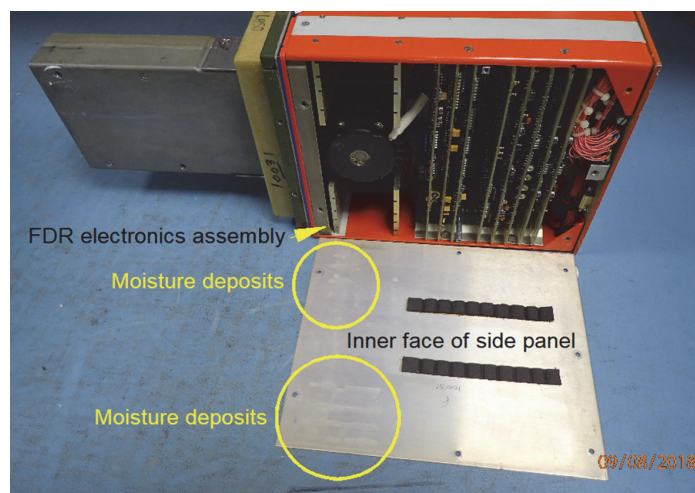
Figure 7

- The inner face of the metal panel that secured the circuit boards was stained with moisture residue (Figure 7).
- An analogue to digital (A/D) converter circuit board (Figure 8) had an area of several cm² of staining that was attributed to moisture.
- Moisture residue and small areas of corrosion was apparent on the solder connections of two power-supply circuit board connectors (PSU1 and

The MRO considered the intermittent recording fault had most likely been caused by moisture ingress. The MRO also added that other PV1584 FDRs received from the same operator's fleet of BAe ATP aircraft had been found with evidence of moisture ingress and damage. On occasion, staining from moisture residue has also been observed on the outside of the unit, indicating that water might have been dripping onto the unit. The FDR removed from SE-MHF did not show evidence of this.

Inside of FDR electronics assembly side panel showing areas of moisture residue

It is recommended that the European Union Aviation Safety Agency (EASA) require BAE SYSTEMS to protect the flight data recorder fitted to those ATP aircraft equipped with large freight doors from the effects of rainwater and other liquids.

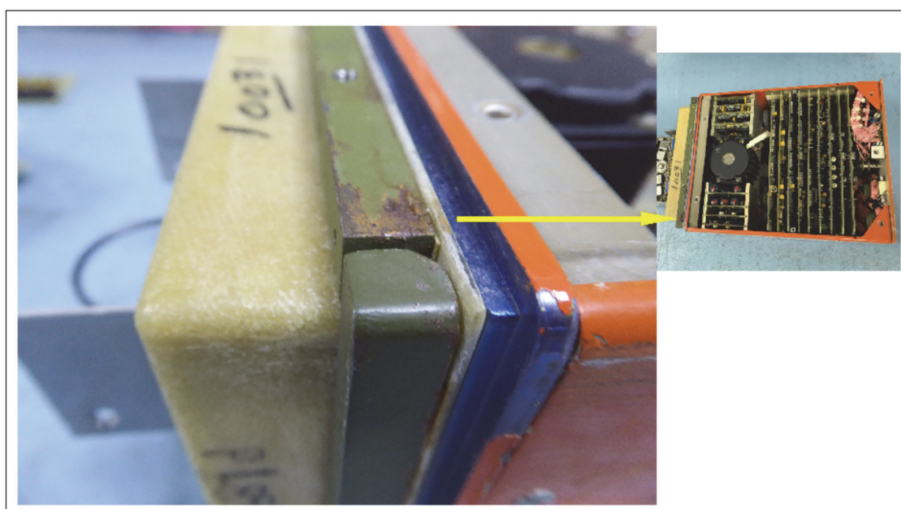
Figure 10

- Corrosion was present on the chassis where the tape transport attached to the electronics module (Figure 10).

Corrosion on FDR chassis adjacent to electronics assembly
