ACCIDENT

Aircraft Type and Registration:	Boeing 737-8AS, EI-GDZ	
No & Type of Engines:	2 CFM56-7B26E turbofan engines	
Year of Manufacture:	2018 (Serial no: 44820)	
Date & Time (UTC):	30 April 2018 at 1035 hrs	
Location:	London Stansted Airport	
Type of Flight:	Commercial Air Transport (Passenger)	
Persons on Board:	Crew - 7	Passengers - 170
Injuries:	Crew - None	Passengers - None
Nature of Damage:	Damage to the left elevator	
Commander's Licence:	Airline Transport Pilot's Licence	
Commander's Age:	48 years	
Commander's Flying Experience:	19,300 hours (of which 5,800 were on type) Last 90 days - 395 hours Last 28 days - 51 hours	
Information Source:	Aircraft Accident Report Form submitted by the pilot

Synopsis

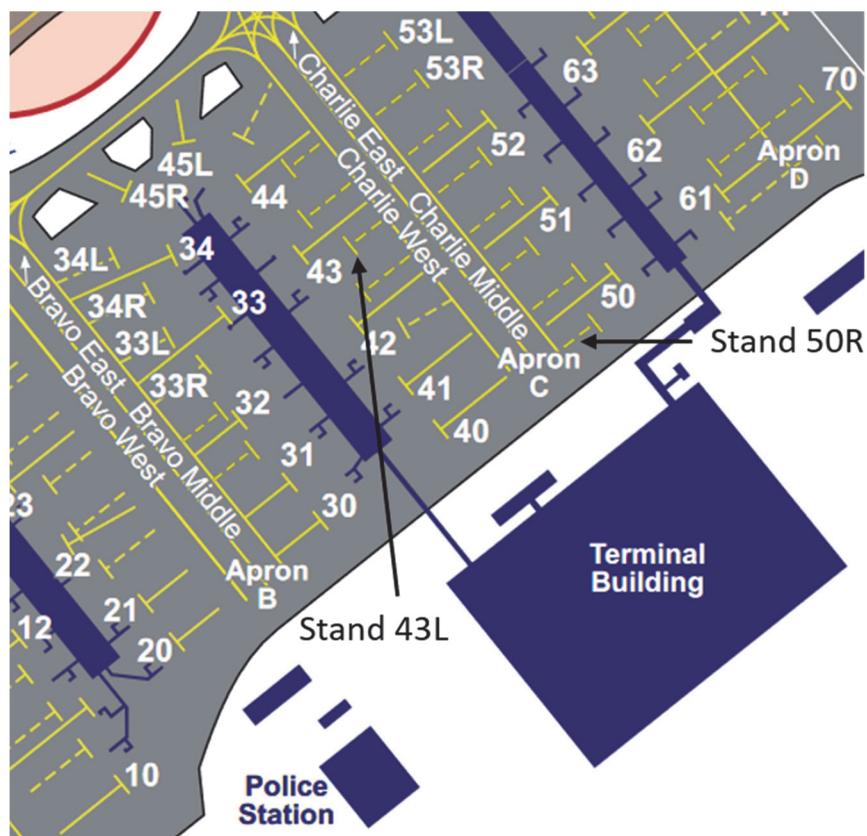
Figure 1

Parking stands and taxi lines with 50R being closest to the blast fence.

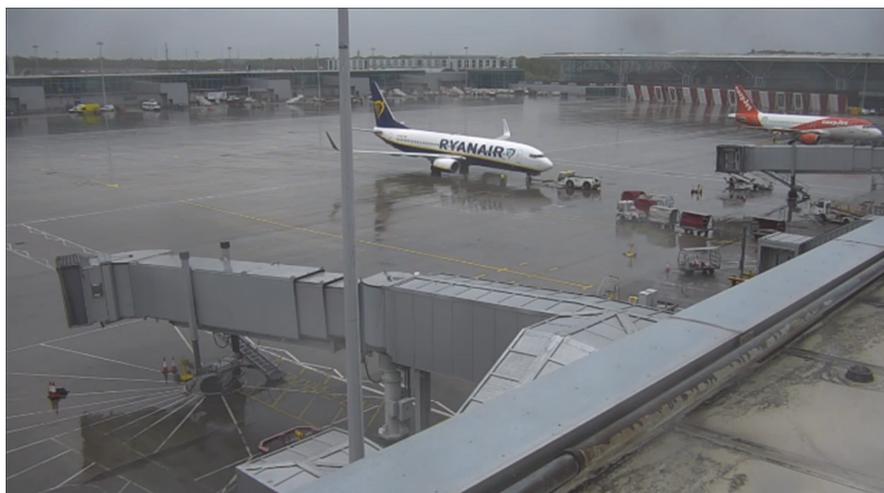
Figure 2

Initial pushback from the Stand 43L

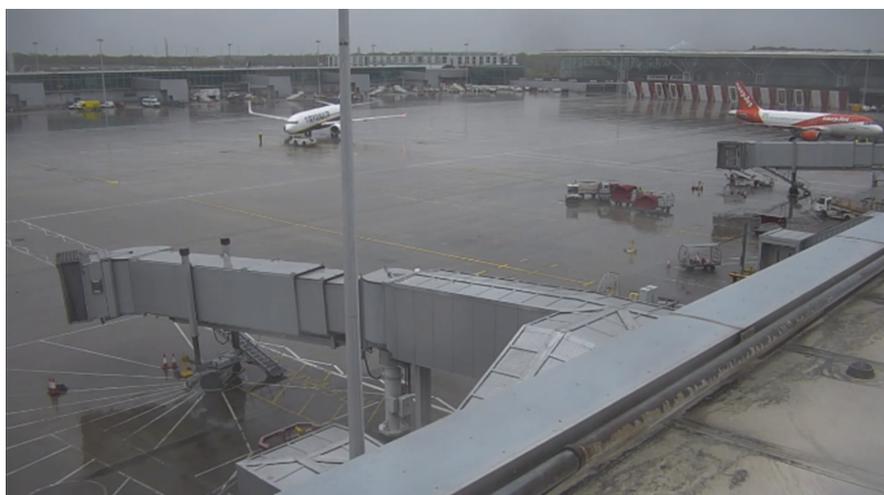
Figure 3

The aircraft approaching the taxi line with the headset person on the right side of the aircraft

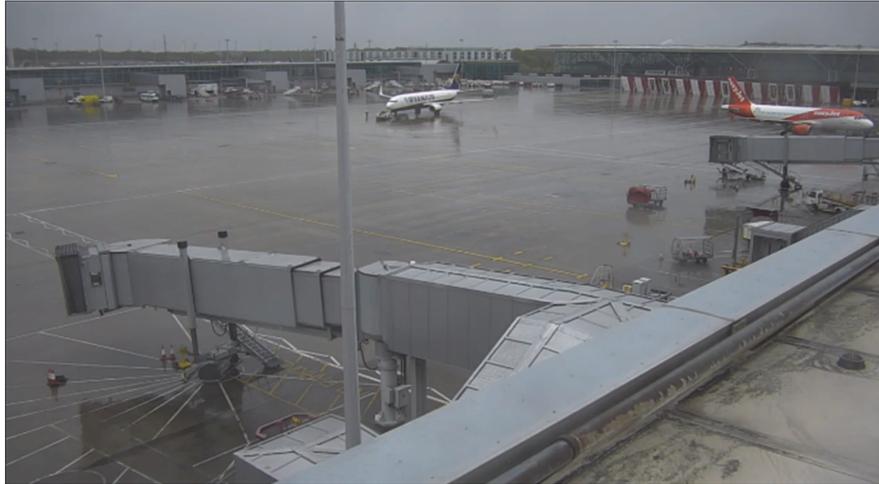
Figure 4
The aircraft established on the taxi line

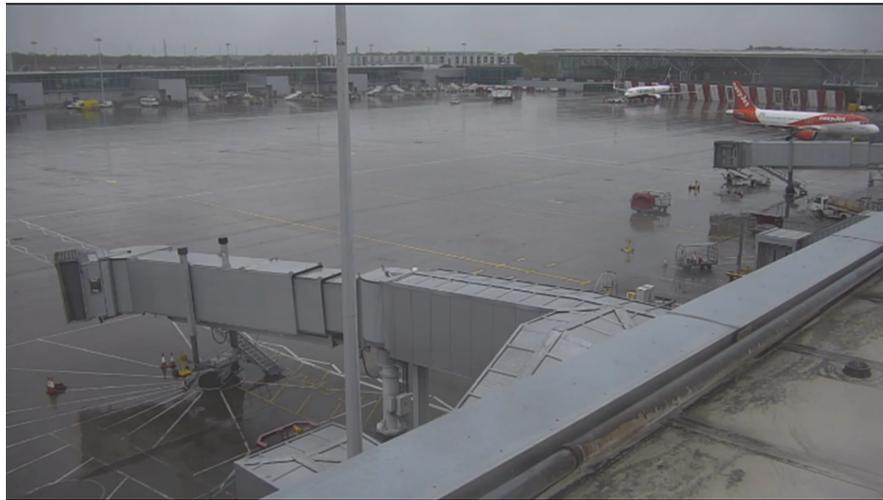
Closed-circuit Television (CCTV) of the event showed that the aircraft was pushed back but moved slightly from side to side as the tug driver attempted to locate and follow the taxi line. When the tail of the aircraft contacted the blast fence, the tug stopped and then reversed a short distance before becoming stationary. The images in Figures 2 to 6 were taken from the CCTV recording.

Figure 5
The aircraft contacting the blast fence

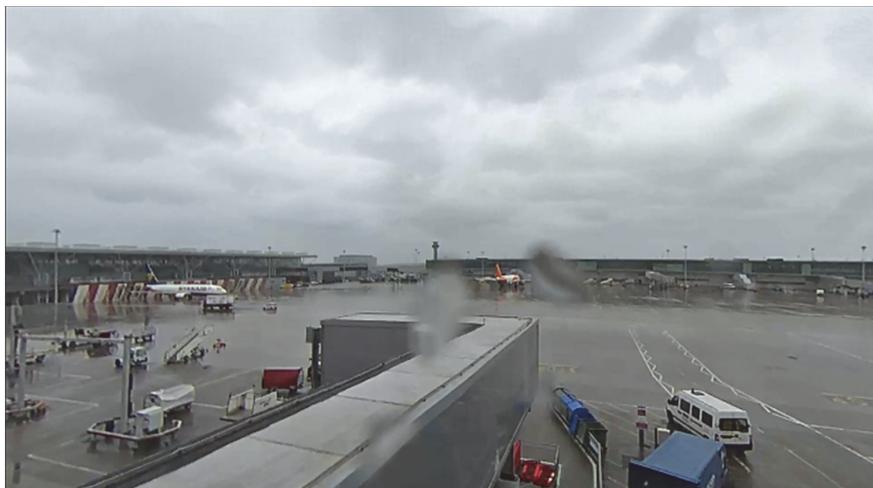
Figure 6
The aircraft contacting the blast fence from a different camera angle
