ACCIDENT

Aircraft Type and Registration:	Cessna 152, G-UFCO
No & Type of Engines:	1 Lycoming O-235-L2C piston engine
Year of Manufacture:	1978 (Serial no: 152-81734)
Date & Time (UTC):	19 April 2018 at 1119 hrs
Location:	Near Crumlin, County Antrim
Type of Flight:	Private
Persons on Board:	Crew - 1 Passengers - 1
Injuries:	Crew - 1 (Fatal) Passengers - 1 (Fatal)
Nature of Damage:	Aircraft destroyed
Commander's Licence:	Private Pilot's Licence
Commander's Age:	77 years
Commander's Flying Experience:	18,383 hours (of which 900 were on type) Last 90 days - 5 hours Last 28 days - 4 hours
Information Source:	AAIB Field Investigation

Synopsis

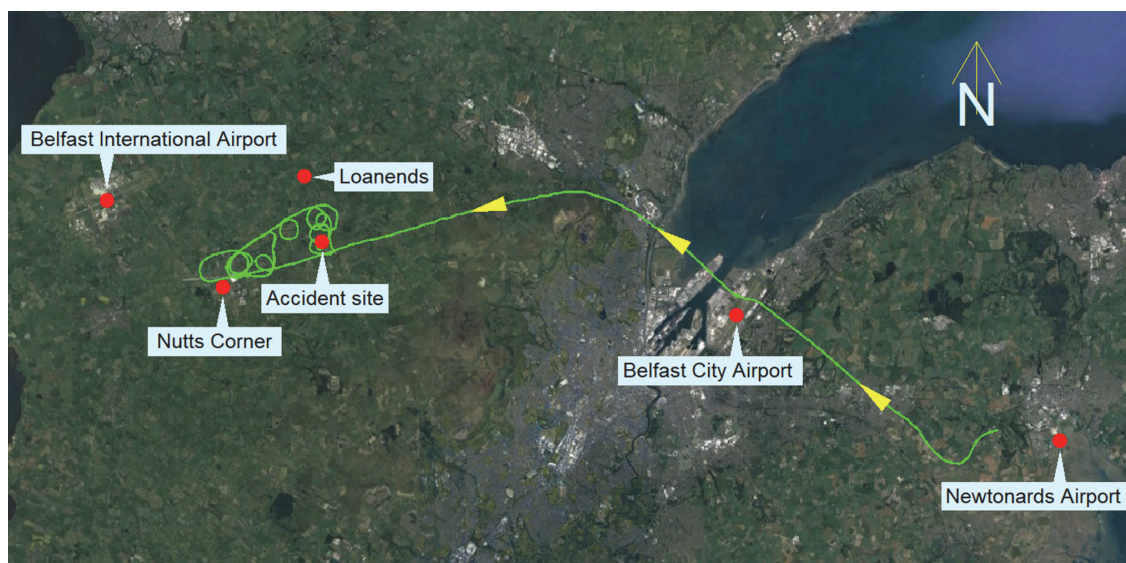
Figure 1

The aircraft took off from Newtownards at approximately 1047 hrs and flew in a north-westerly direction. At 1049 hrs the aircraft was recorded on radar 1.5 nm north-west of Newtownards Airport at an altitude of about 800 ft amsl. This coincided with the pilot making initial radio contact with Belfast City ATC, who the pilot advised that they were operating a photographic flight near Nutts Corner (a disused airfield located 3 nm south-east of Belfast International Airport). The aircraft subsequently transited the Belfast City Control Zone at an altitude of about 1,300 ft amsl, before being transferred to the Belfast International approach frequency. The pilot requested clearance to operate between Nutts Corner and Loanends (Figure 1 and 2), which was granted and the aircraft entered controlled airspace.

Radar track of flight from Newtownards Airport

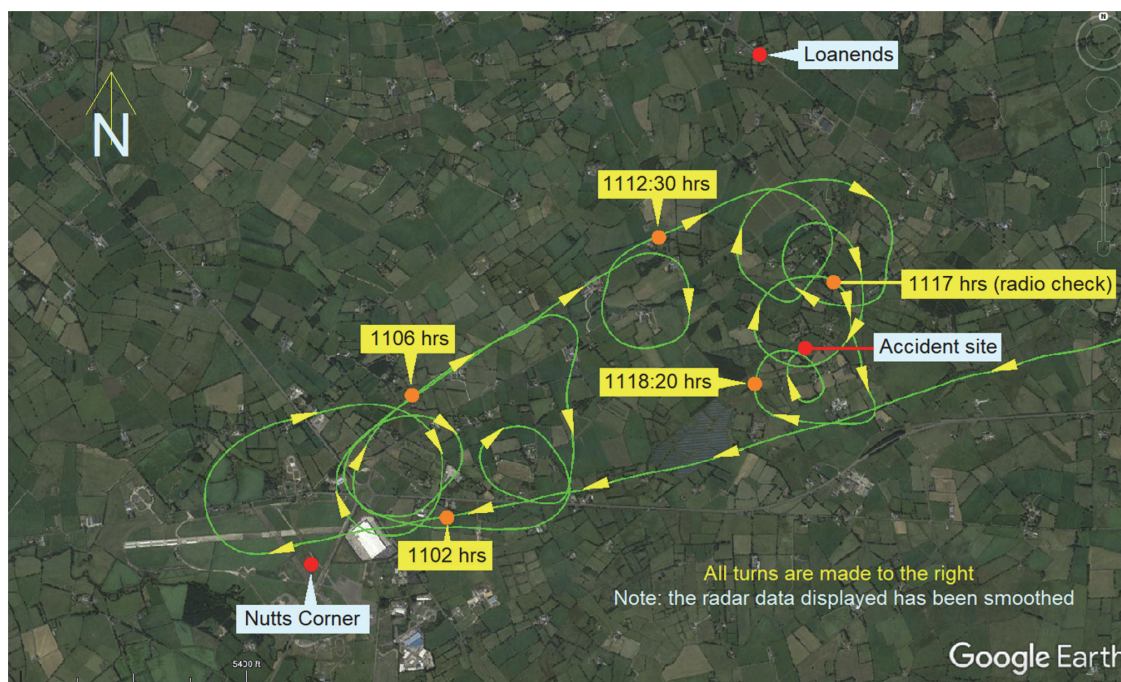
Figure 2

At 1058 hrs the pilot was transferred to the Belfast International tower frequency. A few minutes later at 1102 hrs, as the aircraft approached Nutts Corner, the pilot was instructed to hold position as an aircraft was on approach to land at Belfast International Airport. Having held at Nutts Corner for several minutes, flying at an altitude of about 1,100 ft amsl (a height of approximately 650 ft agl), the pilot reported that he was visual with the other aircraft and at 1106 hrs was cleared to proceed towards Loanends (Figure 2).

Radar track of the last 19 minutes of the flight

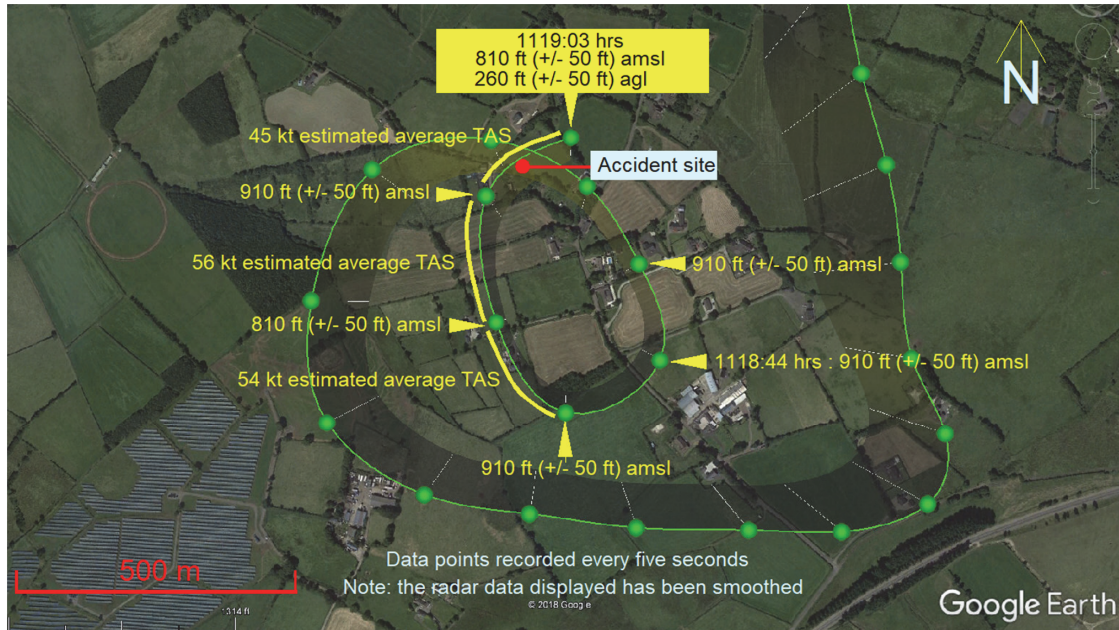
Figure 3

Radar recordings showed that during the next 90 seconds the aircraft maintained an altitude of about 900 ft amsl (approximately 400 ft agl), whilst making turns to the right. At 1118:44 hrs the turn rate increased to an estimated bank angle of about 45° right wing down, before reducing to about 20° right bank. The radar data indicates that the aircraft continued with a gradual turn to the right and at 1119:03 hrs the final radar point was recorded. The aircraft was at an altitude of about 810 ft +/- 50 ft (260 ft +/- 50 ft agl) (Figure 3).

Radar track of the last 120 seconds of the flight

The estimated TAS, derived from radar recordings, show that the aircraft was flying at below normal cruise speed during the latter stages of the flight when it was operating between Nutts Corner and Loanends. The average TAS between the last two data points was calculated to have been about 45 kt⁵. This was the lowest calculated during the flight. The final radar point was 60 m north-east of the accident site (Figure 3).

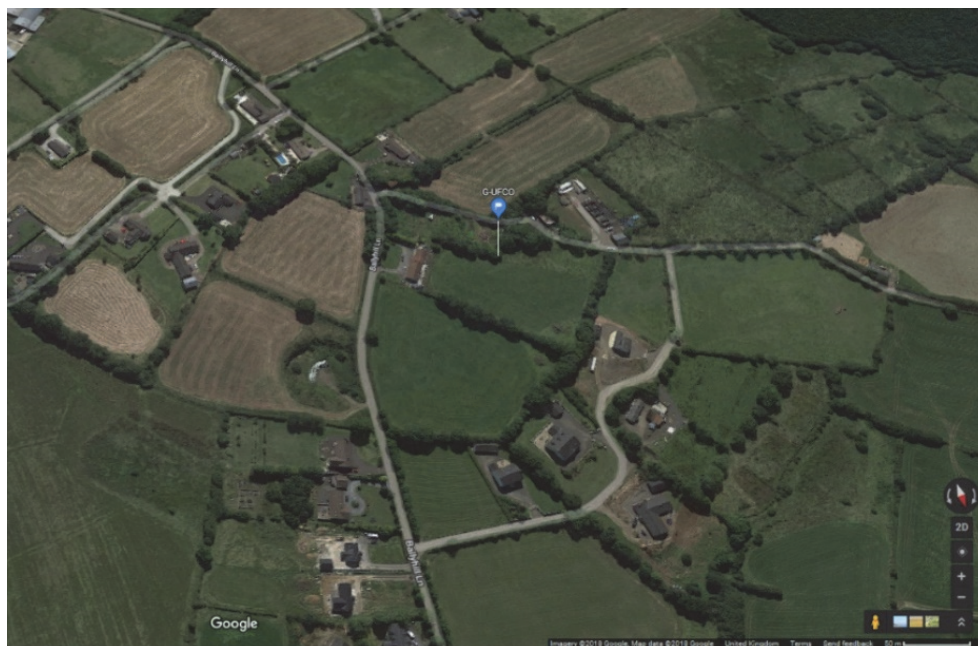
Figure 5
Accident site

The aircraft accident site was in a field approximately 4 nm south-east of Belfast International Airport (Figure 5). The aircraft had passed through a stand of trees, which were approximately 30 ft high, before it struck the ground. A one metre section of the right wing was retained in the trees. The ground impact marks, made by the forward fuselage and the wing leading edges, indicated that the aircraft struck the ground in a steep nose-down attitude (Figure 6). The wreckage site was compact, the aircraft was upright with both wings showing evidence of leading edge compression.

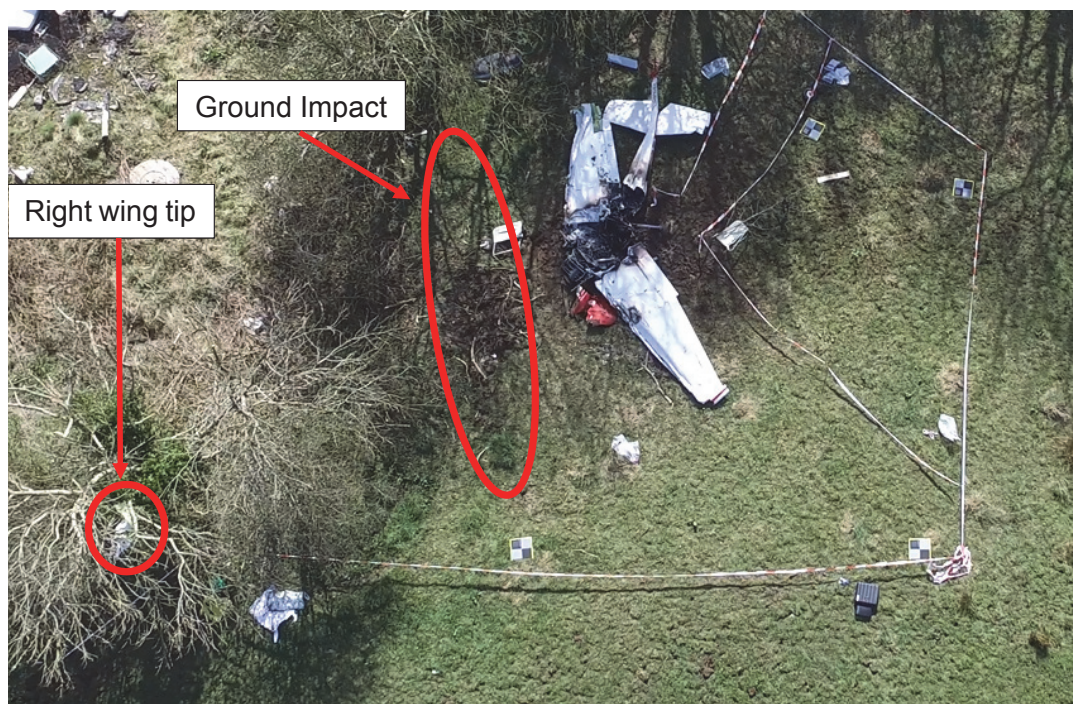
Figure 6
Accident site

The aircraft tail section had separated from the fuselage during the impact and the right wing had been bent rearwards, but the remainder of the aircraft was largely intact. There was a post-crash fire which was confined to the cockpit and inboard section of the right wing which contained one of the aircraft's fuel tanks. Six litres of fuel were later recovered from the left wing tank. The left flap was displaced by approximately 5° from the trailing edge of the wing. It was not possible to measure the position of the right flap due to fire damage.

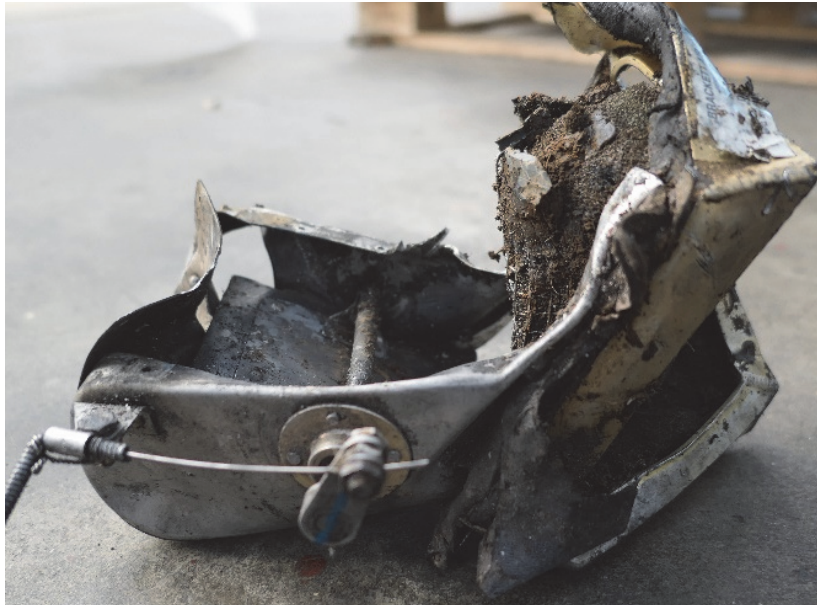
Figure 7
Carburettor heat valve

During removal of the engine, the carburettor heat valve was examined to determine the position of the flap valve. The valve box had deformed during the impact and jammed the flap valve, retaining it in the COLD position (Figure 7).

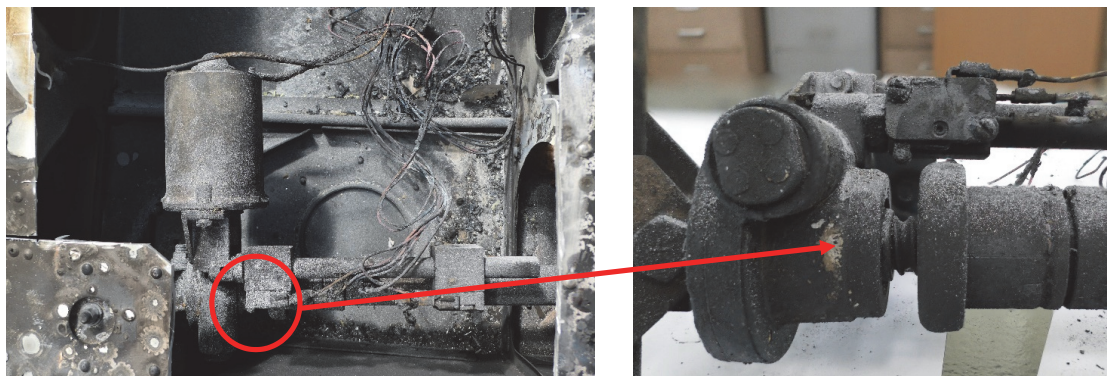
Figure 9
Flap actuator

The flap system was powered by an electrically driven screw-jack actuator in the right wing. The position of the flaps can be determined by measuring the extension of the actuator, the measured extension on G-UFCO was 9.2 mm (Figure 9).

According to the manufacturer's documentation, the actuator is extended by 4 mm at flaps UP. On the accident site, the left flap was found to be at an angle of 5°, which was calculated to require an actuator extension of 38 mm. It is therefore probable that the flap had moved due to the loss of tension in the control cables as a result of the post-crash fire. Discussion with the manufacturer confirmed that 9.2 mm of actuator extension could be accounted for in the flap rigging tolerances and it is therefore considered that the flaps were set to the UP position at the time of the accident.

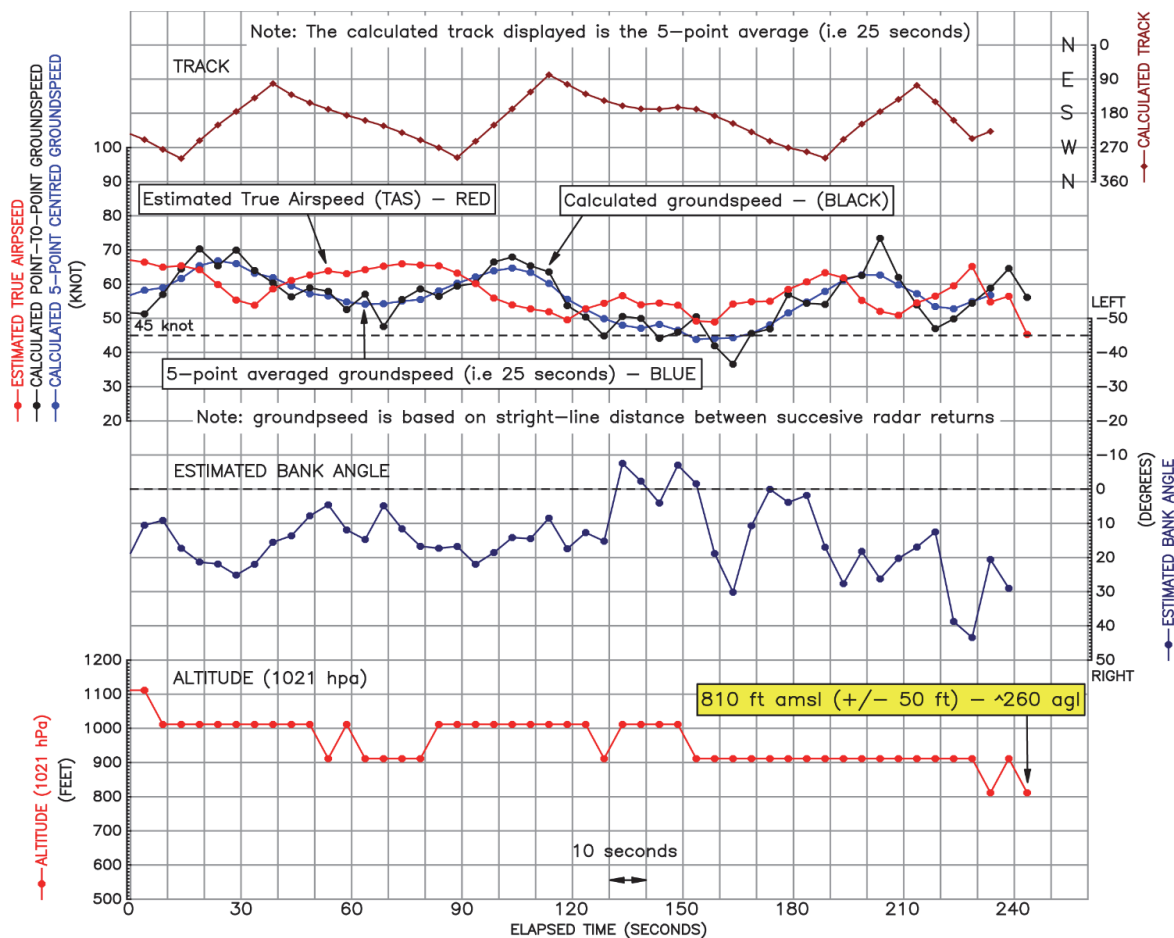
Figure 10 is a plot of the estimated TAS and bank angle during the latter stages of the flight. The bank angle is derived from the aircraft's rate of turn and its TAS measured between each radar point, which were five seconds apart.

Estimated airspeed and bank angle during latter stages of the flight

With the aircraft in a turn, additional engine power is required to maintain altitude and airspeed, but the evidence shows that the engine was operating at a low power setting. About 20 seconds before the final radar point the bank angle was estimated to have increased to about 45° as the aircraft turned through 180°. The altitude was maintained but the airspeed reduced to below 60 kt. The rate of turn was reduced for a short time and then the bank angle increased again to about 30°. The airspeed reduced below 50 kt TAS and the aircraft would have stalled, resulting in a loss of control with insufficient height to recover.

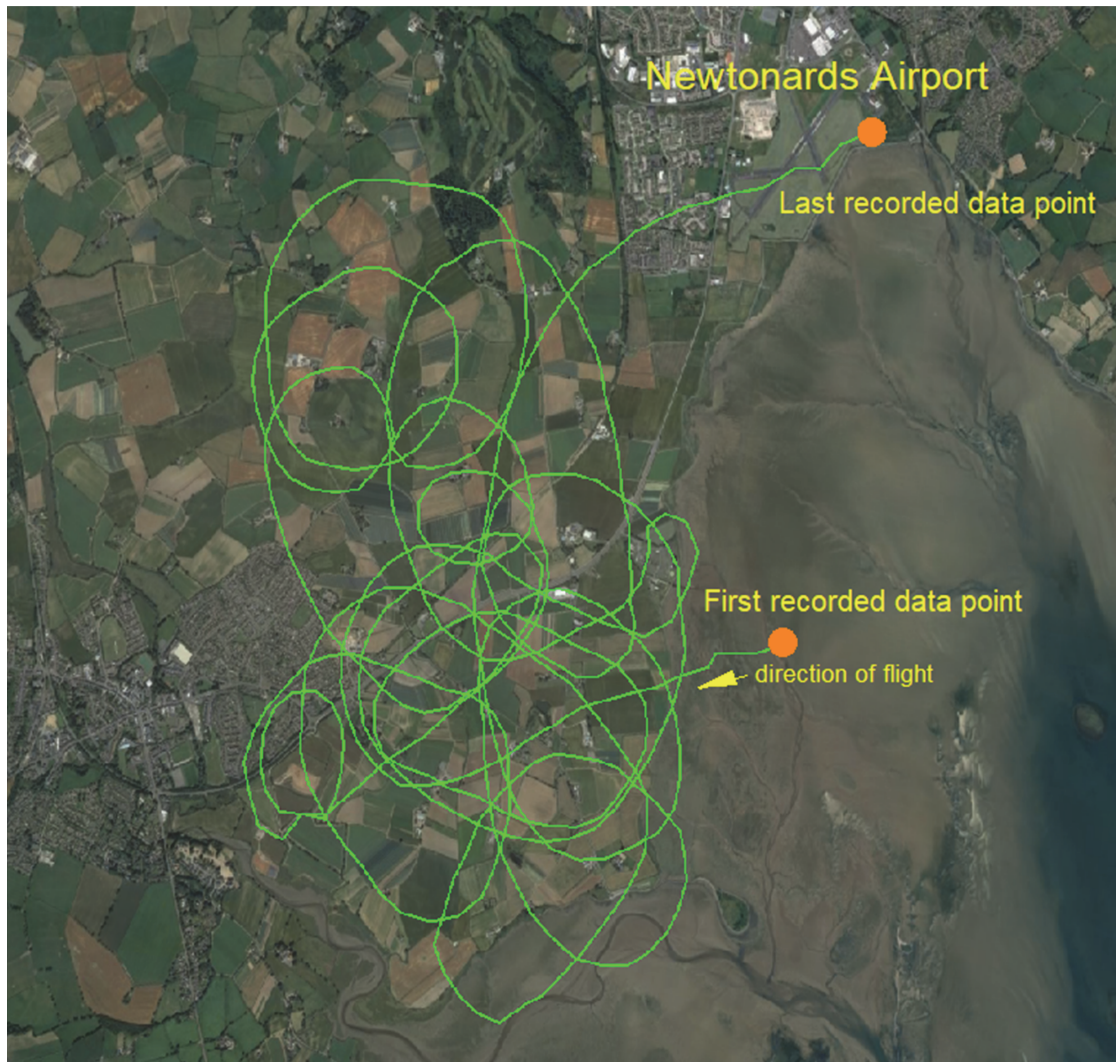
Figure 11

This flight was operated in an area just to the south-west of Newtownards Airport and was similar to the accident flight with multiple clockwise turns flown at between about 550 ft and 1,250 ft agl (Figure 11).

Flight flown by pilot of G-UFCO on 5 April 2018
