ACCIDENT

Aircraft Type and Registration:	Creasey RJ Easy Raider J2.2(2), G-CBKF	
No & Type of Engines:	1 Jabiru 2200A piston engine	
Year of Manufacture:	2002 (Serial no: BMAA/HB/202)	
Date & Time (UTC):	8 April 2018 at 1730 hrs	
Location:	Coombs Farm, Goodleigh, Devon	
Type of Flight:	Private	
Persons on Board:	Crew - 1	Passengers - None
Injuries:	Crew - None	Passengers - N/A
Nature of Damage:	Damage to the right wing, right landing gear and propeller	
Commander's Licence:	National Private Pilot's Licence	
Commander's Age:	55 years	
Commander's Flying Experience:	182 hours (of which 14 were on type) Last 90 days - 14 hours Last 28 days - 4 hours	
Information Source:	Aircraft Accident Report Form submitted by the pilot

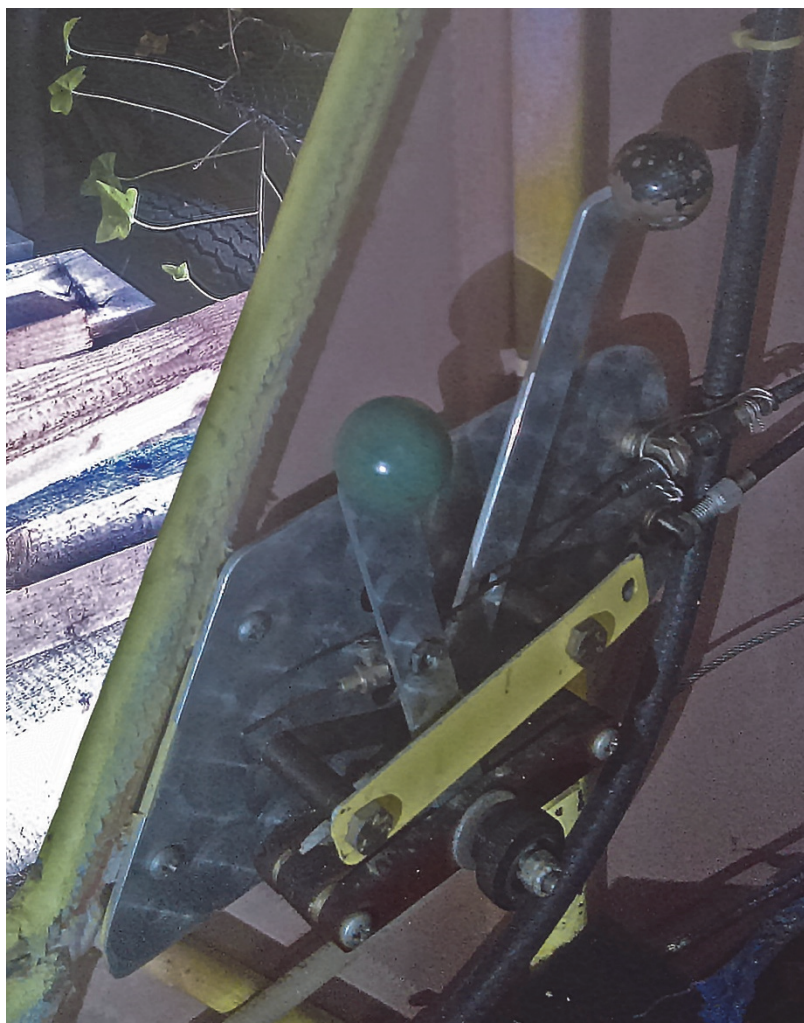
The pilot was returning to a private field and selected a short level area, located at the top of a 20° upslope and orientated into the wind, on which to land. On approach, he selected the first stage of flap, as he intended to fly parallel with the upslope, and returned his left hand to the throttle. However, when the pilot reduced power just prior to landing, he realised that he had in fact been holding the pitch trim control, which was identical in shape and size to the throttle but positioned just inboard (Figure 1).

Figure 1
Pitch trim and throttle controls
