**SERIOUS INCIDENT**

<b>Aircraft Type and Registration:</b>	EC135 P2+, G-POLA	
<b>No &amp; Type of Engines:</b>	2 Pratt & Whitney Canada PW206B2 turboshaft engines	
<b>Year of Manufacture:</b>	2010 (Serial no: 0877)	
<b>Date &amp; Time (UTC):</b>	5 April 2018 at 1040 hrs	
<b>Location:</b>	Morpeth, Northumberland	
<b>Type of Flight:</b>	Flight test	
<b>Persons on Board:</b>	Crew - 1	Passengers - 1
<b>Injuries:</b>	Crew - None	Passengers - None
<b>Nature of Damage:</b>	None	
<b>Commander's Licence:</b>	Commercial Pilot's Licence	
<b>Commander's Age:</b>	49 years	
<b>Commander's Flying Experience:</b>	6,200 hours (of which 2,400 were on type) Last 90 days - 16 hours Last 28 days - 7 hours	
<b>Information Source:</b>	AAIB Field Investigation

**Synopsis**

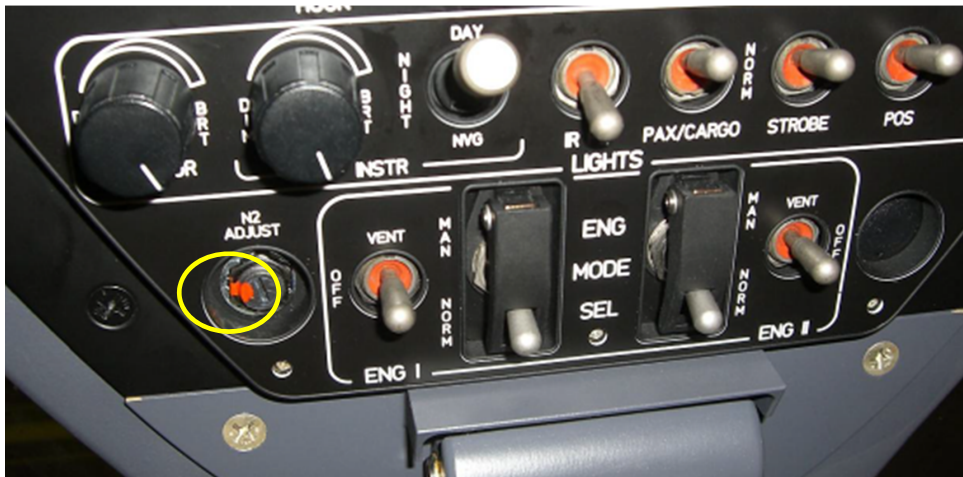
**Figure 1**

The  $N_2$  adjuster is a small rotary switch set into the overhead panel (Figure 1) alongside the ENG I and ENG II MODE and VENT selection switches just behind the rotor brake lever. To operate the adjuster, a small flat-bladed screwdriver must be inserted which then enables it to be turned clockwise or anticlockwise. Within the switch there are a series of radially spaced contacts which are brought into alignment in various combinations as the spindle is rotated. In the switch casing there are 12 detent slots which engage a spring-loaded plunger held in the spindle designed to assist in the accurate alignment of the contacts. The detents give the switch a distinctive but light 'click' as the switch is rotated. There is also a fixed limit stop within the switch casing. However, in this application, it is required to work in a similar way to a three-position switch that can be rotated left or right 45° either side of the neutral setting. This range of movement is set by a stop ring fitted around the spindle of the rotary switch. The stop ring has a tang which protrudes through the switch casing into the path of a moulded lug, thus restricting spindle rotation to between the lug and limit stop. Figure 1 shows the  $N_2$  adjuster location within the overhead switch panel of an example EC135. Safety lacquer (highlighted in Figure 1) is applied after adjustment in accordance with the AMM.

Pratt and Whitney engine EC135 N<sub>2</sub> adjuster location

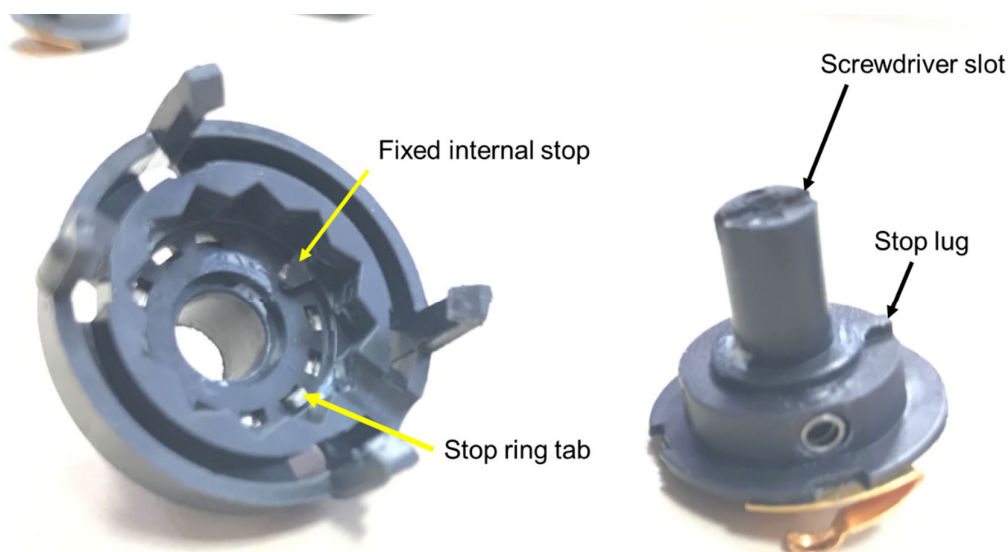
**Figure 2**

Pictures supplied by the manufacturer of the faulty switch showed no outward evidence of damage. However, the small screwdriver slot at the end of the spindle showed some evidence of wear marks left by screwdriver blades in the past (Figure 2).

These effects were compared to the original adjuster removed from G-POLA. The screwdriver slot showed superficial wear and the lug on the rotating part of the adjuster was undamaged (Figure 2).

$N_2$  adjuster fixed casing and spindle.

Note the stop ring tab, fitted to show how it controls the range of spindle rotation

The loss of control of N<sub>2</sub>, and therefore of N<sub>R</sub>, was caused by the absence of the stop ring mechanism within the P2 series EC135 N<sub>2</sub> adjuster, which risked a loss of control of the helicopter. The pilot had not been trained to carry out the procedure but his actions in flight prevented a more serious outcome.

- Issued an AMM amendment regarding the N<sub>2</sub> adjuster installation procedure (76-11-00,8-4), a caution to install the stop ring correctly / take care that the ring is not forgotten.
- Issued an AMM amendment regarding N<sub>2</sub> adjustment maintenance flights (05-60-00, 6-4), to check, prior to flight while on ground without power, that the N<sub>2</sub> adjustment switch works properly (only three switch positions are possible - decrease, neutral, increase). After successful check the switch must be turned into the neutral position.
- Issued Safety Information Notice AH 3254-S-76: '*Engine Controls – Engine Power Turbine Speed (N<sub>2</sub>)*' to draw attention to this occurrence, remind operators of the procedure, and to highlight the difference in N<sub>2</sub> adjustment procedures between the P2 and T2 Series EC135 helicopters.
