SERIOUS INCIDENT

Aircraft Type and Registration:	Boeing 787-9, G-CKWC	
No & Type of Engines:	2 Rolls-Royce Trent 1000-J3 Ten turbofan engines	
Year of Manufacture:	2018 (Serial no: 38893)	
Date & Time (UTC):	28 March 2018 at 2201 hrs	
Location:	London Gatwick Airport	
Type of Flight:	Commercial Air Transport (Passenger)	
Persons on Board:	Crew - 10	Passengers - 260
Injuries:	Crew - None	Passengers - None
Nature of Damage:	None	
Commander's Licence:	Airline Transport Pilot's Licence	
Commander's Age:	63	
Commander's Flying Experience:	18,765 hours (of which 699 were on type) Last 90 days - 190 hours Last 28 days - 60 hours	
Information Source:	Aircraft Accident Report Form submitted by the pilot

Synopsis

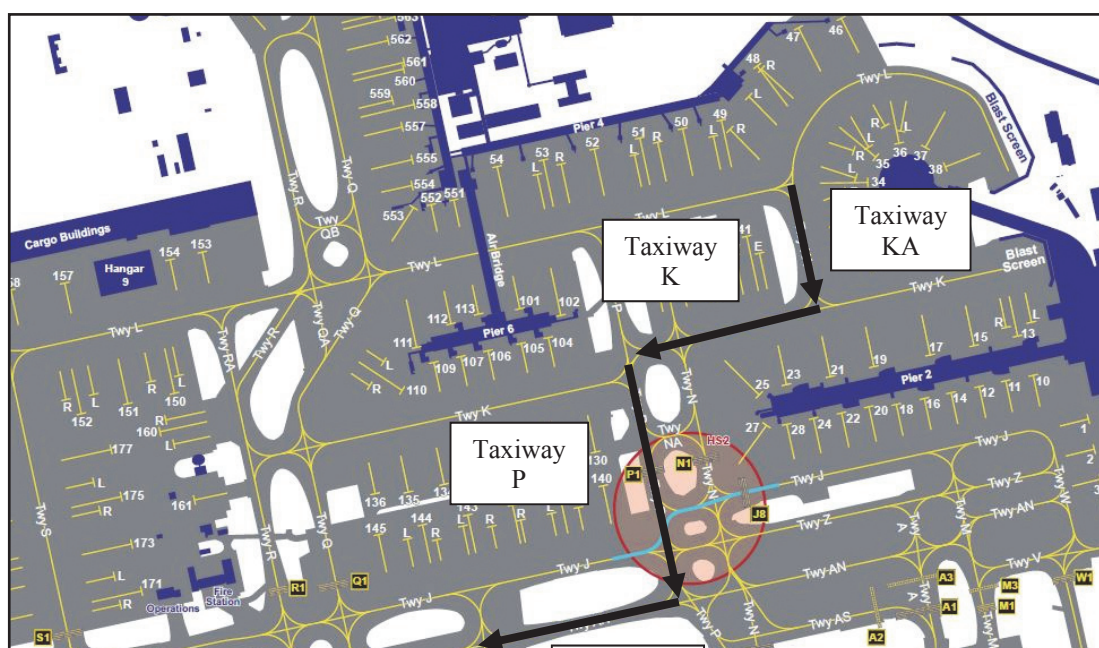
At 2137 hrs, the aircraft pushed back from its stand at LGW. The aircraft taxied out for Runway 26R via Taxiways KA, K to hold at Holding Point P1. At 2156 hrs, the aircraft was given a conditional clearance to line up on Runway 26R after a landing A320. At 2158 hrs the aircraft crossed the holding point at P1 and taxied via P and AN to the runway. Whilst on Taxiway AN, before entering the runway, the crew received their takeoff clearance. Figure 1 shows the taxi routing taken by G-CKWC.

G-CKWC taxiway routing at LGW

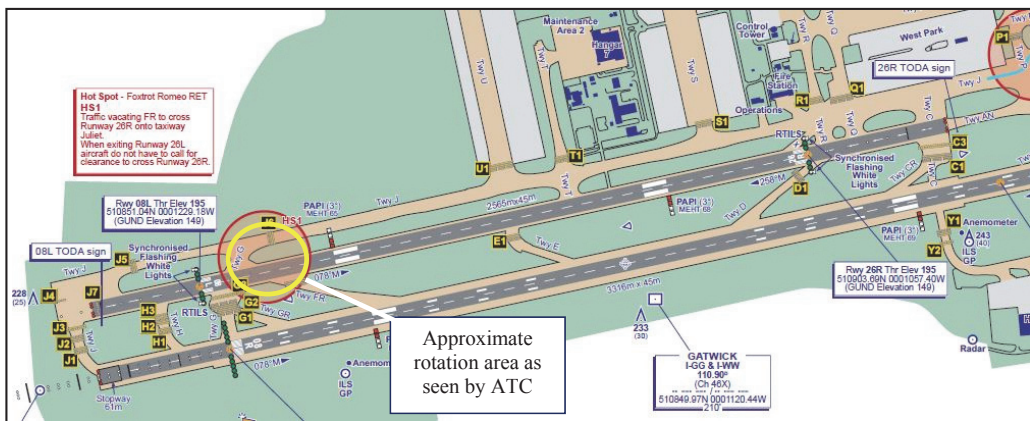
Figure 2

The crew elected to perform a rolling takeoff. The tower controller noted that the aircraft did not appear to put on power or accelerate until at the Runway 26R landing threshold. The controller also saw that the aircraft did not appear to rotate until approximately abeam Taxiway FR as shown in Figure 2. The crew later recalled that there was not much runway remaining at lift-off.

Full length of Runway 26R

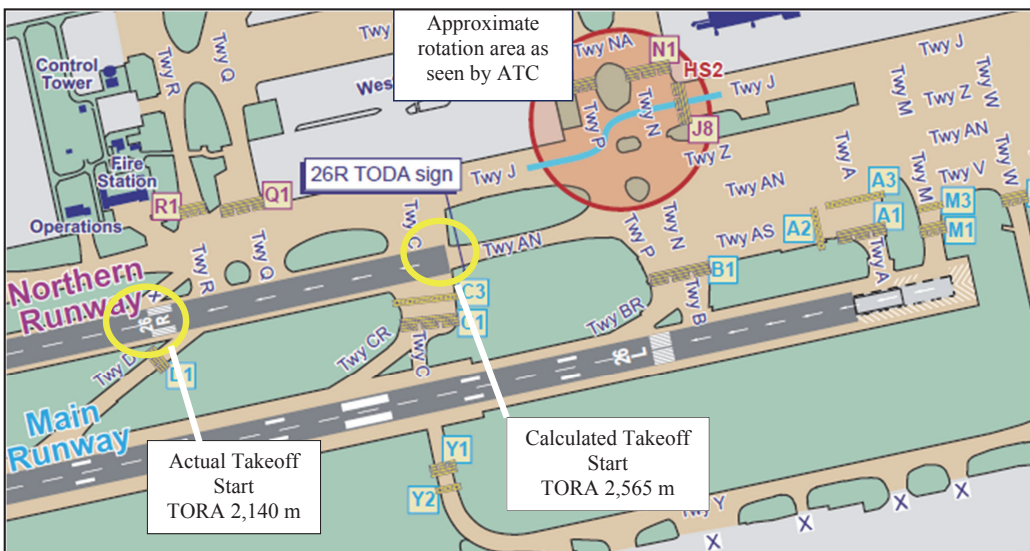
The aircraft began its takeoff roll from the displaced landing threshold of Runway 26R at Gatwick Airport, rather than at the beginning of the runway. This decreased the distance available for the takeoff by 417 m.

Figure 3 shows where the aircraft takeoff performance was calculated from (TORA¹ 2,565 m) and where the takeoff actually commenced (TORA 2,140 m).

The calculated and actual takeoff start points

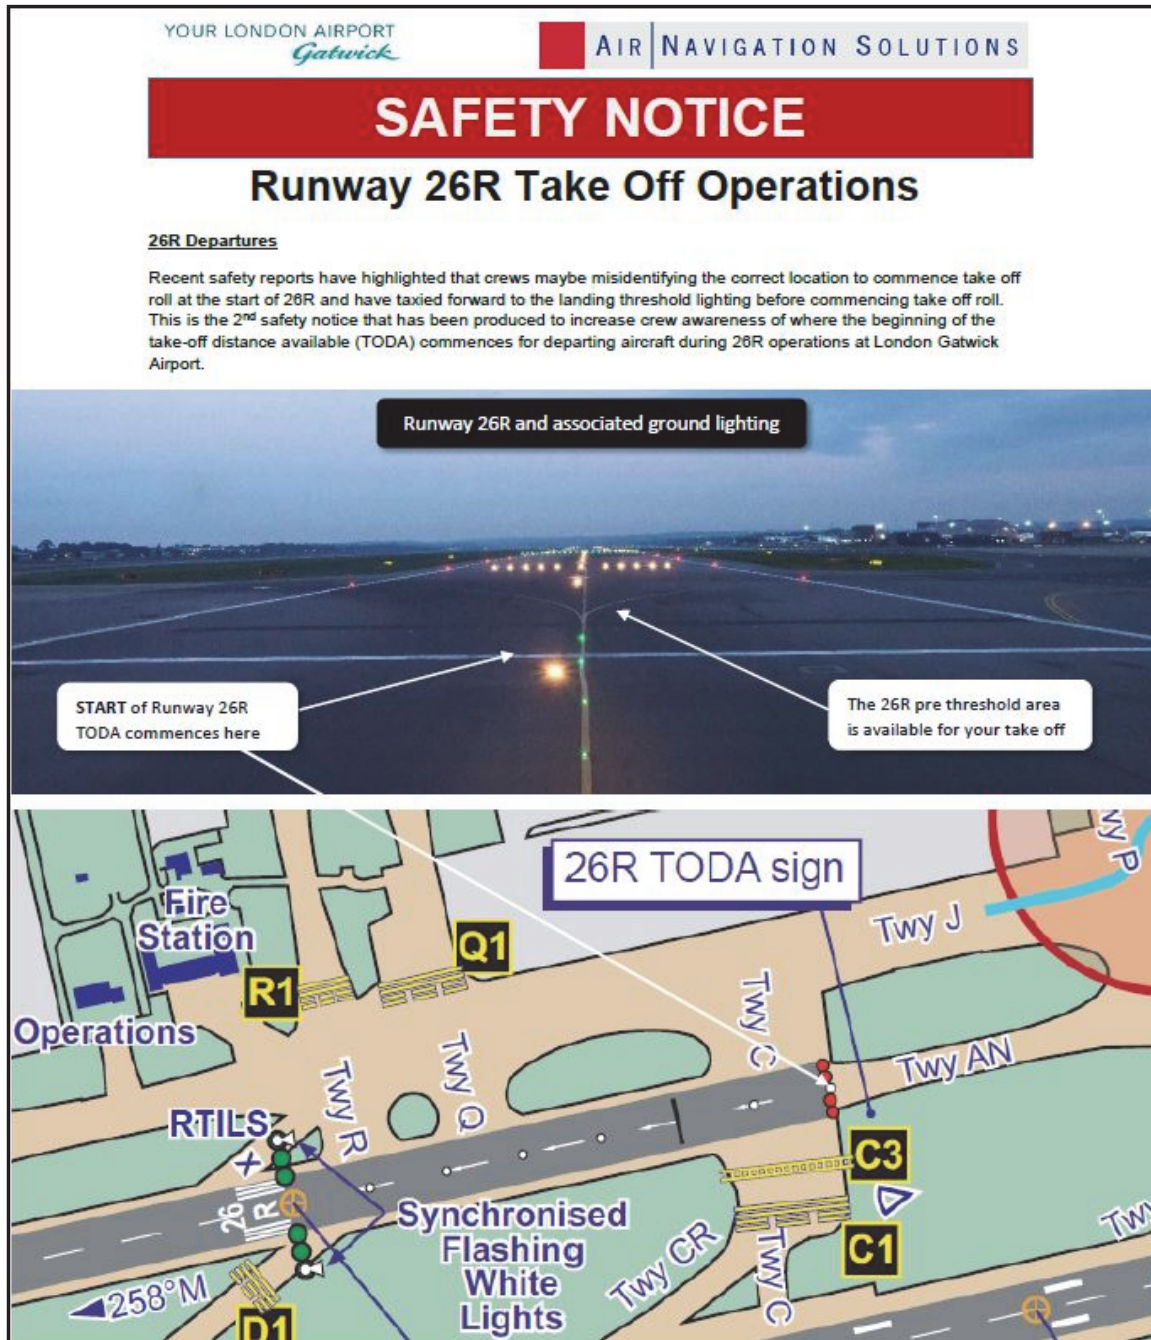
Figure 7

Safety Notice issued by Gatwick and the ANSP

- A Safety Notice was published on 13 April 2018 to provide further information for pilots on the location on Runway 26R from where they can commence their takeoff. This Safety Notice was subsequently amended and reissued to include a photograph with the airfield lighting illuminated. This amended notice is shown at Figure 7.
