ACCIDENT

Aircraft Type and Registration:	Piper PA-28-161 Cherokee Warrior III, G-WAVS	
No & Type of Engines:	1 Lycoming O-320-D3G piston engine	
Year of Manufacture:	1998 (Serial no: 2842035)	
Date & Time (UTC):	8 January 2018 at 1232 hrs	
Location:	Bredon Hill, Overbury, Worcestershire	
Type of Flight:	Training	
Persons on Board:	Crew - 2	Passengers - None
Injuries:	Crew - 2 (Fatal)	Passengers - N/A
Nature of Damage:	Aircraft destroyed	
Commander's Licence:	Commercial Pilot's Licence	
Commander's Age:	52	
Commander's Flying Experience:	5,700 hours ¹ Last 90 days - 131 hours Last 28 days - 18 hours	
Information Source:	AAIB Field Investigation

Synopsis

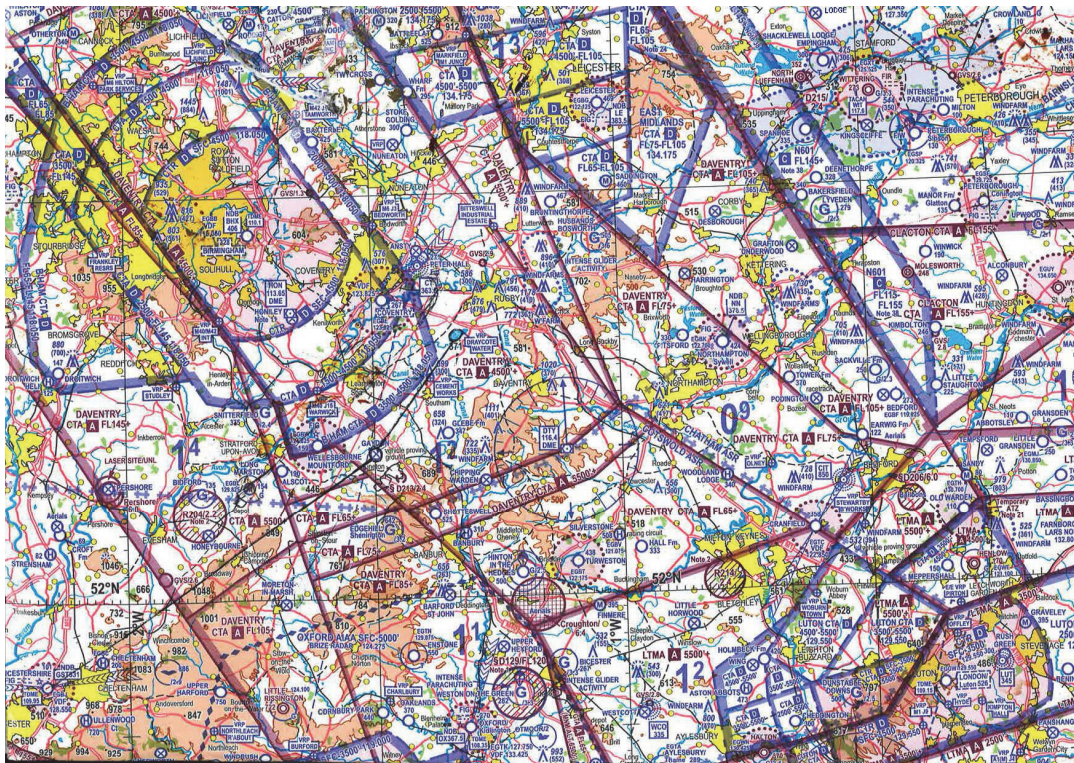
Part of aeronautical chart with track line

The school's operations manual defined minimum safe altitude as being 1,000 ft above the highest obstacle within 5 nm of the intended track. For the planned route at Figure 1 this would have given a safe altitude of 2,400 ft. However, on the day of the accident an altitude of 2,400 ft would have required penetrating icing conditions for which the aircraft was not equipped.

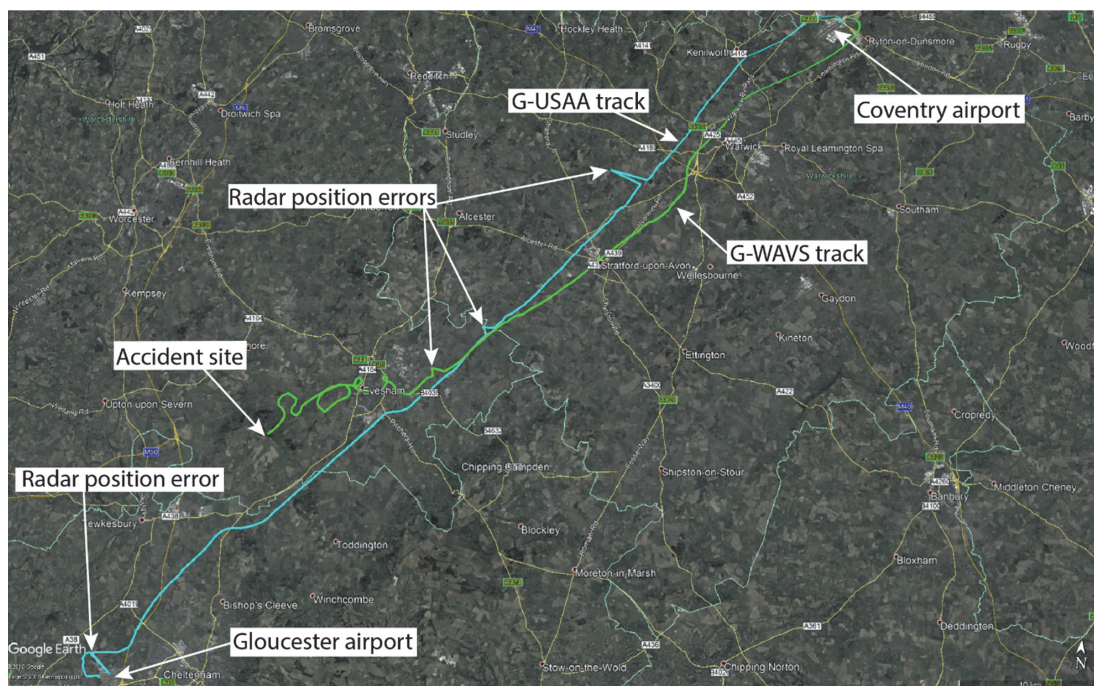
Figure 3

Radar tracks of G-WAVS & G-USAA

The radar data shows G-WAVS flew from Coventry towards Warwick and Stratford-upon-Avon, flying between approximately 800 ft and 900 ft amsl. G-USAA initially tracked to the north of G-WAVS, maintaining a separation of between 1 and 2 nm, but at a higher altitude of approximately 1,100 to 1,200 ft amsl. Both aircraft descended

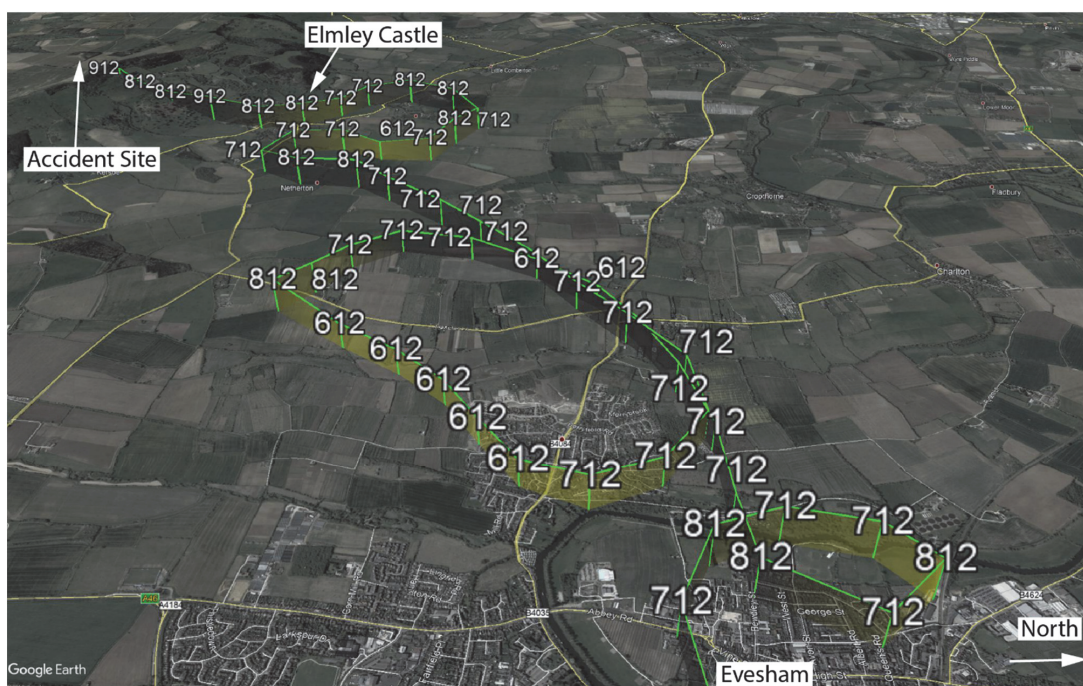
Figure 4

The final track and altitude returns from G-WAVS

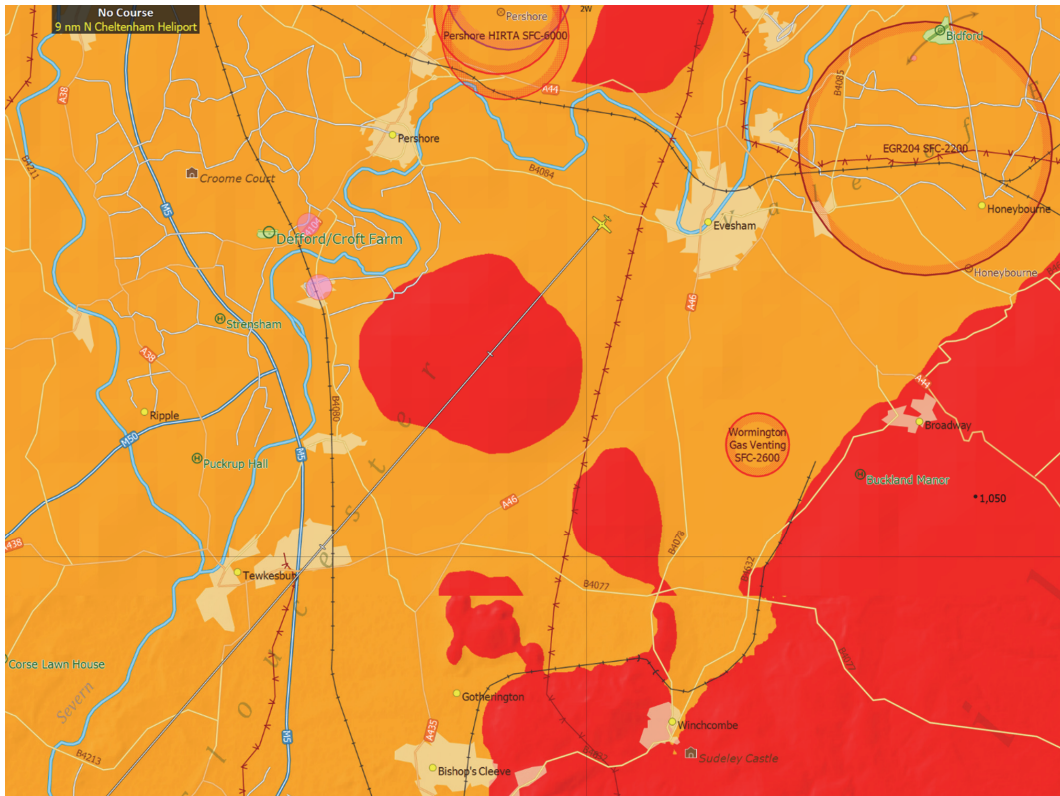
Figure 6

An example application showing the simulated track of G-WAVS towards Bredon Hill

The image shows the rising ground of Bredon Hill relative to the simulated aircraft flying at 900 ft amsl, and high ground to the right side of the Figure.
