**ACCIDENT**

<b>Aircraft Type and Registration:</b>	Cessna 172S JT-A, PR-PTS	
<b>No &amp; Type of Engines:</b>	1 Technify Motors TAE 125-02-114 turbocharged diesel piston engine	
<b>Year of Manufacture:</b>	2017 (Serial no: 172S12057)	
<b>Date &amp; Time (UTC):</b>	23 December 2017 at 2133 hrs (1733 local time)	
<b>Location:</b>	Following takeoff from Providenciales Airport, Turks and Caicos Islands	
<b>Type of Flight:</b>	Private	
<b>Persons on Board:</b>	Crew - 1	Passengers - 1
<b>Injuries:</b>	Crew - 1 (Fatal)	Passengers - 1 (Fatal)
<b>Nature of Damage:</b>	Aircraft destroyed	
<b>Commander's Licence:</b>	Brazilian Commercial Pilot's Licence	
<b>Commander's Age:</b>	44 years	
<b>Commander's Flying Experience:</b>	At least 1,398 hours (of which at least 342 were on type) Last 90 days - unknown Last 28 days - unknown	
<b>Information Source:</b>	AAIB Field Investigation

**Synopsis**

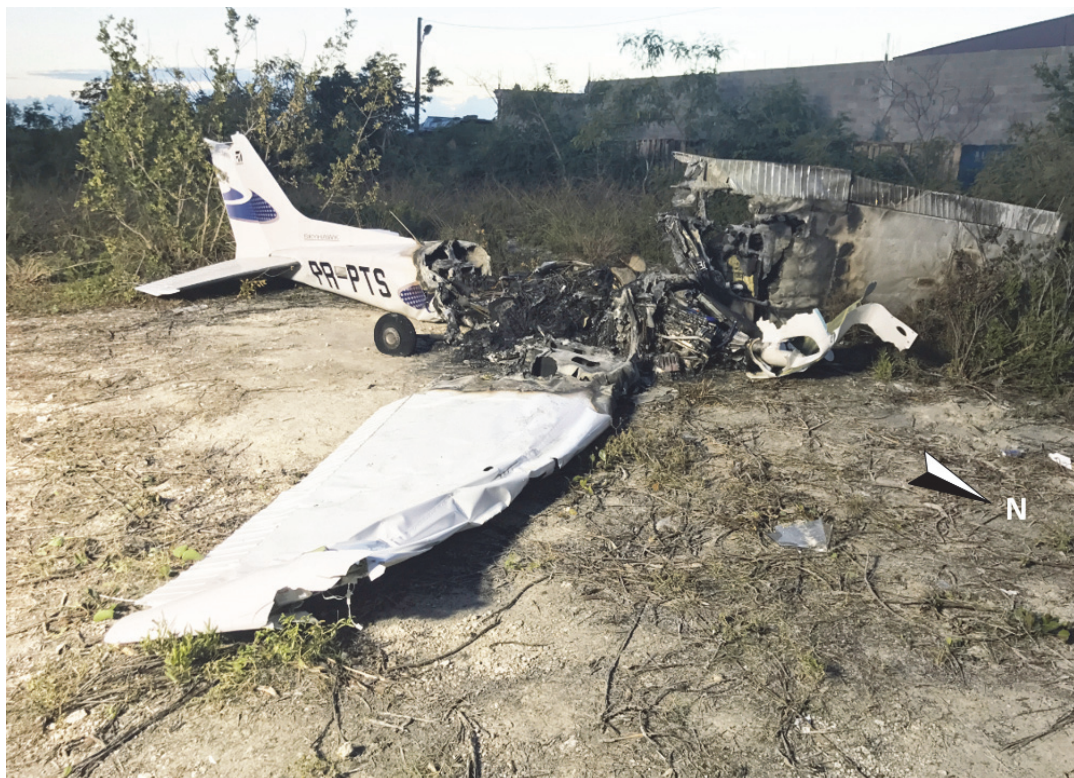
**Figure 1**  
Accident site

The aircraft had struck the ground in a steep nose-down attitude, and had come to rest at the impact point (Figure 1) approximately 270 m north of the runway extended centreline. The impact heading was 010°M, 90° to the left of the departure runway heading. Both wing fuel tanks were ruptured on impact and a severe post-impact fire had developed, consuming the majority of the aircraft's cabin and inboard wing structure.

All major components of the aircraft were located at the accident site. Continuity of the flying controls was established between the cockpit controls and the flying control surfaces. The flaps were fully up and the elevator trim tab was in a neutral position. The pre-impact position of the fuel selector valve could not be determined due to disruption of the cockpit during the accident.

The post-crash fire had consumed most of the engine's air induction and coolant hoses. The intercooler was recovered with both hose clamps and a remnant of the silicone hose in position at the intercooler inlet. The intercooler outlet hose clamps had released from the intercooler during the impact and subsequent fire, but were later identified within the aircraft wreckage. The induction manifold inlet had both hose clamps still in position although the hose itself had burned away. The turbocharger compressor outlet coupler was secured to the turbocharger by its metal V-band clamp, however the single hose clamp that attaches the compressor outlet hose to the turbocharger was not located in the aircraft wreckage or at the accident site.

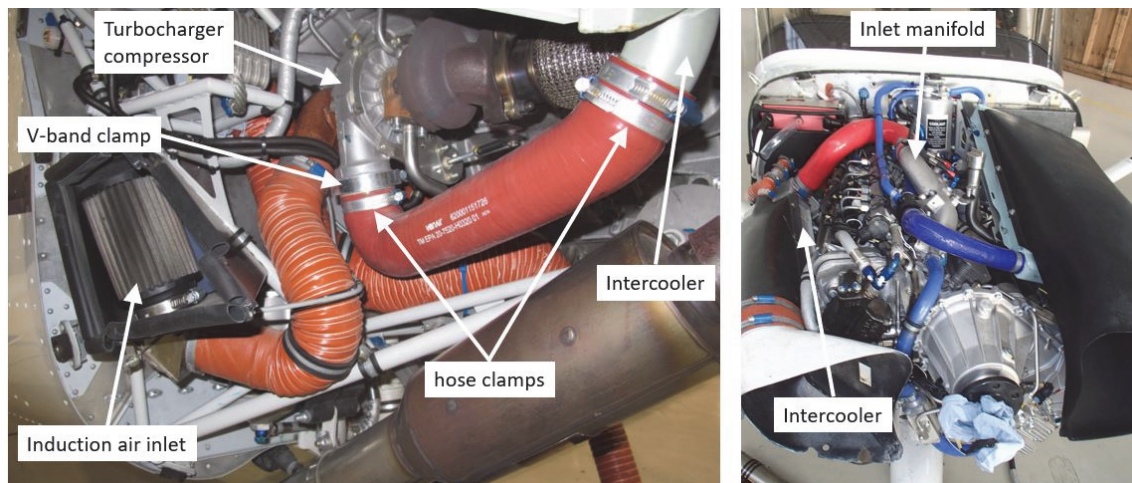
**Figure 2**

Engine induction air is drawn through an inlet and filter on the right lower cowling, before being ducted to the turbocharger compressor inlet (Figure 2). Pressurised induction air

passes from the turbocharger compressor outlet via a silicone hose to an intercooler where the induction air is cooled prior to being routed via a second silicone hose to the engine inlet manifold. Two manifold air pressure sensors, one for each FADEC channel, measure the induction air pressure at the inlet manifold.

The turbocharger compressor outlet has an adapter attached to it, secured by a metal V-band clamp. The silicone hose connecting the turbocharger compressor outlet to the intercooler is attached with a single hose clamp at the coupler end as there is insufficient space for two hose clamps. This hose has two hose clamps at the intercooler end. The silicone hose that connects the intercooler outlet to the inlet manifold has two hose clamps at either end of the hose.

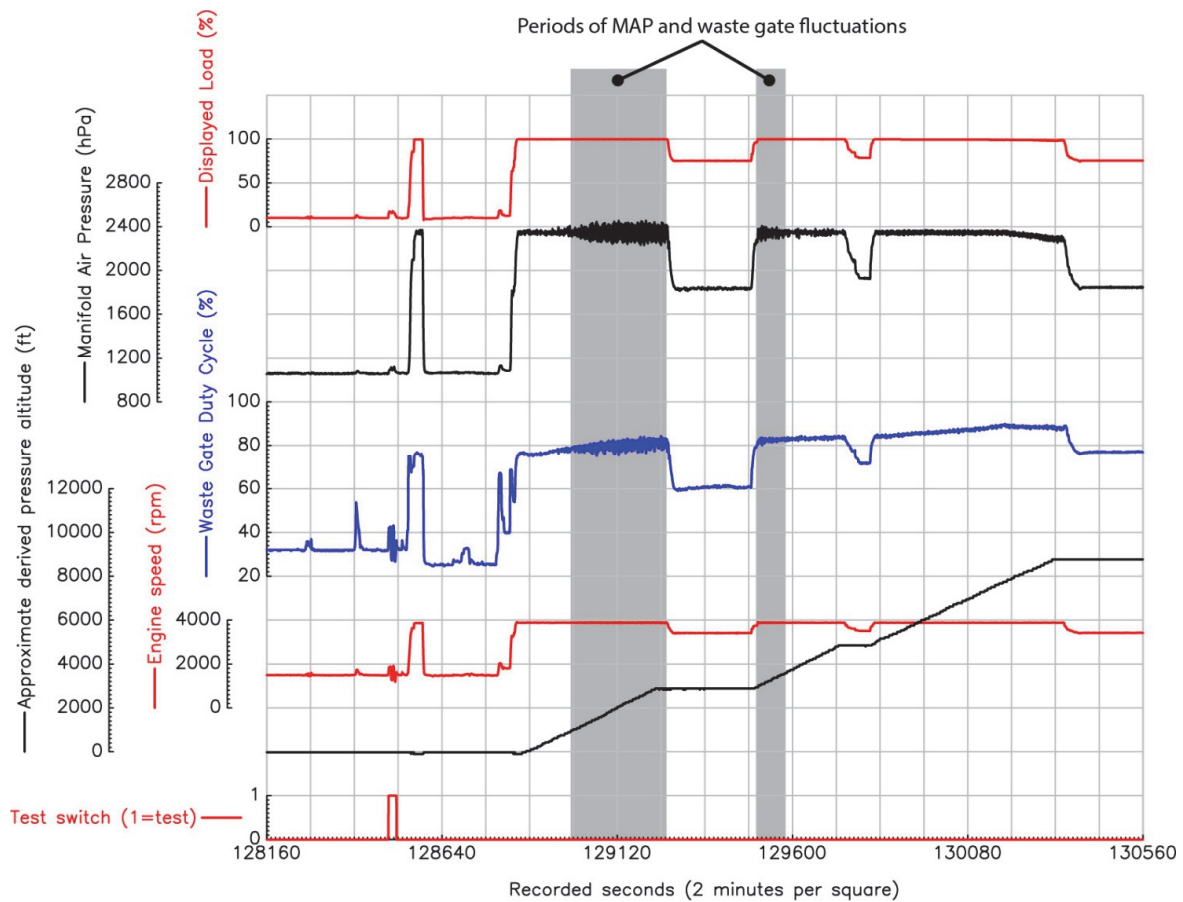
**Figure 4**

During the first flight of the day (Figure 4), climbing through approximately 1,000 ft agl, there was a period where the MAP started to fluctuate with a peak-to-peak value of approximately 200 hPa (200 mbar). This stopped when the engine rpm was reduced after levelling off. The fluctuations returned to a lesser degree when climbing once more, reducing in amplitude as the climb progressed. The waste gate control values also fluctuated when the MAP was fluctuating.

As the MAP and waste gate parameters were only recorded once per second, it could not be determined whether the waste gate control fluctuations were driving the MAP fluctuations or reacting to them. The limited sample rate also means that the frequency of the fluctuations and an accurate amplitude for the fluctuations could not be determined.

The engine manufacturer stated that tests allowed up to 75 mbar of fluctuation but they are normally much less than this, 30 mbar at most.

The MAP fluctuations were also first observed with similar amplitudes, in excess of the manufacturer bench test limits, during a pre-delivery test flight conducted by the aircraft manufacturer on 16 December 2017. Similar MAP fluctuations were present on all subsequent flights. The data shows the MAP fluctuations on 16 December 2017 were present to a greater extent than that shown in Figure 4 but had not drawn the attention of the test pilot. The recorded displayed load parameters indicates that full power was available during the periods of MAP fluctuation.

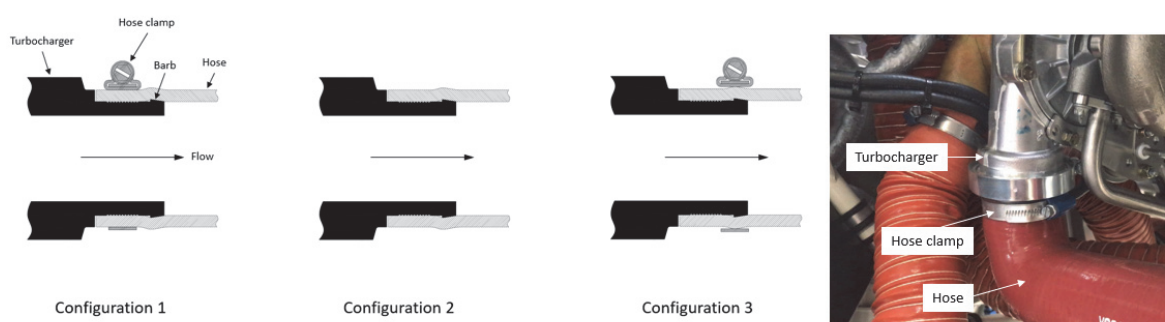
**Figure 5**

Three configurations of the securing of the turbocharger compressor hose were tested (Figure 5). The first test involved the turbocharger hose clamp being correctly positioned and loosened to the point where it was free to rotate about the hose, but still tight enough not to slide over the bulge in the hose due to the turbocharger outlet barb feature. When the engine was run at full power, the hose remained attached and the engine ran normally.

The second test involved removal of the hose clamp. The engine started and ran normally at idle power, but when the power lever was advanced the hose immediately detached from the turbocharger, before full power was reached. When the hose detached, the manifold pressure reduced to ambient pressure and the load reduced to approximately 55%. The exhaust gases were a dark, smoky colour due to an excessive level of unburnt fuel. The engine manufacturer confirmed that an abrupt reduction in manifold pressure would result in a lower air mass flow, leading to a sootier combustion which is visible in the black exhaust gases.

A third test was performed with the hose clamp incorrectly positioned over the bulge in the hose where it passed over the turbocharger barb. With the hose clamp loose enough to be rotated by hand, the hose detached when the engine ran before full power was reached, with similar results to the second test. A fourth test was performed with the hose clamp positioned as for the third test, but with the clamp tightened to the 5 N cm torque level, as required by the Aircraft Maintenance Manual (AMM). The hose clamp and hose remained attached during the subsequent engine run and the engine developed full power with a normal exhaust gas appearance. The clamp torque level was then reduced to 2.5 N cm, only 50% of the AMM-required level. Despite this reduction in clamp torque, the clamp and hose remained attached during an engine run to full power, including slam-throttle tests where the engine was rapidly accelerated from idle to full power.

1. The induction hose connection to the turbocharger compressor outlet may have failed. Since the single hose clamp at this position was not recovered in the aircraft wreckage, it is possible that it detached during

the takeoff sequence although the absence of this component prevented further investigation into this scenario. Tests conducted by the engine manufacturer showed that, with the hose clamp either absent, or loose and misaligned over the turbocharger outlet barb, the induction hose did not remain attached to the turbocharger when the engine was run at full power. Therefore, as the aircraft had flown a number of flights successfully after the removal and reinstallation of the turbocharger and induction hose, for the modification RI-05-0014-01, it can be concluded that the hose clamp was present and was tight enough to retain the induction hose for at least the successfully completed flights.

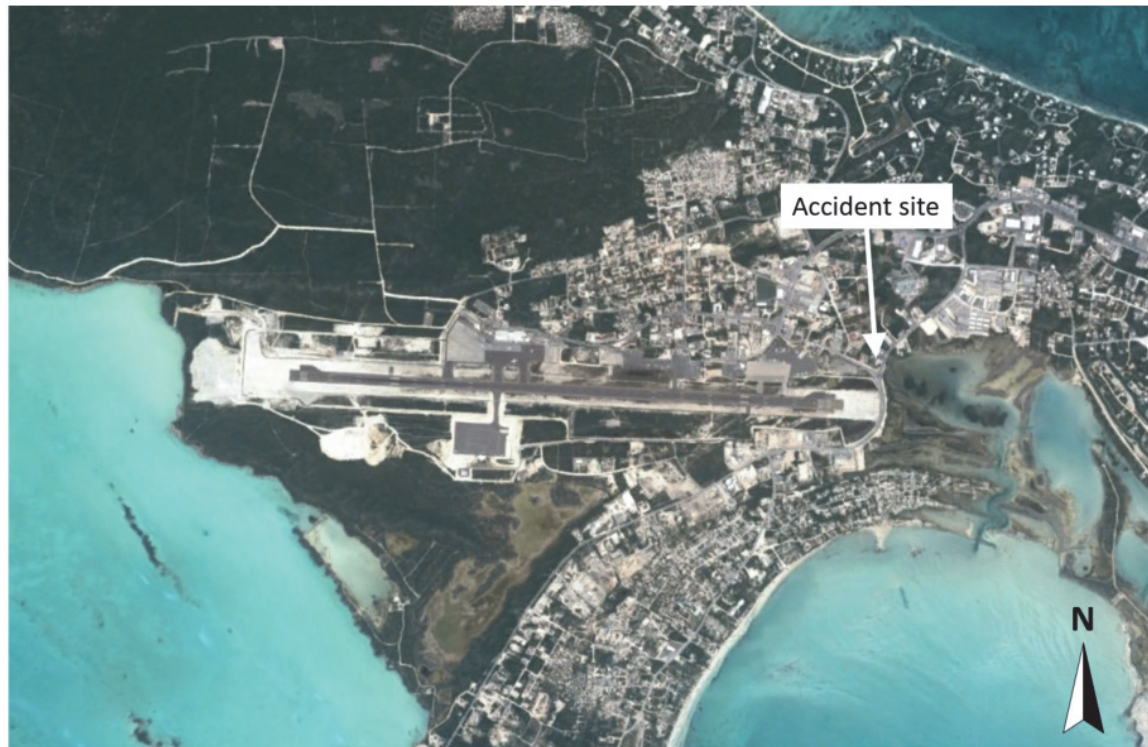
**Figure 6**

The aircraft had struck the ground to the north of the airport and outside the perimeter fence (Figure 6). The accident site was a corner piece of undeveloped land bordered by roads and next to a petrol station. Police and fire services arrived at the scene quickly but a fierce fire had taken hold. The aircraft occupants were fatally injured. Post-mortem investigations showed that it is highly likely both occupants died instantly due to the initial impact.

Providenciales is the main international airport serving the Turks and Caicos Islands. The airport is at 15 ft amsl and has a single runway orientated 10/28. The runway is 2,807 m long. At both ends of the runway there are areas of water. In the case of Runway 10, this is a shallow lagoon containing areas of mangroves. Figure 6 shows the general area of the airport and the areas of water at each end of the runway.
