**ACCIDENT**

<b>Aircraft Type and Registration:</b>	EMB-145EP, G-CKAG
<b>No &amp; Type of Engines:</b>	2 Rolls-Royce AE3007A1 turbofan engines
<b>Year of Manufacture:</b>	1998 (Serial no: 145118)
<b>Date &amp; Time (UTC):</b>	22 December 2017 at 1137 hrs
<b>Location:</b>	Runway 27 at Bristol Airport
<b>Type of Flight:</b>	Commercial Air Transport (Passenger)
<b>Persons on Board:</b>	Crew - 3                      Passengers - 22
<b>Injuries:</b>	Crew - None                      Passengers - None
<b>Nature of Damage:</b>	Left main landing gear fairing strut broken; wheel rims and tyres damaged
<b>Commander's Licence:</b>	Airline Transport Pilot's Licence
<b>Commander's Age:</b>	50 years
<b>Commander's Flying Experience:</b>	8,600 hours (of which 5,100 were on type) Last 90 days - 97 hours Last 28 days - 51 hours
<b>Information Source:</b>	AAIB Field Investigation

**Synopsis**

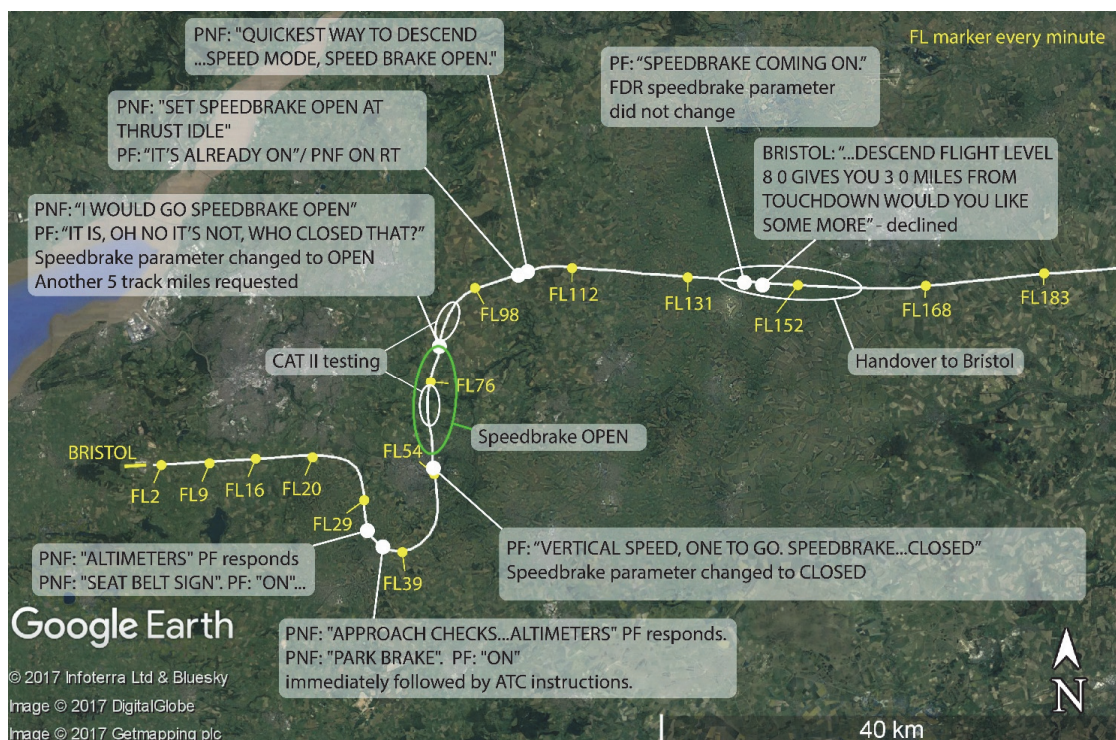
**Figure 2**

Figure 2 shows pertinent extracts from the CVR and FDR overlaid on the radar track of the aircraft. There was significantly more RT than shown due to the weather, and ATC vectoring and management of another aircraft with marginal capability given the runway visibility. There were also significantly more crew communications than shown relating to checklists, minima, alternate airports and other operational issues.

There was no recorded parameter for the parking brake. At the point of ATC handover to Bristol, the PF expressed the intent to set the speed brake but the recorded parameter for the speed brake did not change from closed.

Pertinent extracts from the CVR and FDR overlaid on the aircraft radar track

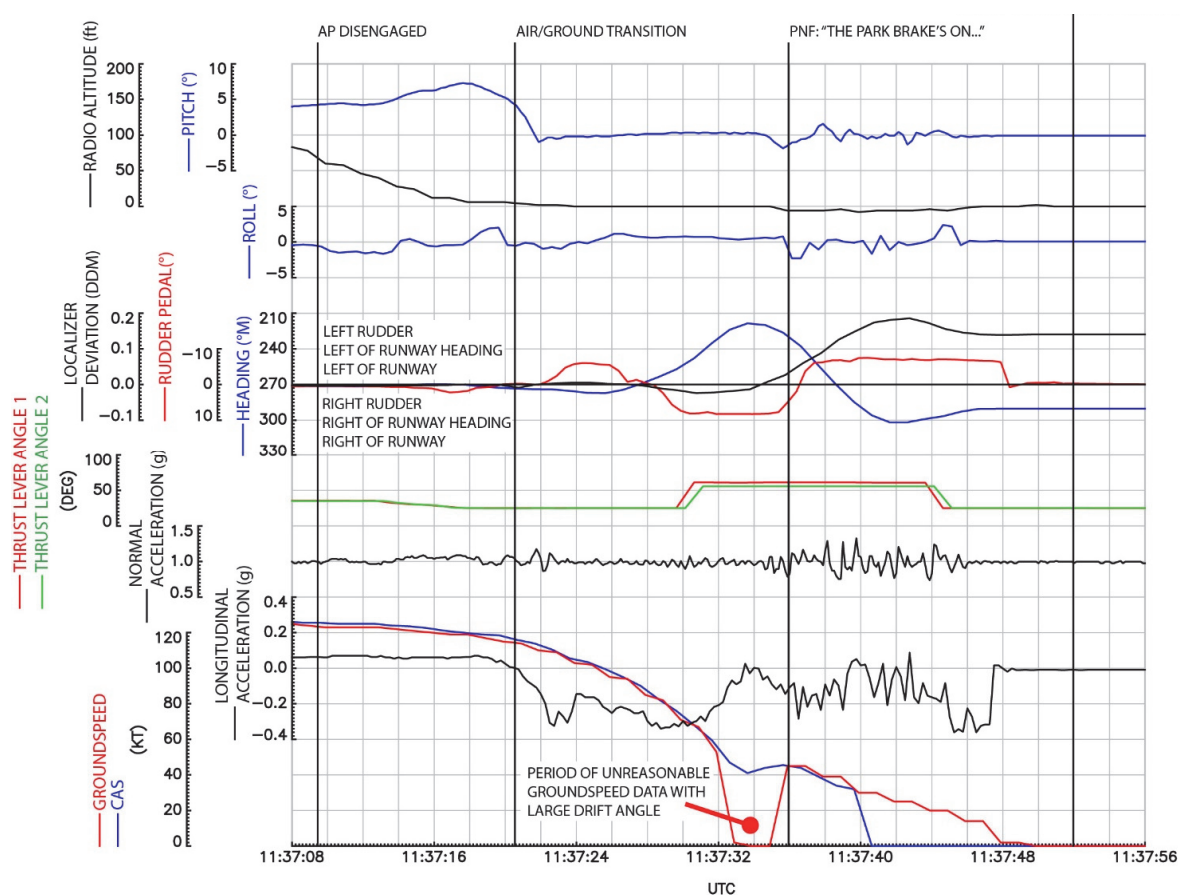
**Figure 3**

Figure 3, shows pertinent extracts from the CVR and FDR during the landing. The autopilot was disengaged at about 80 ft aal and the aircraft touched down on the centreline. The aircraft started tracking right of the runway centreline and opposite rudder was used. The aircraft heading swung to the left of the centreline, skidding approximately along the centreline as indicated by the localizer (the antenna is in the tail). Right rudder was applied but the yawing to the left continued. With a heading of between 15 and 30° to the left of the runway heading the thrust levers were advanced, slightly more left thrust than right. The aircraft carried on yawing to the left and the previous longitudinal deceleration was eroded. The divergence from the runway heading peaked at approximately 50° before starting to reduce, but with thrust applied the aircraft tracked to the left and went off the side of the runway with a groundspeed of approximately 45 kt. The aircraft was decelerating and as the groundspeed reduced to approximately 20 kt the thrust levers were brought back to IDLE. The aircraft came to a stop about three seconds later. The crew identified that the parking brake was applied as the aircraft left the runway.

Pertinent extracts from the CVR and FDR during the landing

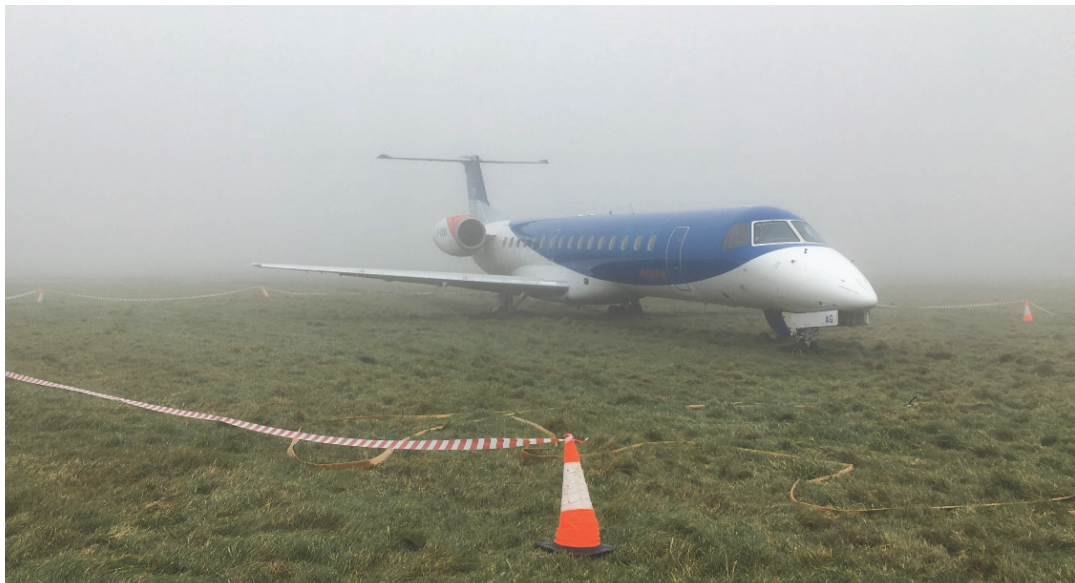
Figure 4 shows the aircraft where it had come to rest and the poor visibility shortly after the time of the accident. Marks and rubber fragments on the runway defined the touchdown point, approximately 468 m from the threshold, and showed the aircraft initially tracking on the runway centreline before drifting first slightly to the right of the centreline and then veering left over 280 m. Overheated fragments of vulcanised rubber were found at various points along the runway, with a cluster of larger fragments approximately 400 m from the touchdown point over an area of approximately 40 m by 3 m. After this point there were faint but reasonably clear lines left on the runway surface made by the wheel rims up to the point where the aircraft left the runway and continued onto the grass.

**Figure 4**  
G-CKAG off the runway

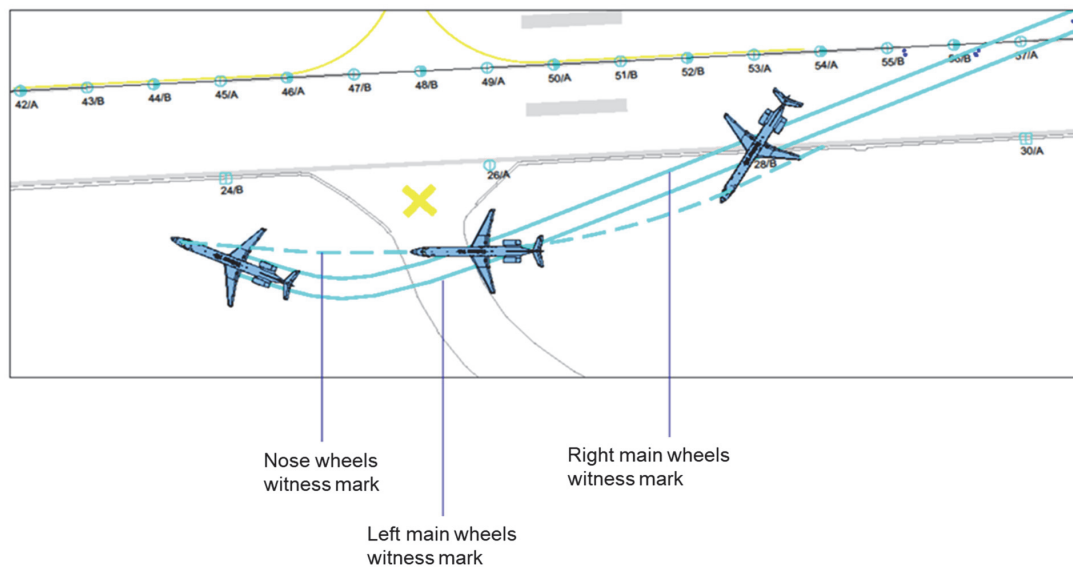
Once on the grass the aircraft left deep furrows in the top soil up to where it traversed a disused taxiway with further deep furrows beyond leading to its final position. The distance from where the aircraft left the main runway until coming to stop was approximately 120 m. Marks showed that it had 'fishtailed' from right to left whilst on the grass. The path of the aircraft from the runway is shown in Figure 5.

**Figure 5**  
The aircraft's path leaving the runway

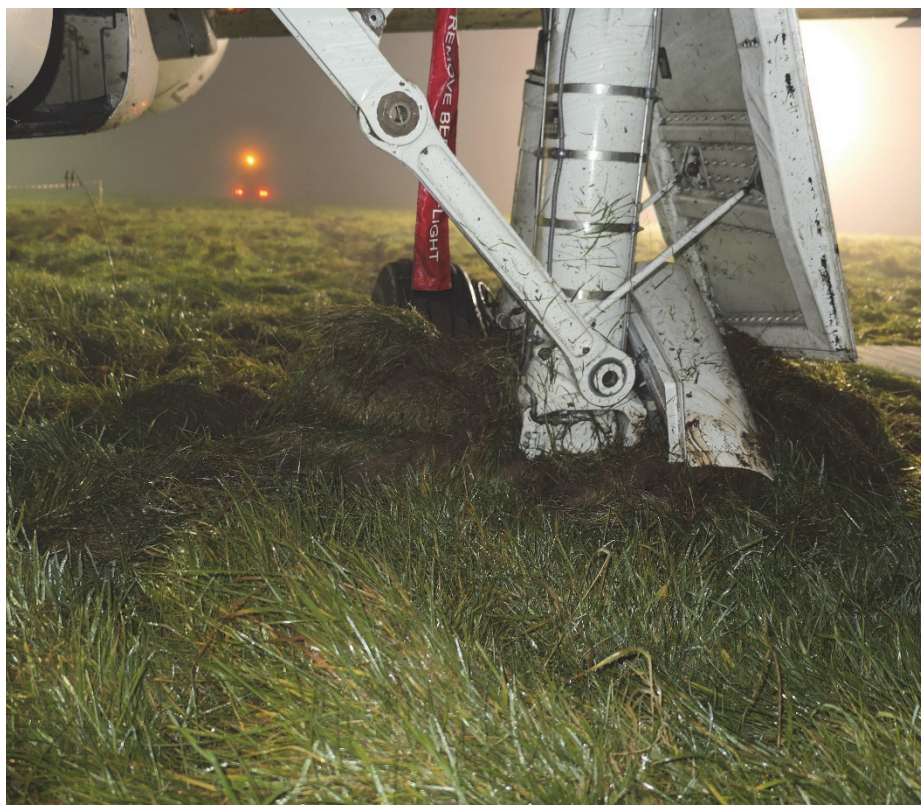
The aircraft stopped on a heading of 296°(M) and all four main wheels were buried up to their axles. The components attached to the front of the left and right main landing gear were clogged with soil and turf. Apart from the detached and loose lower fairing mounting strut on the left landing gear, there appeared to be no other damage. The nose landing gear, fuselage, wings and engines were undamaged although the left wing leading edge had soil residue along its length. Figure 6 shows the extent that aircraft main wheels and landing gear had dug in.

**Figure 6**  
The extent of the entrapment of the main wheels and landing gear  
(left side shown, the right side was similar)

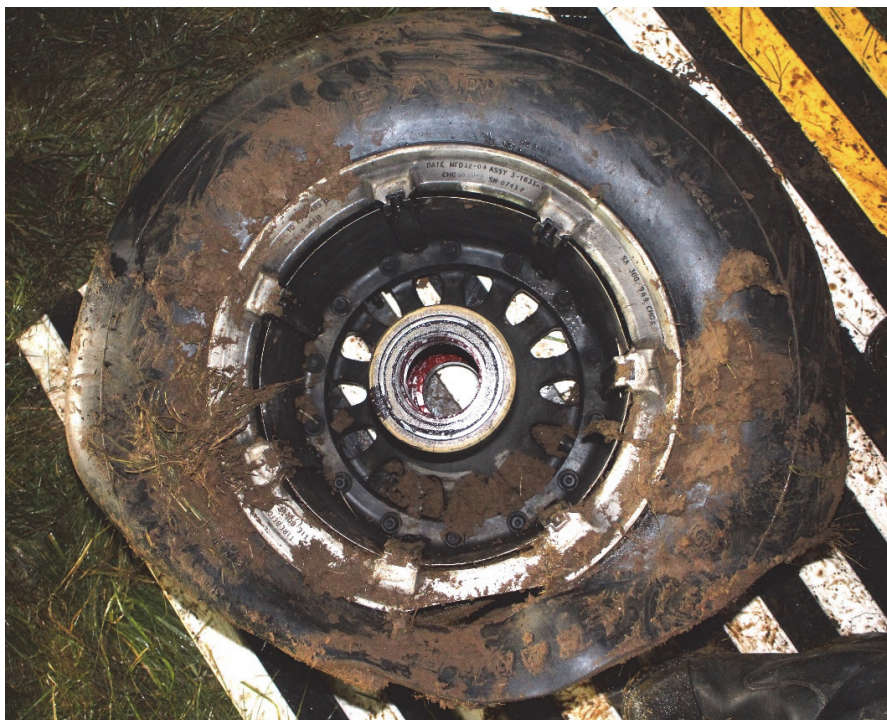
**Figure 7**

The wheels were removed and examined on site. The damage to all the main wheel tyres was similar and they were all deflated.

The wear pattern on the tyres showed the tread surface abraded through leaving ragged edges and missing material. Abrasion then carried on symmetrically though the sidewalls over an approximately 140° arc down to the wheel rims. There was also abrasion of some of the wheel rims where they had contacted the runway surface. None of the tyre beads de-seated and the fusible plugs and valves were not affected. Figure 7 shows the damage to one of the main wheel and tyre assemblies. The other main wheels and tyres exhibited the same extent of damage.

Main wheel and tyre damage

The material evidence supported the conclusion that the aircraft landed with all the main wheel brakes locked on which did not allow any rotation of the main wheels.

The crew noted a more rapid than normal de-rotation on touchdown consistent with the effect of higher drag loads imparted by the tyres as they contacted the runway surface. The small overheated tyre material 'rubbings' suggested the tyres did not immediately burst or deflate on touchdown. However, the cluster of larger fragments and ply material approximately 400 m from touchdown suggested that all the tyres burst either simultaneously or in very quick succession at that point. This left the sidewalls to take the weight and abrade uniformly down to the wheel rims, evidenced by the marks left on the runway, until the aircraft traversed on to the grass.

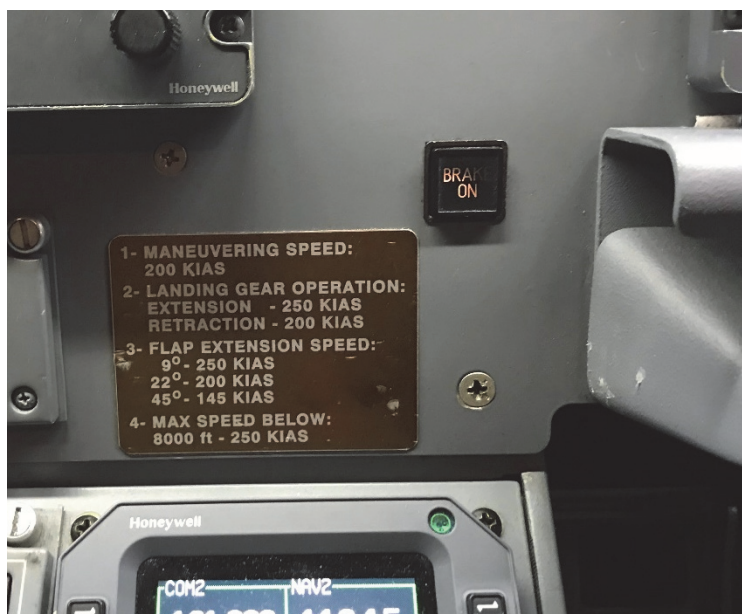
**Figure 8**

The aircraft had been shut down and made safe by the crew with the parking brake left in the OFF position. During examination of the aircraft, the parking brake was operated and, with aircraft electrical power on, the parking brake indicator on the centre panel illuminated. However, the nomenclature on the light did not appear to be as well defined as would be expected, consistent with one of its filaments having failed. Figure 8 shows the parking brake indicator.

Parking brake indicator

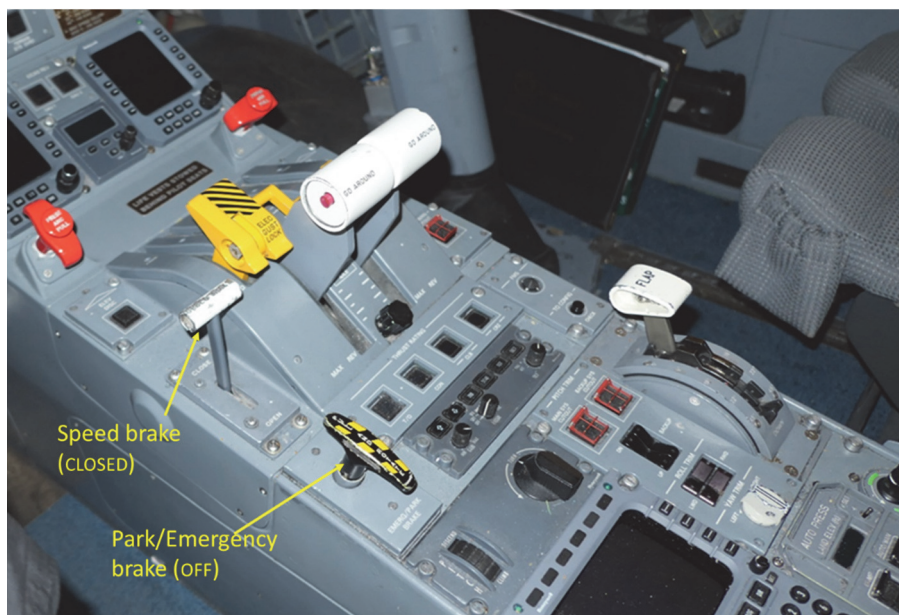
**Figure 9**

The speed brake function is electrically controlled by a small lever next to the power levers on the left side of the centre console (Figure 9). A green 'OPN' caption is displayed on the lower right area of the central Engine Indication and Crew Alerting System<sup>2</sup> (EICAS) screen when any of the surfaces are open.

Location of the controls on the centre console (viewed from the left)

The accident arose as a result of the inadvertent selection of the Emergency/Parking brake instead of the speed brake. The levers are of similar shape and sited close to each other but with a different appearance and mode of action. There is also a BRAKE ON indicator light. These risk controls proved ineffective in preventing the inadvertent selection of the Emergency/parking brake both on this occasion and on at least two previous occasions. Once the parking brake had been set there were opportunities to detect and correct the error, but a busy flight deck environment together with a high workload contributed to it going unnoticed.

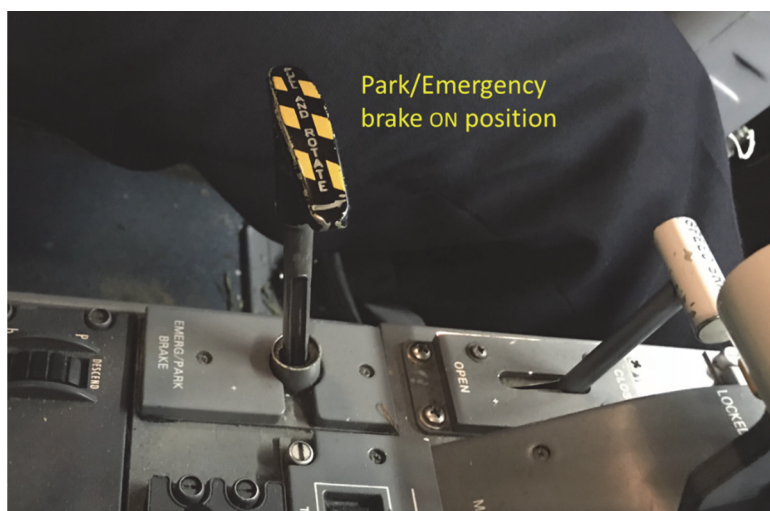
**Figure 10**

Apart from the extended position of the parking brake handle when the parking brake is applied, the only other brake condition indication is on a small illuminated indicator on the instrument panel marked BRAKE ON. Figure 9 shows the location of the controls on the centre console and Figure 10 shows the parking brake in the ON condition.

Figure 10 shows the left seat in its rearwards position. When the seat is towards its fully forward position the parking brake handle is out of the seat occupant's direct line of sight and is likely to be operated by 'feel'. When the aircraft is on the ground with the parking brake set to ON there is a warning feature built into the system which displays an EICAS caution NO TAKEOFF CONFIG if the power levers are advanced to 60%. This system does not apply when the aircraft is airborne.

Parking/Emergency brake ON (viewed from the right, seat in most rearwards position)

On G-CKAG, the BRAKE ON light is situated out of the normal field of view of a pilot in the right seat. For some other variants of the type it is situated higher on the centre panel, next to the landing gear selector lever and closer to the normal field of view, thereby providing an additional opportunity to notice that the light is on when lowering the landing gear. Although this is likely to be a more effective position, the aircraft in one of the two previous events recorded had this configuration. Thus, there was insufficient evidence to draw conclusions about the effectiveness of the different panel layouts in preventing this type of accident.

The operator introduced a revision to the Landing Checklist in the Operations Manual which requires the handling pilot to confirm the parking brake is OFF.
