**SERIOUS INCIDENT**

<b>Aircraft Type and Registration:</b>	BAE Systems (Operations) Ltd ATP, SE-MHF	
<b>No &amp; Type of Engines:</b>	2 Pratt & Whitney Canada PW126 turboprop engines	
<b>Year of Manufacture:</b>	1989 (s/n 2013)	
<b>Date &amp; Time (UTC):</b>	14 December 2017 at 0606 hrs	
<b>Location:</b>	On approach to East Midlands Airport	
<b>Type of Flight:</b>	Commercial Air Transport (Cargo)	
<b>Persons on Board:</b>	Crew - 2	Passengers - None
<b>Injuries:</b>	Crew - None	Passengers - N/A
<b>Nature of Damage:</b>	None	
<b>Commander's Licence:</b>	Airline Transport Pilot's Licence	
<b>Commander's Age:</b>	29 years	
<b>Commander's Flying Experience:</b>	2,089 hours (of which 1,854 were on type) Last 90 days - 82 hours Last 28 days - 29 hours	
<b>Information Source:</b>	AAIB Field Investigation

**Synopsis**

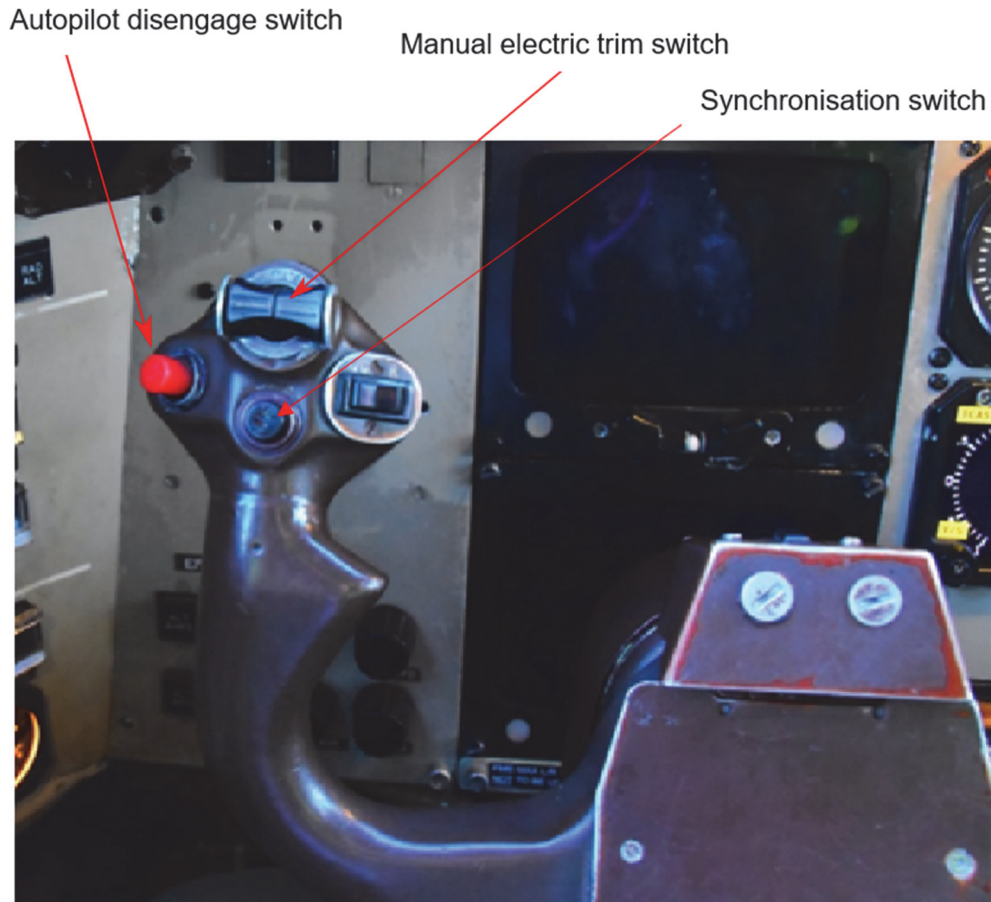
**Figure 1**

On the ILS approach, with autopilot 2 (AP2) engaged, the aircraft descended through 1,000 ft in a normal (gear down, flaps 15°) but not yet stable configuration. The co-pilot decided to disconnect the autopilot earlier than usual to take advantage of the manual handling opportunity. He recalled using the control wheel autopilot disconnect button at between 1,000 ft and 800 ft agl<sup>1</sup>, but the autopilot remained engaged. He then tried using the control wheel trim switch, which should also have disconnected the autopilot, but that was similarly ineffective. He commented aloud that he couldn't disconnect the autopilot but the commander interpreted the comment as confirmation that he was disconnecting it and acknowledged the comment, not having realised that the autopilot was still engaged.

Control wheel switches (captain's control wheel)

The co-pilot noted afterwards that he had been confused by not being able to disconnect the autopilot and by an apparent lack of concern from the commander. He reported that for a while he was focussed on repeatedly trying to disconnect the autopilot and became absorbed by the problem. Although he anticipated he would have to go around, he was not sure how to achieve this. Then, when the commander prompted him for the before-landing actions, and realising that the approach should by now be stable, he again voiced his inability to disconnect the autopilot. The commander called for a go-around and the co-pilot, recalling having practised using the sync switch in training after the previous event in one of the operator's aircraft<sup>4</sup>, pressed and held the sync switch and gained control to carry out the go-around.

The co-pilot advised that during his recurrent simulator training an alternative method of managing an engaged autopilot had been practised, by using the sync switch.

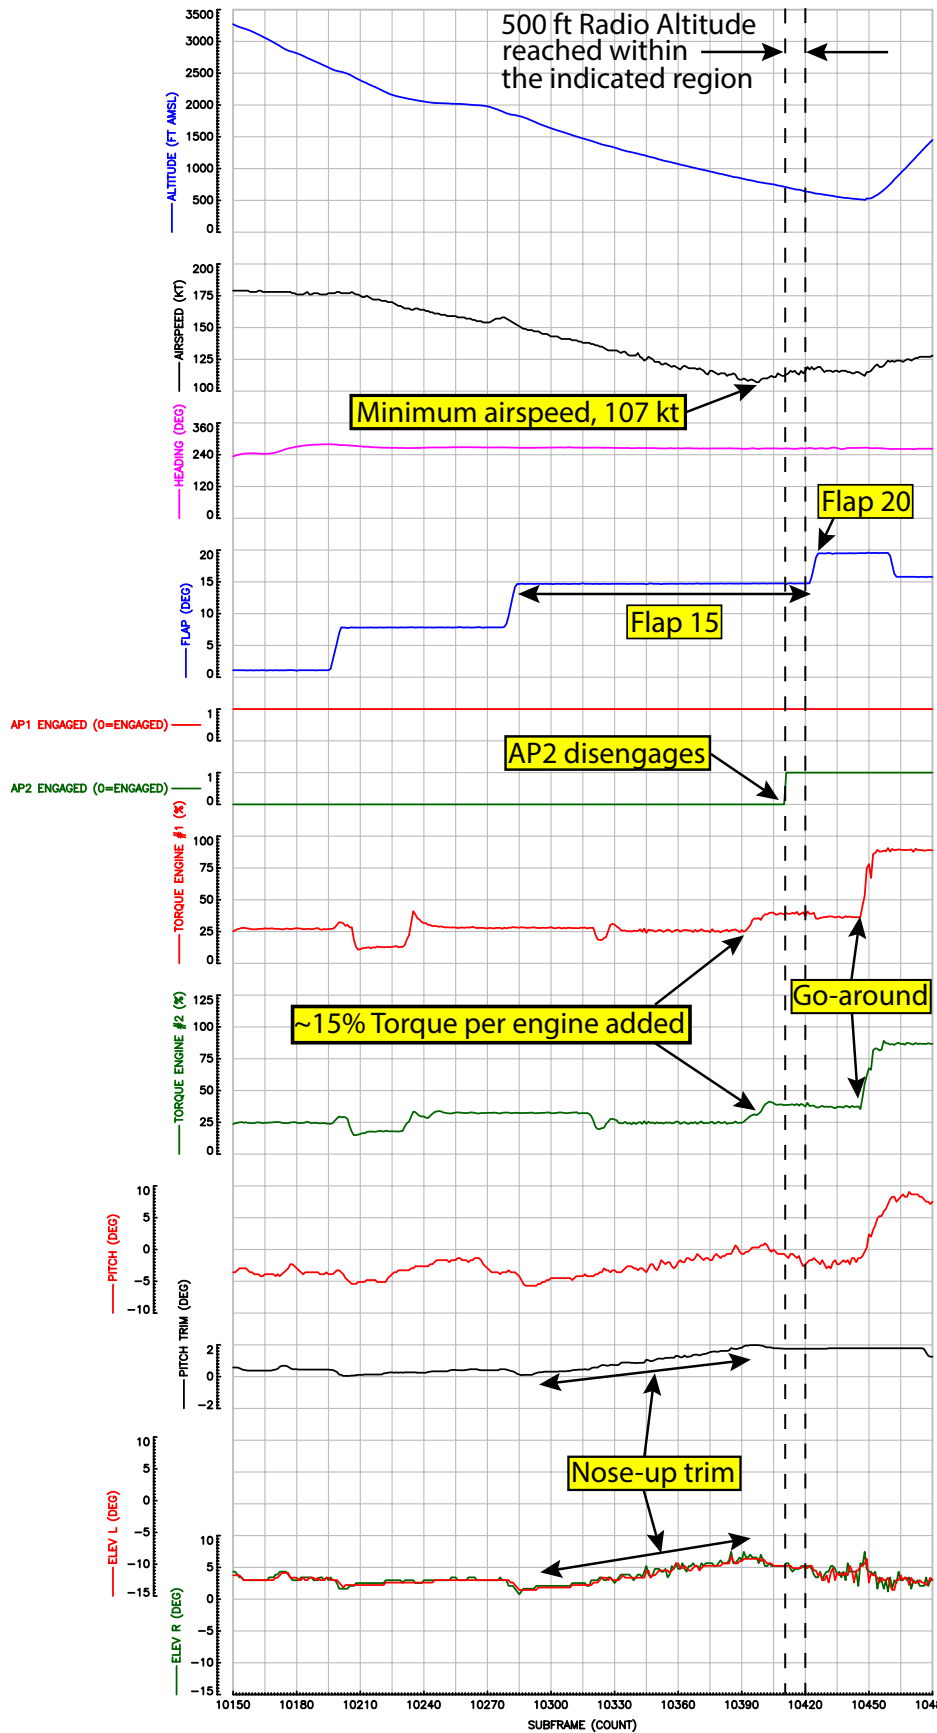
Figure 2

The FDR data for SE-MHF's approach and go-around, is shown below in Figure 2.

The data showed that AP2 was engaged with the aircraft in a gradual descent approaching 2,000 ft amsl as it aligned with the inbound course for Runway 27 at EMA. Flap 7 was selected with the airspeed reducing towards 154 kt and engine torque at 27.5% and 32.5% for engines 1 and 2 respectively. SE-MHF's pitch attitude then decreased, and a descent was started<sup>5</sup>. Engine power remained unchanged and, after a temporary increase in airspeed as the aircraft began to descend, Flap 15 was selected. SE-MHF's airspeed then began to reduce, reaching a minimum of 107 kt at 500 ft aal recorded after a period of 113 seconds. During this time, as the airspeed reduced, both the elevators and the pitch trim provided increasing nose-up inputs. An additional 13-14% of torque

The initial approach and go-around at East Midlands Airport

per engine was applied just prior to the point of minimum airspeed and, subsequently, the airspeed increased to 113 kt. The data then shows that AP 2 disengaged<sup>6</sup> at 425 ft aal (approximately 500 ft radio altitude (RA)) and, thereafter, that the airspeed stabilised around 117 kt. The increase in airspeed of SE-MHF was accompanied by a corresponding decrease in aircraft pitch, but after AP2 disengaged no further pitch trim activity was seen in the data. Flap 20 was selected at 350 ft aal and a go-around was initiated at 230 ft aal.

a go-around was initiated. The crew perception was that the AP disconnected at some time when the aircraft was climbing during the go-around, whereas the flight data indicated that it disconnected during the approach at approximately 425 ft aal.

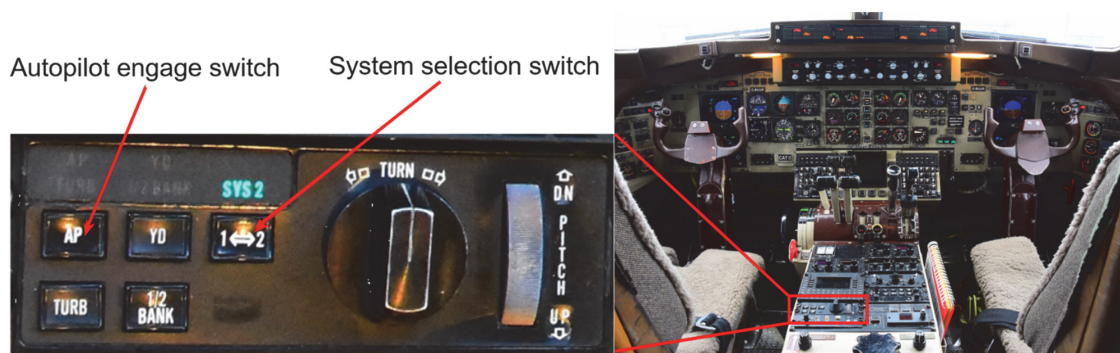
**Figure 3**  
Autopilot controller

An autopilot is engaged by the selection of an autopilot switch on the autopilot controller (Figure 3). The indication on the controller is an AP/YD<sup>7</sup> annunciation and illumination of a SYS 1/SYS 2 light. If No 1 autopilot is engaged, AP1 is shown in green on the left (Captain's) PFD and in white on the right (First Officer's) PFD. The situation is reversed when the First Officer is controlling the aircraft using No 2 autopilot (AP2 is shown in green on the right PFD and white on the left).

When an autopilot is disconnected manually, AP/YD annunciations on the autopilot controller are removed and the AP1/AP2 indications disappear from the PFDs. A one second 'cavalry charge' audio tone is generated. There are no indications if the autopilot is already disengaged and further attempts are made to disconnect.

Once aware of the problem the commander tried to disconnect the AP and also concluded that it would not disengage. When an AP is already disengaged, there are no new indications when there is an additional attempt to disconnect it. It is therefore possible that repeated attempts were perceived as unsuccessful because there was no associated feedback. In the confusion, the aircraft continued to descend below the stabilised approach height of 500 ft RA before go-around action was taken. As the RA was indicating height over the lower terrain to the east for the runway, the aircraft actually descended to 230 ft aal before

As a result of this serious incident, and the two similar preceding events, the manufacturer decided to review the Emergency Checklist to see whether an additional item should be incorporated to address the condition where crews are unable to disengage an autopilot.
