ACCIDENT

Aircraft Type and Registration:	Boeing 737-800, EI-DLV	
No & Type of Engines:	2 CFM56-7B26 turbofan engines	
Year of Manufacture:	2006 (Serial no: 33,598)	
Date & Time (UTC):	15 September 2017 at 0807 hrs	
Location:	London Stansted Airport	
Type of Flight:	Commercial Air Transport (Passenger)	
Persons on Board:	Crew - 6	Passengers - 184
Injuries:	Crew - None	Passengers - None
Nature of Damage:	Failure of left nose landing gear axle and separation of left nosewheel	
Commander's Licence:	Airline Transport Pilot's Licence	
Commander's Age:	33 years	
Commander's Flying Experience:	4,500 hours (of which 4,300 were on type) Last 90 days - 255 hours Last 28 days - 85 hours	
Information Source:	AAIB Field Investigation

Synopsis

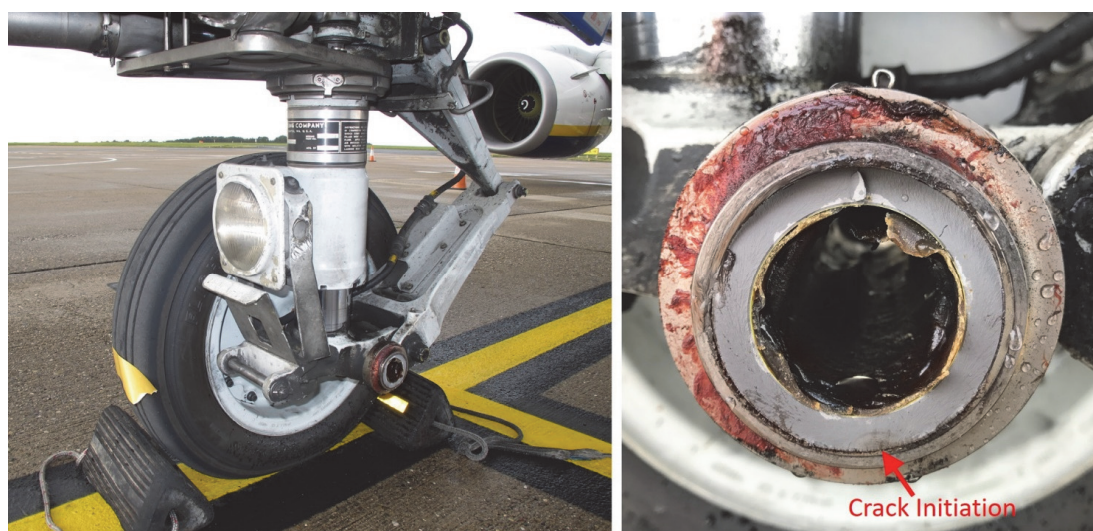
Figure 2

The aircraft was examined after it arrived at East Midlands Airport. The left axle of the nose landing gear (NLG) inner cylinder had failed at the inboard journal location (Figure 2). The wheel bearing spacer was still in place and in good condition. On the axle fracture face, near the 6 o'clock position, there were visible bands consistent with fatigue cracking. The separated nosewheel, axle and wheel bearings were recovered from Stansted Airport and, other than the break in the axle, no anomalies were found with these components.

Left nosewheel axle failure at inboard journal.
Bands of fatigue visible near the 6 o'clock position (right image)

The NLG axle failed as a result of a crack that had initiated near the 6 o'clock position of the left inboard journal and had then propagated over time via fatigue and SCC until the remaining material failed in overload. The final failure occurred as EI-DLV turned onto the runway prior to takeoff.

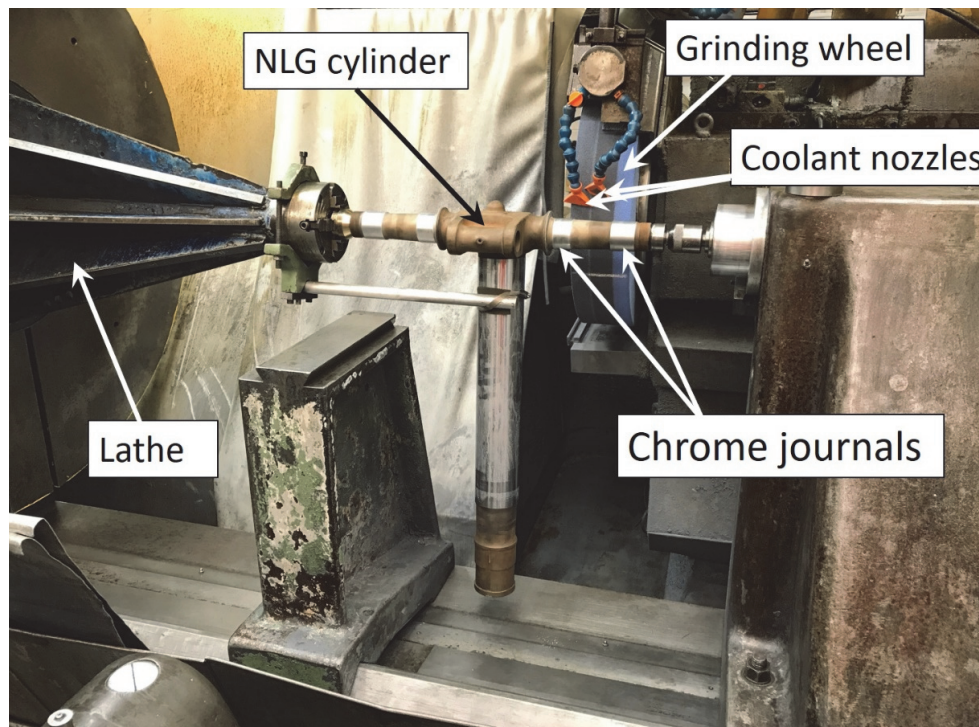
Figure 6

The grinding was then carried out using a manual grinder. The basic setup of the grinder, grinding wheel and the NLG cylinder is shown in Figure 6. The process is manual and involves the operator turning a wheel to move the grinding wheel towards the cylinder which is rotated by the grinder at a speed of 20 rpm. Before starting the grinding operation, the operator uses a Dial Test Indicator (DTI) gauge to measure any high spots on the journals and then marks them with a chinagraph pen. With the grinding wheel stationary, it is then slowly brought towards the rotating cylinder until first contact, which is the highest spot. The digital reader on the machine is then zeroed and the wheel is brought back by 0.1 inches. During the grinding operation there is a ratchet on the handle which prevents the wheel being moved in by more than 0.0001 inches between movements of the ratchet. Checks are carried out and the grinding wheel is dressed (sharpened) after every 0.003 inches to 0.005 inches of material removal.

- Not identifying the highest spot correctly which then results in a large slice being removed at first touch.
- Moving the grinding wheel in too quickly (ie not using the ratchet or moving the ratchet too quickly).
- Poor condition of the cooling fluid or inadequate flow.
- Insufficiently dressed grinding wheel which results in heat build-up.
- Machine setup and balance which results in the part rotating non-concentrically.

As some of the manufacturer's SOPM instructions, such as wheel dressing, are open to interpretation, the MRO is developing an internal protocol for grinding so that there is greater consistency among grinding operators.
