ACCIDENT

Aircraft Type and Registration:	Piper PA-31, N250AC	
No & Type of Engines:	2 Lycoming TIO-540-A2C piston engines	
Year of Manufacture:	1976 (Serial no: 31-7612040)	
Date & Time (UTC):	6 September 2017 at 1723 hrs	
Location:	Caernarfon Airport, Gwynedd	
Type of Flight:	Private	
Persons on Board:	Crew - 1	Passengers - None
Injuries:	Crew - 1 (Fatal)	Passengers - N/A
Nature of Damage:	Aircraft destroyed	
Commander's Licence:	Commercial Pilot's Licence	
Commander's Age:	62 years	
Commander's Flying Experience¹:	Over 4,000 hours (with experience on type) Last 90 days - unknown Last 28 days - unknown	
Information Source:	AAIB Field Investigation

Synopsis

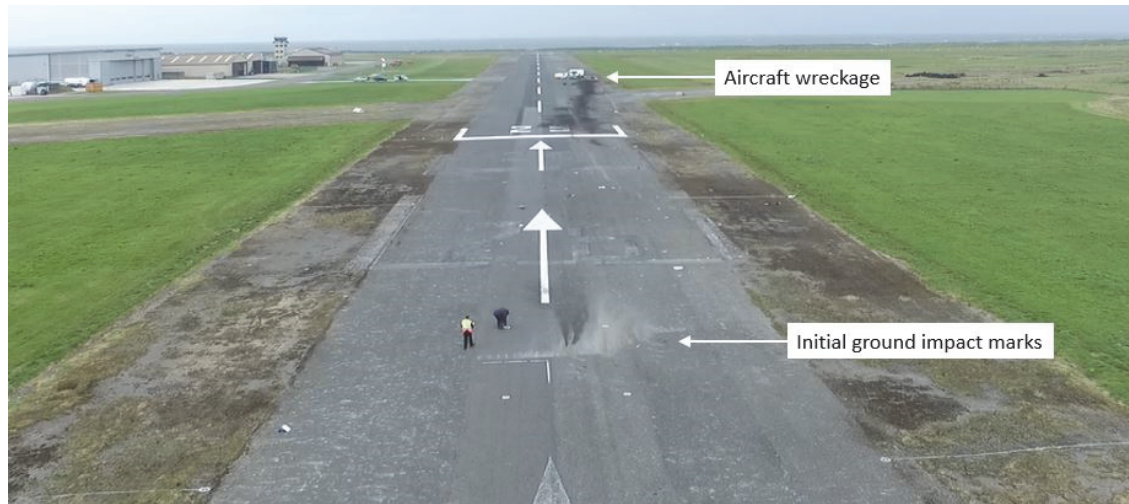
Figure 5

The aircraft had struck the paved surface of Runway 25, 3 m to the right of the runway centreline and 101 m before the displaced threshold (Figure 5). The main wreckage of the aircraft, consisting of the fuselage, empennage, right wing and engine and most of the left wing apart from the left engine had come to rest on the runway surface 293 m beyond the initial impact point. A severe post-impact fire had consumed the majority of the aircraft with only the nose section ahead of the cockpit remaining free from fire damage. Examination of the wreckage confirmed that the aircraft had been structurally complete at the point of impact. The landing gear was retracted and the flaps were fully up, confirmed by the position of the flap jackscrew actuators.

Assessment of the initial ground impact marks indicated that the aircraft had struck the ground in a nose-down attitude with a slight left bank. The distance between the first and second propeller ground impact marks was 72 cm for both the left and right engines, indicating that both engines were operating at the same speed at impact and the aircraft's groundspeed at impact was approximately 180 kt. The absence of ground marks from the aircraft's flaps and landing gear further confirmed that both were retracted at impact.

Accident site (image courtesy of North Wales Police)

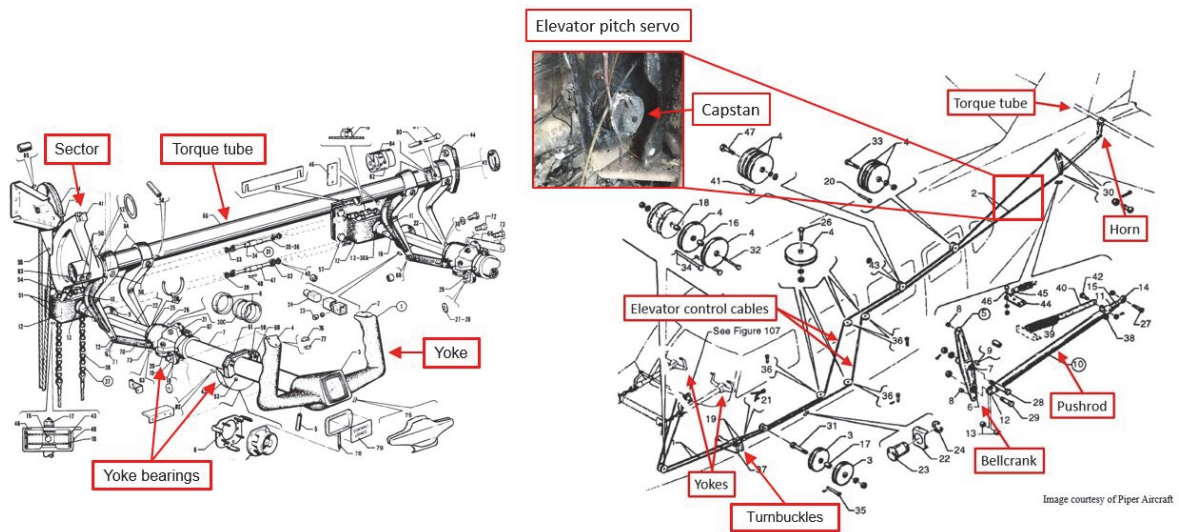
Figure 6

It was not possible to functionally test the left and right control yoke slide assemblies (Figure 6), which translate pilot pitch demand into elevator control cable motion, due to fire damage. Visual examination however confirmed the presence of all the required yoke slide bearings and the correct connection of the yoke slide assemblies to the elevator control torque tube and elevator cable control sector. The elevator control cables were correctly routed and terminated at the elevator control sector.

PA-31 elevator controls

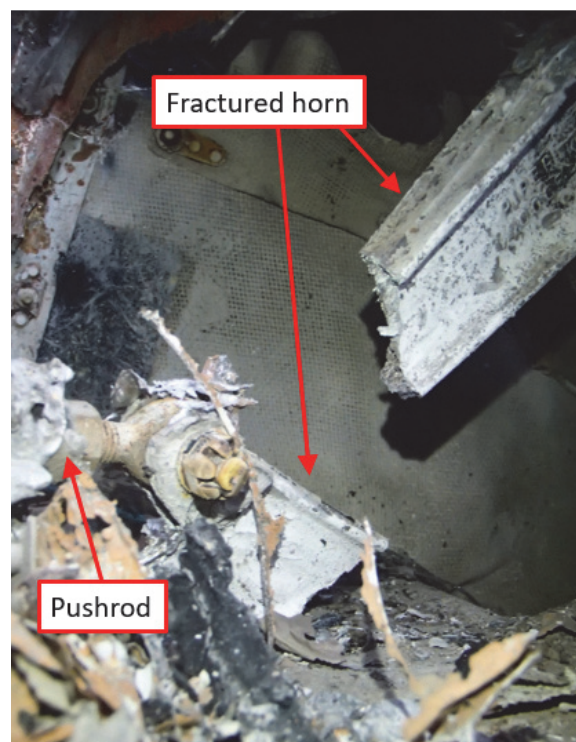
Figure 7

The elevator horn, which connects the pushrod to the elevator torque tube, was found to be fractured on initial examination of the wreckage at the accident site (Figure 7).

Fractured elevator horn as found at accident site

Both parts of the elevator horn had partially melted in the post-accident fire. The lower section of the horn was attached to the pushrod's aft rod-end and the upper section of the horn remained attached to the elevator torque tube. Both parts of the fractured horn were subjected to specialist metallurgical examination.

The fracture damage observed on the broken elevator horn was most probably sustained when the aircraft initially struck the runway as, had the horn fractured during flight, the small area of unburned ductile overload would not have sufficient strength alone to remain intact during the accident sequence.

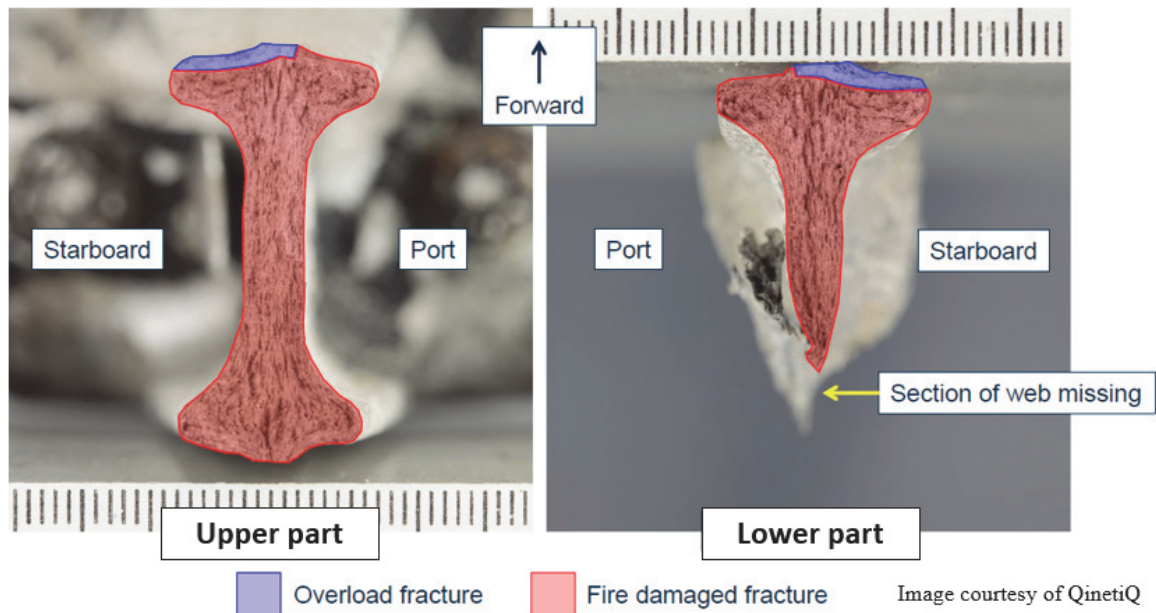
Figure 8

Fractographic assessment of elevator horn fracture surfaces

This examination revealed that most of the horn fracture surface exhibited features consistent with localised melting and fire damage (Figure 8). The fracture surface had a rough macro appearance, with the topography following the underlying grain microstructure of the material. No evidence of progressive crack growth, such as fatigue, was observed and no flat areas of fracture surface were evident that would be consistent with this type of crack growth.

A small area of non-fire damaged ductile overload, equating to 4% of the fracture surface, was visible at the forward section of the horn indicating that this area had separated after the post-accident fire had been extinguished. This may have occurred during disturbance of the wreckage during fire-fighting operations or due to wind blowing on the elevator after the accident.

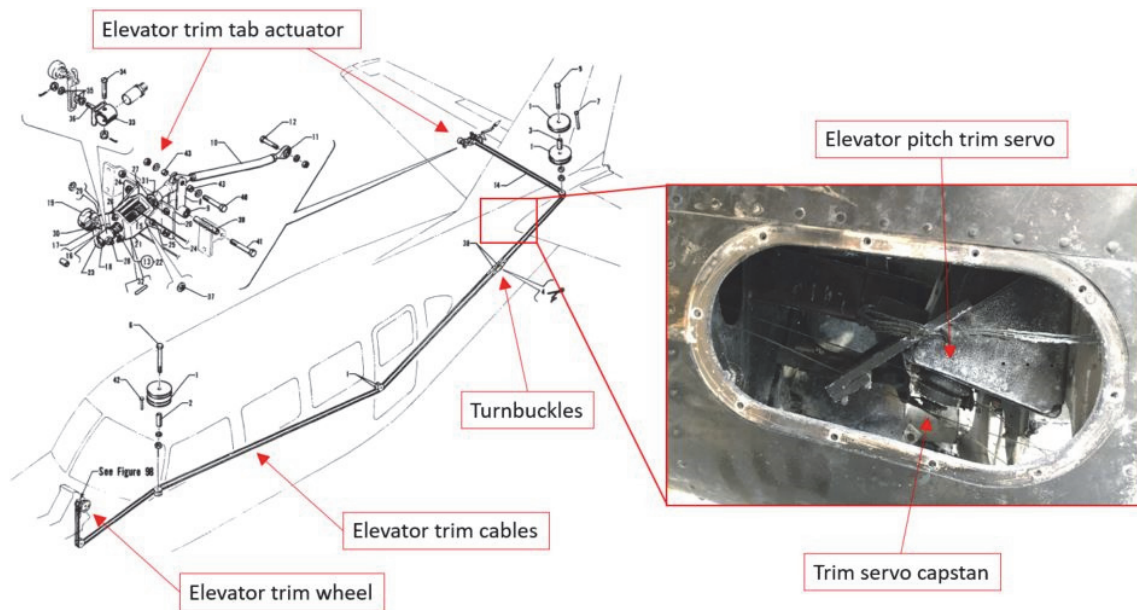
Figure 9
Elevator trim system

The elevator trim system cables were identified in the aircraft wreckage and found to be continuous from the elevator trim wheel in the cockpit to the elevator trim tab actuator in the right tailplane (Figure 9). Both adjustment turnbuckles within the elevator trim cable system were correctly assembled and wire-locked. The elevator trim cable was correctly wrapped around the pitch trim servo capstan and idler pulley assembly, and the pitch trim servo was securely attached to the airframe within its mounting bracket. Fire damage prevented any electrical wiring or functional checks of the pitch trim servo.

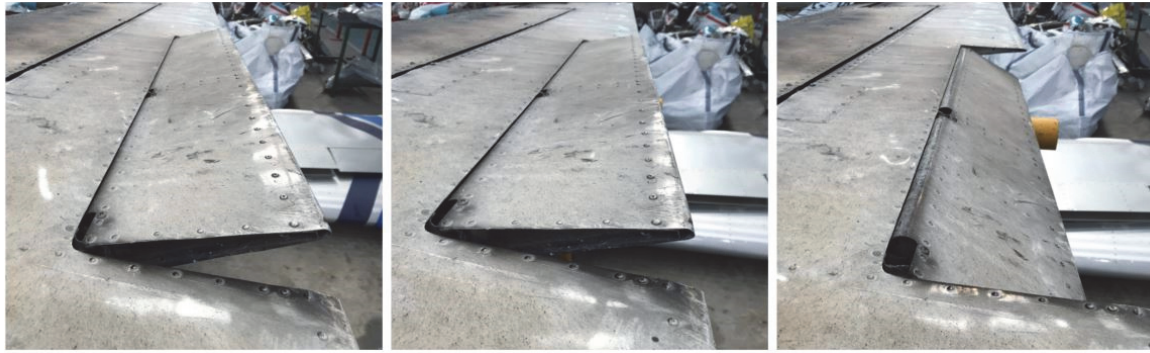
Elevator trim tab position as found at accident site, and range of movement

The elevator trim tab was functionally tested and was free to move between the extreme trailing edge up and down positions. The elevator trim tab position as observed at the accident site was 12.4° trailing edge up, with the elevator held in the neutral position²⁰. The range of elevator trim tab deflection is $16^\circ \pm 1^\circ$ trailing edge up (providing nose-down pitch trim), and $29^\circ \pm 1^\circ$ trailing edge down (nose-up pitch trim), with the elevator in a neutral position (Figure 10). The elevator trim tab position as observed at the accident site was therefore close to, but not at, the full nose-down trim position.

Maximum nose down trim,
tab 16° up

Tab position as found, 12.4° up

The elevator trim tab was found close to, but not at, the full nose-down trim position. This is not a normal position for an approach and landing, and it would have caused the pilot considerable difficulty in controlling the aircraft due to the large control forces. The nose-down forces would have tended to increase as the aircraft slowed down, and with the application of flaps and landing gear.

The elevator trim tab was found close to, but not at, the full nose-down trim position. Impact and fire damage prevented any electrical and functional checks on the aircraft's pitch trim system and therefore it was not possible to identify a cause for a possible pitch trim runaway.
