**ACCIDENT**

| <b>Aircraft Type and Registration:</b> | DH82A Tiger Moth, G-ADXT | |
| <b>Date &amp; Time (UTC):</b> | 26 August 2017 at 0828 hrs | |
| <b>Location:</b> | Near Compton Abbas Airfield, Dorset | |

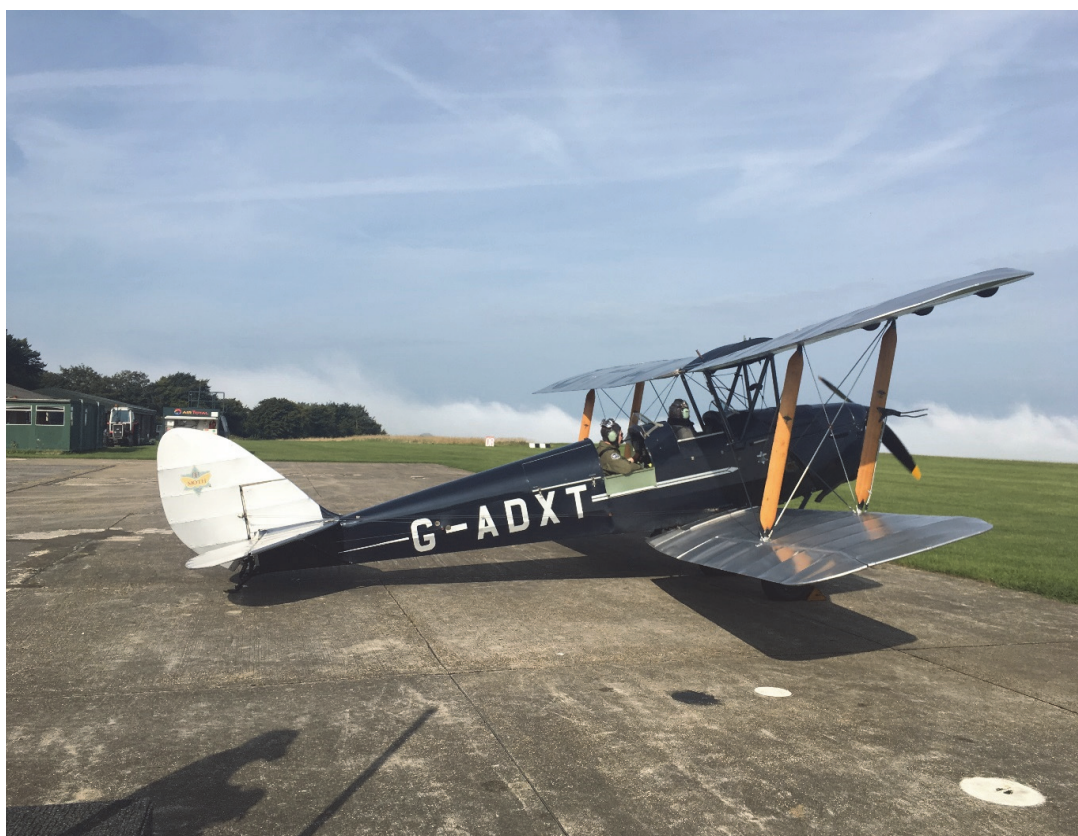
**Figure 1**  
G-ADXT before the accident

Figure 1 below shows the aircraft immediately prior to departure with the weather as described and the fog at the western end of the valley north of the airfield.

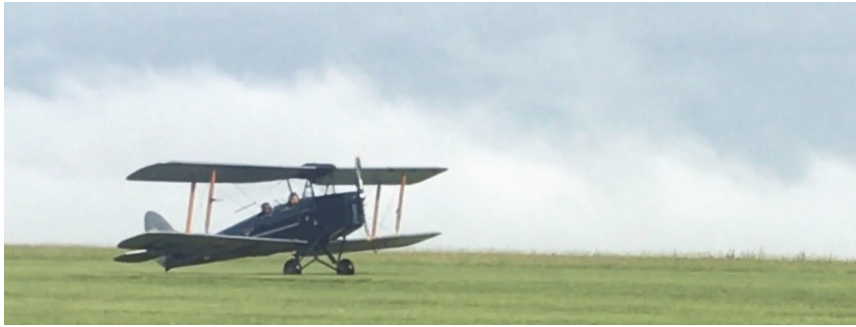
**Figure 3**

At the beginning of the takeoff run showing the tops of cloud or fog in the valley to the west of the airfield

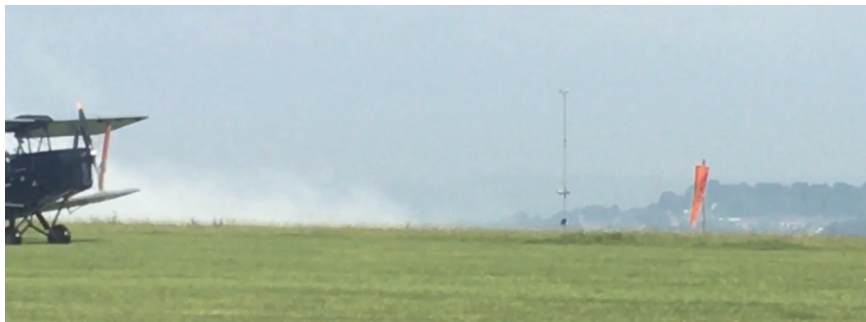
**Figure 4**

The cloud or fog conditions are not the same in the valley to the north of the airfield (separated from the westerly valley by a ridge).  
The windsock indicates a light crosswind from the north

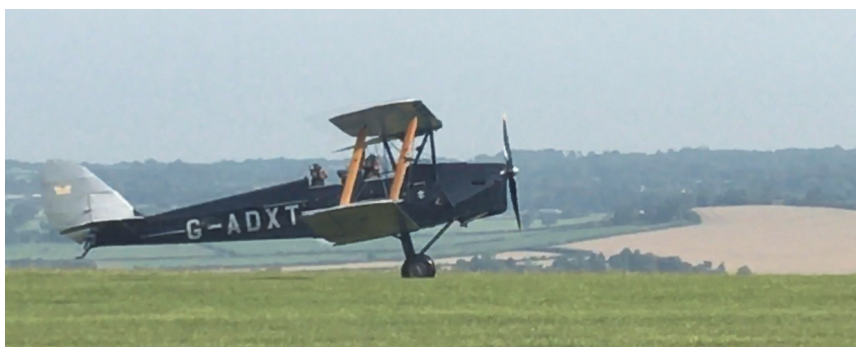
**Figure 5**

Abeam the camera location

The propeller speeds were established from the images in the video clips. The aircraft engine was running at approximately 2,000 rpm when passing the camera location but had reduced to approximately 1,710 rpm by the end of the video clips.

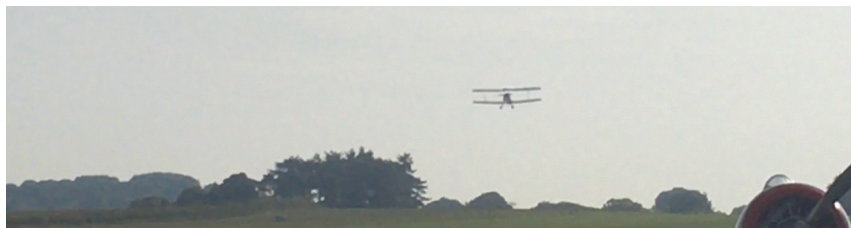
**Figure 8**  
Last video clip, initial climb

Over the period covered by the video clips, the engine speed reduced from approximately 2,000 rpm to approximately 1,710 rpm, but the cause is unknown. A test flight established that the aircraft could not have climbed at 1,710 rpm so the engine power must have increased after the last video clip.

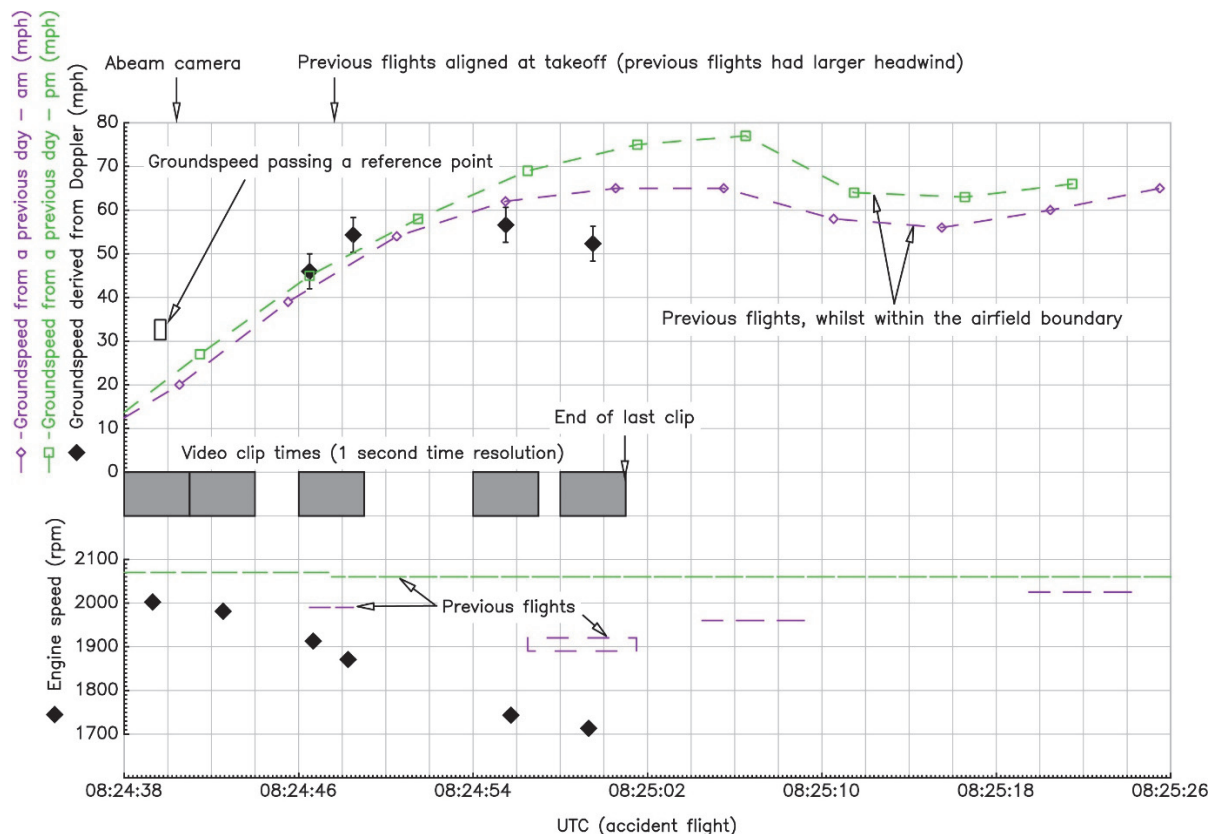
**Figure 9**

Accident flight parameters compared to previous flights aligned to the point in time of takeoff
