SERIOUS INCIDENT

Aircraft Type and Registration:	Boeing 767-332ER, N1608
No & Type of Engines:	2 General Electric CF6-80C2B6F turbofan engines
Year of Manufacture:	2000 (Serial no: 30573)
Date & Time (UTC):	13 August 2017 at 1225 hrs
Location:	London Heathrow Airport
Type of Flight:	Commercial Air Transport (Passenger)
Persons on Board:	Crew - 11 Passengers - 208
Injuries:	Crew - None Passengers - None
Nature of Damage:	None
Commander's Licence:	Airline Transport Pilot's Licence
Commander's Age:	61 years
Commander's Flying Experience:	16,239 hours (of which 5,619 were on type) ¹ Last 90 days - 177 hours Last 28 days - 72 hours
Information Source:	Aircraft Accident Report Form submitted by the operator and further AAIB investigation

On departing London Heathrow Airport, the cabin altitude reached 15,900 ft. The crew donned their oxygen masks, commenced an immediate descent and returned to Heathrow. The cause of the cabin failing to maintain the required pressure could not be established.

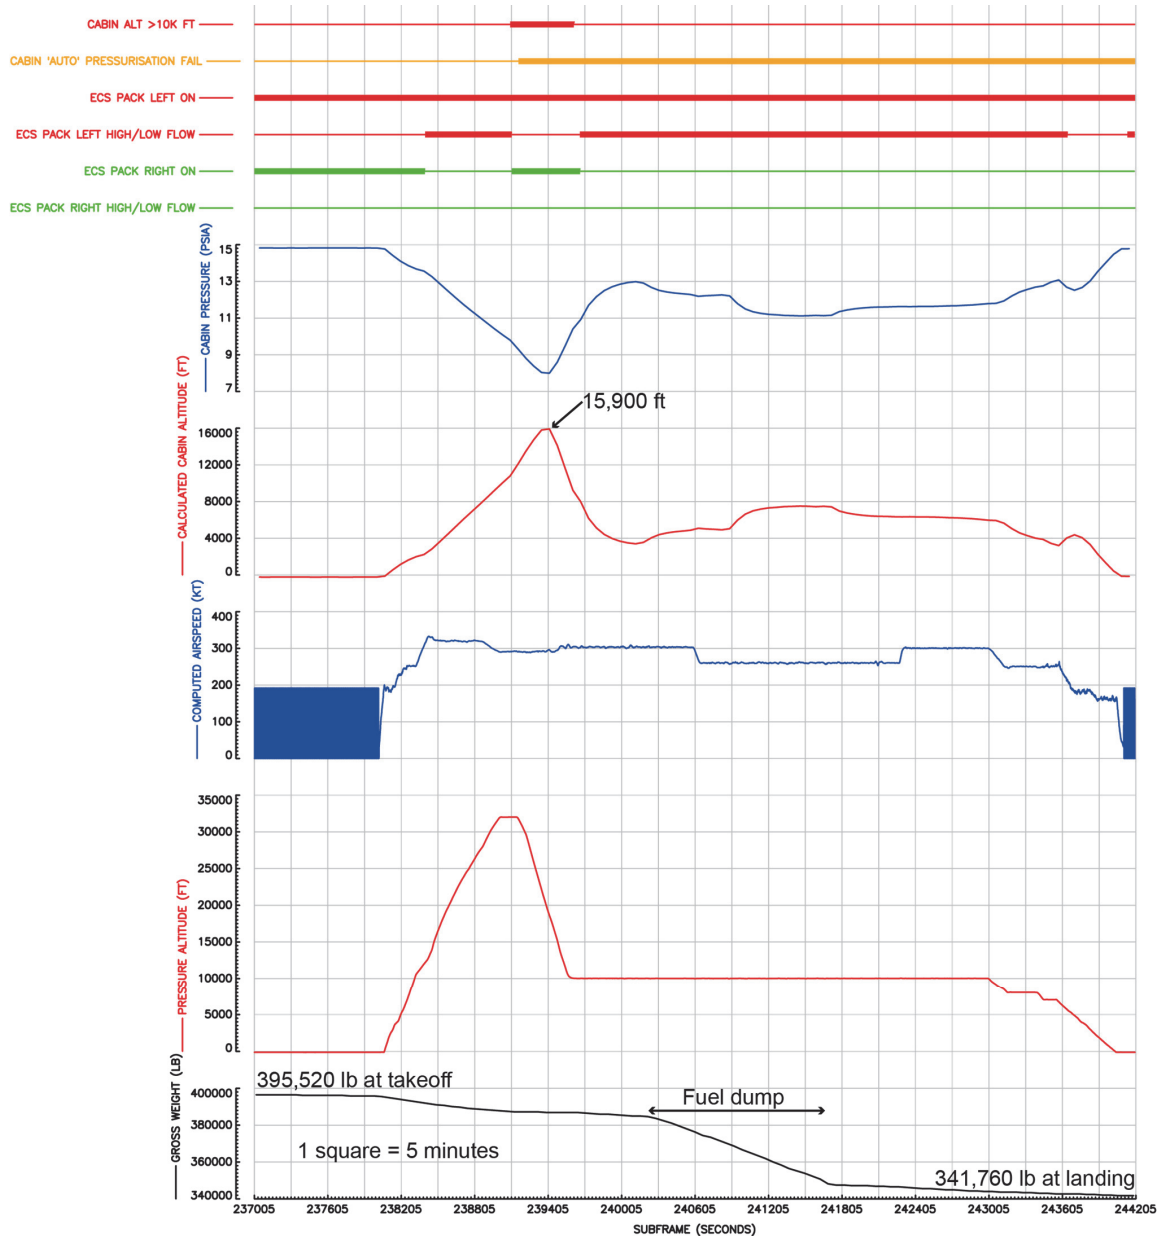
Figure 1

DFDR data at the time of the event – N1608, 13 August 2017

The DFDR data shows that the profile of the calculated cabin altitude followed the aircraft altitude and reached a height of 15,900 ft before reducing as the aircraft descended. There was no evidence of the cabin altitude stabilising between 7,000 to 7,500 ft before this point. The profile of the cabin altitude during the remainder of the flight was consistent with the cabin altitude being manually controlled by the crew. The position of the outflow valve is not recorded on the DFDR.

Approximately five minutes after the aircraft took off, the right Environmental Control System (ECS) pack was switched OFF and the left ECS pack changed to high-flow mode. Eleven minutes later the right ECS pack was switched ON and the left ECS pack returned to low-flow mode. At the same time, the CABIN ALT > 10K FT illuminated followed shortly afterwards by the CABIN AUTO PRESSURISATION WARNING FAIL. After a further nine minutes, when the aircraft had descended to an altitude of approximately 10,000 ft, the right ECS pack was switched OFF, the left ECS pack changed to high-flow mode and the warning CABIN ALT > 10K FT cleared. The right pack remained OFF and the left pack remained in the high-flow mode for the remainder of the flight.

The fault on the right engine PRVC would have generated the EICAS message R ENG PRV, which would have required the crew to turn off the right ECS pack. This action would have caused the left ECS pack to automatically switch to the high-flow mode. It can be seen from the DFDR data, presented at Figure 1, that the left pack automatically switched between low and high-flow mode on two occasions, which is consistent with the crew actioning the QRH. The cabin pressure was also maintained at a satisfactory level during the inbound flight when only the left pack was operating. This indicates that the air conditioning system worked correctly and the flow from the left pack should have been sufficient to pressurise the cabin.
