ACCIDENT

Aircraft Type and Registration:	HPH Glasflugel 304 eS, G-GSGS	
No & Type of Engines:	1 LZ Design D.O.O FES-HPH-M100 brushless electric motor	
Year of Manufacture:	2016 (Serial no: 059-MS)	
Date & Time (UTC):	10 August 2017 at 1121 hrs	
Location:	Parham Airfield, West Sussex	
Type of Flight:	Private	
Persons on Board:	Crew - 1	Passengers - None
Injuries:	Crew - None	Passengers - N/A
Nature of Damage:	Fire damage to FES ¹ batteries and FES battery compartment	
Commander's Licence:	British Gliding Association Gliding Certificate	
Commander's Age:	55 years	
Commander's Flying Experience:	314 hours (of which 25 were on type) Last 90 days - 9 hours Last 28 days - 7 hours	
Information Source:	AAIB Field Investigation

Synopsis

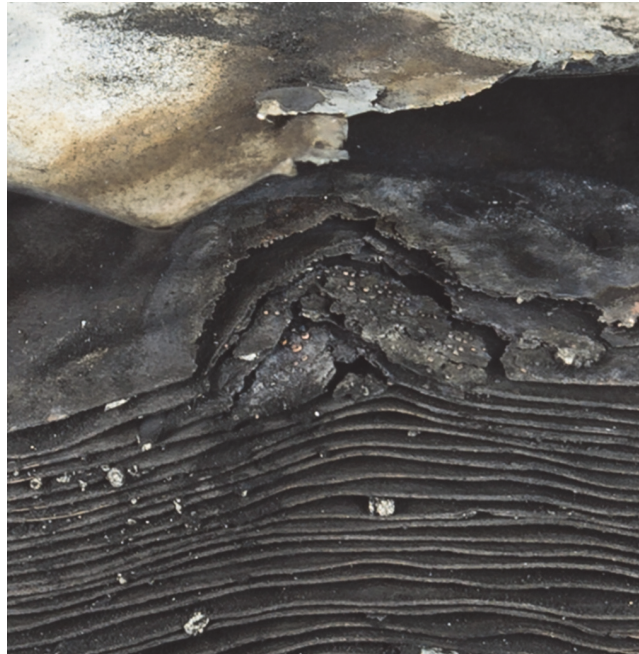
Figure 9

Examination of the hot-spot at cell 6 revealed localised melting of both the aluminium cathode and copper anode electrode sheets (Figure 9) indicating that the temperature at the hot-spot had exceeded 1,085°C, the melting point of copper. The presence of solidified molten copper was further confirmed by examination of the hot-spot location using a scanning electron microscope, and energy dispersive X-ray analysis of the molten copper deposits.

Localised hot-spot at cell 6, with solidified molten copper present
(courtesy QinetiQ)

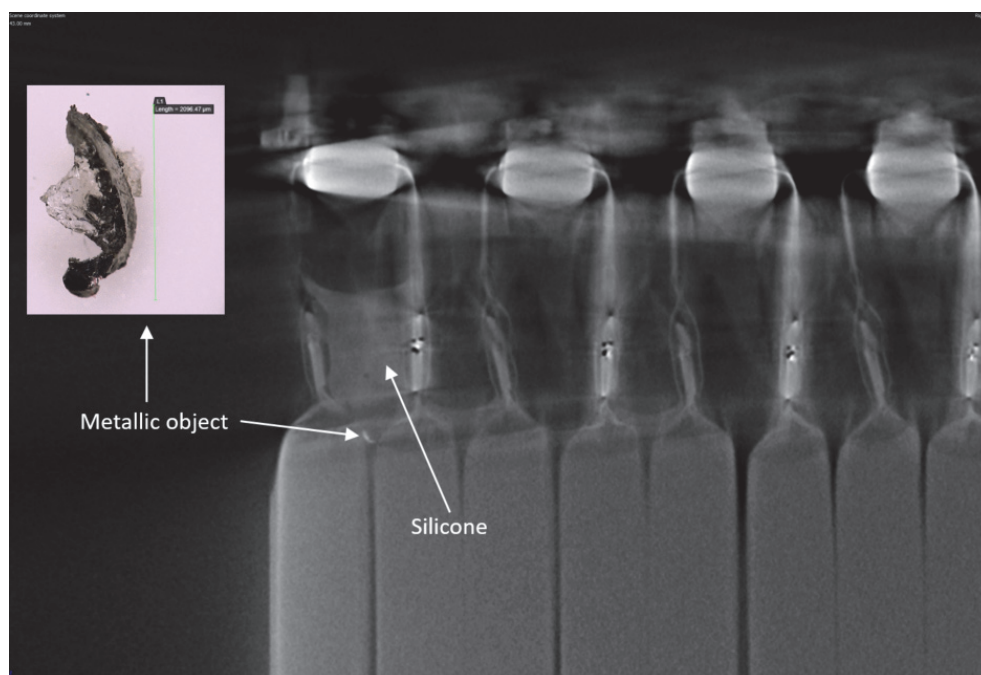
Figure 14

The CT scan of battery pack 080-B, the rear battery pack from G-GSGS, contained one metallic object lying between two cells at the top of the pack (Figure 14). This object was beneath the silicone layer indicating that the foreign object has been present when the battery pack was assembled.

The battery pack was disassembled and the metallic object was recovered. The object was a piece of metal swarf, 2 mm in length, with a distinctive curved shape consistent with the swarf generated during the thread-cutting process of the connector plates.

Metallic swarf debris within battery pack 080-B (courtesy QinetiQ)

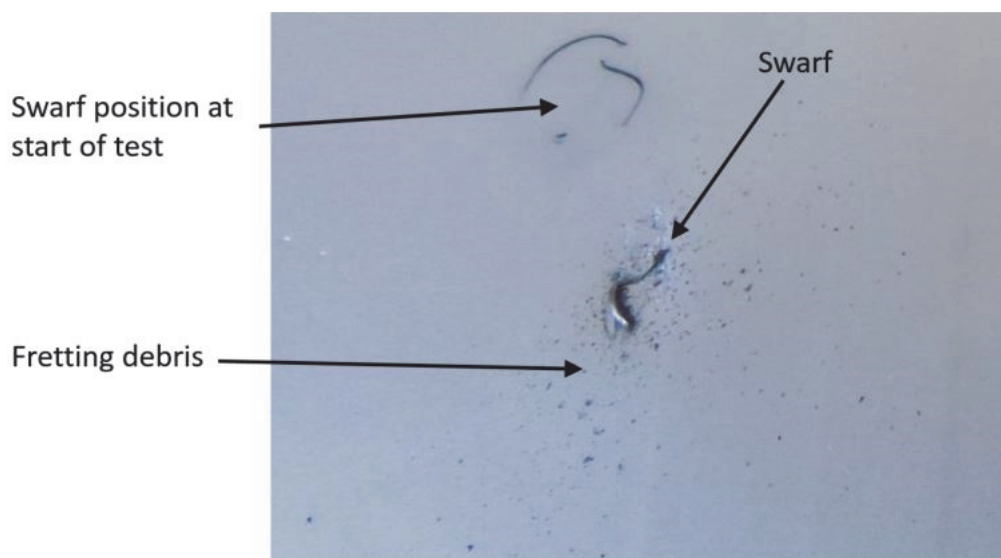
Figure 16

A second test was conducted with 3.0 mm lengths of steel swarf inserted between the cells (Figure 16). The cells were vibrated in the horizontal axis for 30 minutes at a resonant frequency of 20 Hz, during which there were no signs of fire, smoke or unusual odours. Following this test, the cell fixture was disassembled and it was noted that there had been migration of the swarf within the cell fixture and some fretting of the cell pouch material due to contact with the swarf, but the fretting depth had not exceeded the pouch thickness and no electrolyte had been released.

Cell pouch fretting during vibration testing with metal swarf present

The vibration testing conducted by the AAIB showed that whilst cell pouch fretting did occur due to the presence of swarf within a battery assembly, the fretting was not severe enough to cause the swarf to penetrate the cell pouch and cause an internal short circuit within a cell.
