ACCIDENT

Aircraft Type and Registration:	HK36 TC Super Dimona, G-FMKA	
No & Type of Engines:	1 Rotax 912-A3 piston engine	
Year of Manufacture:	2000 (Serial no: 36.672)	
Date & Time (UTC):	13 July 2017 at 1830 hrs	
Location:	Near Brimslade Farm, Wiltshire	
Type of Flight:	Training	
Persons on Board:	Crew - 2	Passengers - None
Injuries:	Crew - 2 (Fatal)	Passengers - N/A
Nature of Damage:	Destroyed	
Commander's Licence:	Airline Transport Pilot's Licence and EASA Private Pilot's Licence	
Commander's Age:	57 years	
Commander's Flying Experience:	18,200 hours Last 90 days - 266 hours Last 28 days - 40 hours	
Information Source:	AAIB Field Investigation

Synopsis

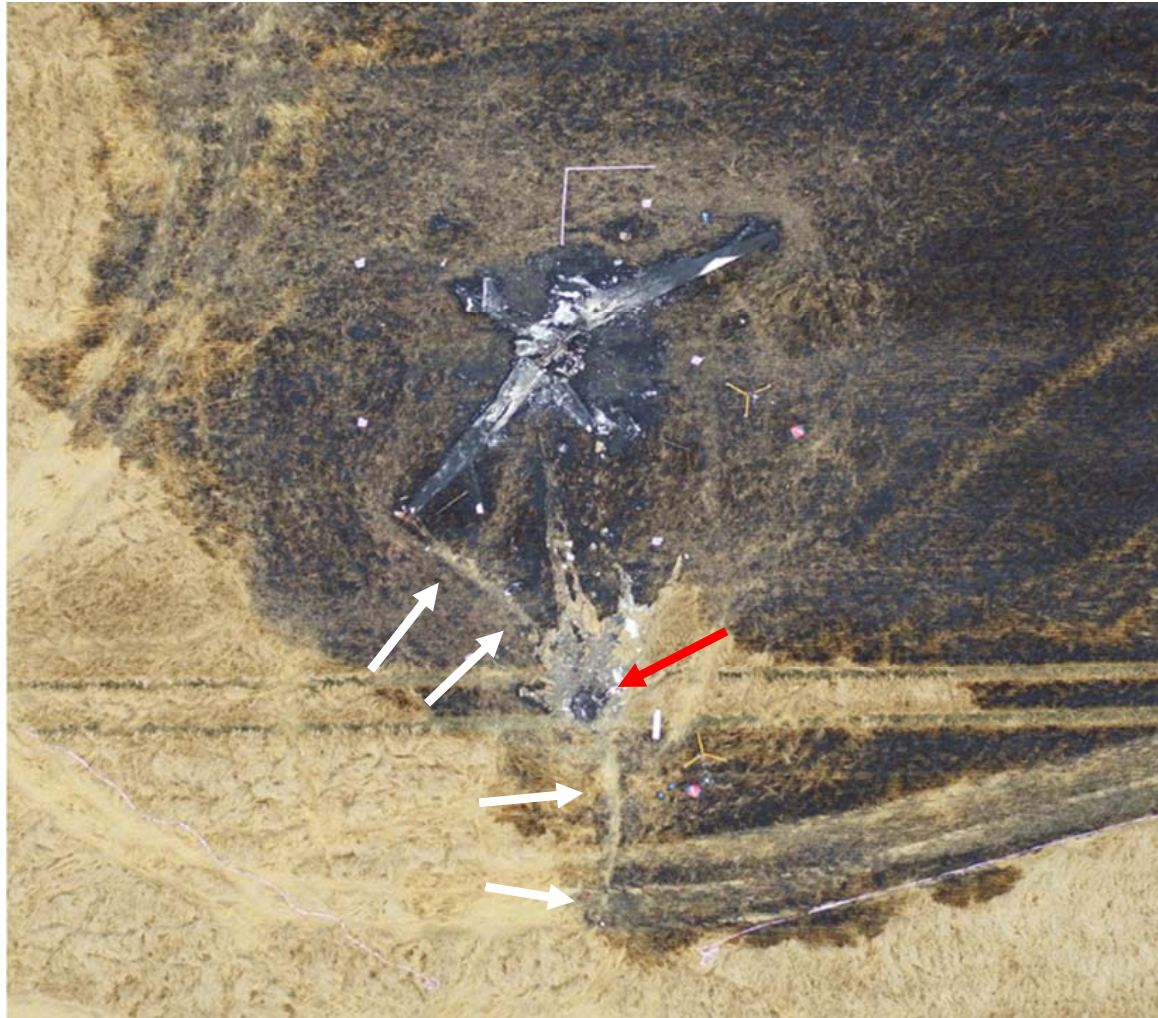
Figure 2

An aerial survey of the accident site (Figure 2) was carried out using the AAIB's camera-equipped drone. This revealed impact markings created by the leading edges of the wings which formed symmetrical arcs centred at the point where the engine was buried. The pronounced curvature of the arcs indicated that the wings were experiencing considerable upwards bending at the point of impact. Measurements of the wing deflection were supplied to the aircraft manufacturer for analysis.

According to the analysis by the aircraft manufacturer, to produce the degree of upwards wing bending indicated by the ground impact marks, the aircraft would have to have been subjected to a positive acceleration approaching 9 g.

It was the aircraft manufacturer's opinion that such loads could not be achieved without an elevator control input.

Aerial photo of accident site
(white arrows indicated curved impact marks from wing leading edges;
red arrow indicates engine impact location)

The vertical nature of the flight path of the aircraft at impact, coupled with the elevator input required to create the 9 g impression in the ground, is consistent with the aircraft having been beyond the vertical shortly before ground contact.
