ACCIDENT

Aircraft Type and Registration:	Auster AOP.9, G-BXON	
No & Type of Engines:	1 Bombardier Cirrus 20801 piston engine	
Year of Manufacture:	1955 (Serial no: AUS/10/60)	
Date & Time (UTC):	18 June 2017 at 1135 hrs	
Location:	Spanhoe Airfield, Northamptonshire	
Type of Flight:	Private	
Persons on Board:	Crew - 1	Passengers - 1
Injuries:	Crew - 1 (Fatal)	Passengers - 1 (Serious)
Nature of Damage:	Aircraft destroyed	
Commander's Licence:	Private Pilot's Licence	
Commander's Age:	49 years	
Commander's Flying Experience:	409 hours (of which 0.5 hours were on type) Last 90 days - 2.0 hours Last 28 days - 0.5 hours	
Information Source:	AAIB Field Investigation

Synopsis

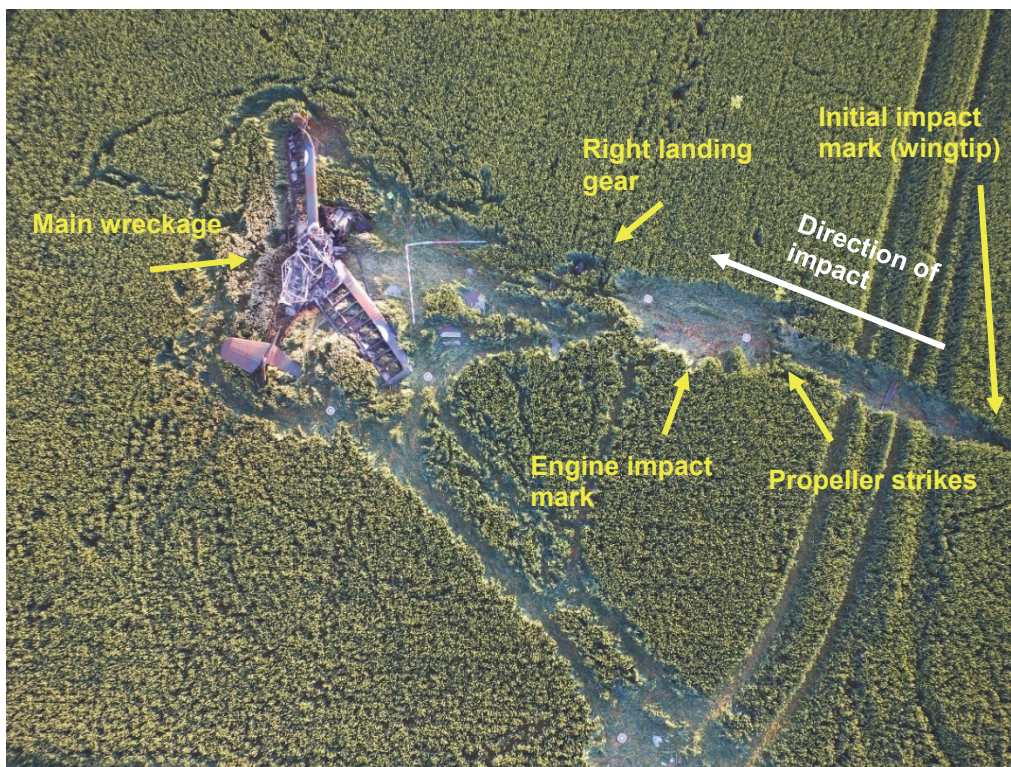
Both wings had detached from the fuselage mounting points as a result of the impact and fire damage but remained close to the fuselage. The right elevator had separated and was found close to the main wreckage. All three aircraft doors had detached during the impact. The engine was no longer attached to its mounting points and was lying on its side.

Figure 2
Aircraft wreckage and impact trail

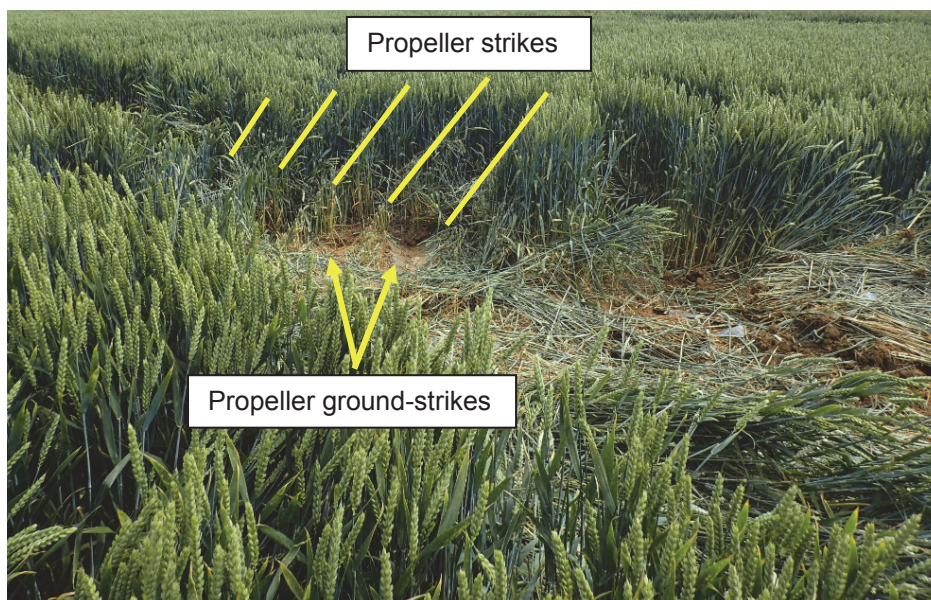
Figure 3
Propeller strikes

The propeller, spinner and No.1 cylinder baffles exhibited damage consistent with striking the ground and a number of the engine accessories were broken or had been damaged in the post-impact fire. However, the engine otherwise appeared largely intact. The engine would not rotate freely until the camshaft was removed and, although not visually apparent, it was determined that impact-related distortion in the cam assembly had prevented both the camshaft and engine from turning.

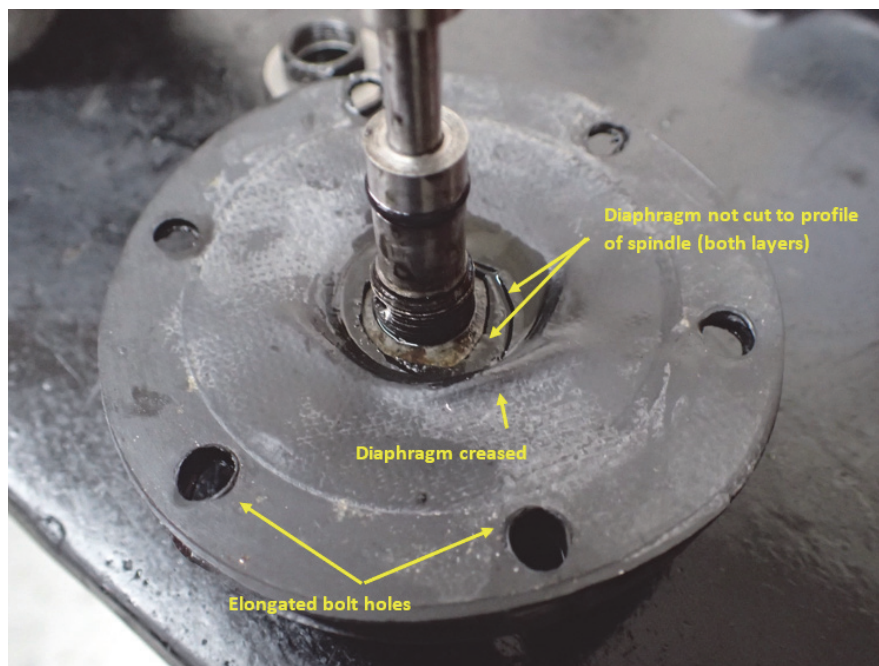
Figure 4

Disassembly revealed that on both pumps the clamping nut at the base of the central spindle was loose, resulting in the internal diaphragm not being adequately clamped. Additionally, the diaphragms did not have the appearance of having been professionally fitted and cut to size, exhibiting stretching and creasing, elongated bolt holes and a crudely-cut central hole (Figure 4). Oil had leaked to the fuel side of the diaphragm, indicating that the diaphragm did not form an effective seal between the fuel and oil (atmospheric) side of the pump. One effect of this is that fuel could escape through the centre of the diaphragm into the oil side of the pump and exit a fuel drain in the upper part of the pump body; this would result in reduced suction.

View showing oil side of diaphragm from right mechanical fuel pump

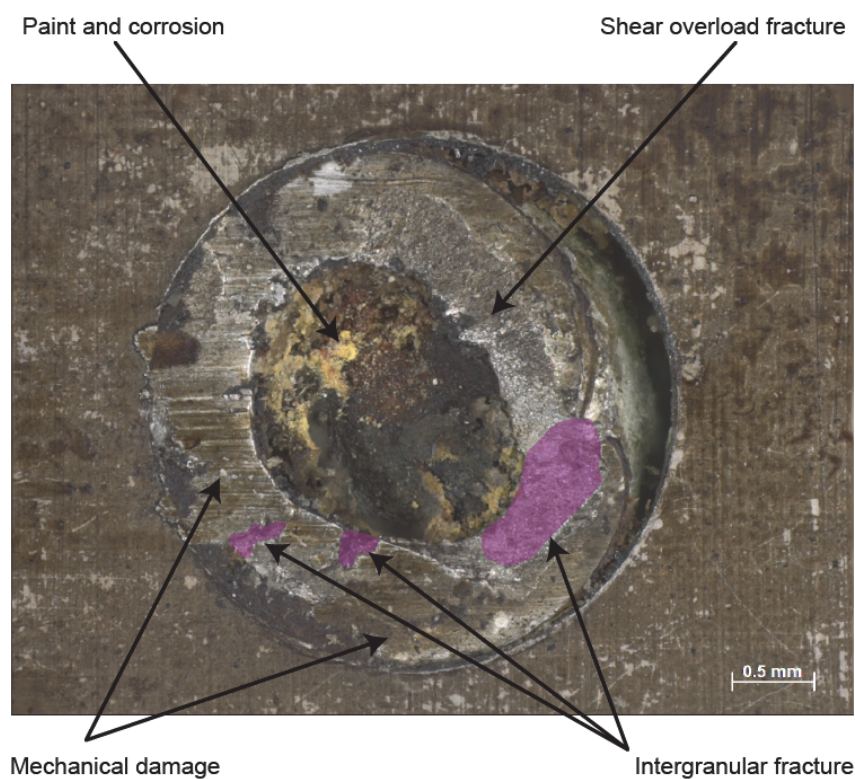
Figure 6

Metallurgical examination showed that the fracture surfaces of all four rivets exhibited differing amounts of mechanical damage, caused by contact between the opposing fracture surfaces during detachment of the end-fitting. The remaining surface detail showed that all four rivets had failed as a result of ductile overload in shear, indicating that they were carrying load at the time of failure. The outboard rivet also exhibited three distinct patches of intergranular fracture (shown in purple in Figure 6), which indicated the presence of pre-existing intergranular cracking prior to the shear overload failure. The precise extent of the intergranular fracture could not be determined due to the mechanical damage, but the areas in which it was observed indicated that it may have extended across one third of the surface area.

Fracture surface of outboard rivet showing areas of intergranular corrosion

Intergranular corrosion and stress corrosion cracking¹¹ was also observed on the internal surfaces of the inboard and outboard rivets. Although no intergranular fracture was evident on the fracture surface of the inboard rivet, the mechanical damage may have destroyed any pre-existing cracking that was present.
