**ACCIDENT**

<b>Aircraft Type and Registration:</b>	Rolladen-Schneider LS7, G-CFMY	
<b>No &amp; Type of Engines:</b>	None	
<b>Year of Manufacture:</b>	1988 (Serial no: 7004)	
<b>Date &amp; Time (UTC):</b>	4 May 2019 at 1416 hrs	
<b>Location:</b>	Near Blaenau Ffestiniog, Gwynedd	
<b>Type of Flight:</b>	Private	
<b>Persons on Board:</b>	Crew - 1	Passengers - None
<b>Injuries:</b>	Crew - 1 (Fatal)	Passengers - N/A
<b>Nature of Damage:</b>	Destroyed	
<b>Commander's Licence:</b>	British Gliding Association Gliding Certificate	
<b>Commander's Age:</b>	64 years	
<b>Commander's Flying Experience:</b>	3,349 hours Last 90 days - 30 hours Last 28 days - 17 hours	
<b>Information Source:</b>	AAIB Field Investigation

**Synopsis**

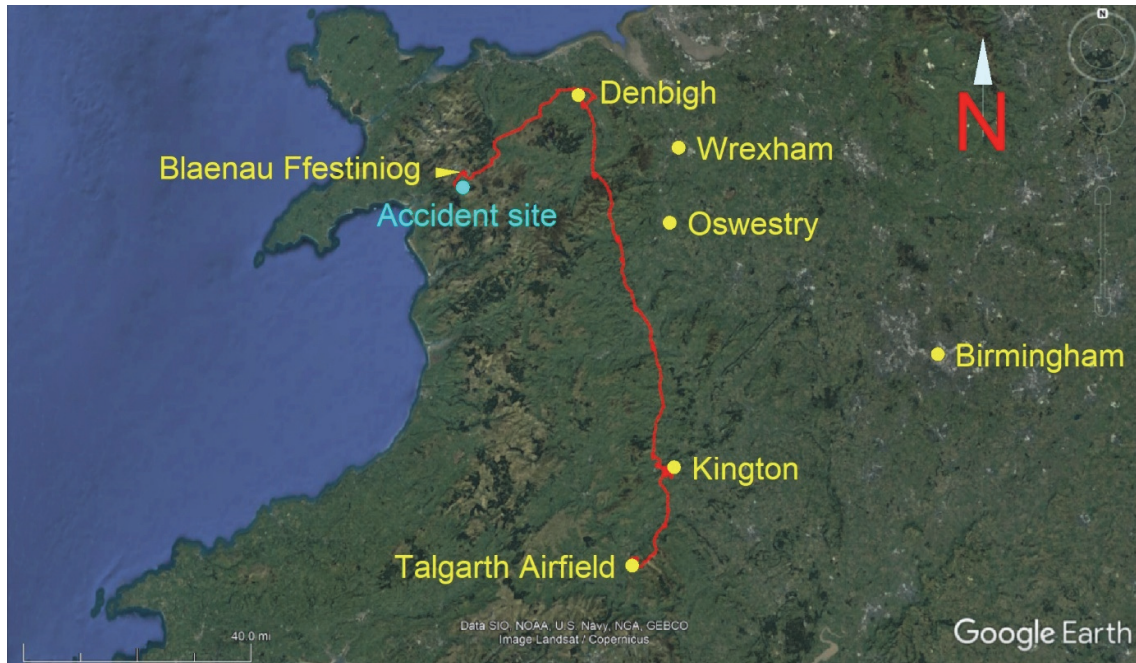
**Figure 1**  
GPS track of G-CFMY

The recording started at 1011 hrs when G-CFMY was positioned on Runway 33 at Talgarth. A few minutes later the glider was towed to an altitude of about 2,000 ft amsl. It then proceeded on a northerly course towards the town of Denbigh, Wales, which it

reached at 1307:30 hrs. Having passed almost overhead Lleweni Parc Airfield (located near to Denbigh) at 1323 hrs, the pilot altered course, initially to the west, and then to the south-west, towards the southern area of Snowdonia National Park.

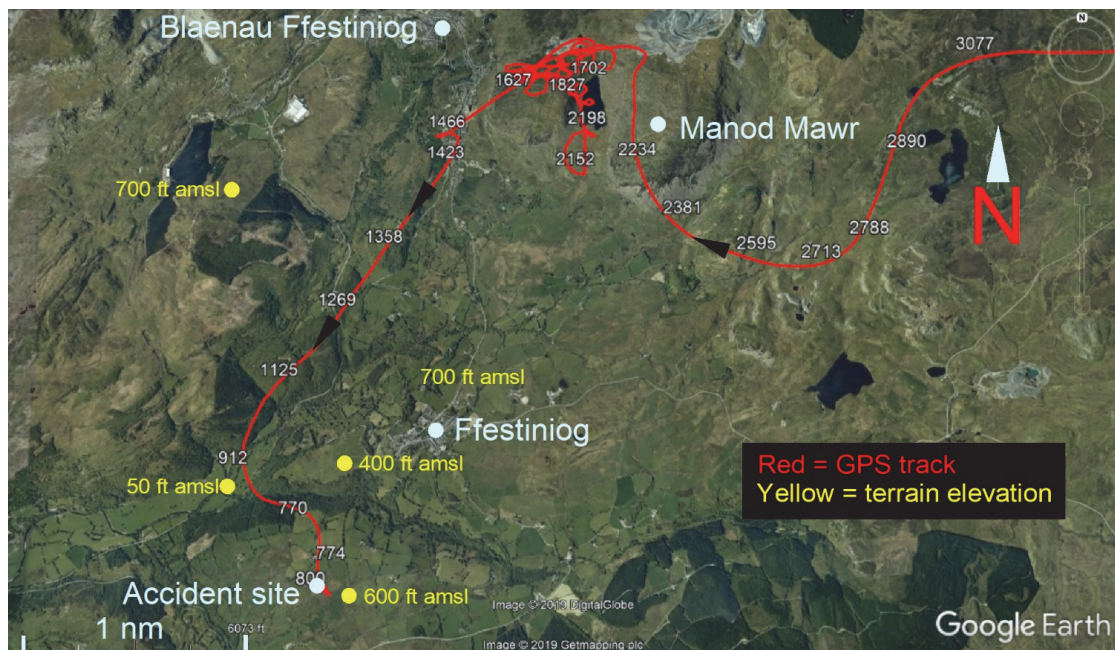
**Figure 2**  
GPS track of final 15 minutes of flight  
(values presented are aircraft altitude amsl and terrain elevation)

At 1359 hrs, the glider was positioned about 6 nm north-east of the village of Ffestiniog. After several minutes of soaring it climbed to an altitude of about 3,500 ft before resuming a course towards the south-west. Several minutes later, having descended to an altitude of about 2,700 ft, the glider turned northwards towards Manod Mawr mountain, where it then proceeded to soar in an area just west of the summit above a quarry on the south facing slope. The glider soared in this area for about eight minutes, during which its altitude varied from between about 2,200 ft and 1,700 ft. At 1412:30 hrs the glider was at an altitude of 1,630 ft when it headed towards the south-west.

About 30 seconds later, the glider made a single right-hand orbit at an altitude of about 1,400 ft amsl (a height of approximately 700 ft agl) before turning onto a course of about 215°. The glider's ground speed was about 60 kt and it was descending at an average rate of 280 ft/min. Due to the sloping terrain elevation, G-CFMY maintained a relatively constant height above the ground as it descended. When the glider was 0.8 nm west of Ffestiniog its altitude was about 900 ft (a height of about 850 ft agl). At this point it was overhead the valley floor that extended towards the coastline which was approximately 8 nm to the south-west.

The glider then started a left turn towards the east, which was almost immediately followed by a right turn onto a southerly course that took the glider towards rising terrain. The final data points were recorded shortly after, which indicated that the glider had made a left turn. The final data point was recorded at 1416:01 hrs with the glider almost overhead the accident site at a height of about 200 ft agl and on a recorded track of 273°.

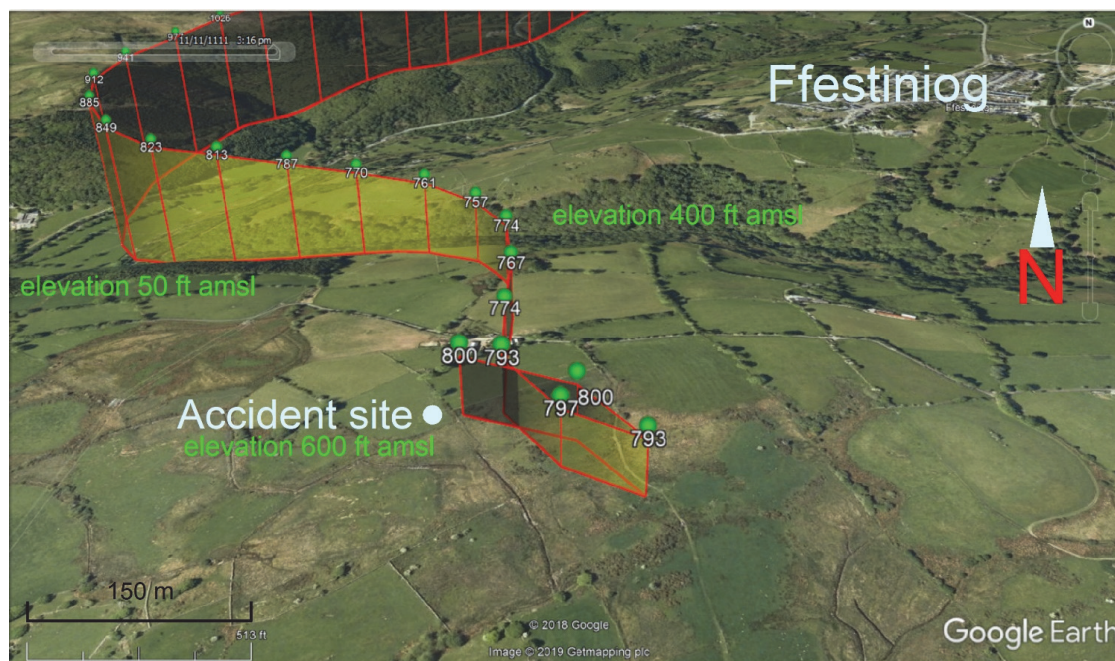
**Figure 3**

GPS track of final 15 minutes of flight  
(values presented are aircraft altitude amsl and terrain elevation)

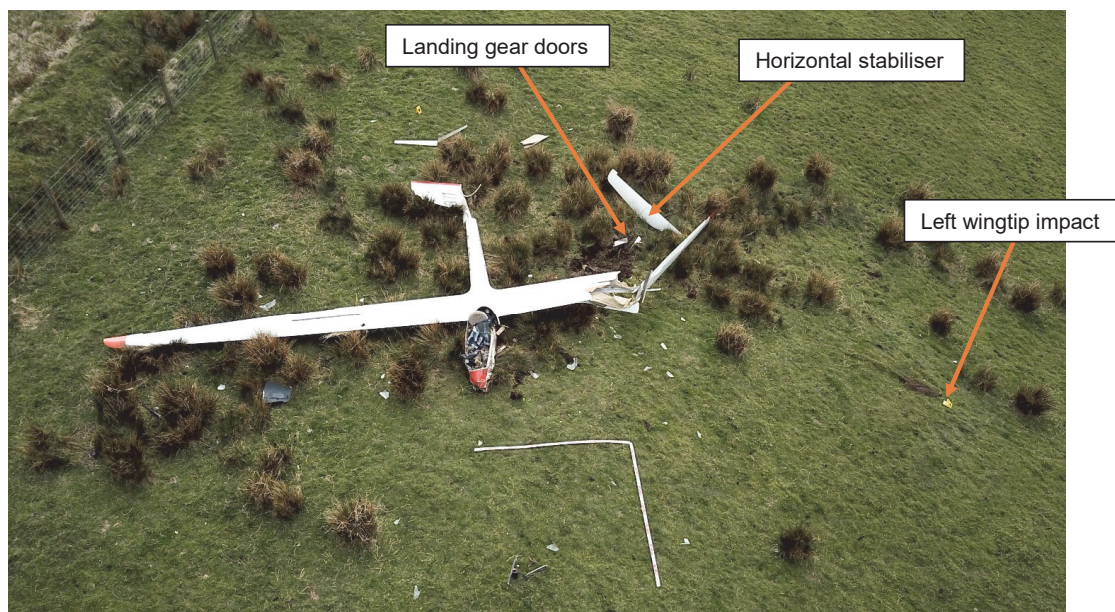
**Figure 4**  
Aerial view of the accident site

The accident site was in a field that was used for grazing cattle. The nearest buildings, which were adjacent to a road, were approximately 150 m away but none were inhabited. Assessment of the ground impact marks indicated that the glider had struck the ground in a slightly nose-down attitude and with a slight left bank of approximately 10°. It was structurally complete before the accident with the landing gear extended.

Both wings were found to be still attached to the fuselage, but the left wing was broken because of forces imparted during the accident. The glider had bounced in a counter-clockwise direction when viewed from above before coming to rest (Figure 4). The right wing was largely undamaged with the airbrake slightly deployed. The tail boom was broken, and the horizontal stabiliser and elevators had detached. Broken remnants of the canopy acrylic were found throughout the accident site. The furthest forward item was part of the canopy frame and was found approximately 16 m forward of the glider.

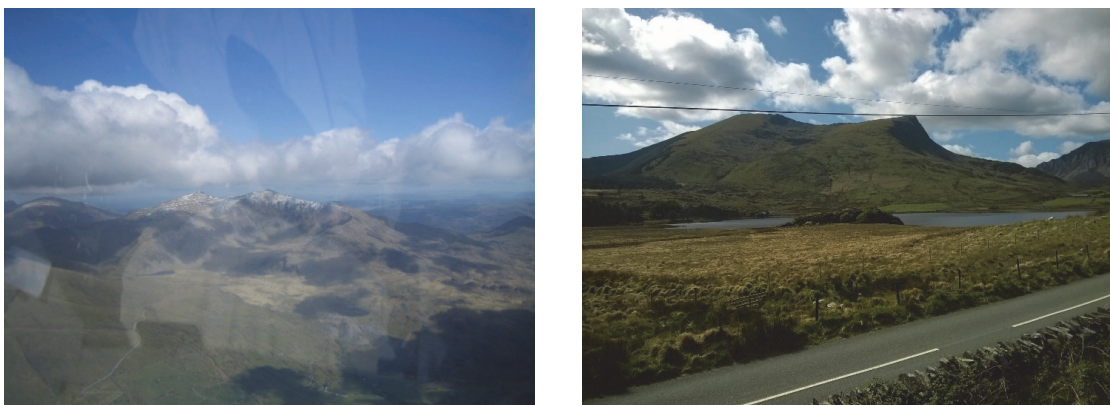
**Figure 5**

Three other glider pilots who were flying in the same region at a similar time that the accident occurred were interviewed. They described the weather as northerly wind at approximately 20 kt with cloud base around 4,000 ft amsl. The cloud base was higher further south. They described challenging gliding conditions with significant turbulence particularly in the lee of the hills. The photographs in Figure 5 give an indication of the cloud cover in the area at the time of the accident. The left picture was taken by a glider pilot flying to the west of Mount Snowdon approximately one hour before the accident. The right picture was taken from the ground near Rhyd Ddu (9 nm north-west of the accident site) looking west.

Photographs showing the weather near the accident location

An aftercast provided by the Met Office confirmed the weather on the day of the accident was dominated by high pressure centred to the north-west of the UK. Surface winds were generally moderate north or north-easterly at around 15 kt. Winds at altitude were northerly at around 20 to 25 kt across Snowdonia. This would be sufficient to generate some lee wave activity but, any activity was relatively weak with maximum descent rates of around 100 ft/min. There were no large convective clouds within the area to introduce additional downdraughts. Maximum ascent rates of around 200 to 300 ft/min were very localised over Snowdon itself, and do not appear to have propagated downwind.
