ACCIDENT

Aircraft Type and Registration:	Colomban MC-30 Luciole, G-CIBJ	
No & Type of Engines:	1 Briggs And Stratton 0114-E1 piston engine	
Year of Manufacture:	2013 (Serial no: LAA 371-15002)	
Date & Time (UTC):	10 April 2019 at 1815 hrs	
Location:	Farm strip at Thankerton, South Lanarkshire	
Type of Flight:	Private	
Persons on Board:	Crew - 1	Passengers - None
Injuries:	Crew - None	Passengers - N/A
Nature of Damage:	Destroyed	
Commander's Licence:	National Private Pilot's Licence	
Commander's Age:	83 years	
Commander's Flying Experience:	15,324 hours (of which 60 were on type) Last 90 days - 1 hour Last 28 days - 1 hour	
Information Source:	Aircraft Accident Report Form submitted by the pilot

Synopsis

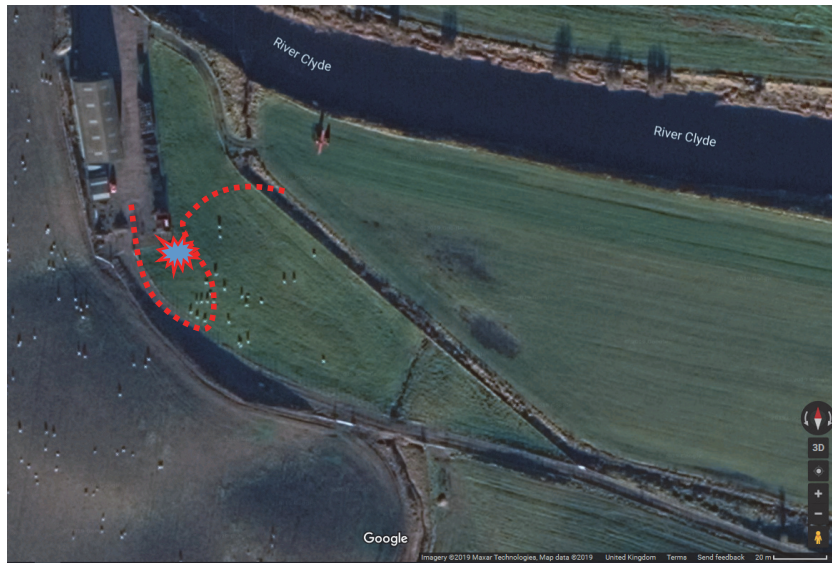
Figure 1

The pilot had returned to the farm strip in Thankerton, where the aircraft was based, after an uneventful local flight. After landing the pilot taxied the aircraft to the hangar. The route from the airstrip to the hangar involved several tight turns (Figure 1) and it was following a left turn, where the pilot applied full left rudder pedal, that he felt a restriction. Shortly afterwards the cockpit filled with smoke and the pilot quickly exited the aircraft. In his haste to exit he did not wait for the aircraft to come to a halt, turn off the fuel or turn off the ignition. The aircraft was destroyed by fire (Figure 2) but the pilot did not suffer any injuries.

Thankerton farm strip – taxi route and accident location

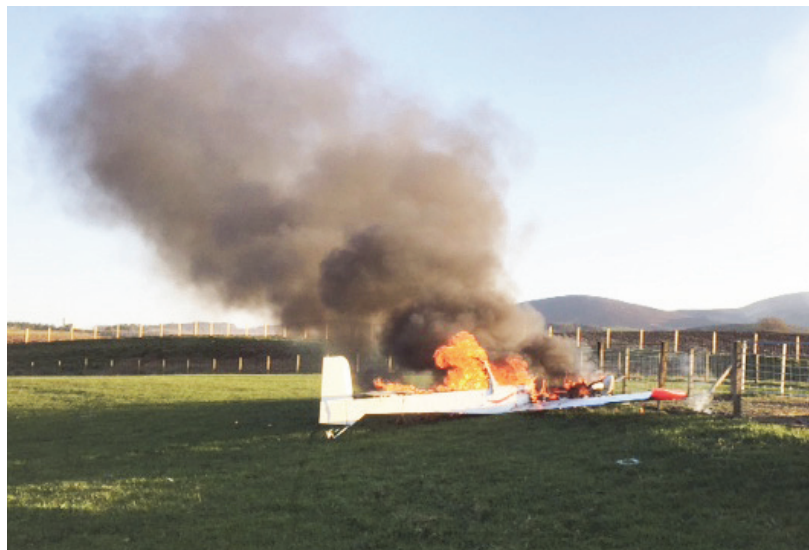
Figure 2

G-CIBJ shortly after the pilot had evacuated

The source of the fire which consumed the aircraft was the electrical system, which had overheated due to a short circuit. The short circuit was made by the metal rudder pedal contacting the exposed terminals of the starter solenoid mounted to the engine bulkhead. The rudder pedals had been adjusted to the fully forward position and due to the pedal inputs required for the taxiing manoeuvres, the left pedal had contacted the exposed terminal. The plans for the aircraft required the terminals to be insulated; however, the insulation had not been fitted to G-CIBJ. The LAA will mandate that the fuel pipes on all UK-registered Luciole aircraft be modified to a higher heat resistant specification.

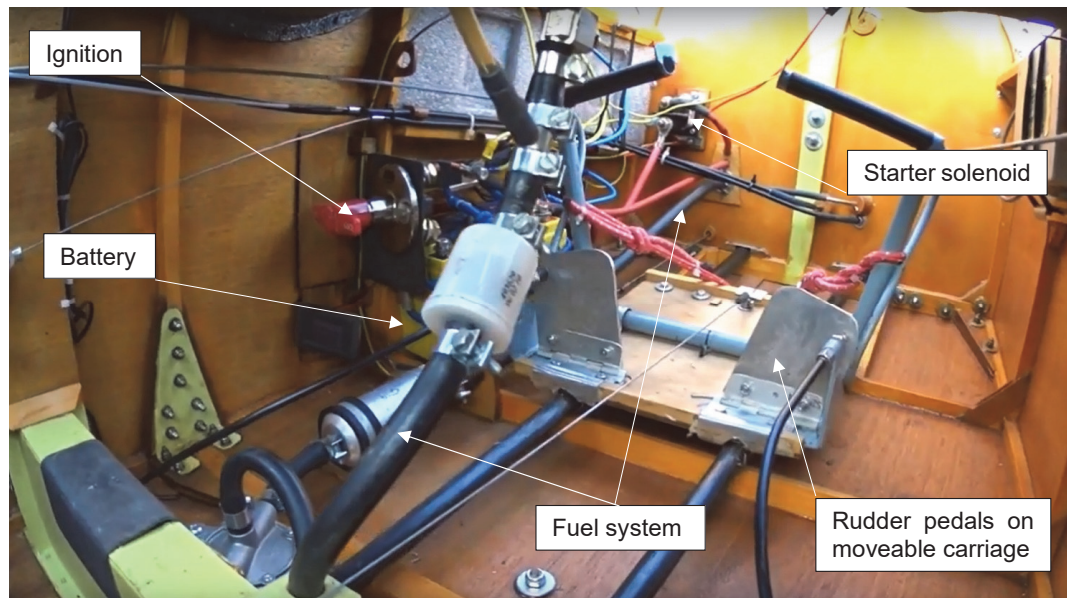
Figure 3

side of the cockpit, going forward and through the engine bulkhead just beneath the starter solenoid. The rudder pedals are adjustable fore and aft on a moveable carriage to suit the pilot and are centralised using elastic cords (Figure 3). During the accident flight the rudder pedals were adjusted fully forward.

Cockpit interior (not G-CIBJ)

During the taxi manoeuvres the pilot noted a restriction when he applied full left rudder pedal and shortly afterwards smoke was seen in the cockpit. It is probable that, as the rudder pedal carriage was in the fully forward position, the metal pedal contacted the exposed terminals of the starter solenoid. The solenoid is connected directly to the battery and the metal rudder pedal created a short circuit to earth, resulting in rapid discharging of the battery and overheating of the electrical system. Evidence was found of local heat damage to the engine bulkhead around the starter solenoid. This overheating may have caused the fuel pipe to melt, with a spark igniting the fuel and the aircraft was then consumed by the fire.

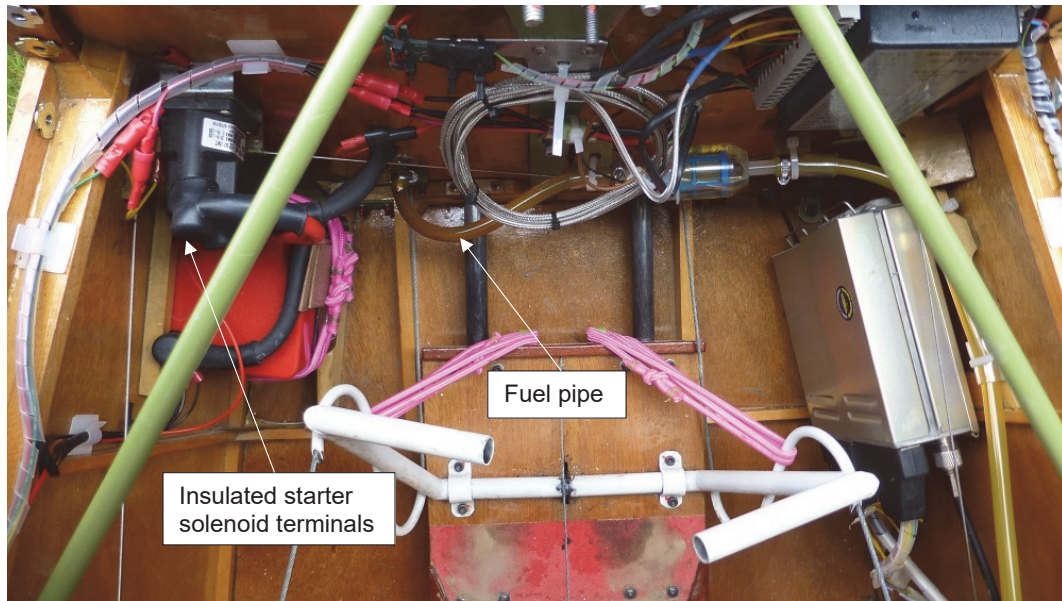
Figure 3

The plans for the aircraft state that the terminals of the solenoid should be “*perfectly isolated*”. The Light Aircraft Association (LAA) has examined all other Luciole aircraft registered in the UK and confirmed that all the terminals are insulated (Figure 4). It is suspected that only G-CIBJ did not have this insulation and awareness of this issue has been raised by the LAA in their June 2019 “*Safety Spot*” publication and Technical Leaflet TL3.26. The LAA intends to mandate a change to the specification of the fuel pipe in the cockpit to one that is more heat resistant and will require all UK owners to modify their aircraft to this new fuel pipe specification.

Cockpit interior (not G-CIBJ)

The LAA will mandate that all UK-registered Colomban Luciole aircraft be modified to the higher heat resistant fuel pipe specification.

The LAA has recommended that all UK-registered Colomban Luciole aircraft be modified to the higher heat-resistant fuel pipe specification.
