AAIB Bulletin

10/2018

AS350 B3e Ecureuil	G-MATH	05-May-17	3
--------------------	--------	-----------	---

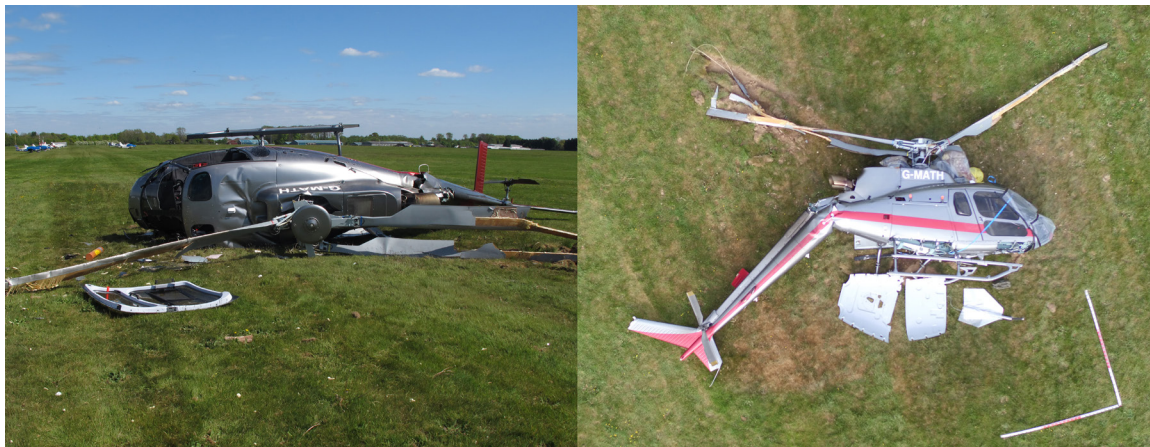
Figure 1

The accident site was located within the airfield boundary, about 200 m north of the centre of Runway 06/24. The helicopter had struck the ground on its left side with little forward speed (Figure 1). The ground impact marks showed that the main rotor blades had struck the ground first when the helicopter was in a near 90° left bank, and the damage to the blades was consistent with them being powered. The tail boom had failed as a result of the inertia loads of the impact but there was no damage to the tail rotor. The fuselage came to rest on a heading of 019° (M).

G-MATH accident site

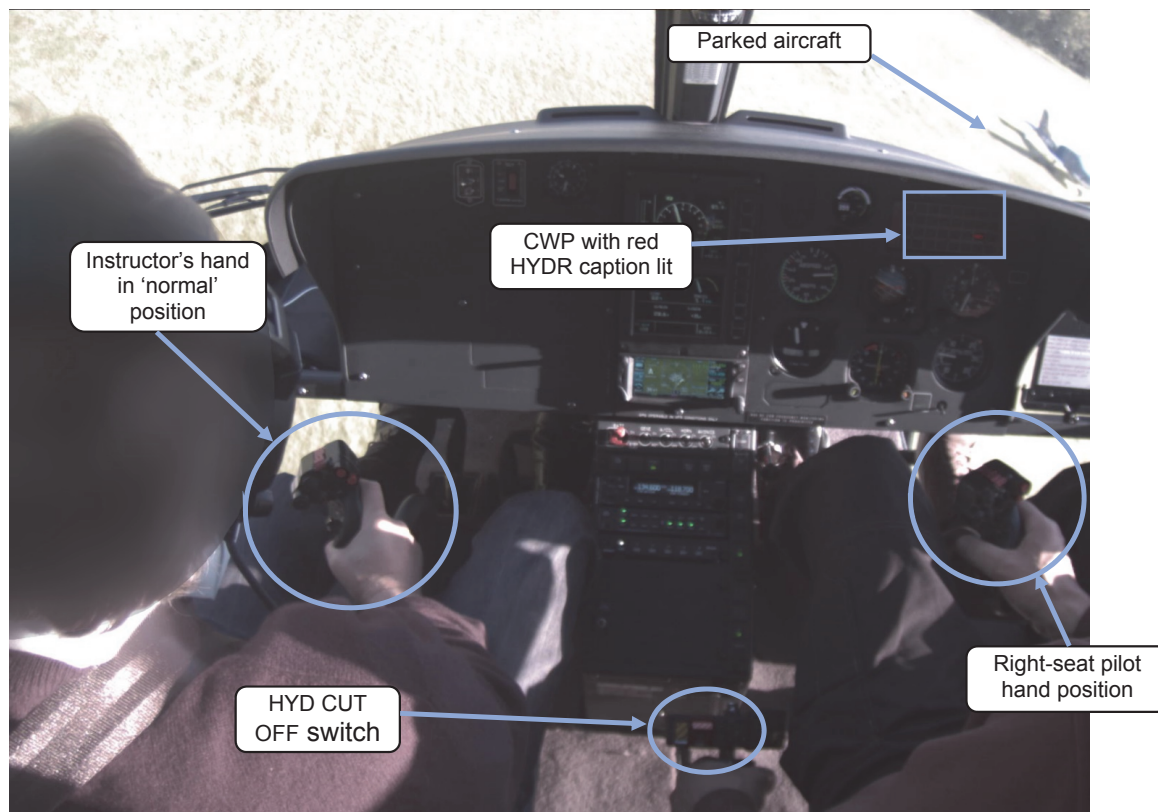
Figure 4

Second go-around showing right-seat pilot with hands and feet on the controls (instructor's head has been blurred).

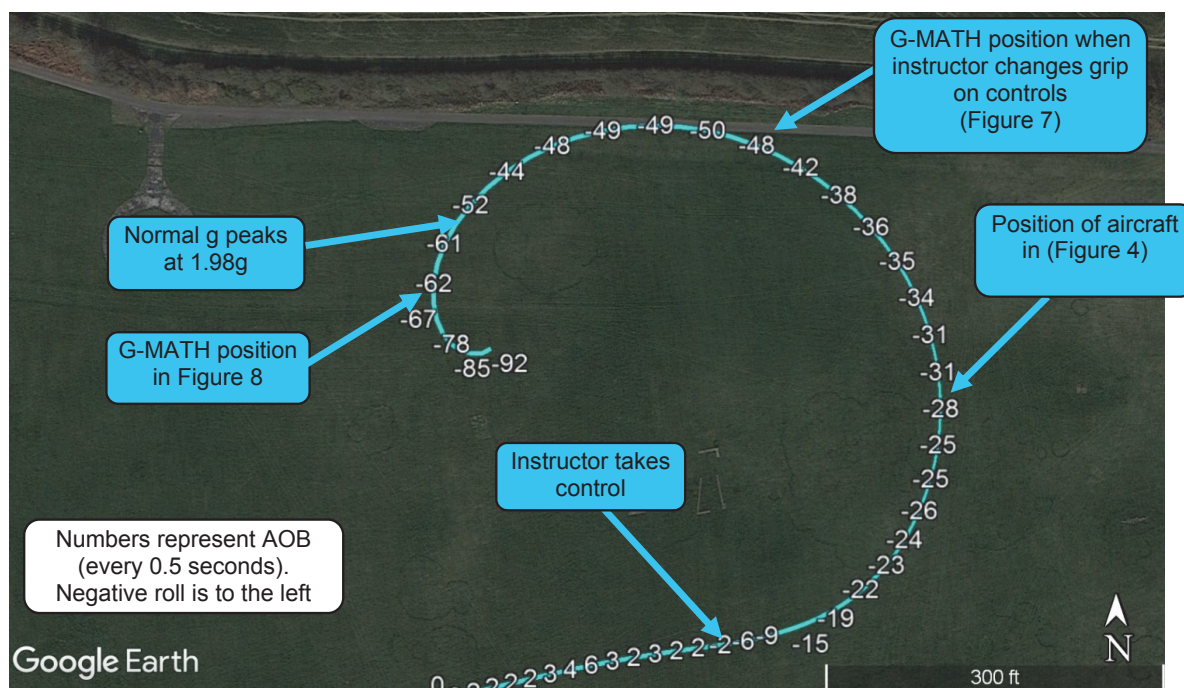
Figure 6

In the final stages of the second go-around (Figure 6) the AOB increased to 50° left and the helicopter pitched down to -19° over four seconds. (The view from the cockpit video and recorded position at this point showed the helicopter was just inside the airfield boundary hedge). The recorded height was 64 ft agl.

G-MATH final go-around manoeuvre showing AOB

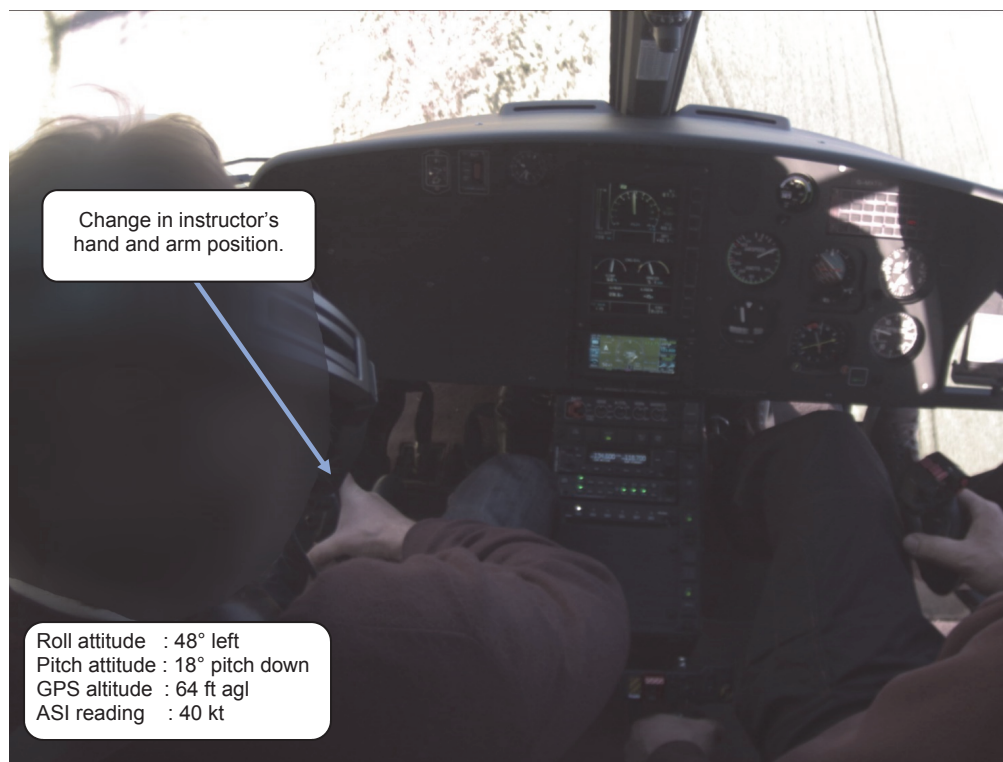
**Figure 7**

G-MATH at 0832:54 hrs during second go-around showing changed grip for instructor (compare with Figure 4). (Instructor's head has been blurred)

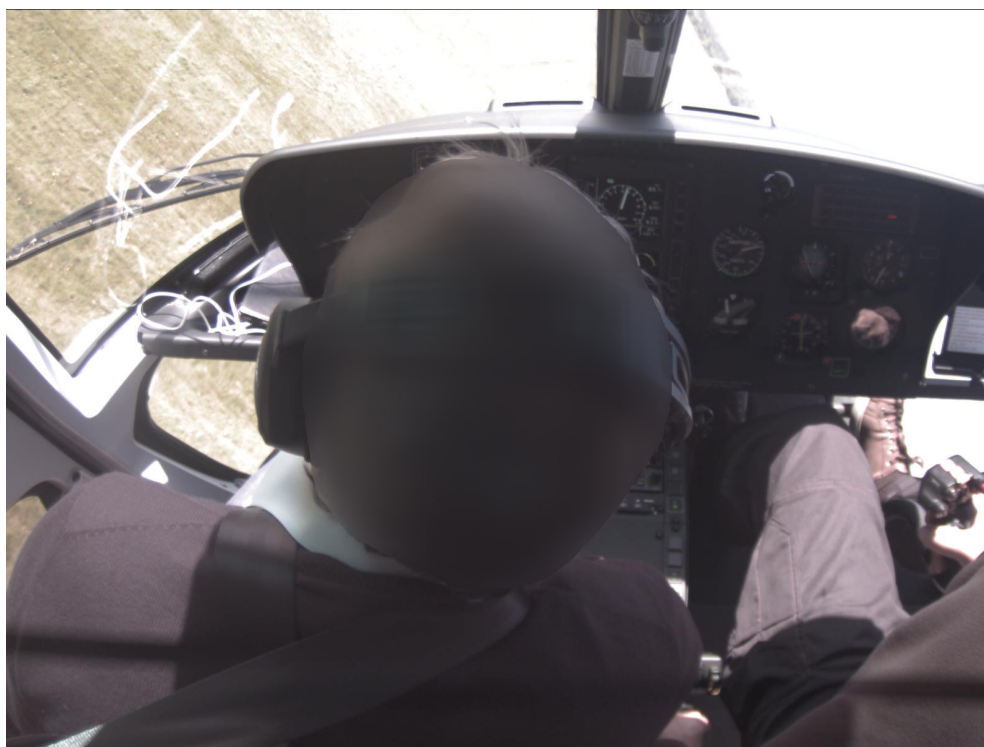
**Figure 8**

After the instructor's grip on the cyclic had changed, his body also leant to the right (Figure 8) and for the final 3 seconds prior to the accident, obscured the Vision 1000's view of the right collective lever and the position of the hydraulic cut-off switch on the end of the right collective. The view of the CWP was not obscured and the red HYDR light remained illuminated until the end of the recording.

G-MATH at 0832:58 hrs during second go-around showing instructor's right lean (62° AOB). (instructor's head has been blurred)

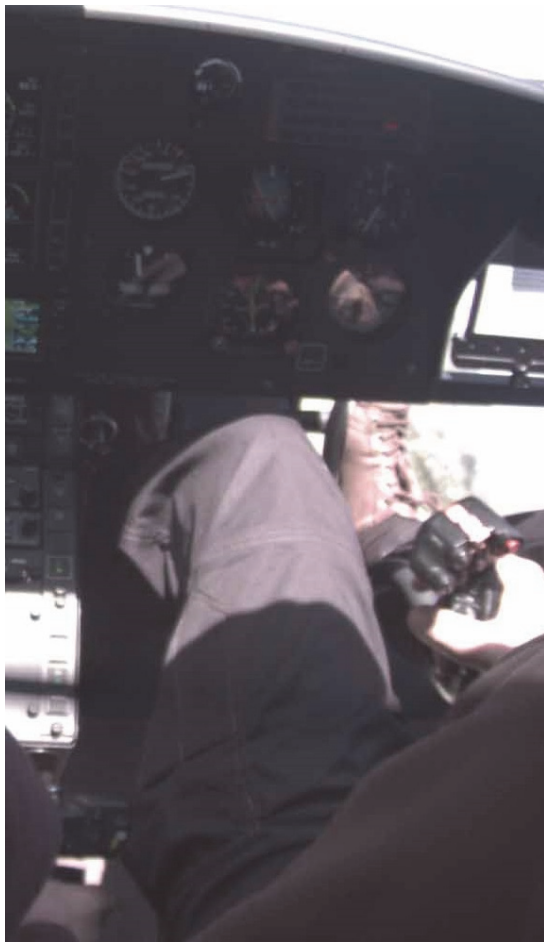
Figure 9

G-MATH Vision 1000 view showing right-seat pilot's cyclic position at its furthest right during the second go-around

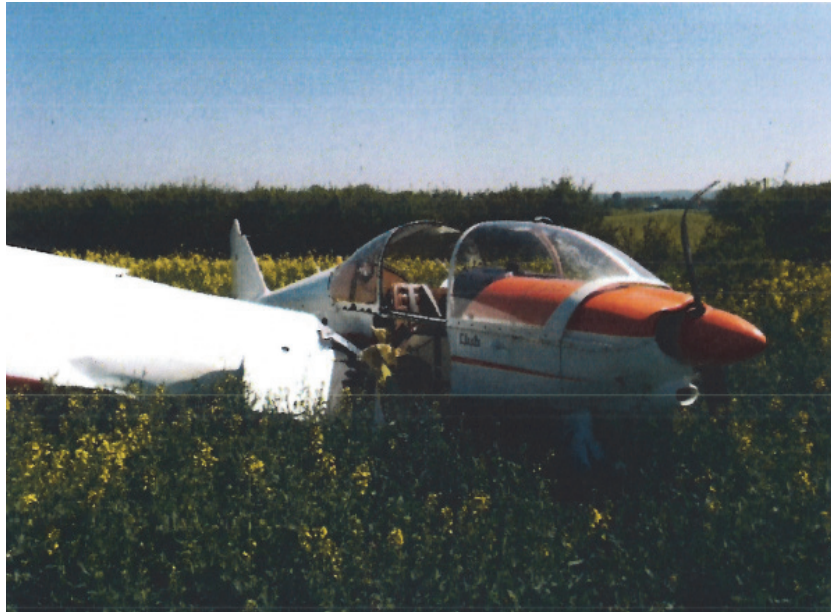
Figure 1

The pilot decided to use Runway 29, although it would involve a slight tailwind, as it would be away from buildings close to the threshold of the runway. After completing his checks, the pilot commenced the takeoff roll. The aircraft reportedly reached an airspeed of 40 kt approximately 400 m along the runway, but its acceleration did not continue as expected. The aircraft collided with a 2 m (6.6 ft) high hedge at the far end of the runway at an estimated airspeed of 45 kt. (The rotate speed for this aircraft is 49 kt and the best climb angle speed is 62 kt.) Both occupants, who were wearing four-point harnesses, were uninjured and able to vacate the aircraft unaided. The aircraft was substantially damaged, (Figure 1).

General view of the aircraft post-accident

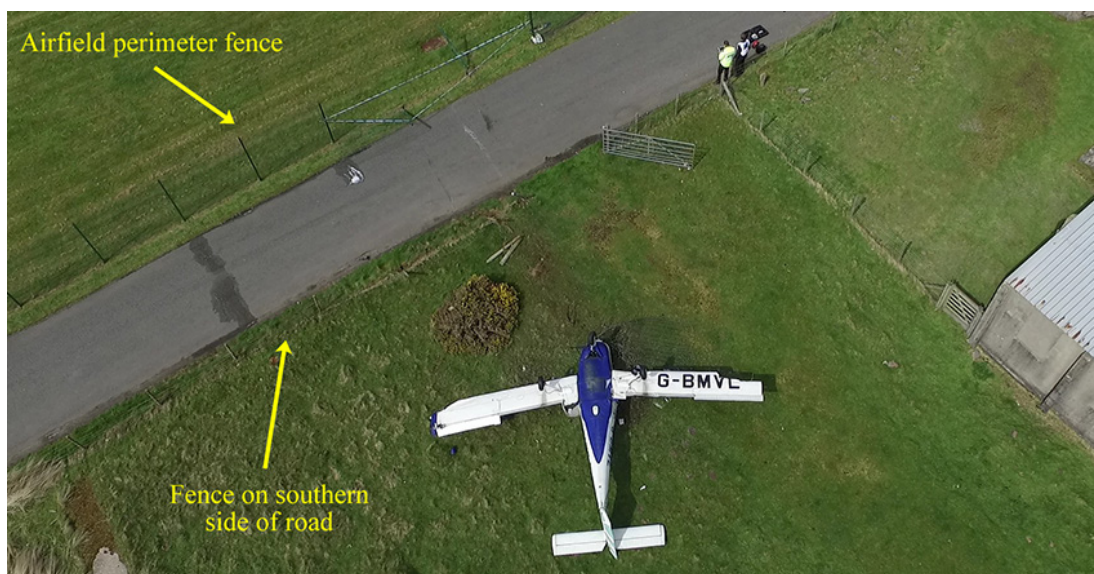
Figure 2

View of accident site from police drone
(Picture courtesy of North Wales Police)

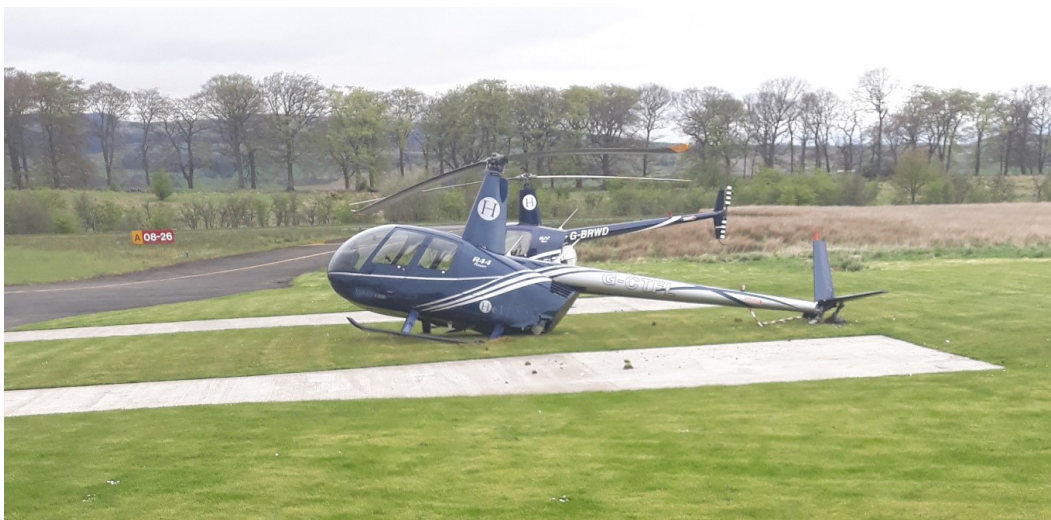
Figure 2

The pilot of G-CTFL heard a bang and recalled that his helicopter pitched nose-up and right, so he made a forward cyclic control input to return towards the helipad and lowered the collective lever. He then realised the helicopter was pitching nose-down so he moved the cyclic stick aft, but the tail struck the ground, before the helicopter bounced forward off its skids, towards the R22. The pilot stated that he reacted by making a left cyclic stick input, but that the rotor blades then struck the ground and the helicopter vibrated violently, so he lowered the collective lever fully. G-CTFL landed heavily in a nose-up attitude, near the R22, with its tail resting on the ground (Figure 2).

G-CTFL after the accident, facing towards Apron A, with the R22 visible behind, on the northern helipad, and with loose debris in the foreground

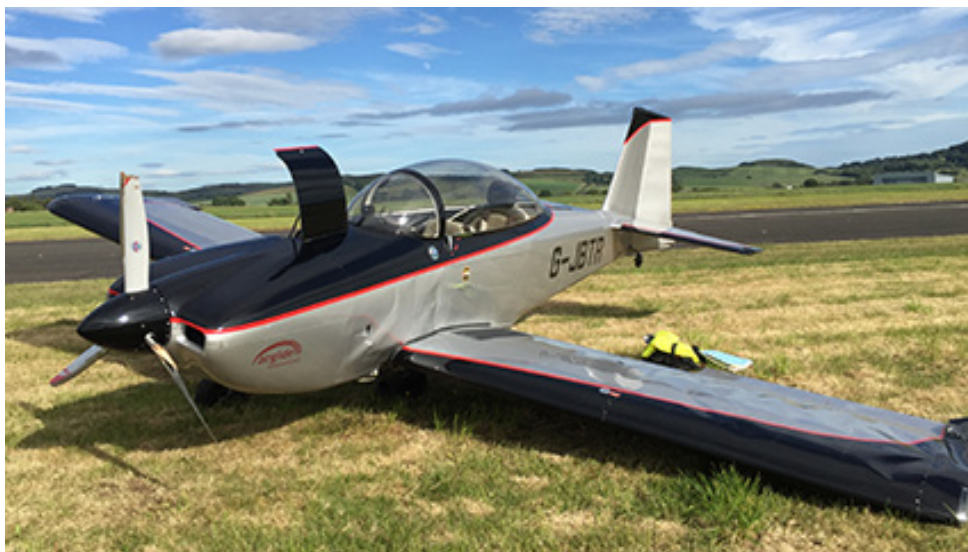
Figure 1

The aircraft slid sideways and as it left the paved surface, moving at a groundspeed of approximately 40 kt, the left main landing gear collapsed, causing the left wing and the propeller to strike the ground. The occupants vacated without difficulty after the aircraft came to rest, orientated on a northerly heading (Figure 1).

No mechanical defects were evident, so the pilot suspected that he may have initiated the right turn by inadvertently applying right brake, with the left mainwheel possibly lifting during the turn. This may have meant his subsequent application of left brake was ineffective, while rudder authority was diminished as the aircraft decelerated.

G-JBTR showing evidence of damage to the propeller, the fuselage and the left wing

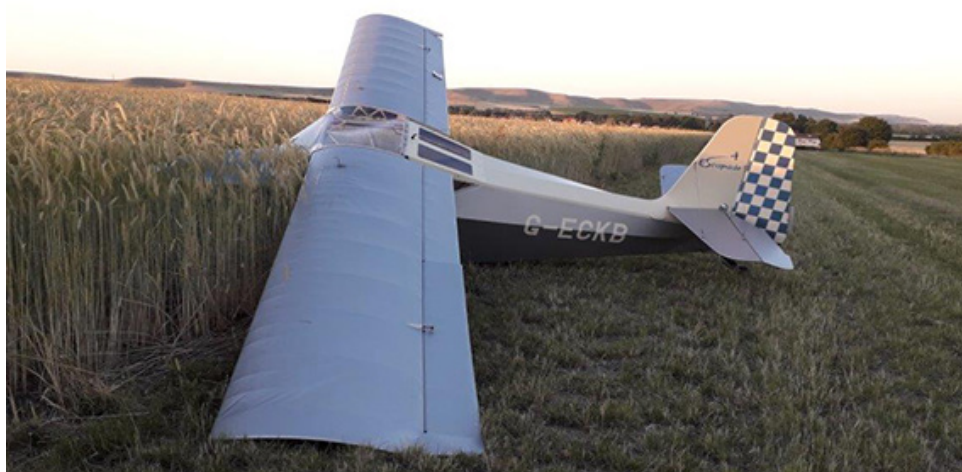
Figure 1

While on final approach the aircraft sank in turbulence, and this alarmed the passenger who then, inadvertently, restricted the control stick from being moved rearwards. Consequently, the pilot could not prevent the aircraft from descending rapidly, and the left main landing gear detached in the ensuing ground contact with the grass runway. While this occurred the passenger was instructed to allow the pilot freedom to move the control stick and, after a single bounce, the pilot landed the aircraft on its right main landing gear and tailwheel. However, as the airspeed reduced, the aircraft settled onto its left wingtip and slewed left, before coming to rest at the edge of grain crop which adjoined the runway (Figure 1).

G-ECKB resting on its left wingtip at the edge of the grain crop

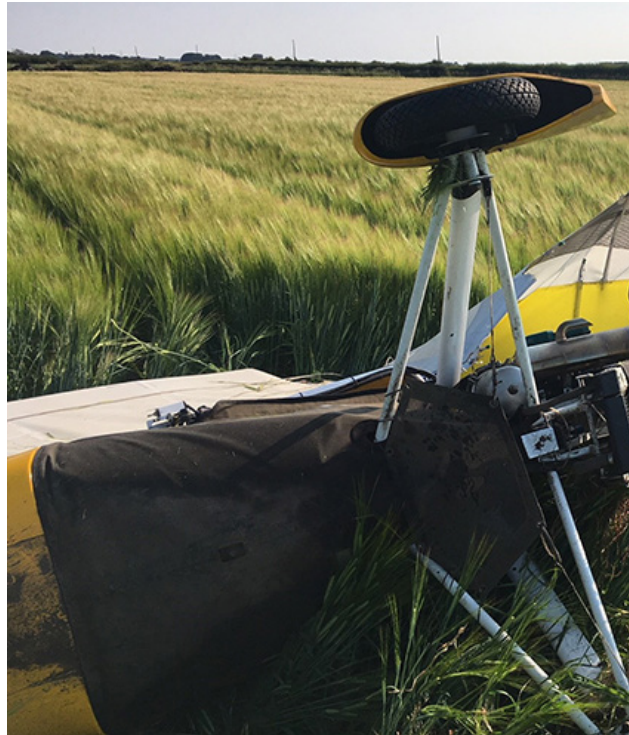
Figure 1
G-CGSO on its side after the accident
