# ***AAIB Bulletin***

***11/2018***

Published 8 November 2018

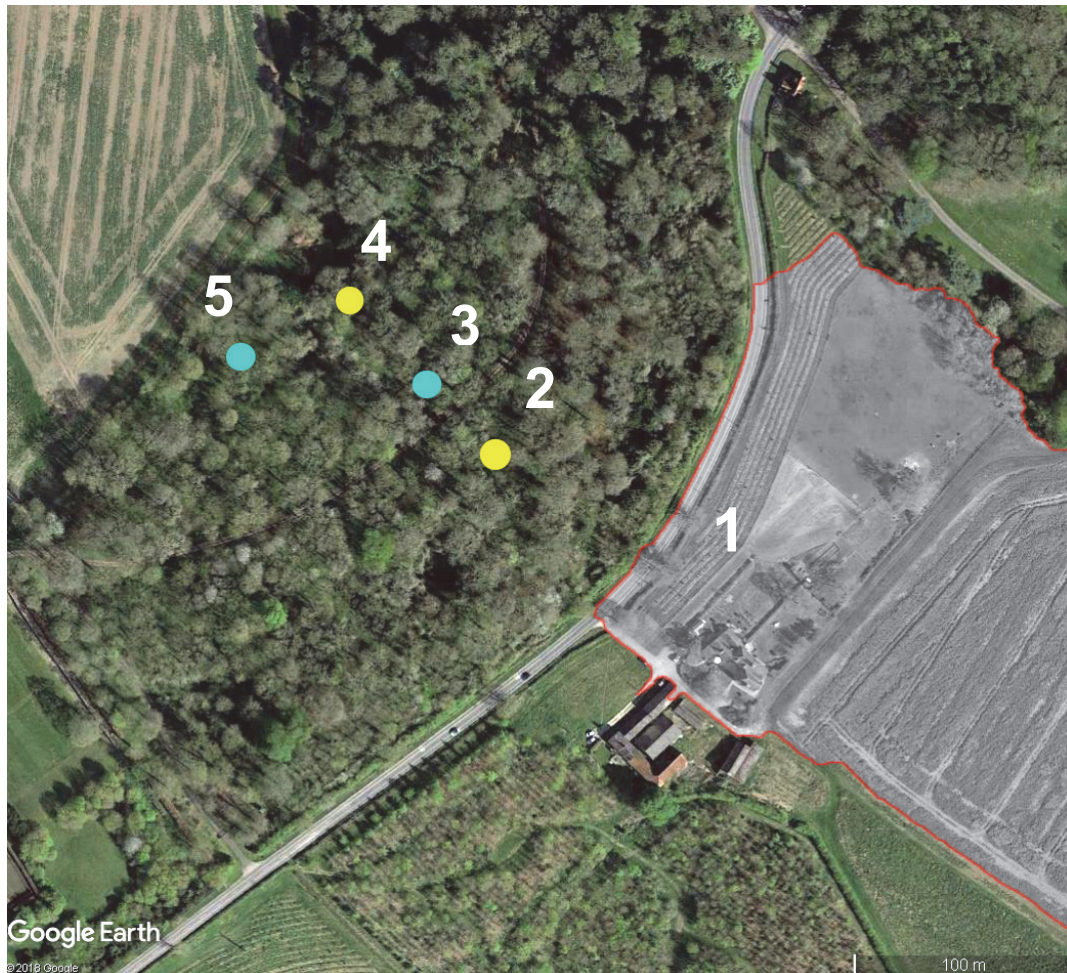
**Figure 5**

Both aircraft came down in the grounds of Waddesdon Estate and there was a debris trail approximately 300 m in length in a direction of approximately 312°M. There were five areas of interest (Figure 5) and, apart from area 1, the wreckage from both aircraft was contained within an area of woodland.

Debris recovered from area 1 consisted of small, lightweight items that were identified to be from the right wing of G-WACG. This included the navigation light, sections of fibreglass from the wingtip and parts of the right aileron and outer wing skin. Paper pages from a Cessna Pilot Operating Handbook were also recovered from this area. The aircraft's empennage, including both elevators and the rudder, was found in area 2.

G-WACG's fuselage and wings were found in area 4, having come to rest upside down opposing the direction of travel. There was no evidence of fire. The right wingtip and approximately 0.6 m of the outboard section of the right wing were missing. The right mainwheel was found adjacent to the wreckage, having broken off its axle; the nosewheel and left mainwheel remained attached to the fuselage. The leading edge of the right wing

The wreckage of G-JAMM was found mainly in area 3. It had come to rest upright, in the direction of travel and it had sustained considerable damage when it struck and descended through the trees. Some components, including the right door and fragments of the windscreen, were found several metres from the main wreckage. Most of the composite fuselage had been consumed by a post-crash fire and one of the main rotor blades was missing. The two rotor blades that remained in-situ were extensively damaged but unburnt. The tail boom and tail rotor remained attached but the structure was badly disrupted. The main rotor blade that had detached from the helicopter was found in area 5.

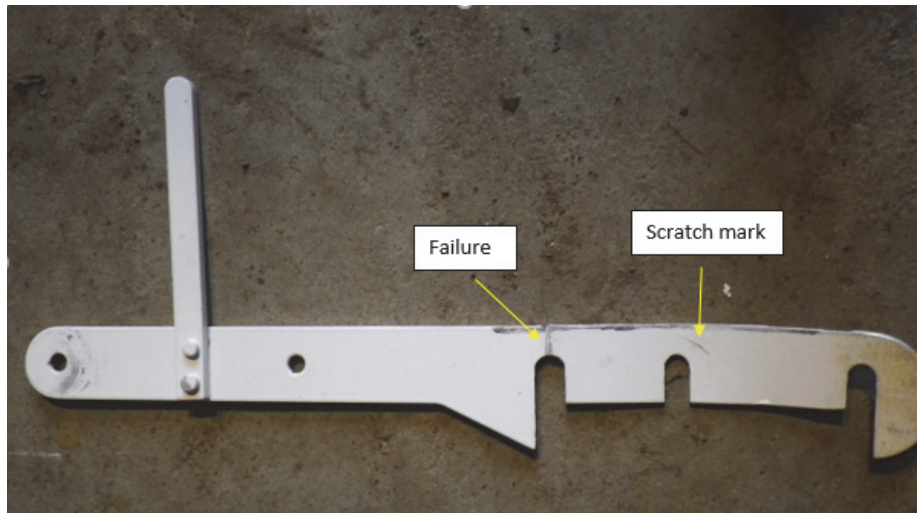
**Figure 5**

The flap operating lever had failed in overload as a result of a force having been applied from the left side of the lever. Marks on the front of the lever were consistent with normal operating wear marks. However, there was a fresh scratch in the paint on the right side of the lever, adjacent to the second flap latching position (Figure 5).

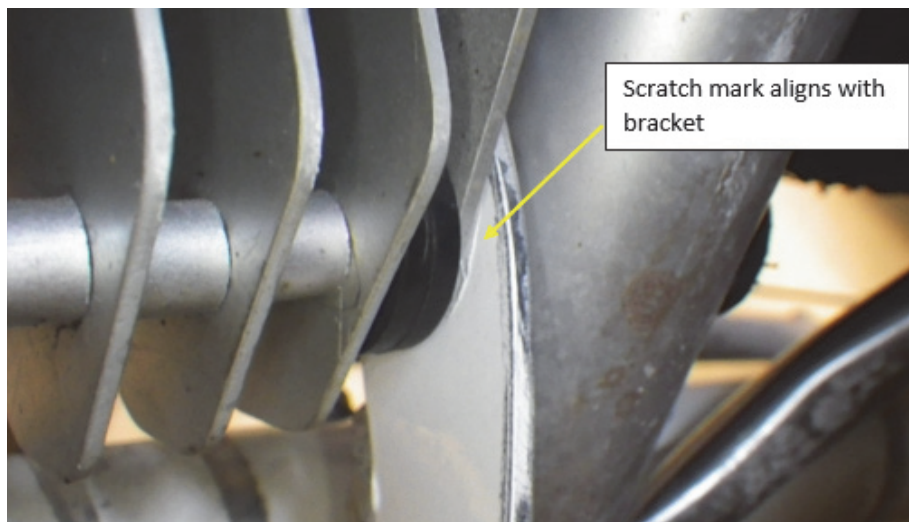
**Figure 6**

The scratch mark on the flap operating lever aligned with the edge of the latching bracket, which corresponded with the flaps being at the takeoff (Flap 15°) position (Figure 6).

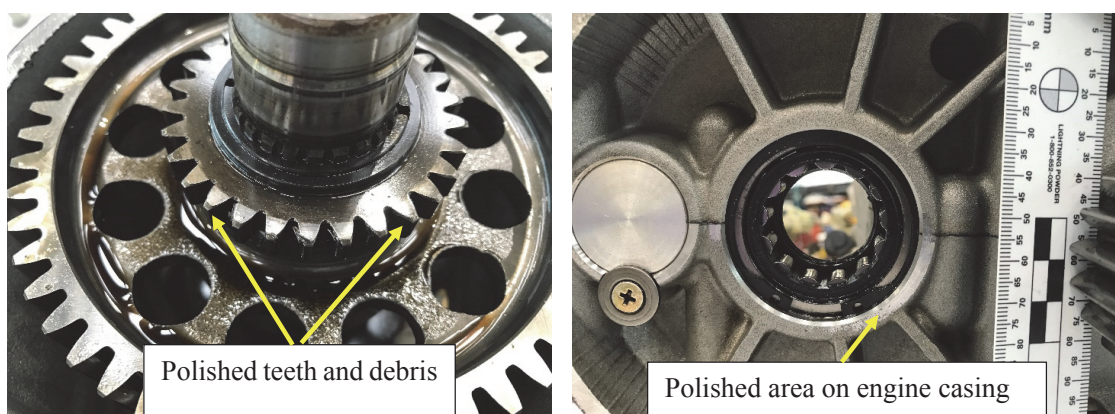
**Figure 7**

There was a small amount of debris between five of the teeth on the small gear in the reduction gearbox which was used to drive accessories such as a vacuum or hydraulic pump, however, this drive was not used on this engine. The sides of the teeth had a polished appearance which corresponded with a polished area on the engine casing that extended across an arc of approximately 80° (Figure 7). It was assessed that this damage occurred during the impact because of the propeller drive shaft being pushed into the reduction gearbox, causing the sides of the teeth to contact the engine casing. It was this contact, and possible distortion of the reduction gearbox casing, that had prevented the engine from being rotated by hand during the initial inspection.

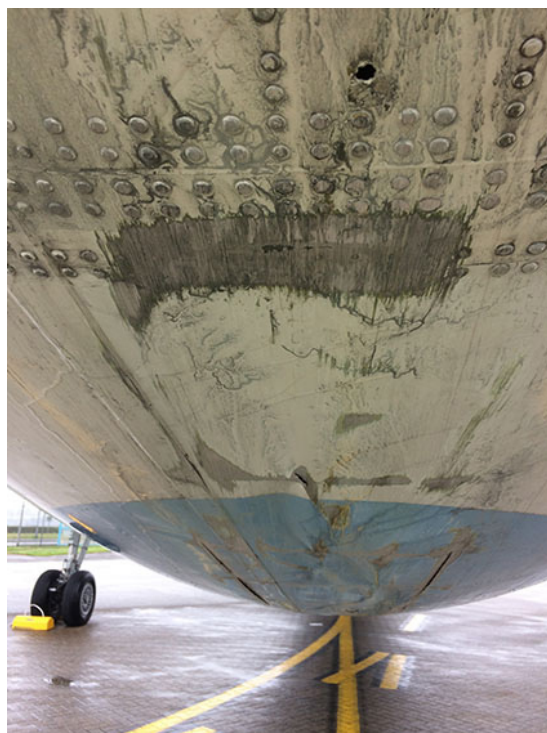
The aircraft was examined by the manufacturer. Damage was found to several skin panels, frames, stringers and aft pressure bulkhead.

**Figure 2**  
Damage to aft fuselage

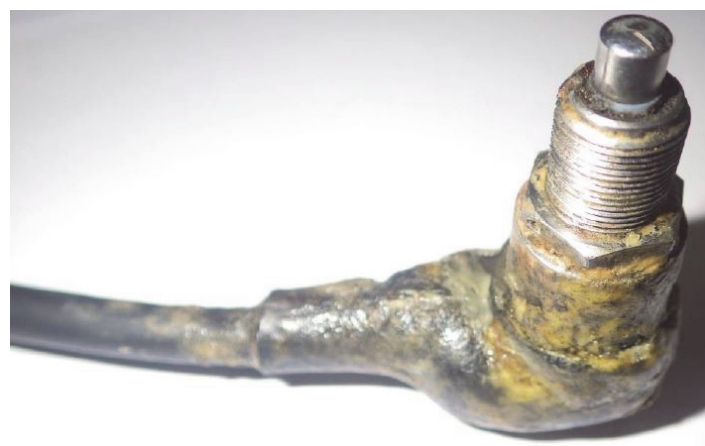
**Figure 2**

The NLG primary downlock microswitch and its associated wiring harness were removed from the aircraft for further examination (Figure 2). No visual defects were identified but movement could be felt between the wiring harness and the microswitch which was due to damaged and broken wires in the harness.

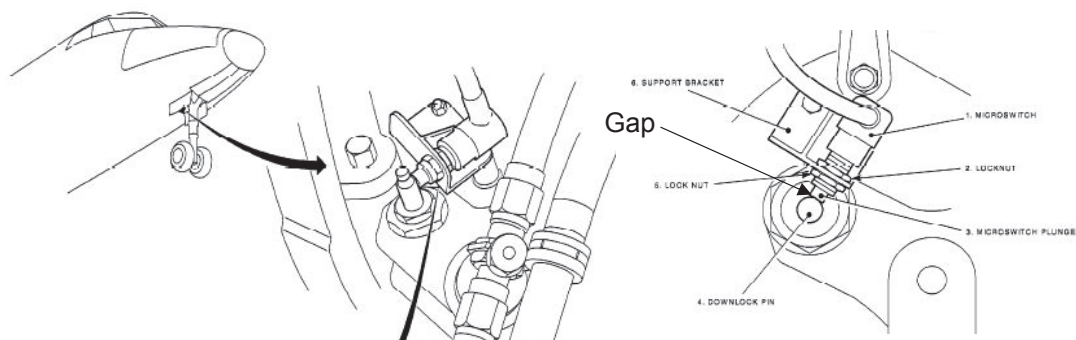
**Figure 3**

The NLG standby microswitch was in a serviceable condition but there was a gap between the microswitch plunger and the downlock pin resulting in the switch not operating when the landing gear was 'down and locked' (Figure 3). This condition could have resulted from being rigged incorrectly at the last maintenance interval, the microswitch support bracket having moved in-service, or a combination of both.

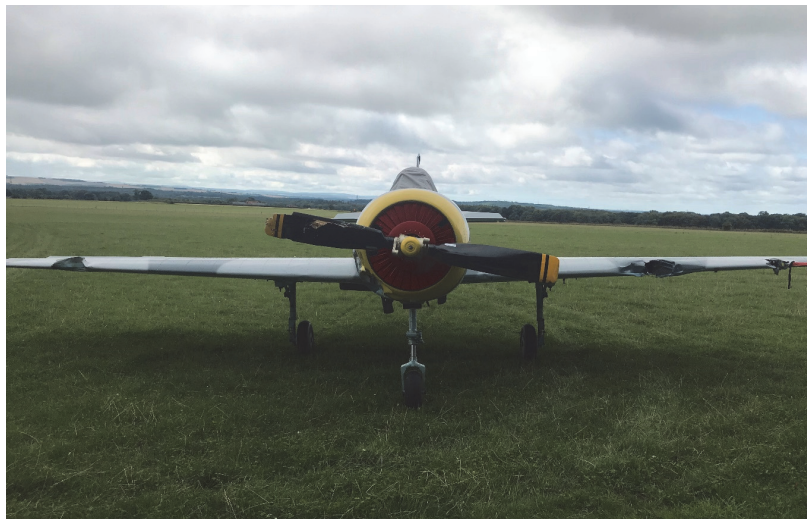
**Figure 2**

The collision with the fence caused damage to both leading edges, the right lower cowling and the propeller (Figure 2).

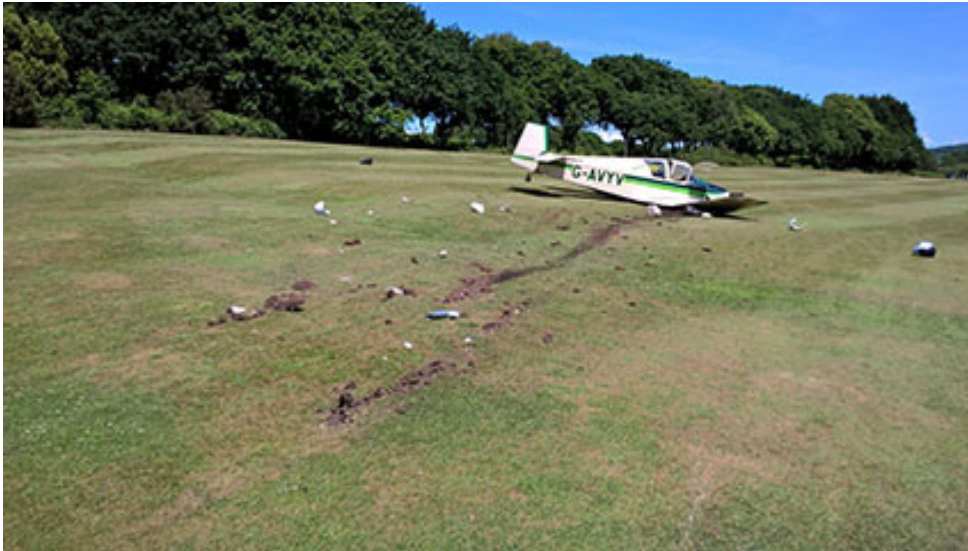
**Figure 1**

Aircraft and initial impact marks

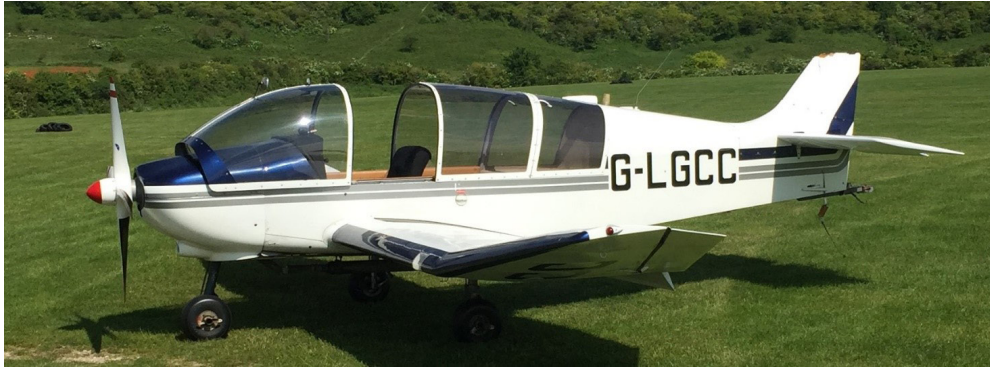
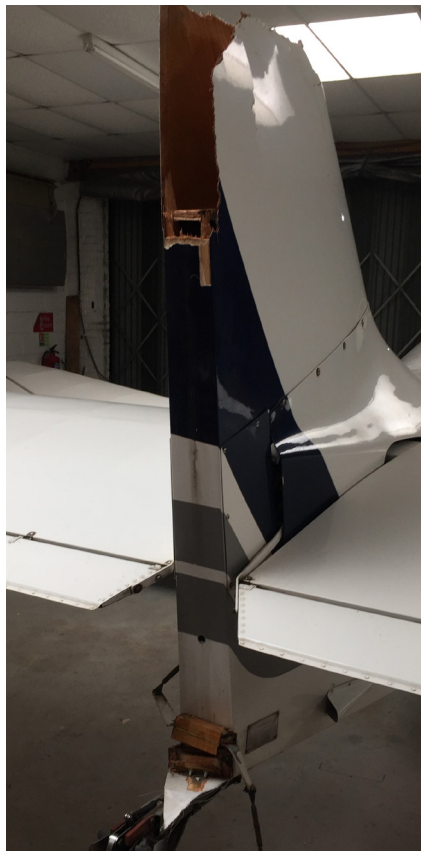
tug's tail fin detached along with the rudder (Figures 2 and 3). Stress marks found on the tug's right wing were consistent with damage discovered on the inner lower surface of the glider's right wing.

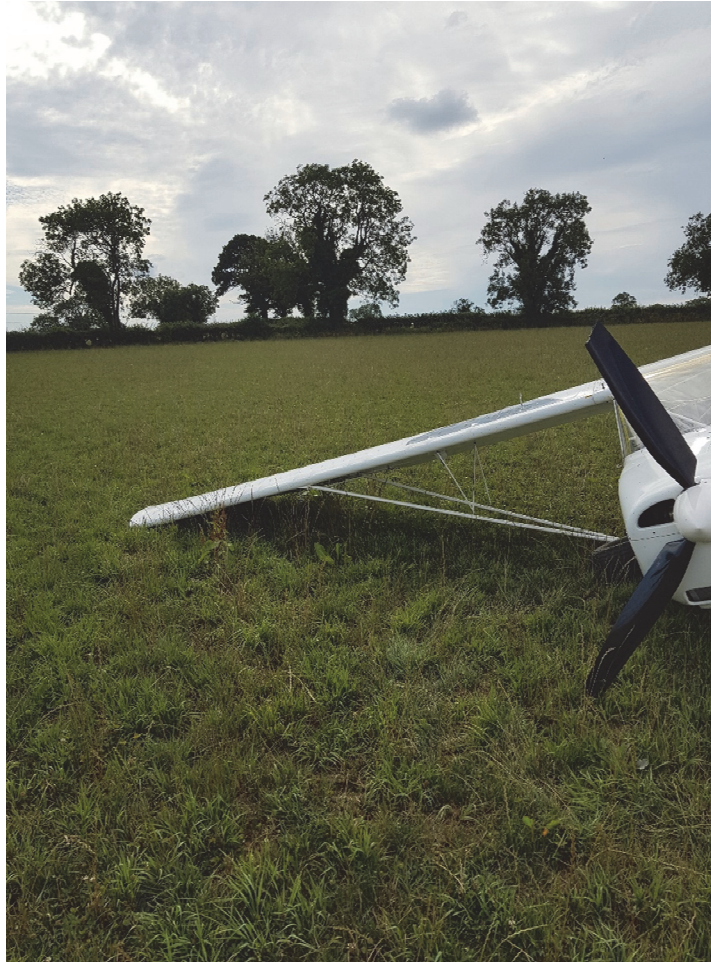
**Figure 1**  
Aircraft resting on the right wingtip

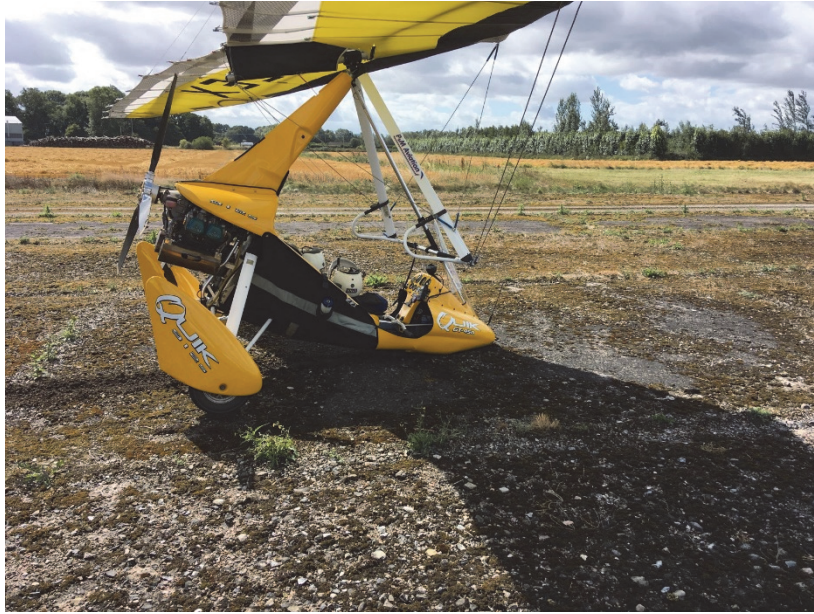
**Figure 1**  
G-CFEX off the side of the runway
