AAIB Bulletin

12/2018

BAE Systems (Operations) Ltd ATP	SE-MHF	14-Dec-17	3
BAE Systems (Operations) Ltd ATP	SE-MHE	14-Feb-18	15

Piper PA-28-161 Cherokee Warrior III	G-WAVS	08-Jan-18	34
--------------------------------------	--------	-----------	----

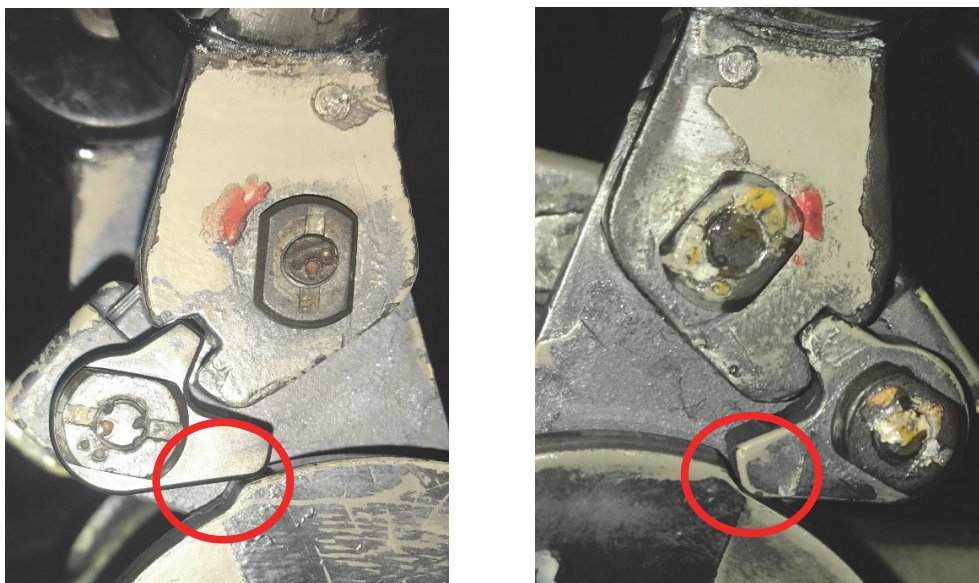
Figure 8

Repeated operation of the roll-over levers found that the left lever did not always lock down when it was returned to the forward position; it sometimes ‘bounced’ out of position and remained unlocked. With the left roll-over lever in this condition, the associated power lever could not be advanced from FLIGHT IDLE. The ‘feel’ and operation of the right roll-over lever was different and it always ‘positively’ locked down when returned to the forward position (Figure 8). The anomaly was not always apparent but could be repeated with relative ease. Examination of another aircraft found that both catches showed positive locking.

The left roll-over catch did not always lock (left)
The right roll-over catch always showed positive locking (right)

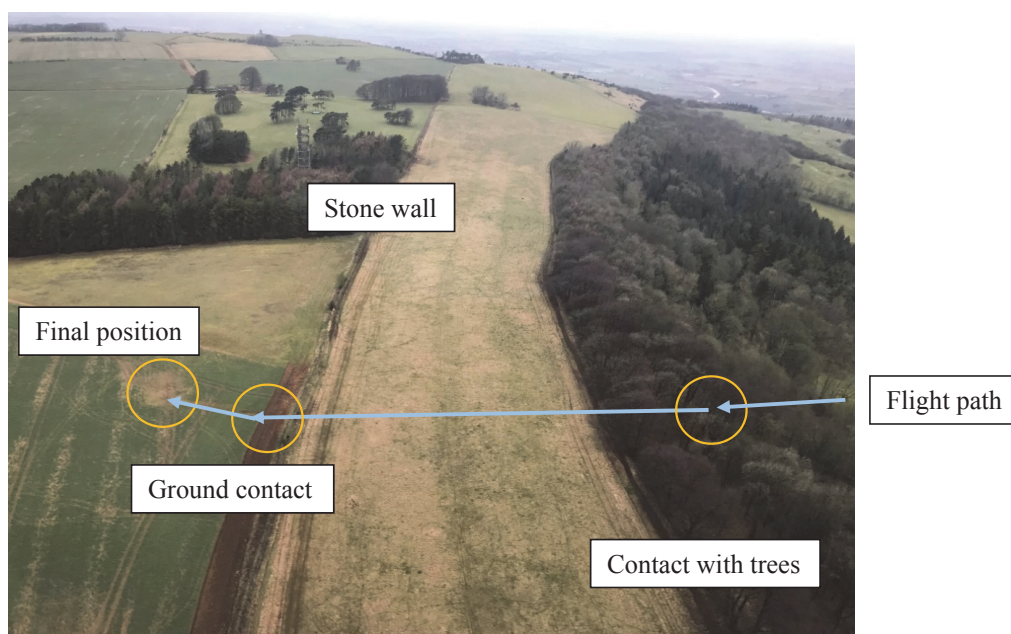
Figure 2
Accident site and Bredon Hill mast

Inspection of the accident site and wreckage indicated that the aircraft struck the top of trees near the summit of Bredon Hill on a heading of approximately 230°. This initial impact detached a portion of the outer left wing approximately 1.8 m in length, and part of the left aileron. The remainder of the aircraft then rolled to the left and descended to the ground approximately 170 m past the trees landing on its left side in a nose-down attitude causing further substantial damage. The aircraft contacted the surface close to and past a stone wall, which had not been contacted, and then quickly came to rest. This indicated that the final descent had been steep and at a slow forward speed.

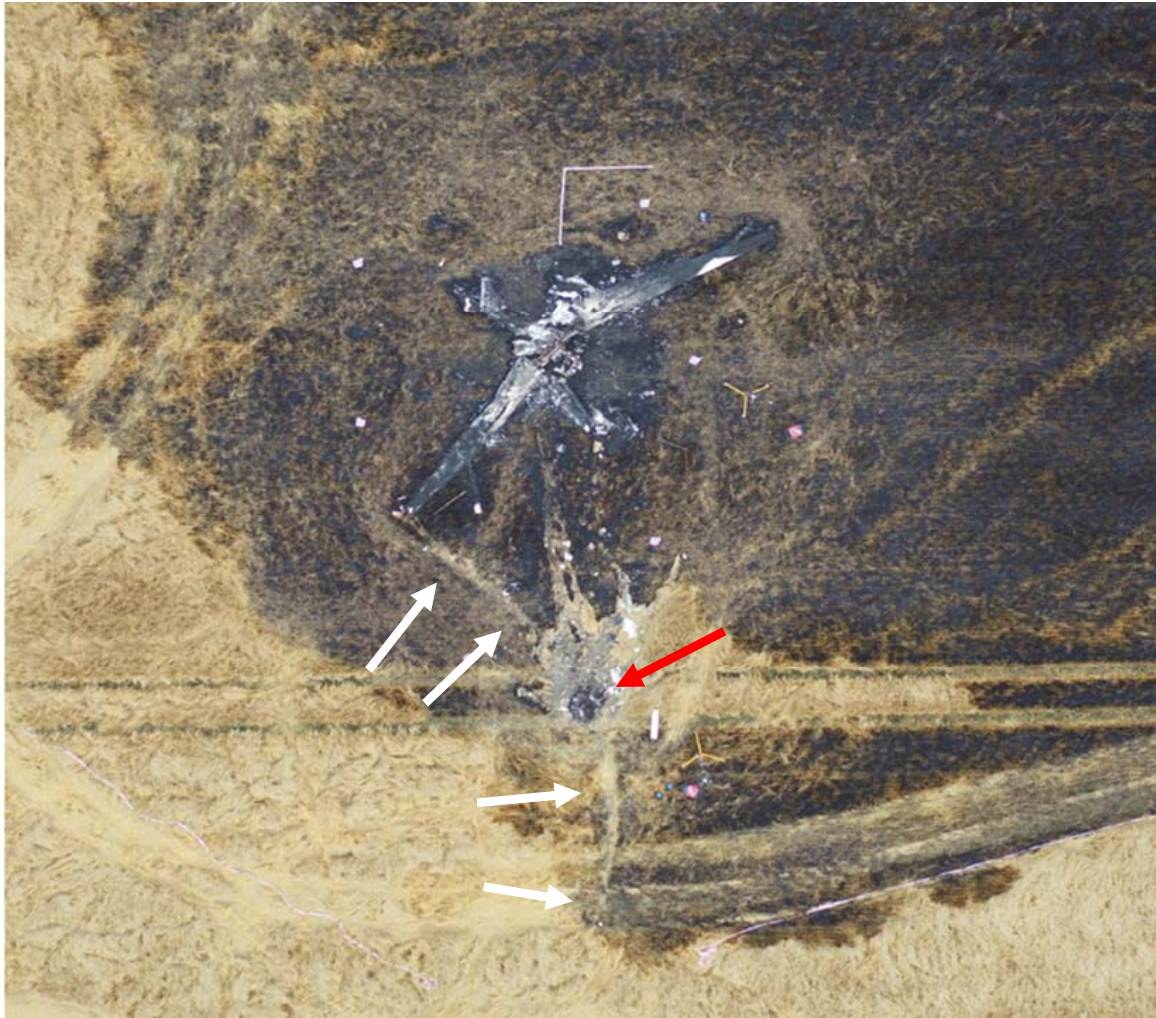
Figure 2

Aerial photo of accident site
(white arrows indicated curved impact marks from wing leading edges;
red arrow indicates engine impact location)

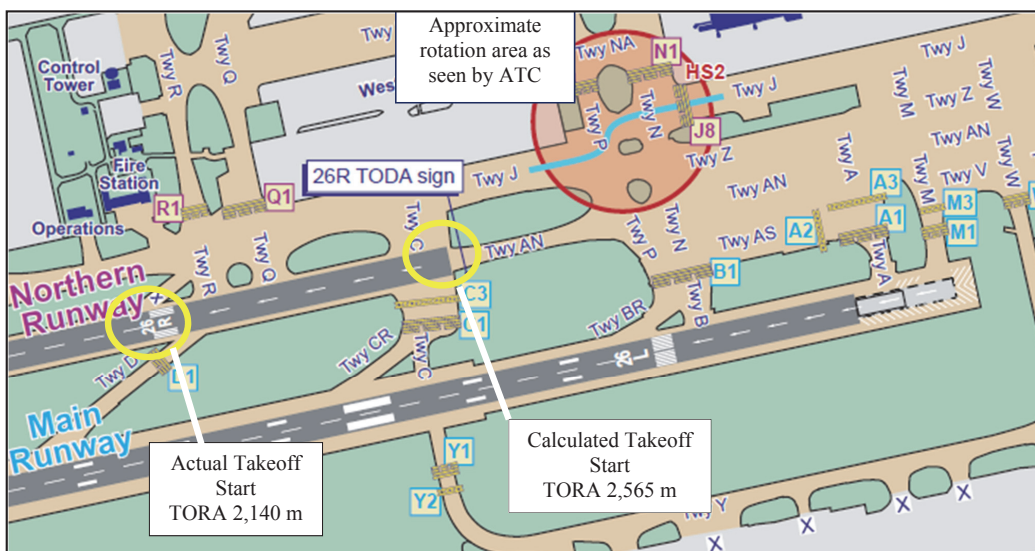
Figure 3 shows where the aircraft takeoff performance was calculated from (TORA¹ 2,565 m) and where the takeoff actually commenced (TORA 2,140 m).

The calculated and actual takeoff start points

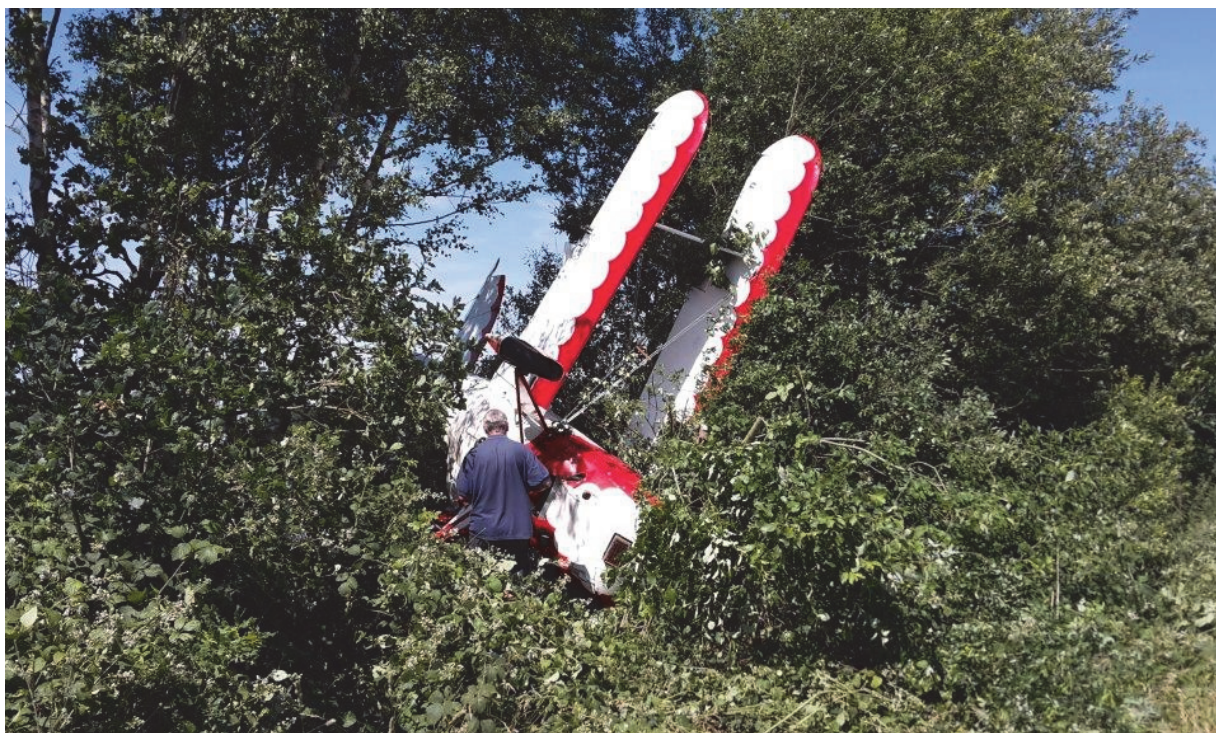
The pilot commented that he had commenced the takeoff roll about 15° left of the strip's track and flown towards the first tree. He believes this was caused by a failure to apply sufficient right rudder to counter the engine torque and not maintaining sight of the right edge of the runway, which borders a field of crops, in his peripheral vision.

Figure 1
G-SKIE after the accident

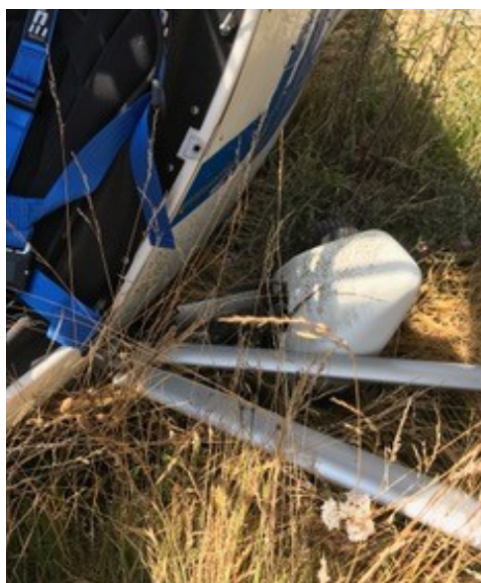
Figure 1

Shortly after touchdown, G-ULSY's left landing gear assembly failed, allowing the mainwheel to pivot rearwards and inwards towards the fuselage. The aircraft veered left uncontrollably, departed the prepared surface and came to rest in long grass adjacent to the runway (Figure 1). Neither occupant was injured and they vacated the aircraft unaided.

G-ULSY's left landing gear assembly after the accident

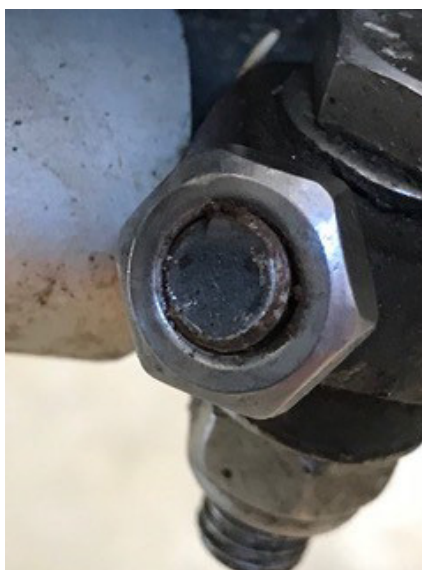
Figure 3

Investigation revealed that the rod end bolt connecting the drag link to the undercarriage assembly had sheared forward of the rose joint lock nut (Figures 2 and 3).

Rose joint/rod end bolt fracture face

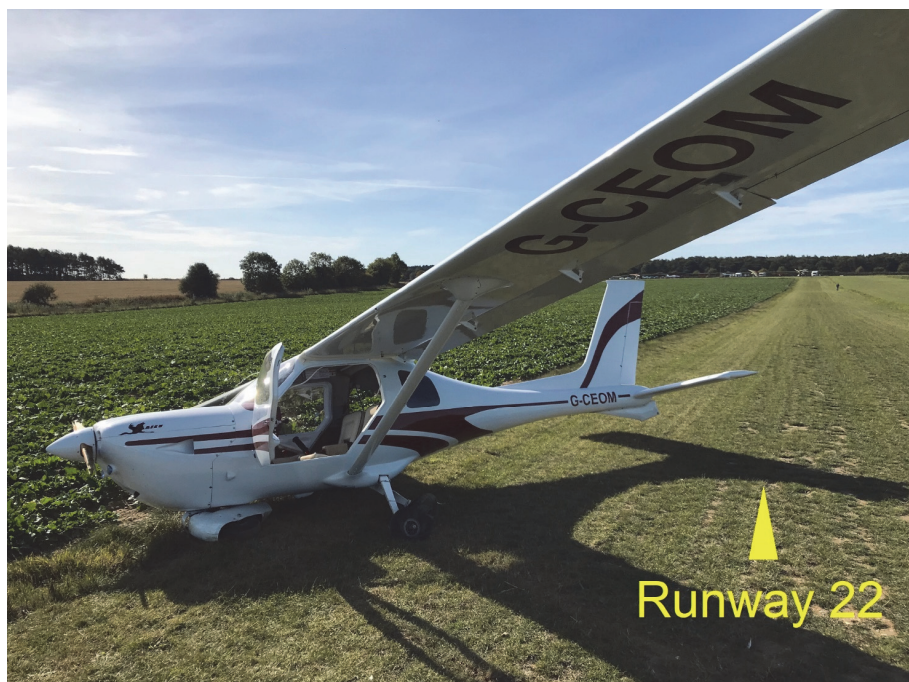
The pilot reported that the left tyre was found to be deflated and there were grooves in the runway caused by the left wheel and brake assembly. He considered that, following inflation of the tyres at Darley Moor, the left wheel tyre valve had not fully sealed, allowing air to slowly leak from the tyre.

Figure 1
G-CEOM gear collapse
