AAIB Bulletin

2/2019

Published 14 February 2019

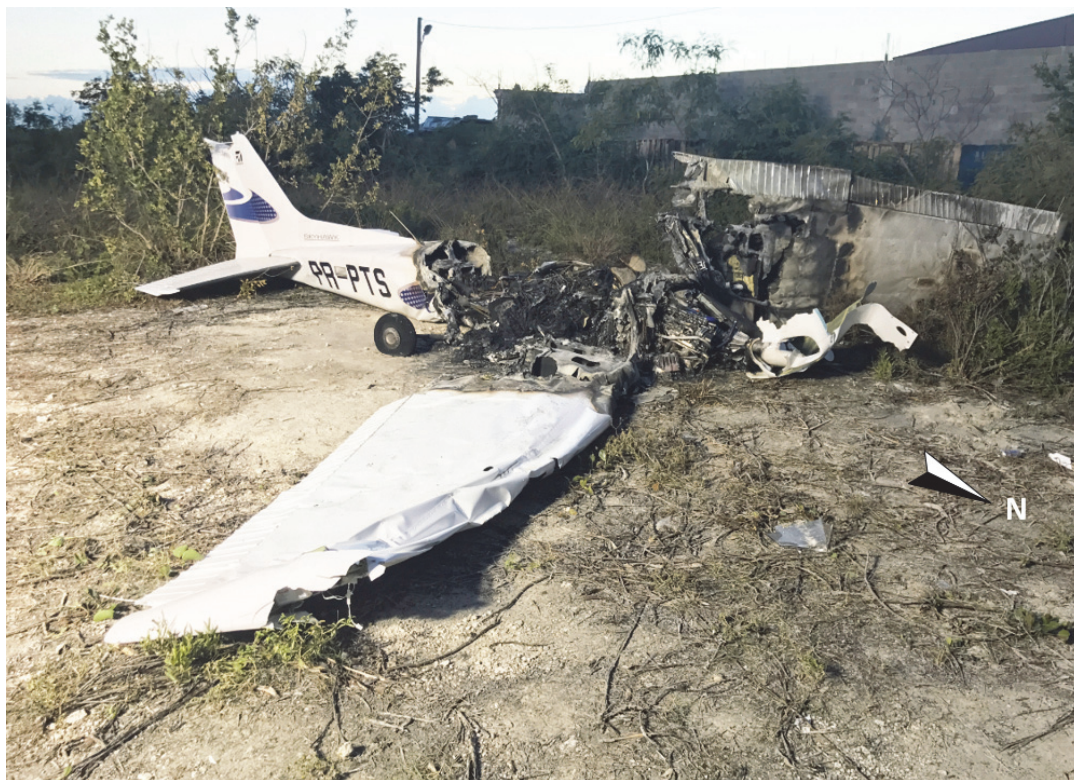
Figure 1
Accident site

The aircraft had struck the ground in a steep nose-down attitude, and had come to rest at the impact point (Figure 1) approximately 270 m north of the runway extended centreline. The impact heading was 010°M, 90° to the left of the departure runway heading. Both wing fuel tanks were ruptured on impact and a severe post-impact fire had developed, consuming the majority of the aircraft's cabin and inboard wing structure.

The post-crash fire had consumed most of the engine's air induction and coolant hoses. The intercooler was recovered with both hose clamps and a remnant of the silicone hose in position at the intercooler inlet. The intercooler outlet hose clamps had released from the intercooler during the impact and subsequent fire, but were later identified within the aircraft wreckage. The induction manifold inlet had both hose clamps still in position although the hose itself had burned away. The turbocharger compressor outlet coupler was secured to the turbocharger by its metal V-band clamp, however the single hose clamp that attaches the compressor outlet hose to the turbocharger was not located in the aircraft wreckage or at the accident site.

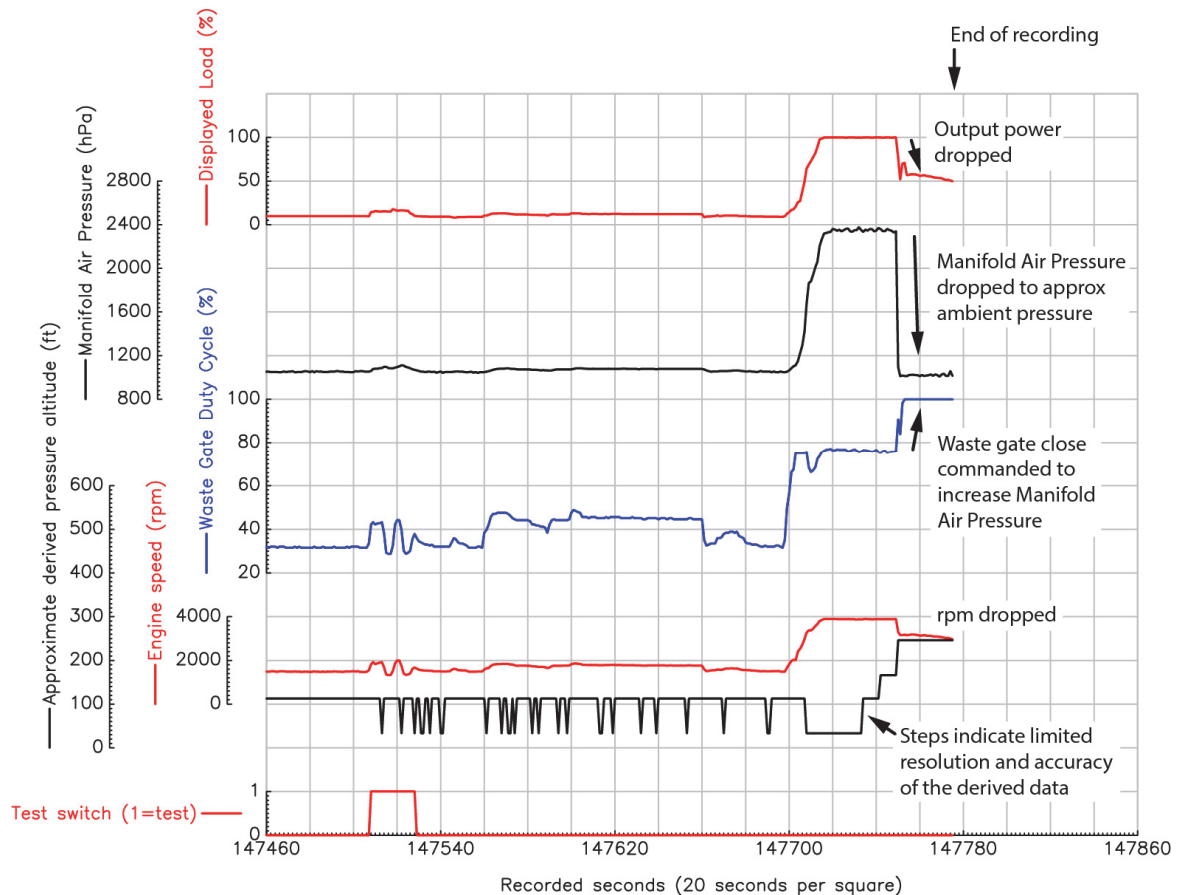
Figure 3

The FADEC started logging data at a recorded time of 2118:31 hrs. The engine speed on the ground was generally held stable at 1,500 rpm. A test was carried out at 2130:49 hrs. Three minutes later the engine started developing full power and then the aircraft started to climb. Shortly after this the manifold air pressure (MAP) fell to approximately ambient pressure conditions and the engine waste gate was commanded to close to increase this pressure. The data stopped shortly after this. The displayed power had reduced to 49.8%.

Extract from FADEC data – accident flight

The event log did not include any warnings associated with the time of the failure. A comparison of this initial takeoff with previous successful ones using the same aircraft did not find any anomalies up to moment when the MAP dropped.

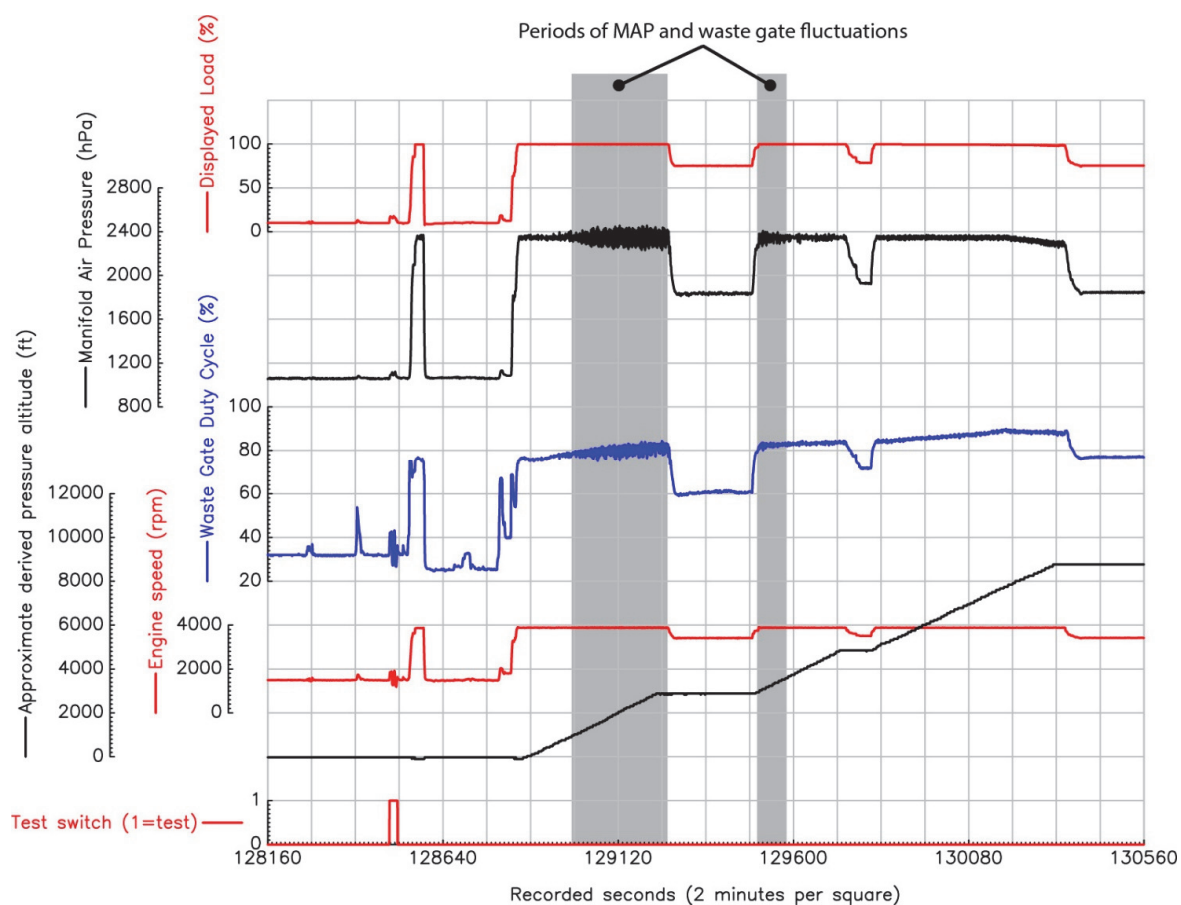
Extract from FADEC data – previous flight

The MAP fluctuations were also first observed with similar amplitudes, in excess of the manufacturer bench test limits, during a pre-delivery test flight conducted by the aircraft manufacturer on 16 December 2017. Similar MAP fluctuations were present on all subsequent flights. The data shows the MAP fluctuations on 16 December 2017 were present to a greater extent than that shown in Figure 4 but had not drawn the attention of the test pilot. The recorded displayed load parameters indicates that full power was available during the periods of MAP fluctuation.

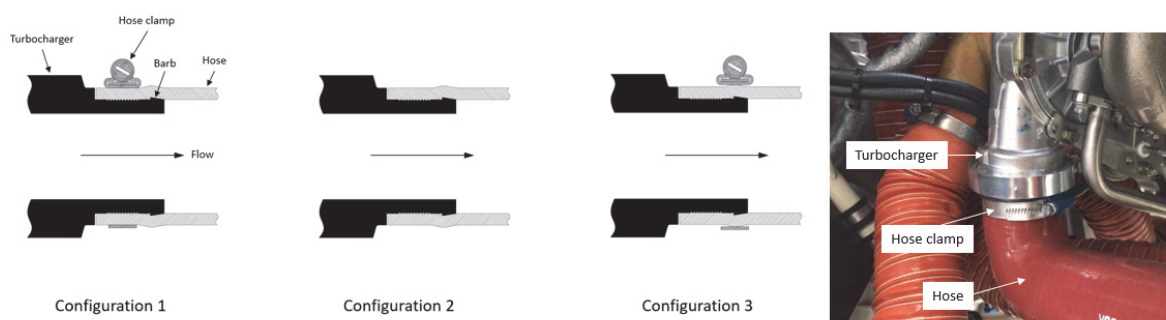
Figure 5

Three configurations of the securing of the turbocharger compressor hose were tested (Figure 5). The first test involved the turbocharger hose clamp being correctly positioned and loosened to the point where it was free to rotate about the hose, but still tight enough not to slide over the bulge in the hose due to the turbocharger outlet barb feature. When the engine was run at full power, the hose remained attached and the engine ran normally.

The second test involved removal of the hose clamp. The engine started and ran normally at idle power, but when the power lever was advanced the hose immediately detached from the turbocharger, before full power was reached. When the hose detached, the manifold pressure reduced to ambient pressure and the load reduced to approximately 55%. The exhaust gases were a dark, smoky colour due to an excessive level of unburnt fuel. The engine manufacturer confirmed that an abrupt reduction in manifold pressure would result in a lower air mass flow, leading to a sootier combustion which is visible in the black exhaust gases.

A third test was performed with the hose clamp incorrectly positioned over the bulge in the hose where it passed over the turbocharger barb. With the hose clamp loose enough to be rotated by hand, the hose detached when the engine ran before full power was reached, with similar results to the second test. A fourth test was performed with the hose clamp positioned as for the third test, but with the clamp tightened to the 5 N cm torque level, as required by the Aircraft Maintenance Manual (AMM). The hose clamp and hose remained attached during the subsequent engine run and the engine developed full power with a normal exhaust gas appearance. The clamp torque level was then reduced to 2.5 N cm, only 50% of the AMM-required level. Despite this reduction in clamp torque, the clamp and hose remained attached during an engine run to full power, including slam-throttle tests where the engine was rapidly accelerated from idle to full power.

Turbocharger compressor outlet hose clamp

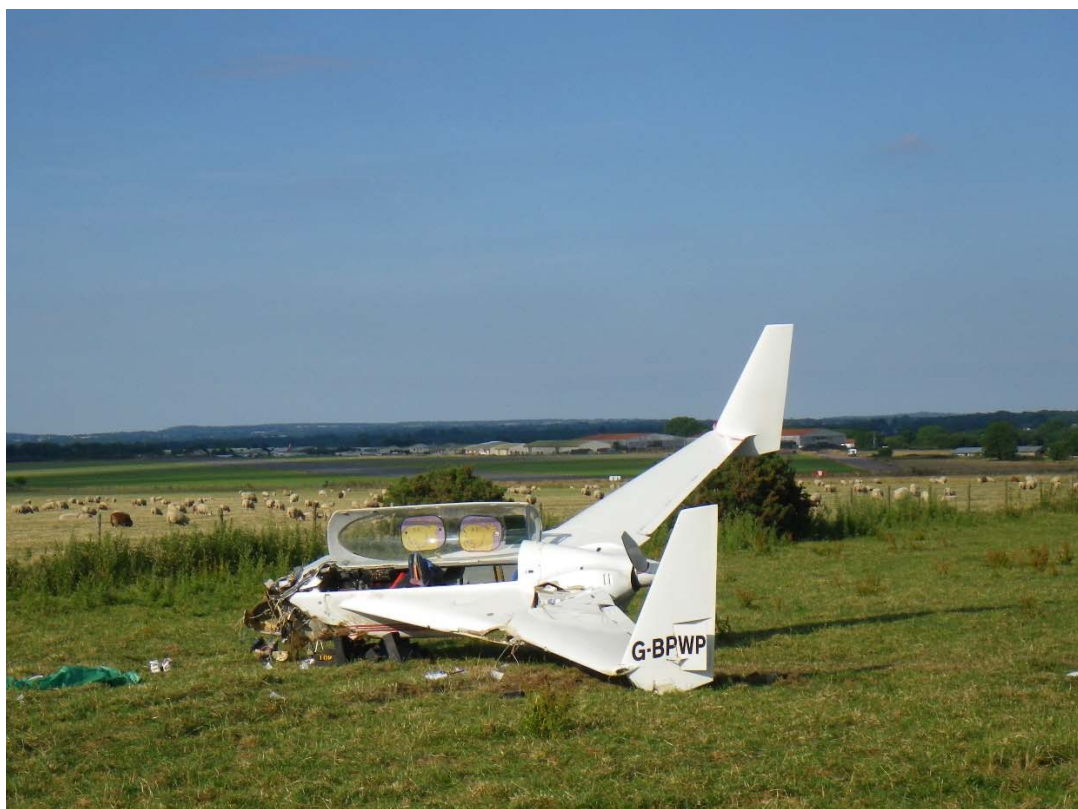
Figure 1
Accident site

G-BPWP came to rest in a field slightly to the left of the extended centreline, and approximately 550 m from the threshold of Runway 04, at Dunkeswell Airfield. The ground marks and damage to the aircraft indicated that the aircraft initially landed heavily on the left mainwheel and nosewheel. The left landing leg structural cross beam member failed at the centre of the fuselage, the nose landing leg detached, and the forward section of the fuselage was badly damaged when it struck the ground. The left fin and canard also contacted the ground with sufficient force to break the main spar in the left wing and damage the canard. Following the initial impact, the aircraft continued to travel across the ground for a further 54 m before stopping on a heading of 340°(M). The aircraft was 11 m from the fence which the pilot tried to avoid. See Figure 1.

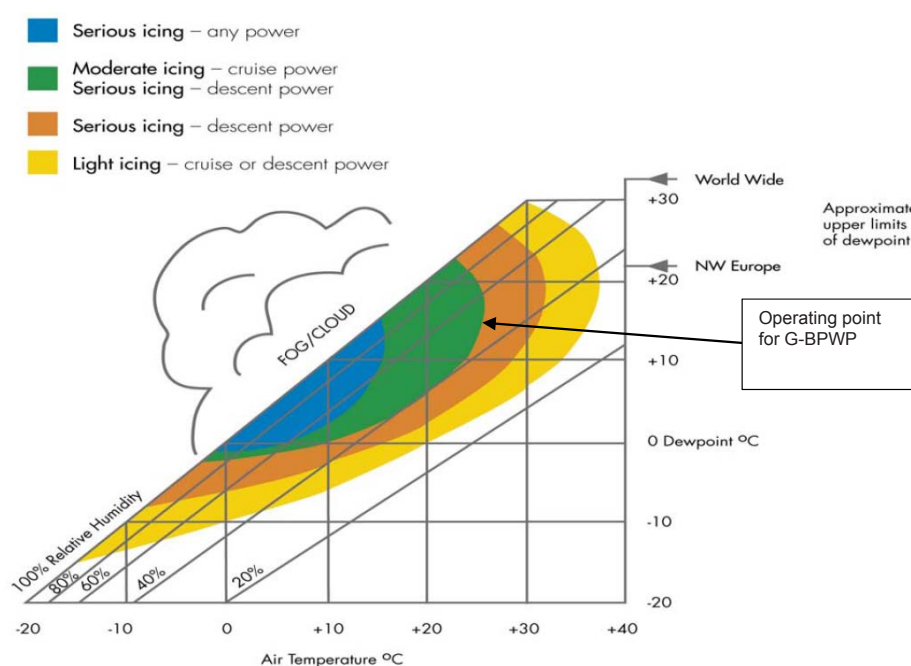
Figure 6

An aftercast from the Met Office reported that at the time of the accident the air temperature was 25°C and the dew point was 14°C. From the CAA graph on the probability of carburettor icing (Figure 6), at the time of the accident there would have been a moderate risk of carburettor icing during the cruise and a serious risk during the decent.

Probability of carburettor icing

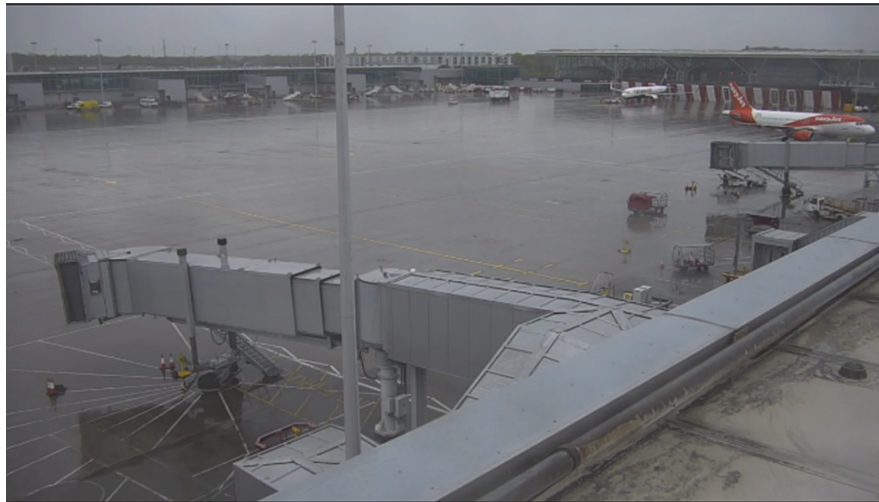
Figure 5
The aircraft contacting the blast fence

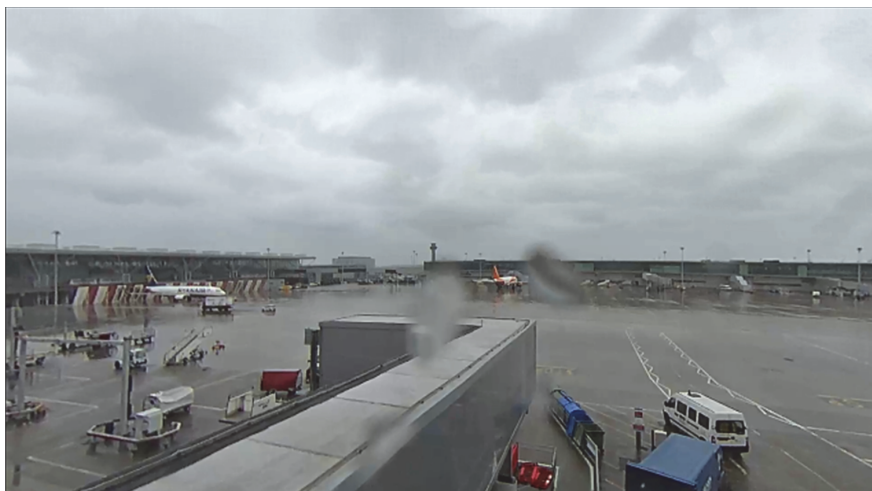
Figure 6
The aircraft contacting the blast fence from a different camera angle

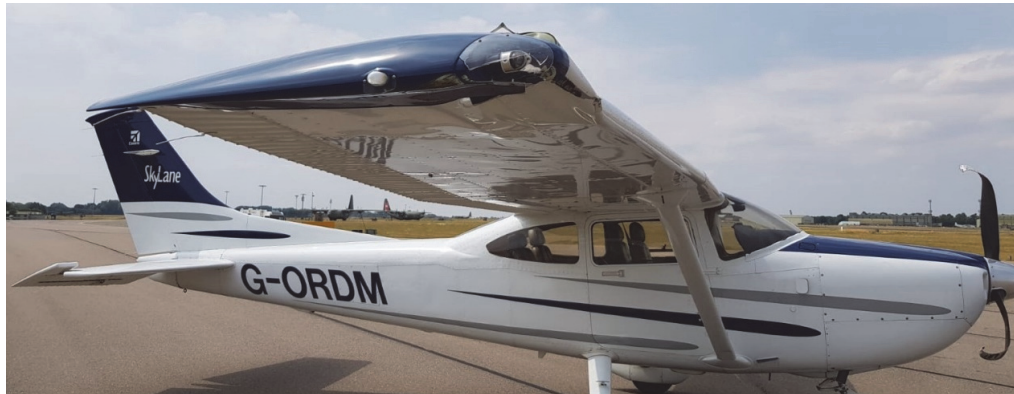
Figure 2

Midway through his positioning turn, the pilot of G-ORDM heard the C-130J's engine note increase and immediately felt violent buffet from its propwash. The turbulent airflow lifted the Cessna's nosewheel clear of the ground and its wings began to rock violently. Concerned that his aircraft might be flipped backwards, G-ORDM's pilot attempted to clear the propwash area by turning right. Despite the application of left aileron to hold the wing down, the aircraft was briefly lifted off the ground before being tipped onto its right wing. It then pivoted on the right mainwheel and nosewheel and was blown sideways for approximately 8 m before coming to rest upright, on all three wheels (Figure 2).

G-ORDM on the taxiway after the accident

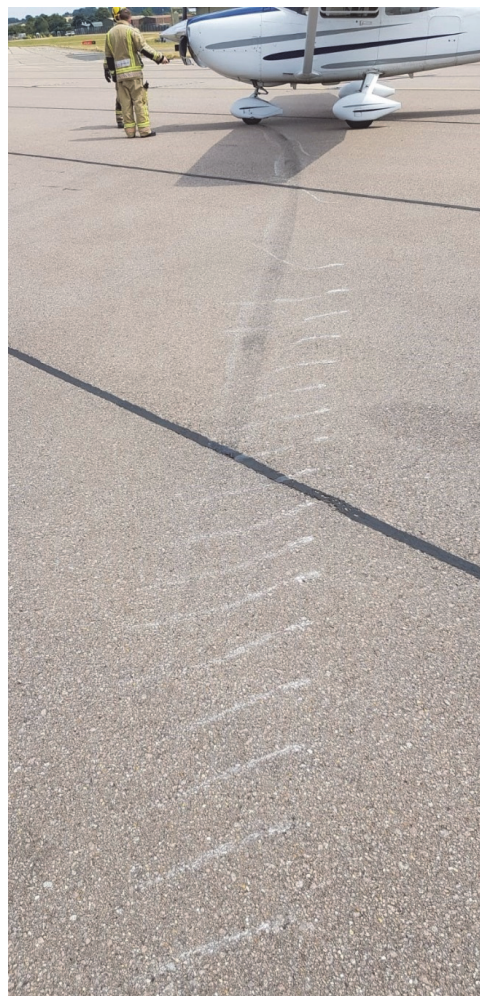
Figure 3

During the sideways movement the propeller struck the ground numerous times before the engine failed (Figure 3). The pilot, who was uninjured, transmitted a Mayday call and vacated the aircraft unaided.

Witness marks on the taxiway from G-ORDM's nosewheel and propeller

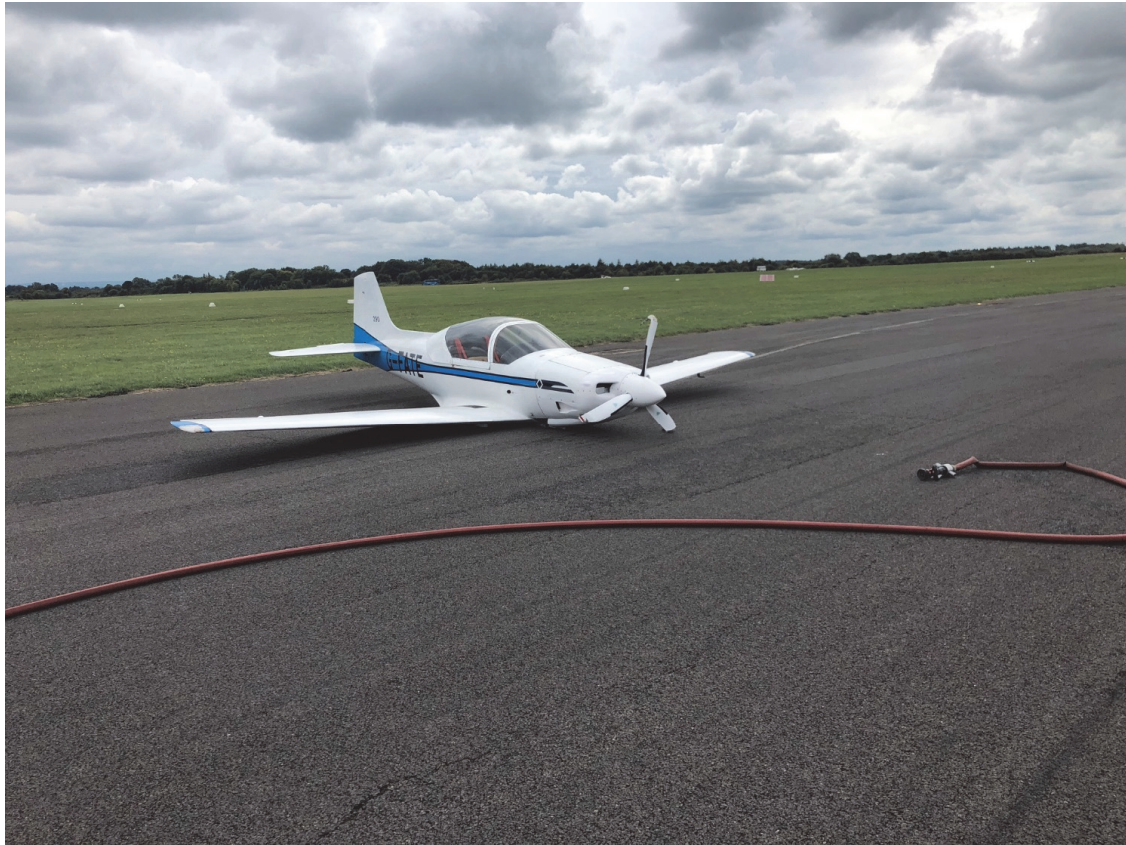
Examination of the aircraft after the accident found that the nose gear strut had deformed, likely because of the initial hard landing. This had caused the undercarriage to jam once it had been retracted.

Figure 1
G-FATE in situ once it had come to rest

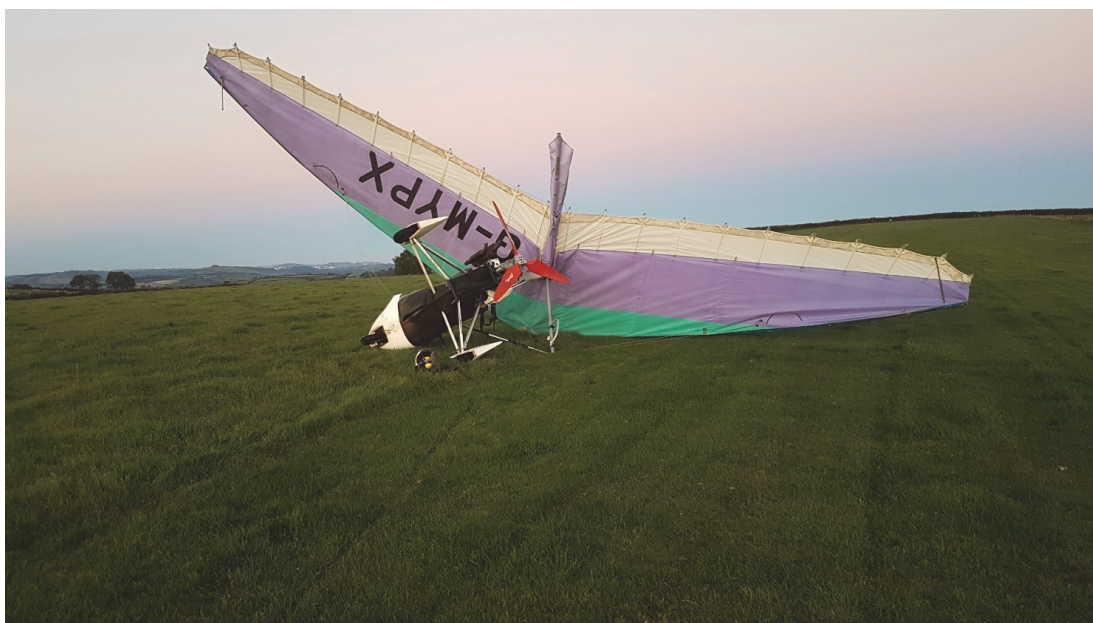
Figure 1

G-MYPX suffered damage including a bent nosewheel, a cracked pod on the trike, and a broken port washout tube. The wing keel tube fractured at the point where the kingpost attaches to the wing. The wing spars were also subsequently discovered to be damaged. The pilot was unhurt.

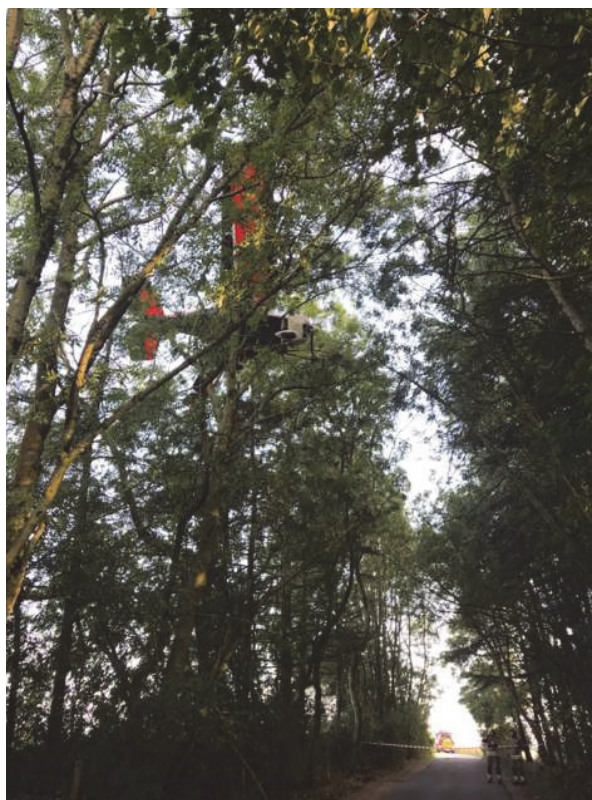
The aircraft was relatively undamaged in the accident but was damaged beyond economical repair during the recovery operation.

Figure 1
Aircraft in tree canopy
