AAIB Bulletin

3/2019

Aircraft Type and Registration:	Piper PA-31, N250AC	
No & Type of Engines:	2 Lycoming TIO-540-A2C piston engines	
Year of Manufacture:	1976 (Serial no: 31-7612040)	
Date & Time (UTC):	6 September 2017 at 1723 hrs	
Location:	Caernarfon Airport, Gwynedd	
Type of Flight:	Private	
Persons on Board:	Crew - 1	Passengers - None
Injuries:	Crew - 1 (Fatal)	Passengers - N/A
Nature of Damage:	Aircraft destroyed	
Commander's Licence:	Commercial Pilot's Licence	
Commander's Age:	62 years	
Commander's Flying Experience¹:	Over 4,000 hours (with experience on type) Last 90 days - unknown Last 28 days - unknown	
Information Source:	AAIB Field Investigation

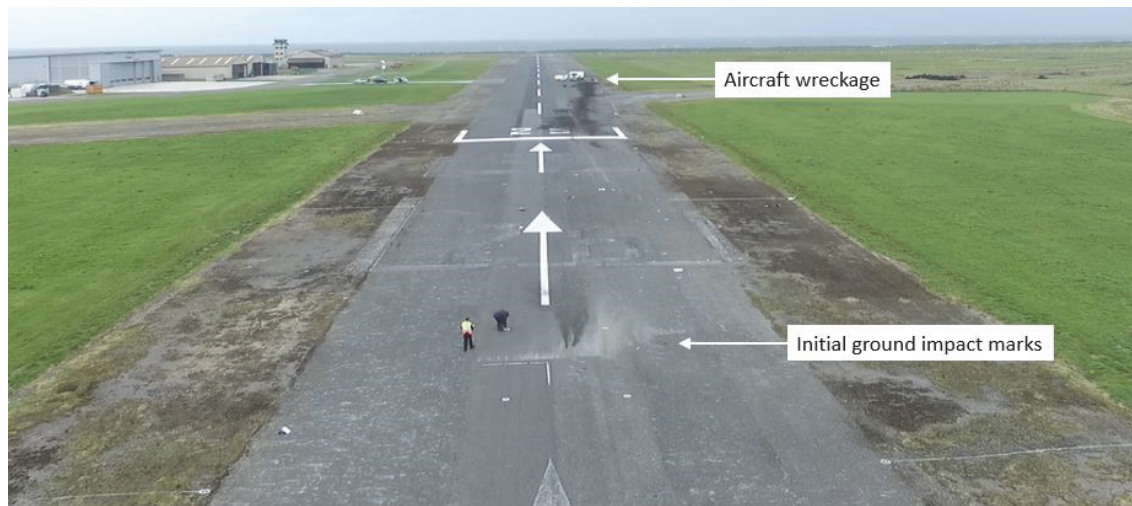
Figure 5

The aircraft had struck the paved surface of Runway 25, 3 m to the right of the runway centreline and 101 m before the displaced threshold (Figure 5). The main wreckage of the aircraft, consisting of the fuselage, empennage, right wing and engine and most of the left wing apart from the left engine had come to rest on the runway surface 293 m beyond the initial impact point. A severe post-impact fire had consumed the majority of the aircraft with only the nose section ahead of the cockpit remaining free from fire damage. Examination of the wreckage confirmed that the aircraft had been structurally complete at the point of impact. The landing gear was retracted and the flaps were fully up, confirmed by the position of the flap jackscrew actuators.

Assessment of the initial ground impact marks indicated that the aircraft had struck the ground in a nose-down attitude with a slight left bank. The distance between the first and second propeller ground impact marks was 72 cm for both the left and right engines, indicating that both engines were operating at the same speed at impact and the aircraft's groundspeed at impact was approximately 180 kt. The absence of ground marks from the aircraft's flaps and landing gear further confirmed that both were retracted at impact.

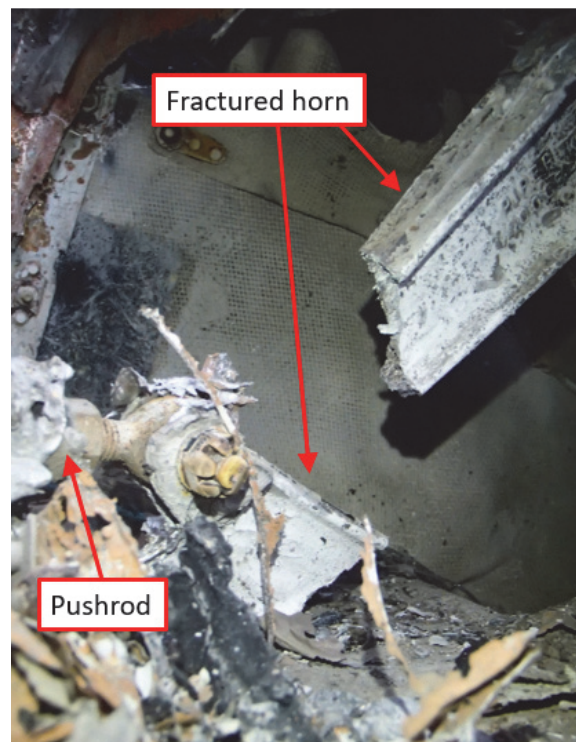
Figure 7
Fractured elevator horn as found at accident site

The elevator horn, which connects the pushrod to the elevator torque tube, was found to be fractured on initial examination of the wreckage at the accident site (Figure 7).

Both parts of the elevator horn had partially melted in the post-accident fire. The lower section of the horn was attached to the pushrod's aft rod-end and the upper section of the horn remained attached to the elevator torque tube. Both parts of the fractured horn were subjected to specialist metallurgical examination.

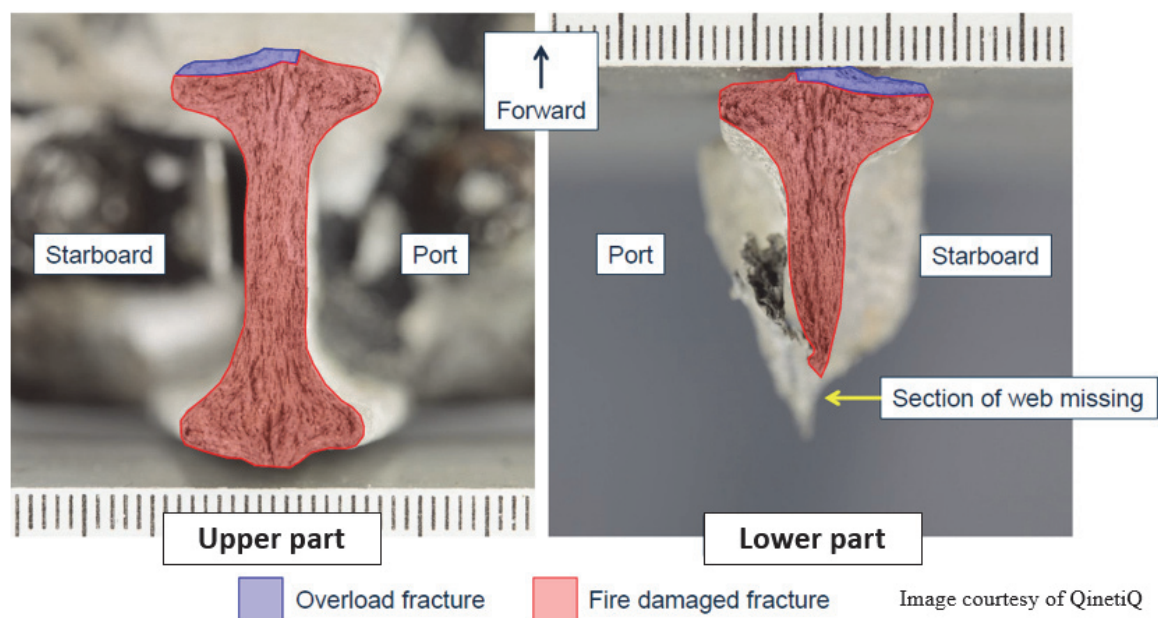
Figure 8

Fractographic assessment of elevator horn fracture surfaces

This examination revealed that most of the horn fracture surface exhibited features consistent with localised melting and fire damage (Figure 8). The fracture surface had a rough macro appearance, with the topography following the underlying grain microstructure of the material. No evidence of progressive crack growth, such as fatigue, was observed and no flat areas of fracture surface were evident that would be consistent with this type of crack growth.

A small area of non-fire damaged ductile overload, equating to 4% of the fracture surface, was visible at the forward section of the horn indicating that this area had separated after the post-accident fire had been extinguished. This may have occurred during disturbance of the wreckage during fire-fighting operations or due to wind blowing on the elevator after the accident.

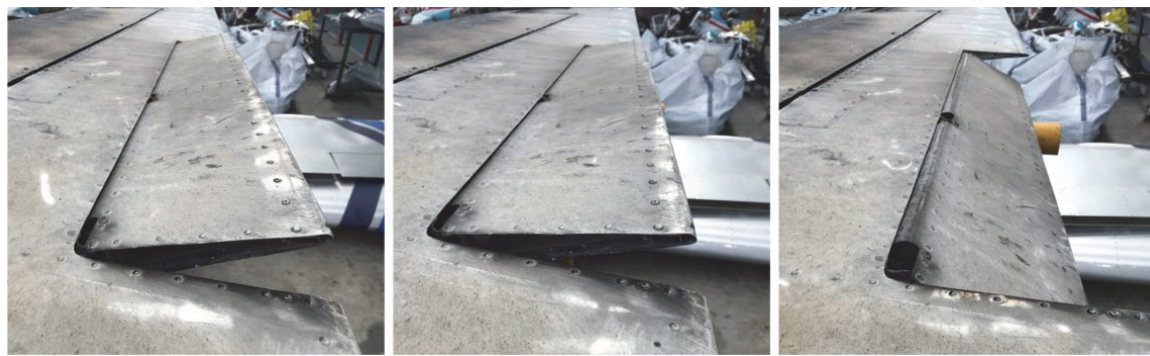
The elevator trim tab was functionally tested and was free to move between the extreme trailing edge up and down positions. The elevator trim tab position as observed at the accident site was 12.4° trailing edge up, with the elevator held in the neutral position²⁰. The range of elevator trim tab deflection is $16^\circ \pm 1^\circ$ trailing edge up (providing nose-down pitch trim), and $29^\circ \pm 1^\circ$ trailing edge down (nose-up pitch trim), with the elevator in a neutral position (Figure 10). The elevator trim tab position as observed at the accident site was therefore close to, but not at, the full nose-down trim position.

Maximum nose down trim,
tab 16° up

Tab position as found, 12.4° up

Elevator trim tab position as found at accident site, and range of movement

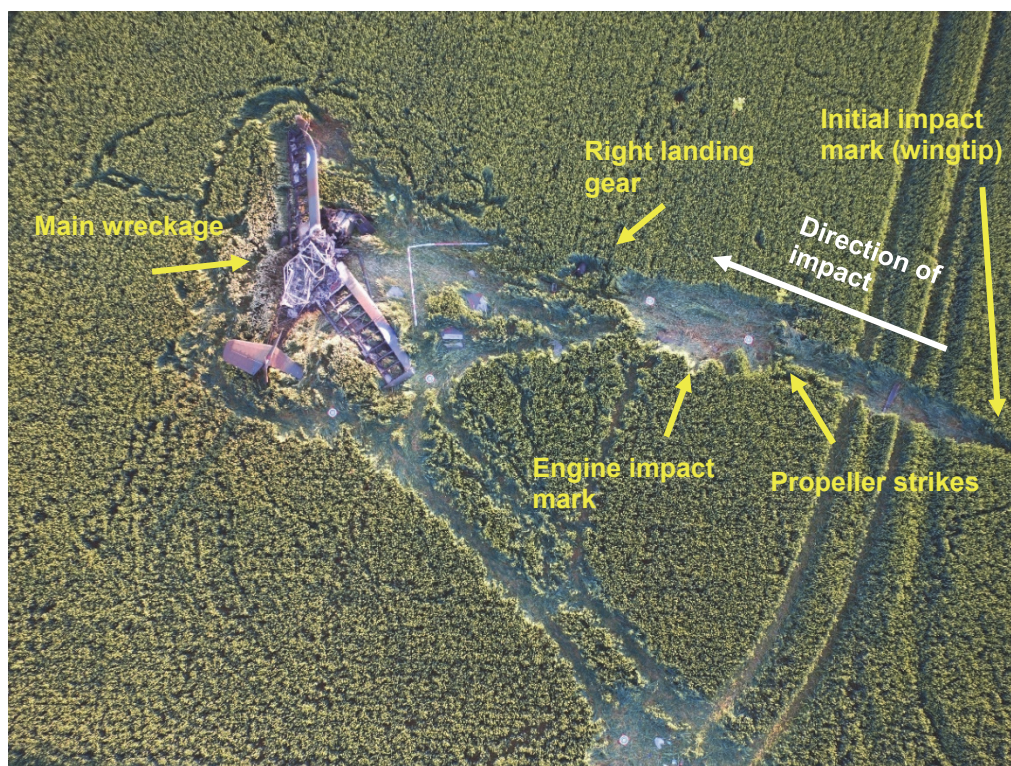
Figure 2
Aircraft wreckage and impact trail

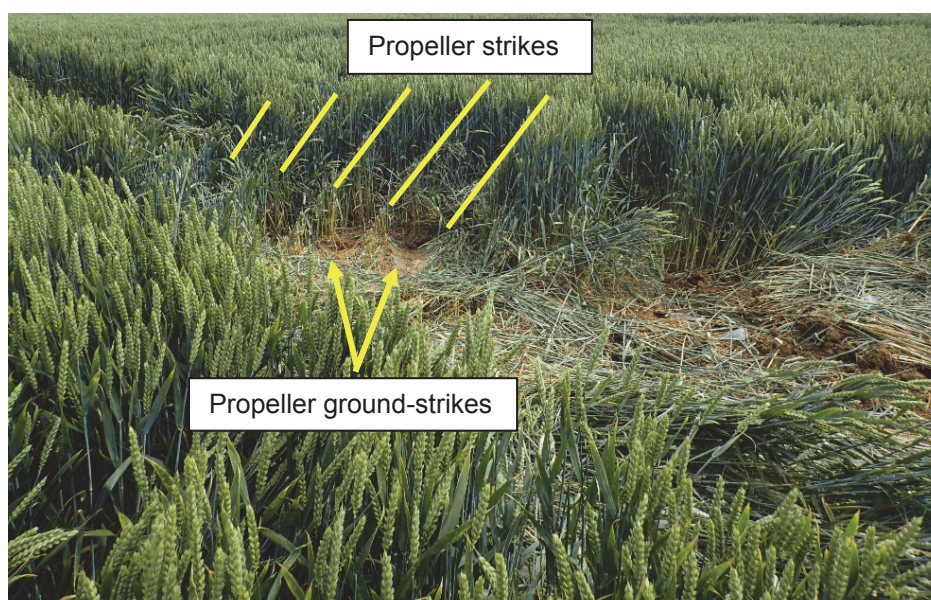
Figure 3
Propeller strikes

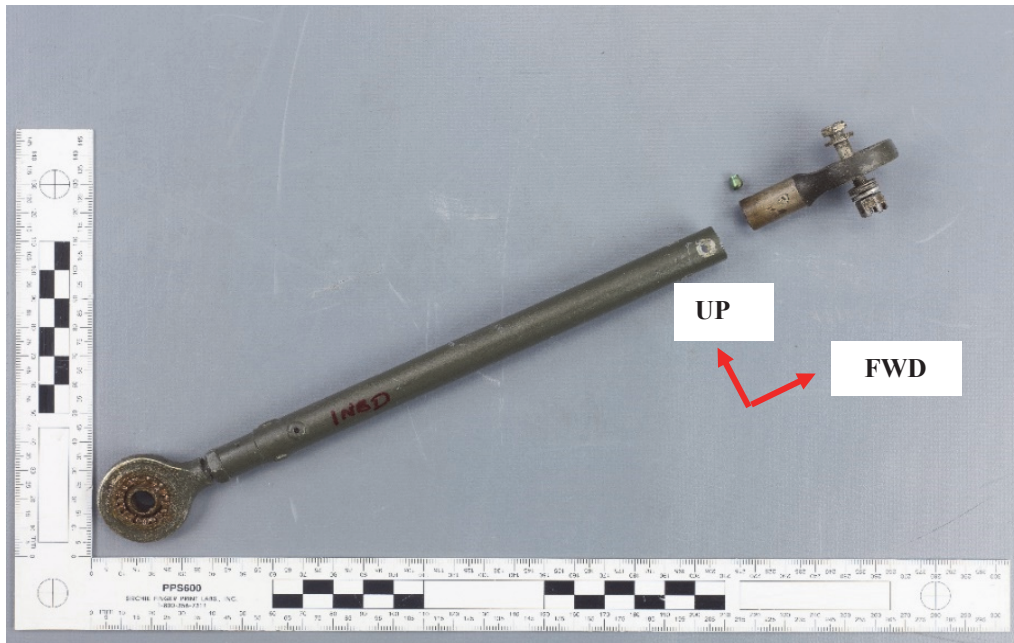
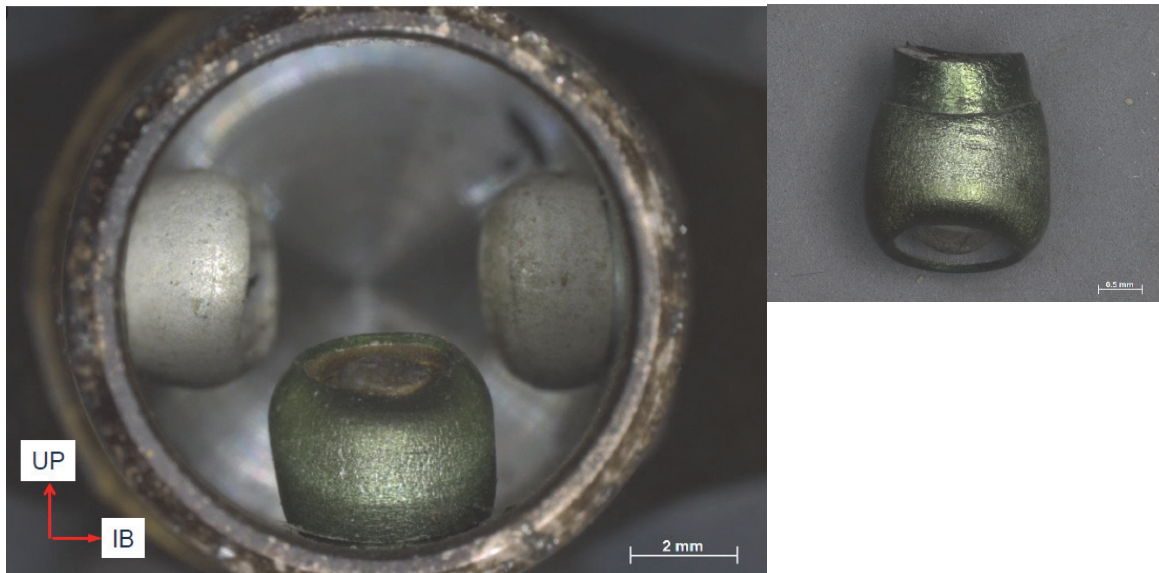
Figure 5

The heads of the failed rivets in the left aileron control rod forward end-fitting were not found. However, the rivet tails remained within the end-fitting and were subjected to metallurgical examination. The top rivet tail came loose during removal of the control rod from the aircraft and is shown separately in Figure 5.

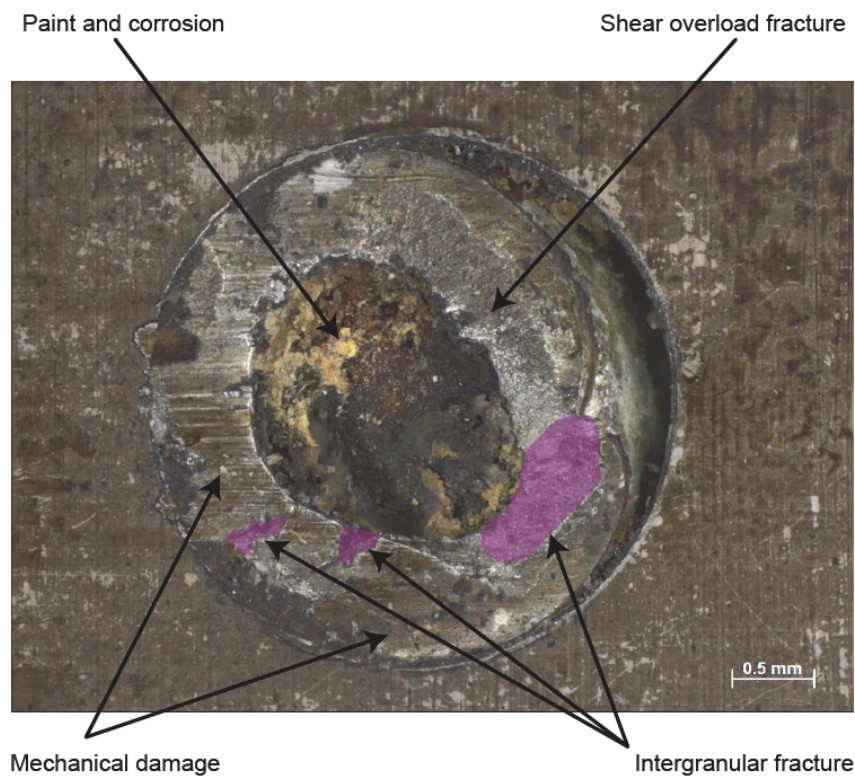
Figure 6

Metallurgical examination showed that the fracture surfaces of all four rivets exhibited differing amounts of mechanical damage, caused by contact between the opposing fracture surfaces during detachment of the end-fitting. The remaining surface detail showed that all four rivets had failed as a result of ductile overload in shear, indicating that they were carrying load at the time of failure. The outboard rivet also exhibited three distinct patches of intergranular fracture (shown in purple in Figure 6), which indicated the presence of pre-existing intergranular cracking prior to the shear overload failure. The precise extent of the intergranular fracture could not be determined due to the mechanical damage, but the areas in which it was observed indicated that it may have extended across one third of the surface area.

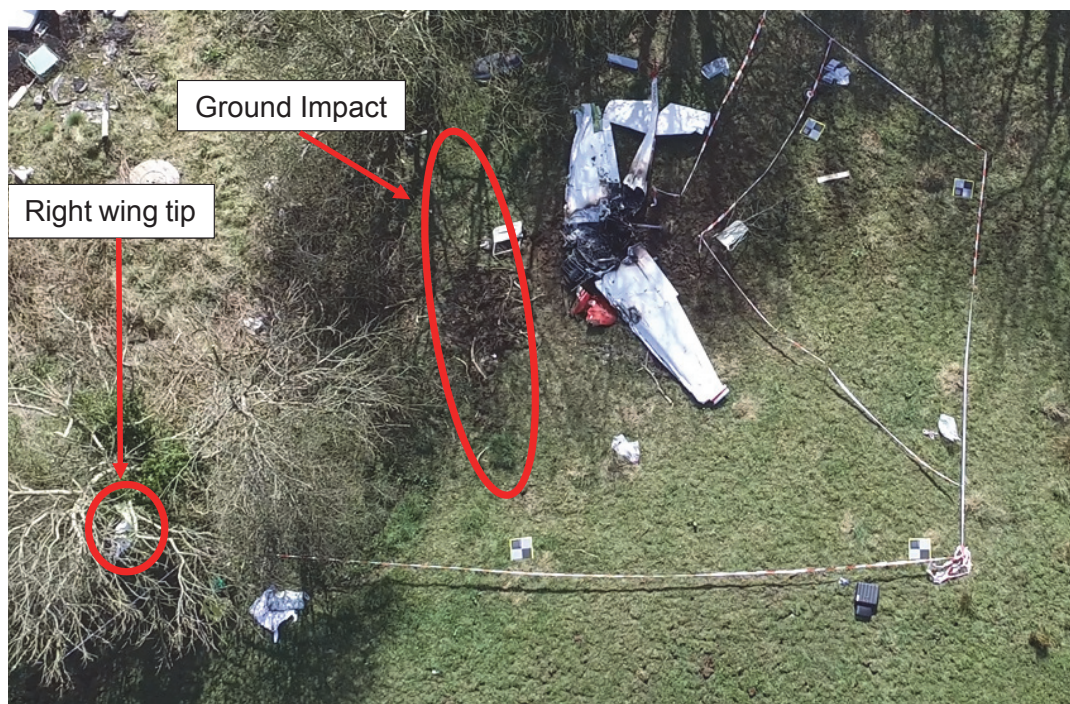
**Figure 6**

The aircraft tail section had separated from the fuselage during the impact and the right wing had been bent rearwards, but the remainder of the aircraft was largely intact. There was a post-crash fire which was confined to the cockpit and inboard section of the right wing which contained one of the aircraft's fuel tanks. Six litres of fuel were later recovered from the left wing tank. The left flap was displaced by approximately 5° from the trailing edge of the wing. It was not possible to measure the position of the right flap due to fire damage.

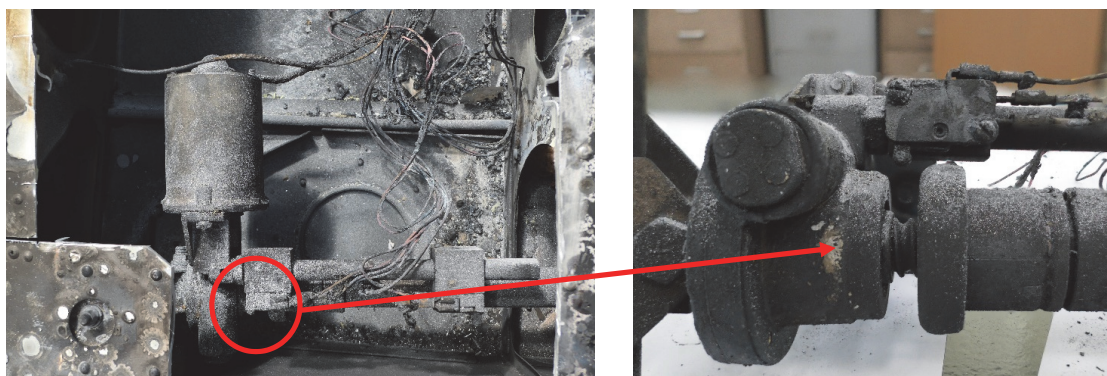
The flap system was powered by an electrically driven screw-jack actuator in the right wing. The position of the flaps can be determined by measuring the extension of the actuator, the measured extension on G-UFCO was 9.2 mm (Figure 9).

Figure 9
Flap actuator

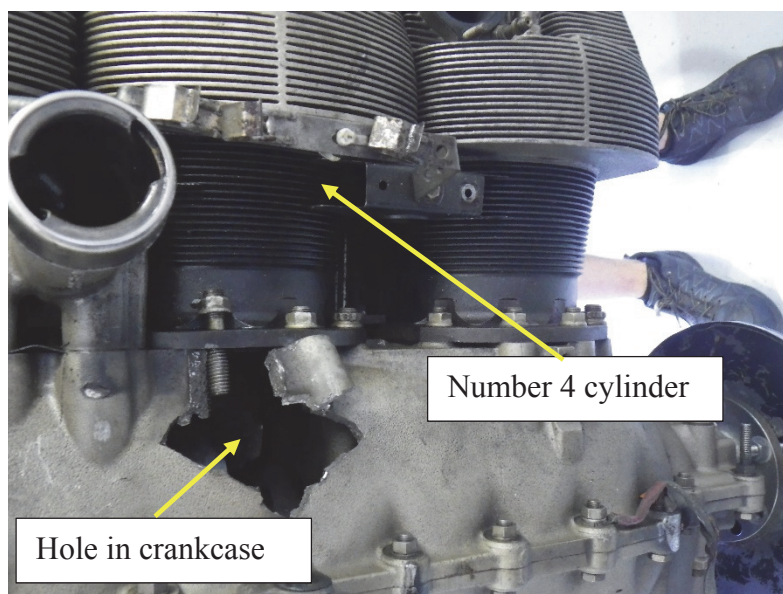
Figure 9

The bearing caps on the No 3 and No 4 piston connecting rods had become disconnected. Damage to the No 4 connecting rod indicated that it had then been struck by the crankshaft with sufficient force for it to knock a hole approximately 10 cm by 8 cm in the crankcase beneath the No 4 cylinder (Figure 9).

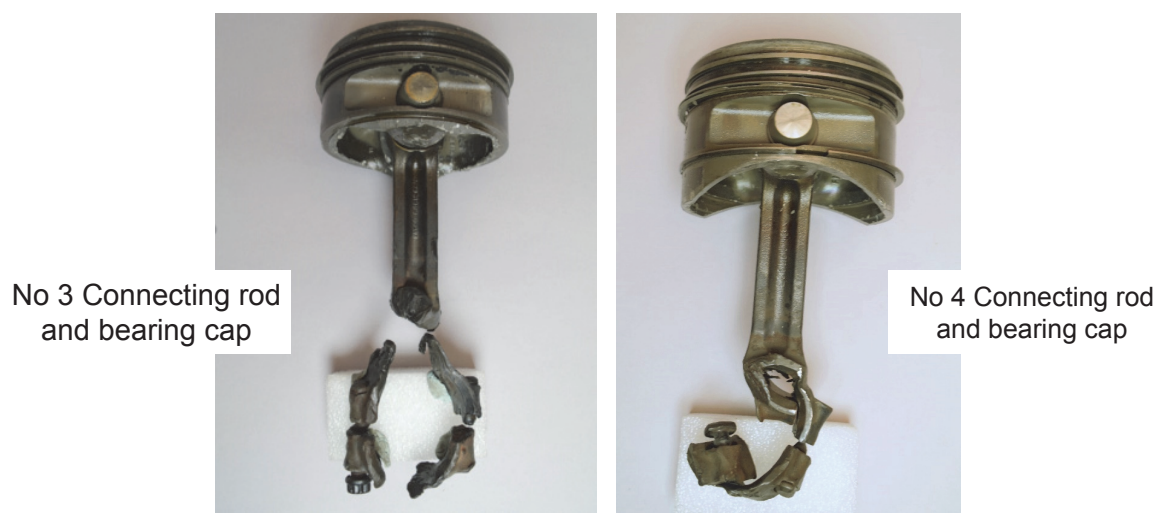
Figure 11

The bottom of the No 3 connecting rod and bearing cap had broken into four parts and the remnants of the bolts exhibited failure in overload. The skirt on the piston had also broken off (Figure 11). The No 4 bearing cap was intact, and distorted, and had separated from the connecting rod. The parts of the two bolts that remained in the bearing cap also exhibited necking associated with failure in overload.

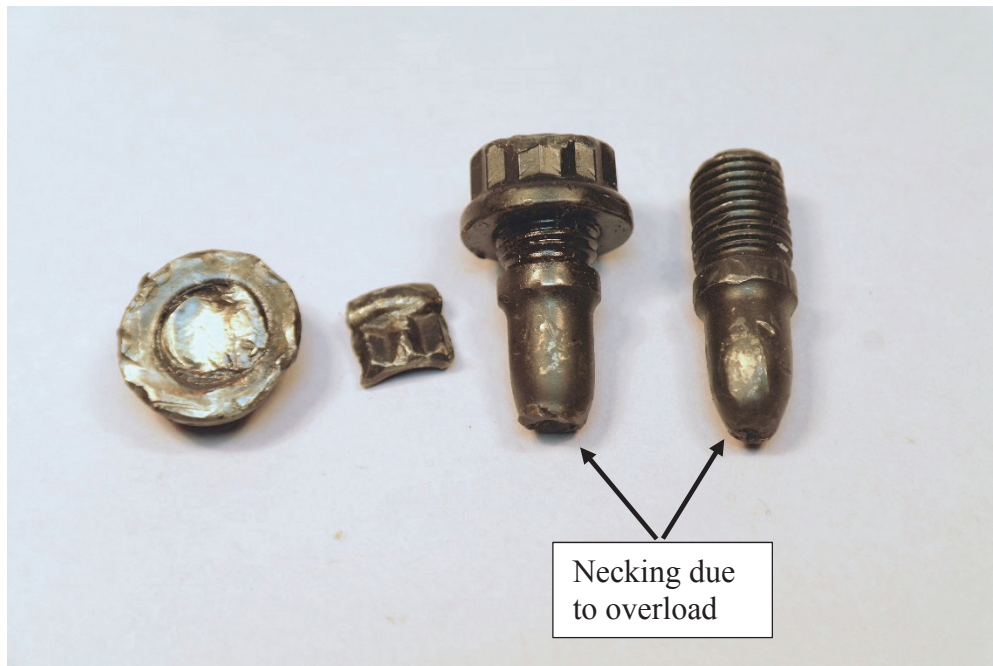
Figure 12

Parts of two bolts, that had failed in overload, a nut containing part of a bolt that had failed in shear and a broken part of a nut were found in the engine (Figure 12).

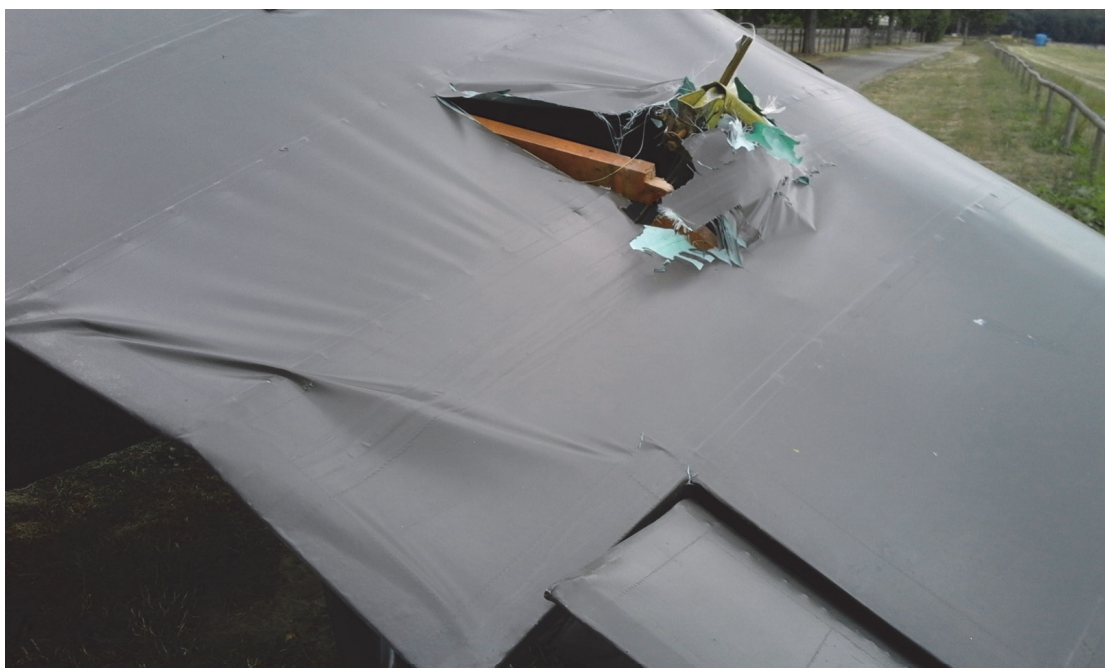
Figure 2
Damage to the right wing

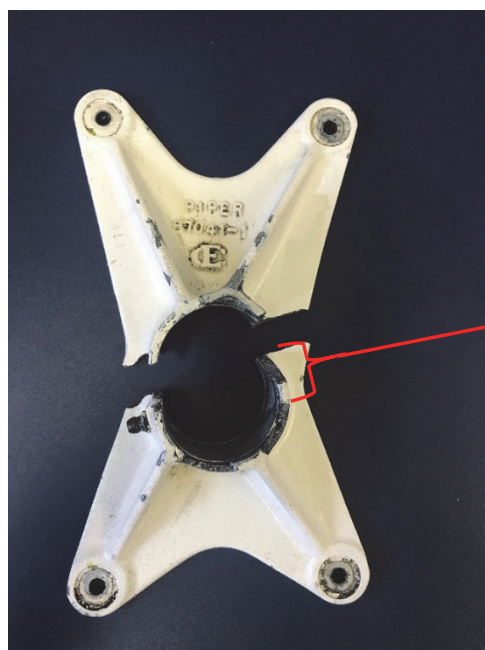
**Figure 2**

Failed right main landing gear forward trunnion

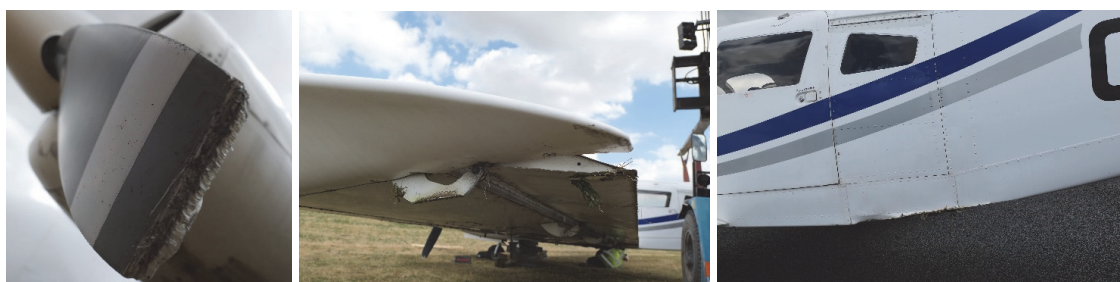
Figure 2
Aircraft damage

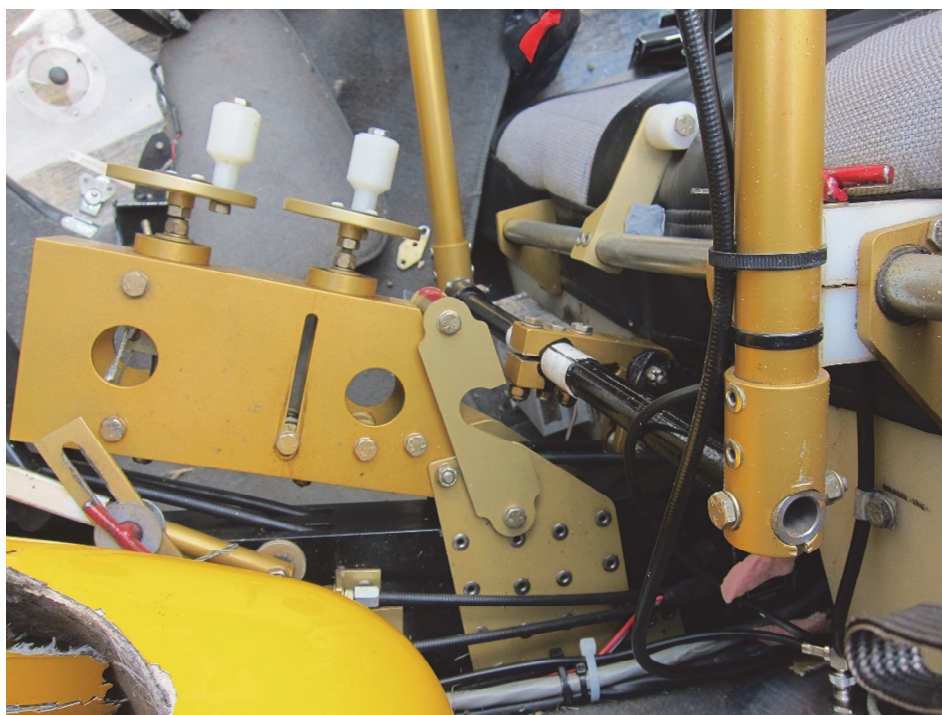
Figure 3
Photo taken after the accident showing the gust lock disengaged
