# ***AAIB Bulletin***

***4/2019***

S1/2019 - Piper PA-46-310P Malibu	N264DB	21-Jan-19	3
-----------------------------------	--------	-----------	---

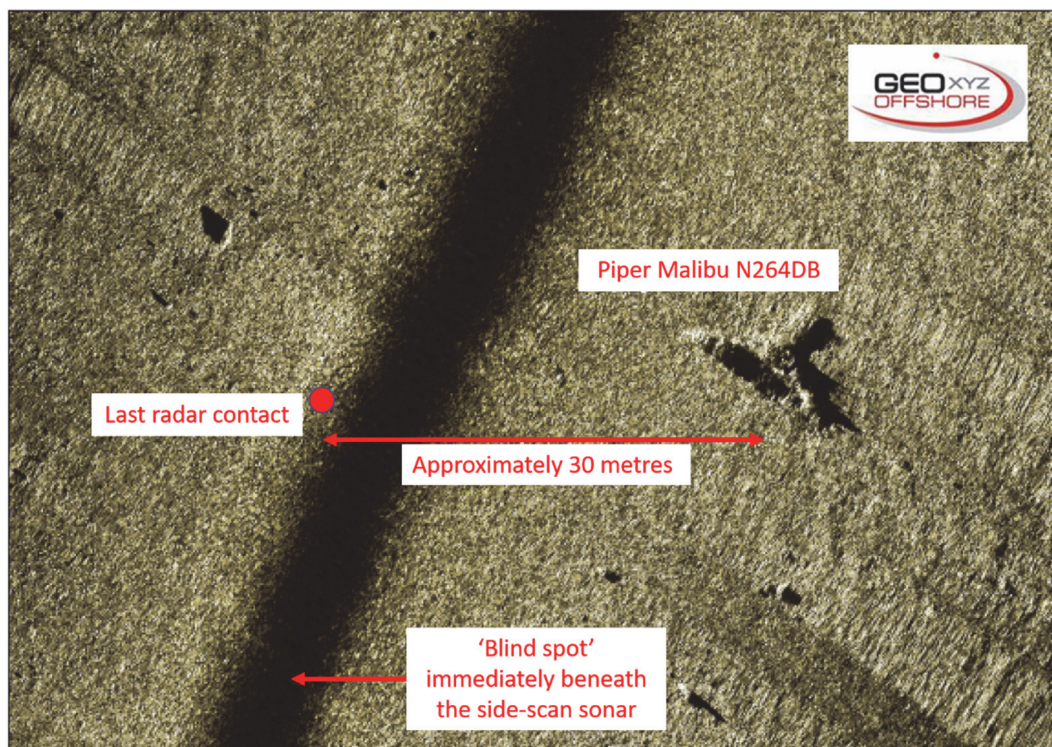
**Figure 6**

Side-scan sonar image of N264DB

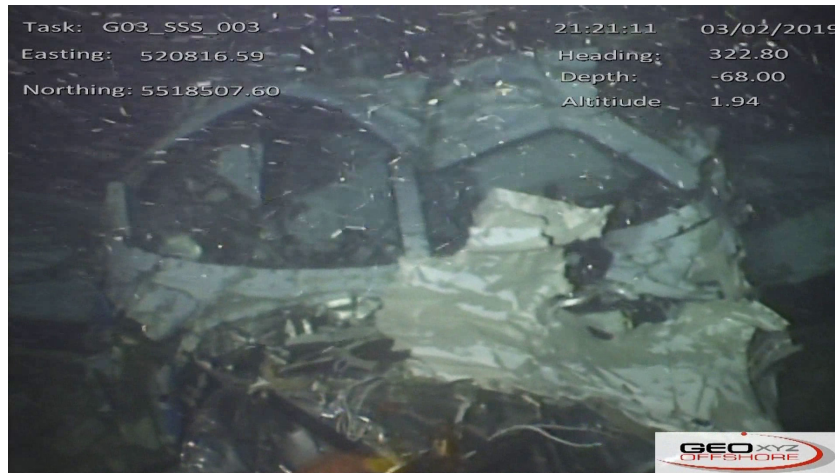
**Figure 7**

From the ROV video examination it was possible to establish that the aircraft was extensively damaged, and the main body of the aircraft was in three parts held together by electrical and flying control cables. The engine had disconnected from the cockpit area, and the rear section of the fuselage had broken away from the forward section adjacent to the trailing edge of the wing. The outboard section of both wings, tail plane and fin were missing. Figures 7 to 9 show images taken by the ROV.

View looking at windscreen and cockpit area

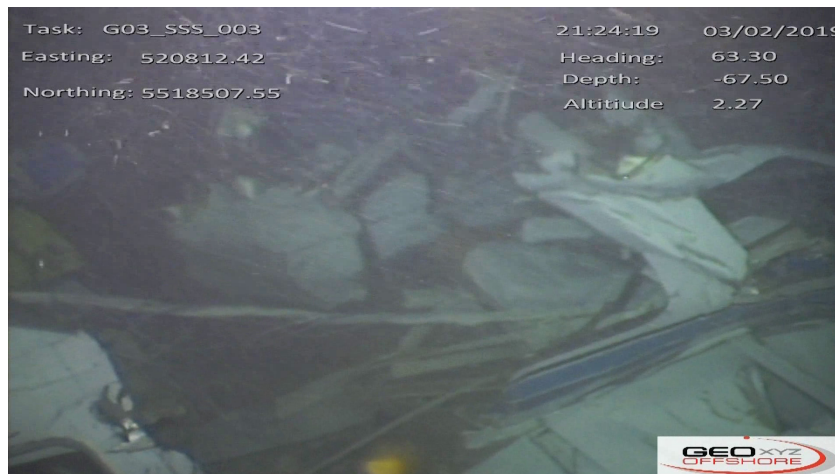
**Figure 8**

View looking at cabin and break in fuselage

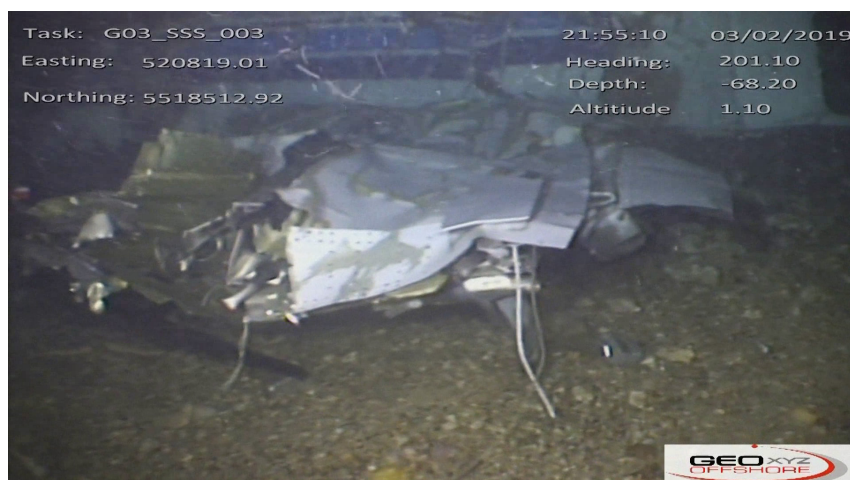
**Figure 9**

View looking at remains of inner wing

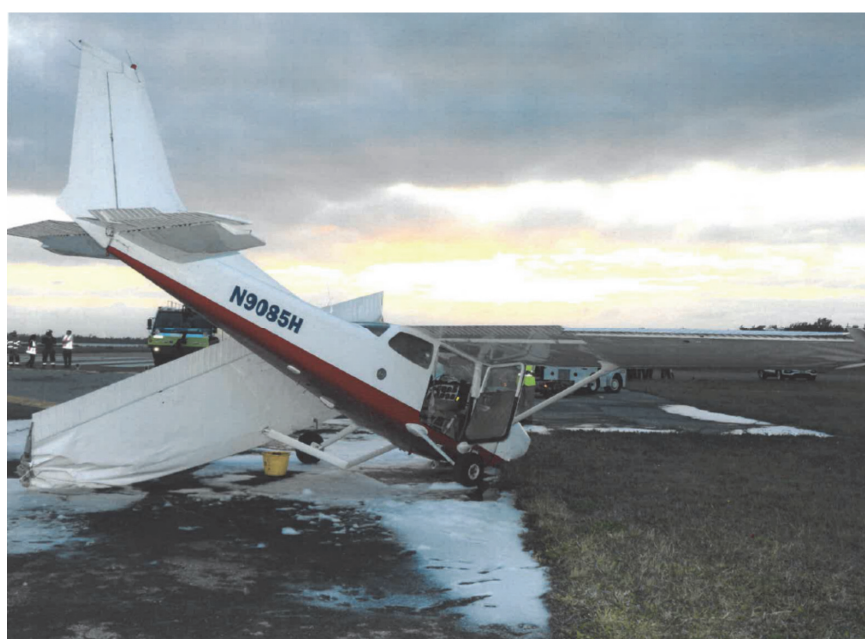
**Figure 1**

Image of the aircraft taken shortly after the accident

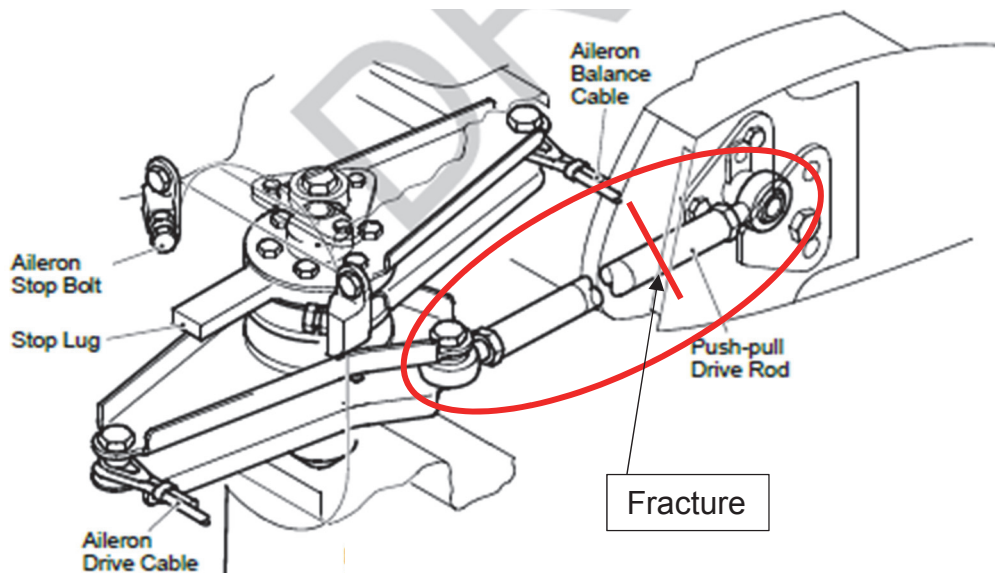
**Figure 1**

On the evening after the incident flight, the maintenance organisation attended the aircraft and replaced the broken aileron drive rod in the right wing (Figure 1).

Aileron drive mechanism

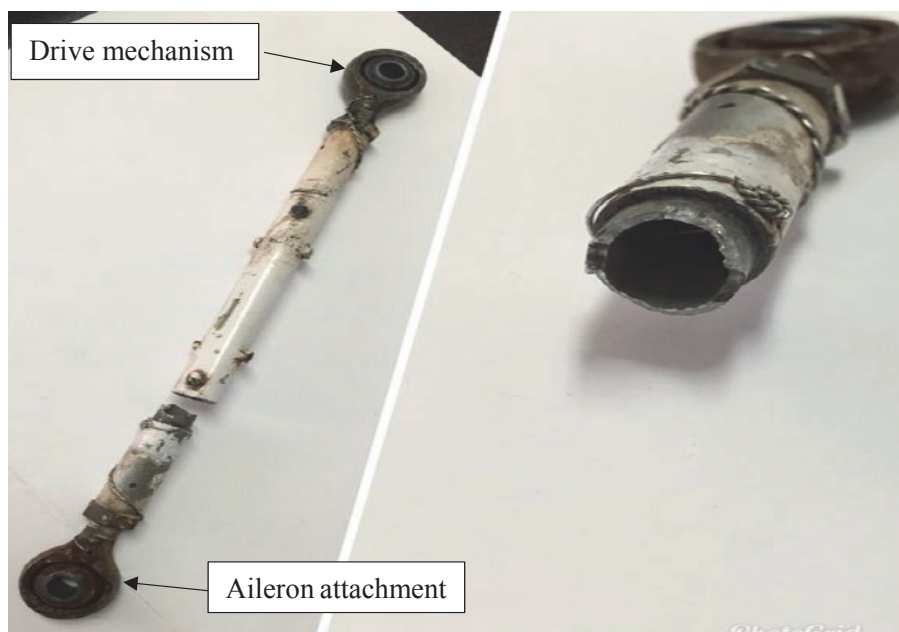
**Figure 2**

An examination of the drive rod found that the spherical bearing in the rod end that connected to the aileron was heavily corroded and had seized. The rod had suffered an overload fracture 70 mm from the rod end at an area where the rod end had been riveted (Figure 2).

Broken drive rod

It is the assessment of the aircraft manufacturer that the cause of the failure of the drive rod was initiated by the bearing corroding, which resulted in the seizure of the bearing. When normal operation loads were applied to the aileron drive mechanism they were sufficient to overload the rod and cause it to fracture. The aircraft manufacturer has published Service letter SL 127 '*Greasing of Aileron Rod End Bearings*' to remind operators of the greasing requirements and to request relevant feedback on bearing corrosion.

An aileron drive rod bearing had corroded and seized which resulted in the drive rod becoming overloaded and failing under normal operational loads. It is possible that the operating environment was more corrosive than the aircraft manufacturer expected when defining the lubrication tasks in the aircraft maintenance programme.

A fleet-wide corrosion inspection of all drive rod/bearing assemblies.

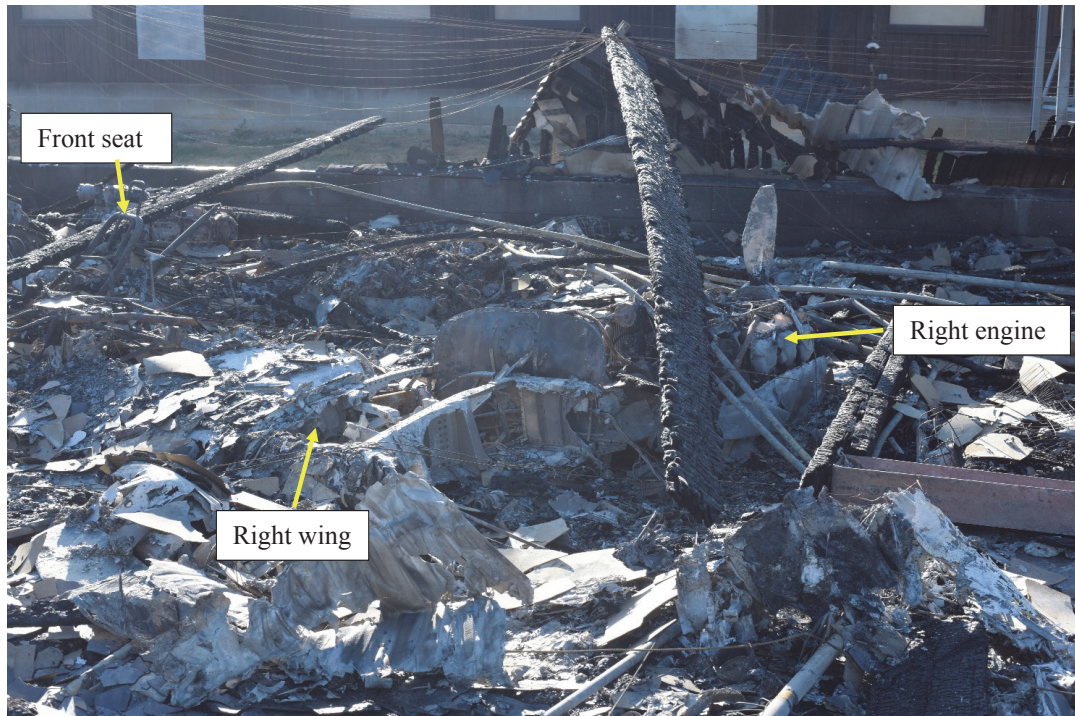
**Figure 2**

The aircraft had crashed into a poultry farm on the edge of the airfield, destroying part of a timber-framed building that was partially lined with asbestos. The resulting fire caused a substantial loss of poultry, from the effect of the fire and asbestos contamination. The aircraft was destroyed in the intense fire (Figure 2).

Remains of aircraft and engines at the accident site

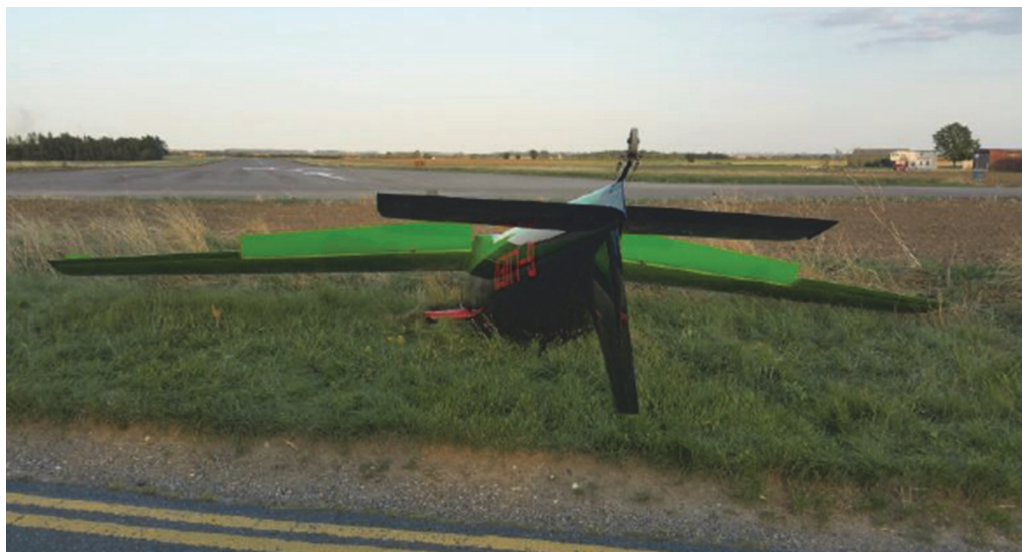
**Figure 1**

G-LUED inverted after the accident (image ©Lincolnshire Police)

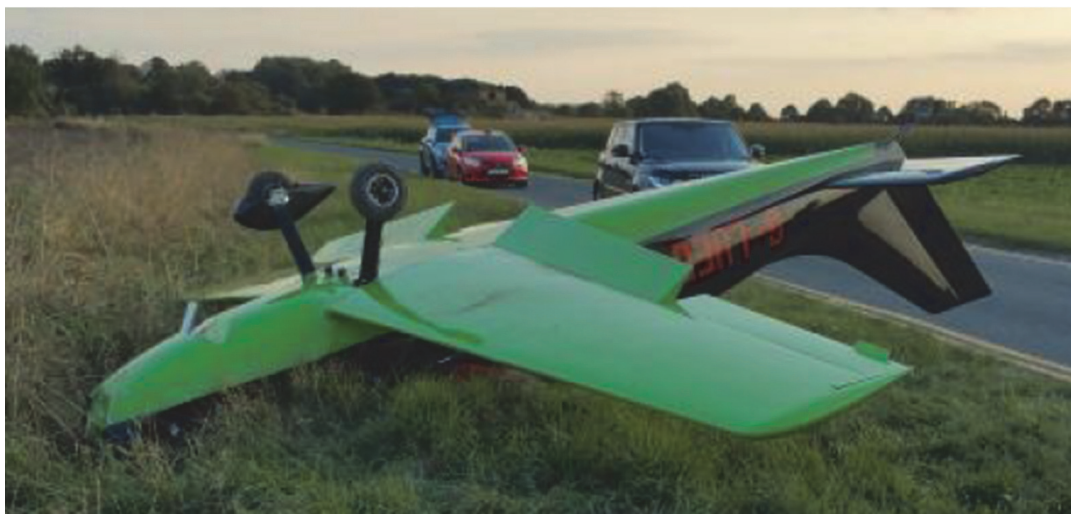
**Figure 3**

G-LUED inverted with trailing edge flaps extended (image ©Lincolnshire Police)

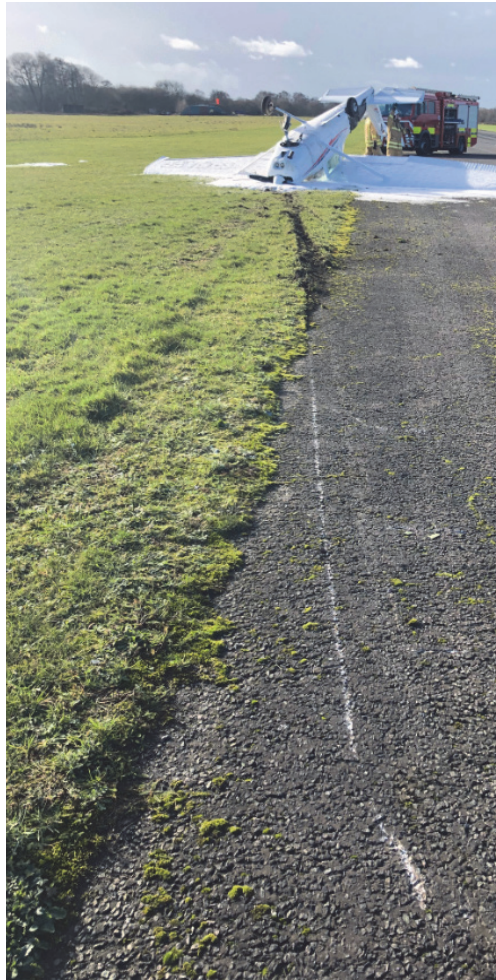
**Figure 1**

Witness marks on the runway from G-OLEE's nose gear

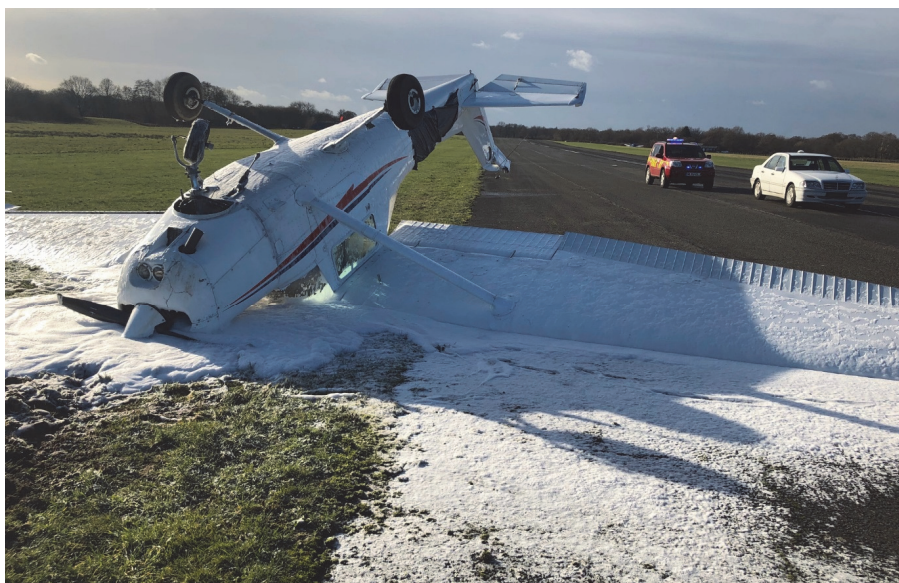
**Figure 2**

G-OLEE after coming to rest

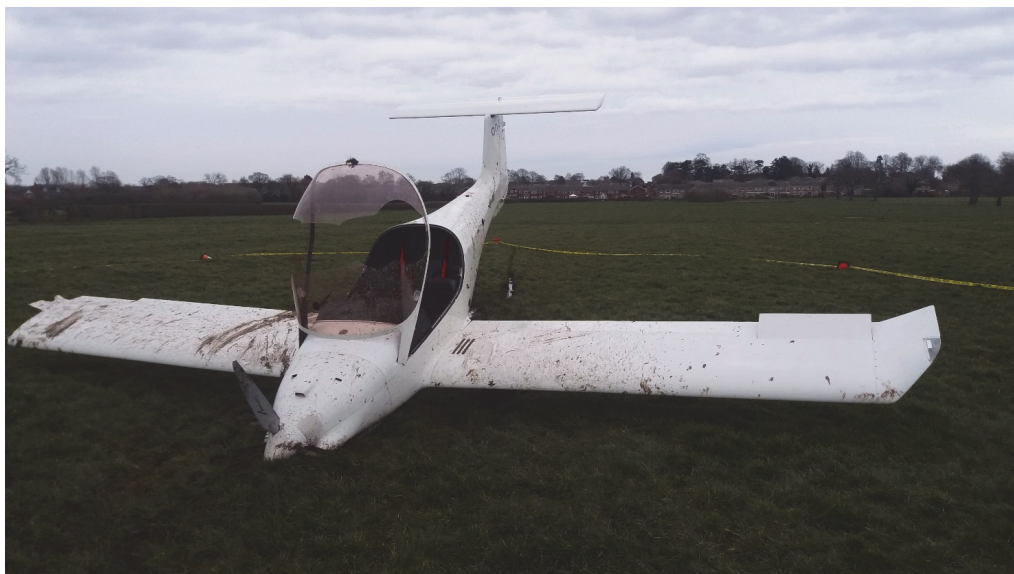
**Figure 1**

The pilot was uncertain as to why the section of canopy broke away, but he stated that it may have been due to a collision with a drone.

OO-D51 damage to canopy and aircraft after forced landing

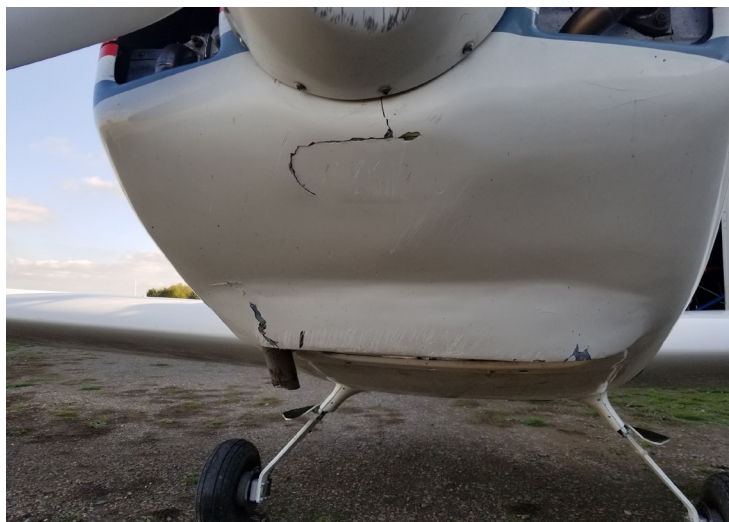
The Grob G109A is a tailwheel motor glider with dual-function airbrake levers which, when pulled, deploy the airbrakes and, when pulled further, apply the mainwheel brakes. The aircraft has a 'car-type' ratchet parking brake. After landing, pilots hold the control column fully back, to keep the tail from lifting, and pull the airbrake lever firmly aft to actuate the wheelbrakes. On this occasion the student pilot did not deflect the airbrake lever sufficiently to generate effective wheel-braking. The instructor called "more brake" three times to prompt him to apply greater force to the lever. The student mis-interpreted these calls and applied the parking brake instead, which resulted in "hard, uncontrolled braking". Despite rapid intervention by the instructor, the aircraft tipped forward damaging the nose cowling and propeller (Figures 1 and 2).

**Figure 1**  
Damage to nose fairing and spinner

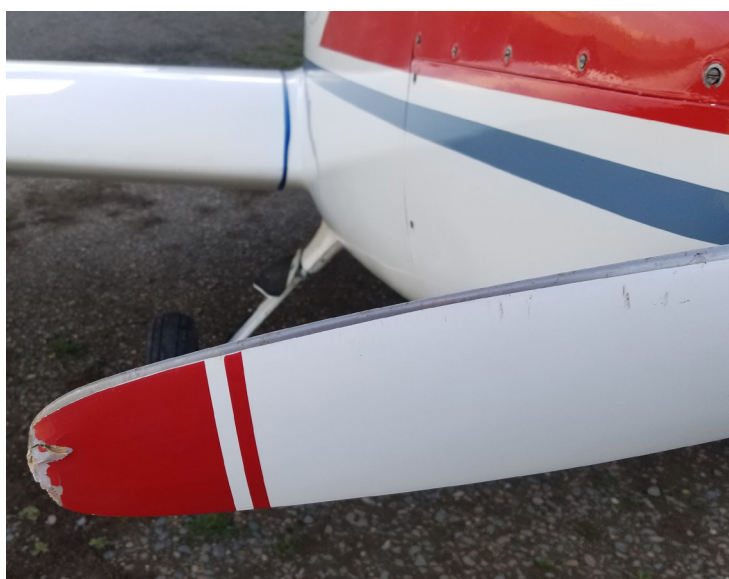
**Figure 2**  
Damage to propeller
