AAIB Bulletin

5/2019

Published 9 May 2019

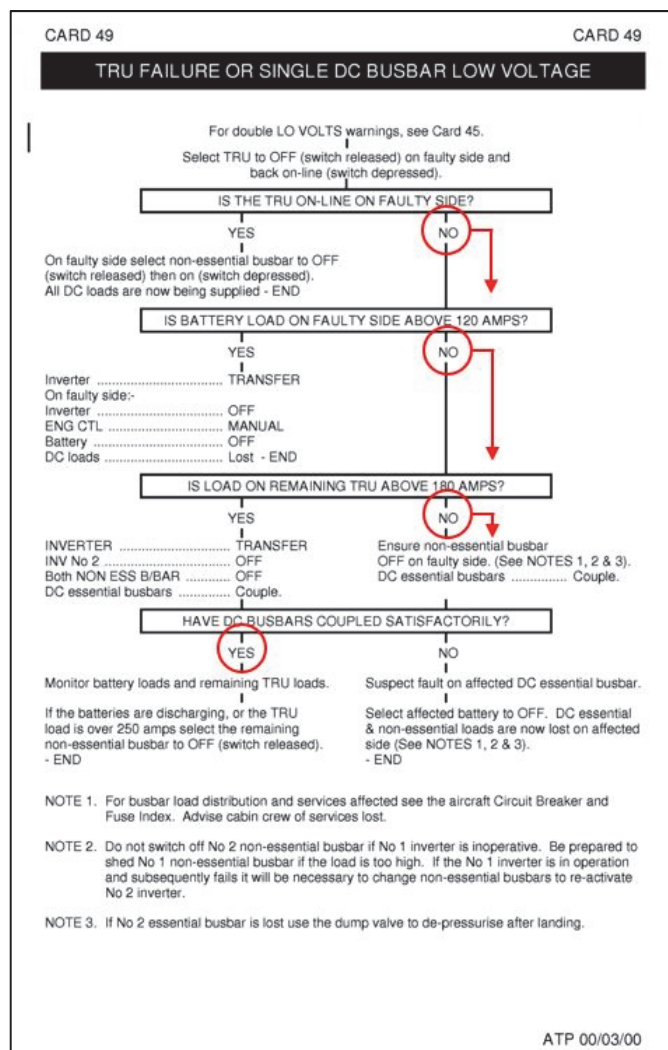
Figure 1

The crew carried out Emergency and Abnormal Checklist (EAC) Card 49 '*TRU failure or single DC busbar low voltage*' (Figure 1). The commander initially attempted to reset TRU 1, but this was not successful. He then switched the No 1 non-essential DC busbar OFF and selected the DC essential busbar couple to connect the No 1 and No 2 essential DC busbars together. Following these selections, the DC LO VOLTS warning message extinguished, and the crew observed that the No 1 battery voltage indicator was in the green arc, indicating that the battery voltage was between 23 and 29 V. During this period, the commander was recorded on the CVR stating that he considered it was a busbar relay fault, rather than a TRU fault.

EAC Card 49, with actions followed by crew annotated

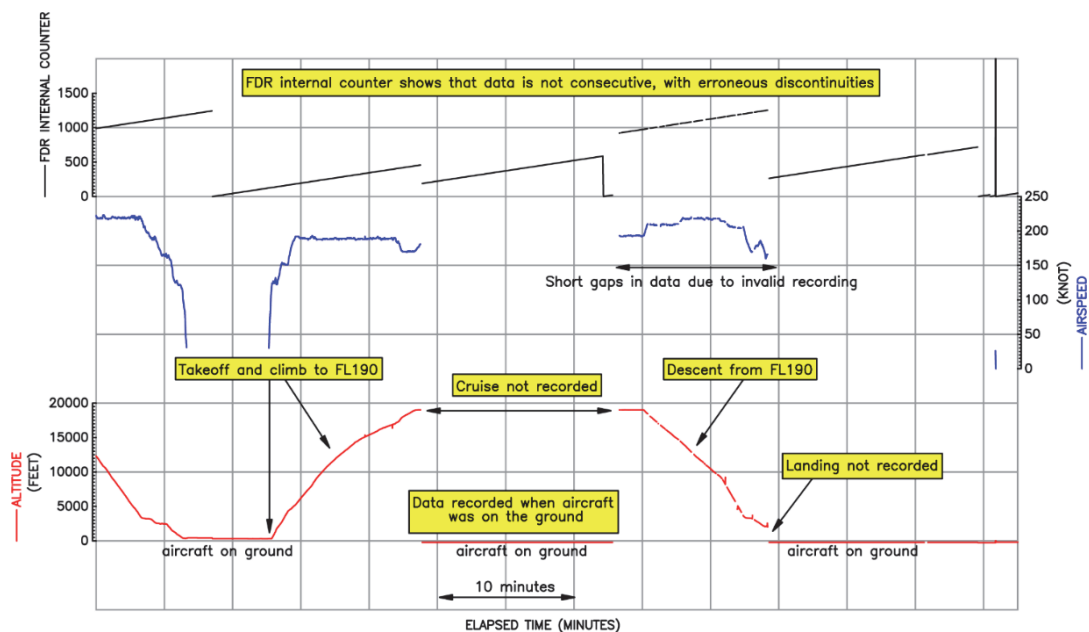
Analysis of the flight data indicated that an intermittent fault within the FDR had resulted in a combination of partial recording of several flights and just over nine hours of historical data that should have been overwritten. Figure 5 provides an example of the partial flight recording and Figure 6 a time sequence of the FDR and QAR data. The time sequence coloured green in Figure 6 represents data that was correct, and the area coloured red (six flights) that should have been overwritten by more recent data coloured yellow (nine flights).

Figure 5
Example of SE-MHF erroneous FDR recording

This data showed that the electronics in the FDR that provide the QAR with data had continued to operate correctly, but an intermittent fault had prevented data from being written to the FDR's magnetic tape.

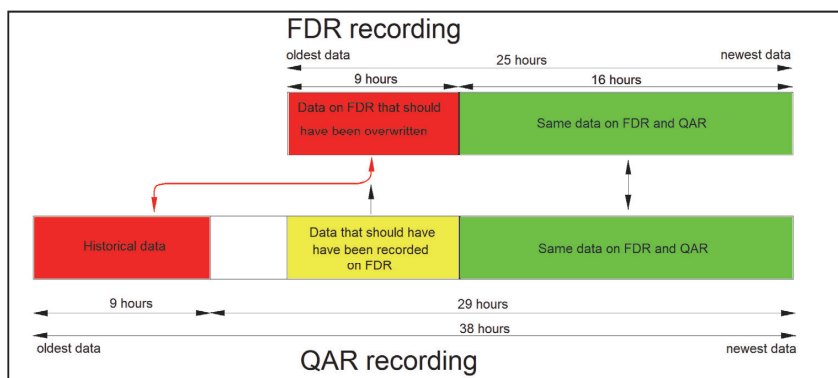
Figure 6

Pictorial time sequence of FDR recording

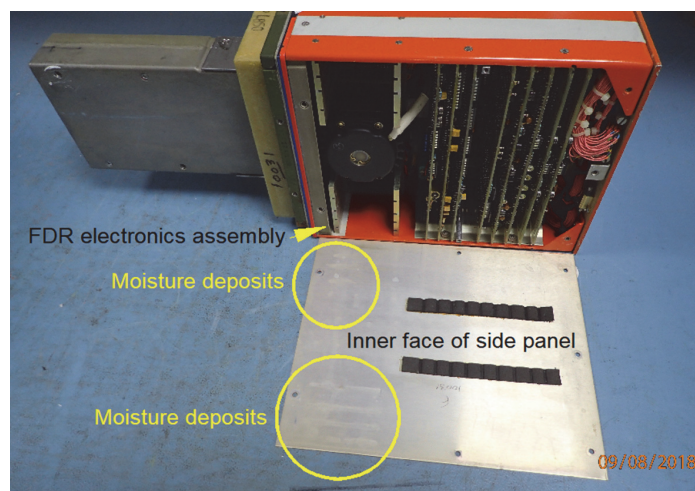
Figure 7

- The inner face of the metal panel that secured the circuit boards was stained with moisture residue (Figure 7).
- An analogue to digital (A/D) converter circuit board (Figure 8) had an area of several cm² of staining that was attributed to moisture.
- Moisture residue and small areas of corrosion was apparent on the solder connections of two power-supply circuit board connectors (PSU1 and

The MRO considered the intermittent recording fault had most likely been caused by moisture ingress. The MRO also added that other PV1584 FDRs received from the same operator's fleet of BAe ATP aircraft had been found with evidence of moisture ingress and damage. On occasion, staining from moisture residue has also been observed on the outside of the unit, indicating that water might have been dripping onto the unit. The FDR removed from SE-MHF did not show evidence of this.

Inside of FDR electronics assembly side panel showing areas of moisture residue

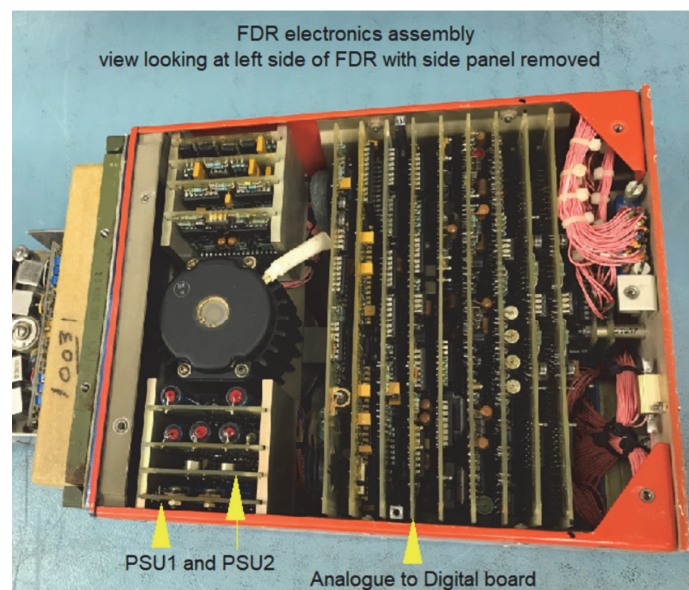
Figure 8

Position of PSU1, PSU2 and A/D circuits boards damaged by moisture

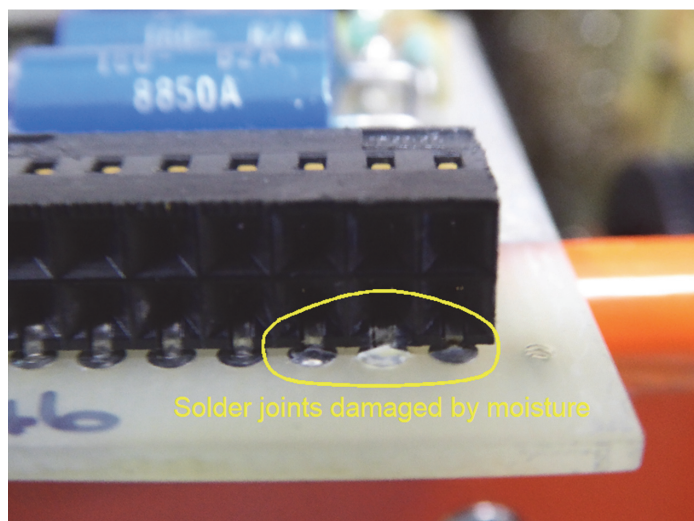
Figure 9

PSU1 connector solder joints damaged by moisture

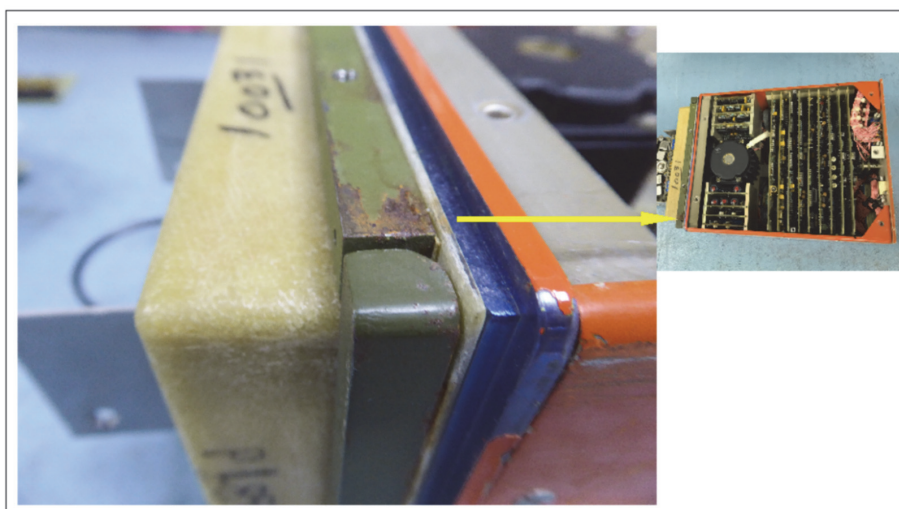
Figure 10

- Corrosion was present on the chassis where the tape transport attached to the electronics module (Figure 10).

Corrosion on FDR chassis adjacent to electronics assembly

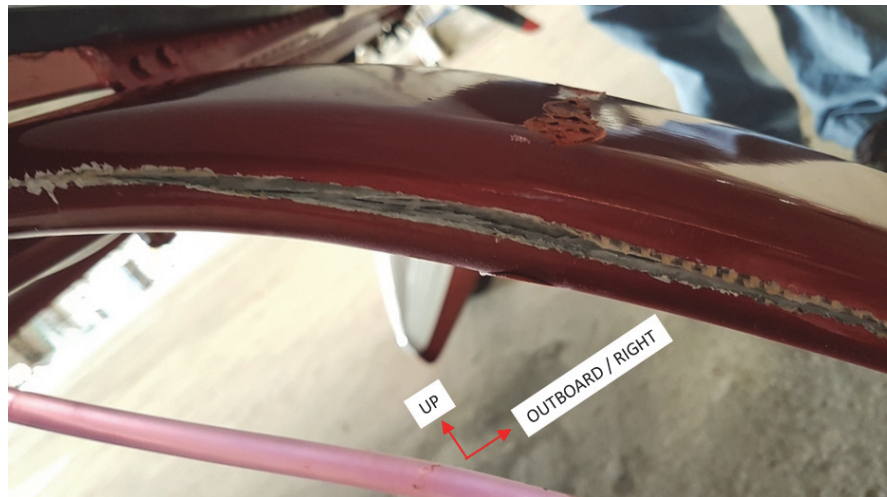
The pilot, accompanied by one passenger, flew the aircraft on a 20-minute flight from Graveley Airstrip, Hertfordshire, to Fowlmere Aerodrome. The pilot stated that the landing at Fowlmere was smooth and that the taxi to the parking area was uneventful. After vacating the aircraft, the pilot noticed that a large crack was present in the rear face of the right MLG leg (Figure 1). The leg retained sufficient residual strength to support the aircraft when parked.

Figure 1
Damage to right MLG leg

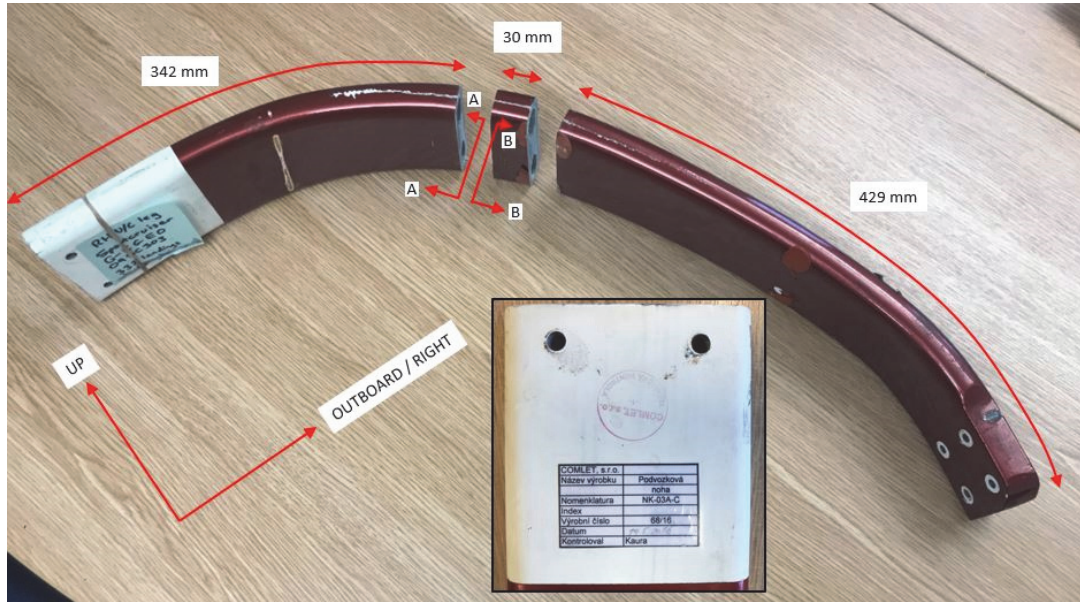
Figure 2

The damaged right MLG leg was examined by the AAIB to determine the cause of the failure. The visible crack in the rear face of the leg was 239 mm long. The leg was cut into three sections (Figure 2).

Sectioning of right MLG leg (leg dataplate image inset)

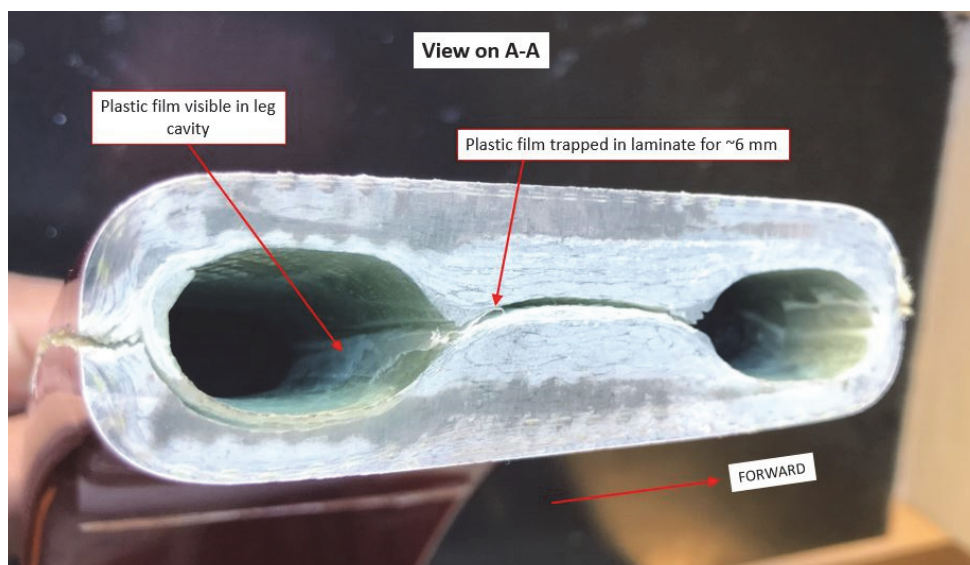
Figure 3

When the leg was cut open, plastic film was visible within the rear hole (Figure 3). Approximately 6 mm of the plastic film was trapped within the laminate between the rear and forward holes at section A-A.

View on section A-A

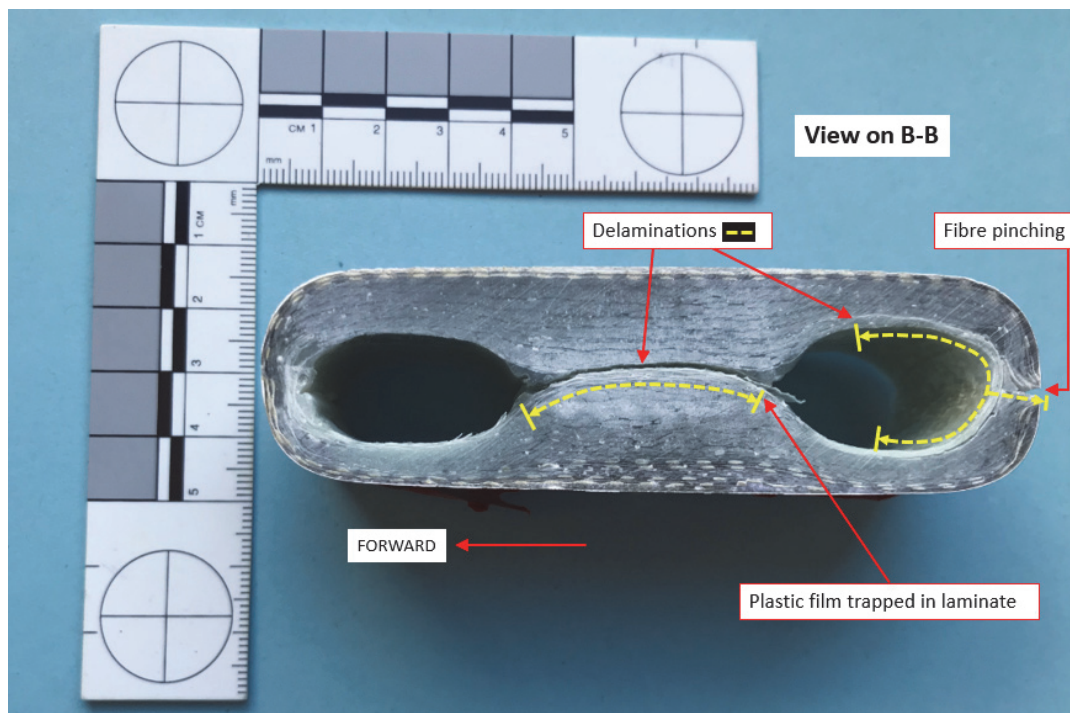
Figure 4

The leg's composite structure had delaminated between the forward and rear holes (Figure 4). Additional delaminations were observed around the rear half of the rear hole, and between the rear hole and the aft face of the leg section. A small area of fibre pinching was also present at the rear of the leg section.

View on section B-B

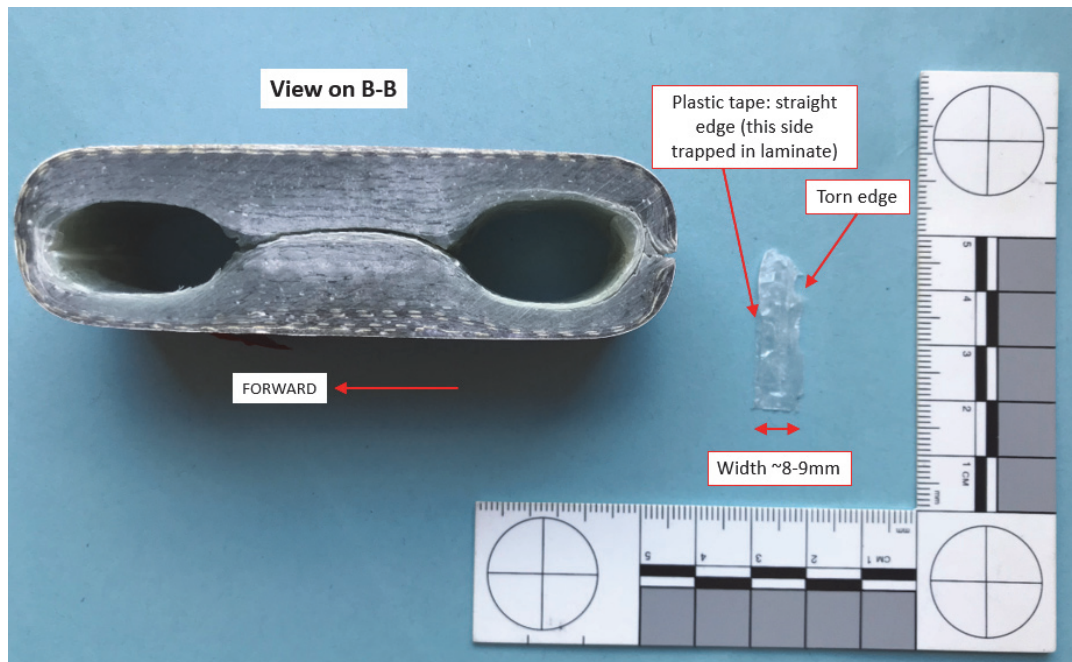
Figure 5

Plastic film sample recovered at section B-B

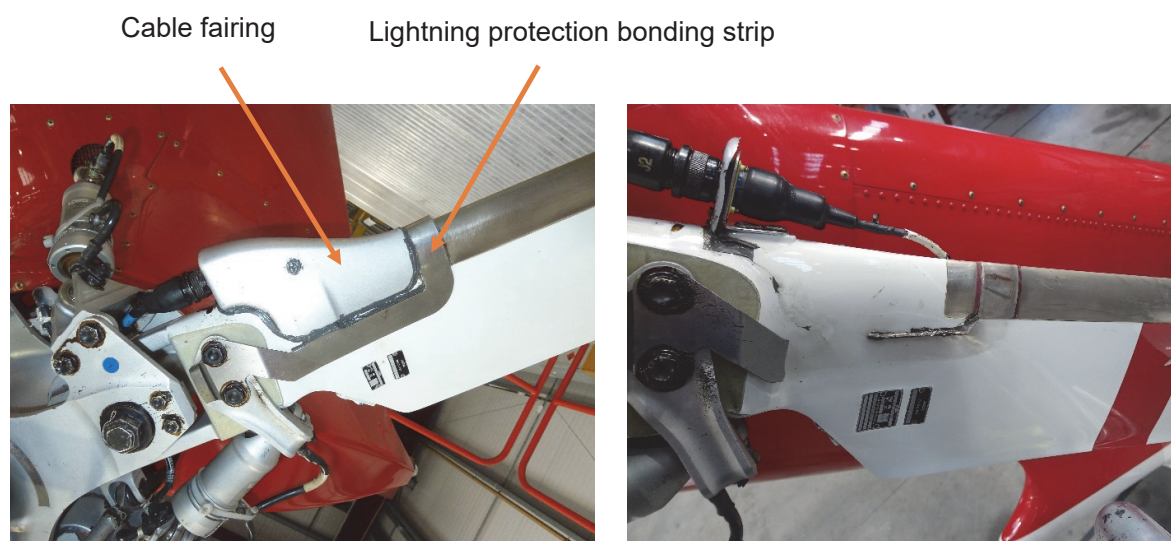
Figure 1

Visual examination of the helicopter found that a bonding strip and cable fairing had detached from one of the tail rotor blades (Figure 1). The missing parts were not recovered.

Examination of the other three tail rotor blades found that two more bonding strips were cracked.

Tail rotor blade fairing and lightning protection bonding strip installation
(left image shows an undamaged blade;
right image shows the damaged blade on G-MCSD)

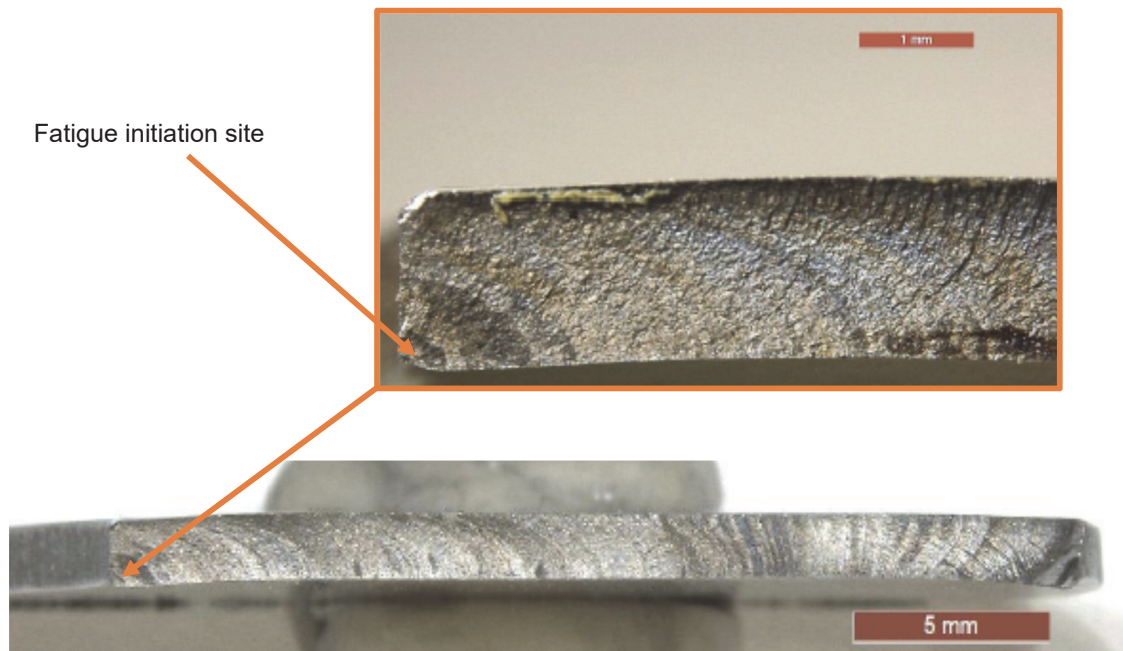
Figure 2

Microscopic examination established that all three bonding strips had cracked because of fatigue. The fatigue originated in the same location on all three items (Figure 2).

Fracture surface (fatigue originated from the lower left corner)

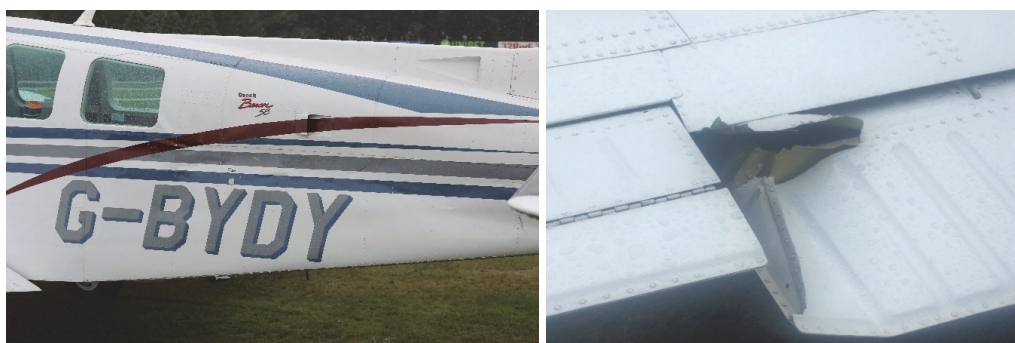
Figure 2

The damage to the Beech Baron was limited to the aft fuselage skin panel and several fuselage frames. The outer end of the flap on the left wing was also damaged but could still be retracted (Figure 2).

Damage to the Beech Baron – Fuselage and flap

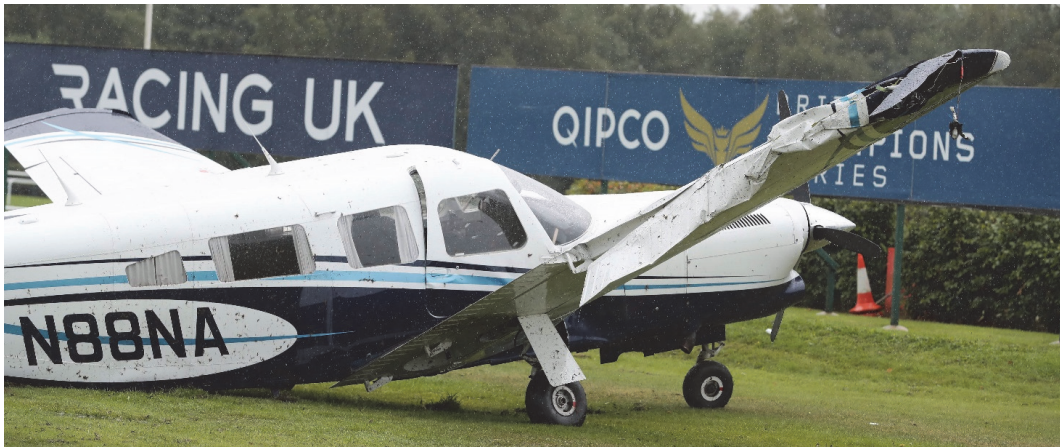
Figure 3

The PA-32 Saratoga was extensively damaged with evidence of impact on the right wingtip and aileron. As a result of the impact, the airframe was significantly distorted (Figure 3).

Damage to the PA-32 Saratoga

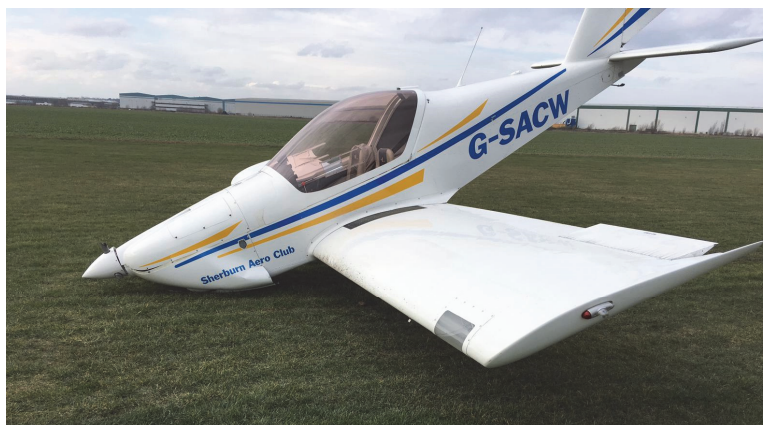
During the takeoff roll on grass Runway 19, the aircraft went over a "hump" in the runway at an airspeed of about 40 kt and became airborne. The pilot reported that, as the aircraft was "below flying speed", he reduced the pitch attitude slightly, but the aircraft's nose continued to drop and, upon contact with the runway, the nosewheel detached. The aircraft came to a stop shortly after (Figure 1) and the pilot shut down the engine. Both occupants were uninjured.

Figure 1
G-SACW nosewheel detached

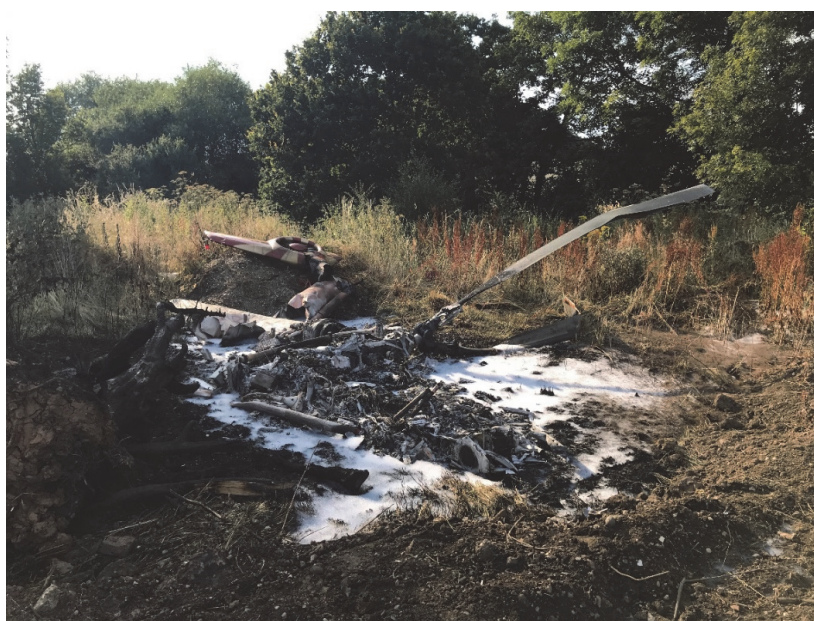
After the fire had subsided, there was very little remaining of the helicopter (Figure 1). The maintenance organisation recovered the helicopter wreckage to their facility and conducted an investigation but were unable to establish a cause of a loss of power. There was no evidence that the engine had suffered an uncontained failure and the turbine was intact and could be rotated through about 30°, but no further due to impact damage to the combustion chamber. There was very little remaining of the fuel system that could be examined. The engineer at the maintenance organisation thought that the fuel tank had probably been punctured by a pallet or metallic materials on the ground where the helicopter came down, resulting in the post-crash fire.

Figure 1
Remains of YU-HMC at the accident site
(image used with permission)

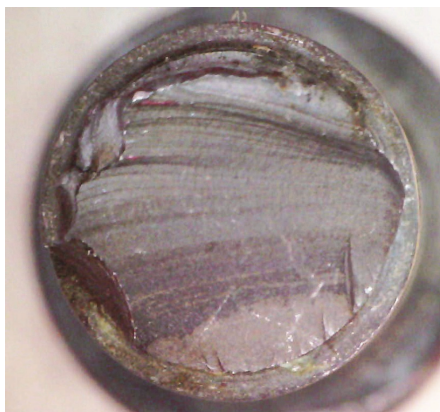
Figure 1

A post-accident examination of the engine found that the flywheel had detached due to fatigue failure of at least one of its mounting bolts (Figure 1). Jabiru 2200 engines, which have the same flywheel mounting arrangement, have experienced similar failures.

Fatigue striations on flywheel attachment bolt

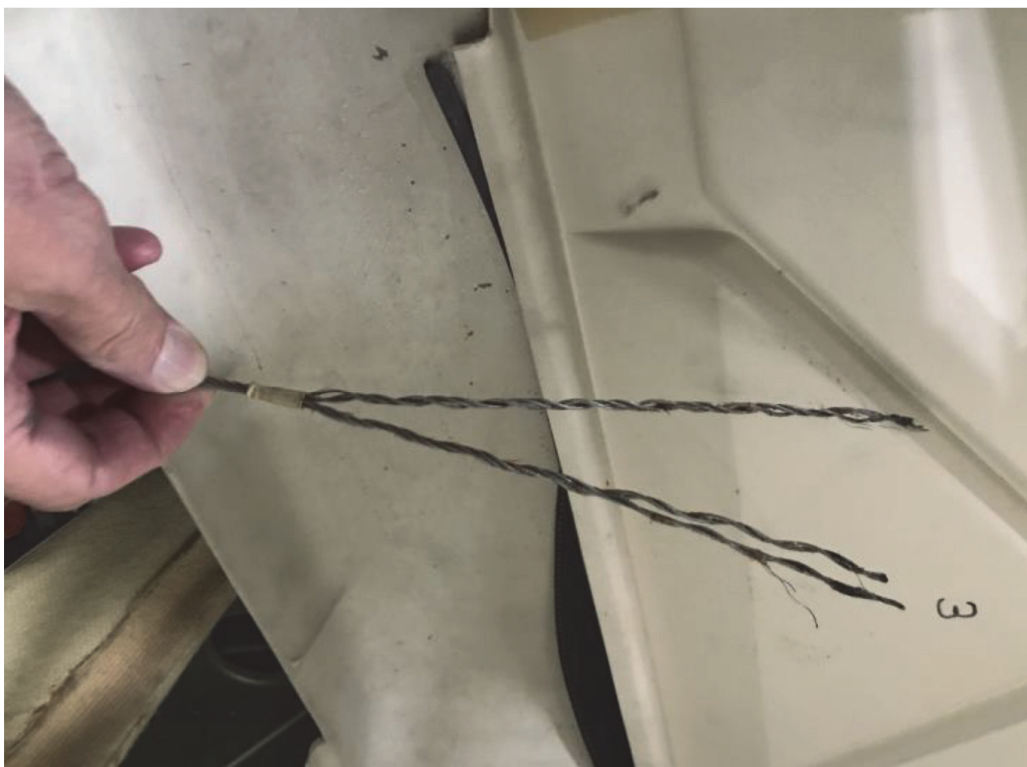
Figure 1

Inspection of the aircraft revealed the right rudder cable had chafed against the standby battery wiring and shorted to earth. The heat generated by the electrical short had melted through the steel-braided rudder cable. Figures 1 and 2 show the damage to the rudder control cable and standby battery wiring.

Damage to the rudder control cable

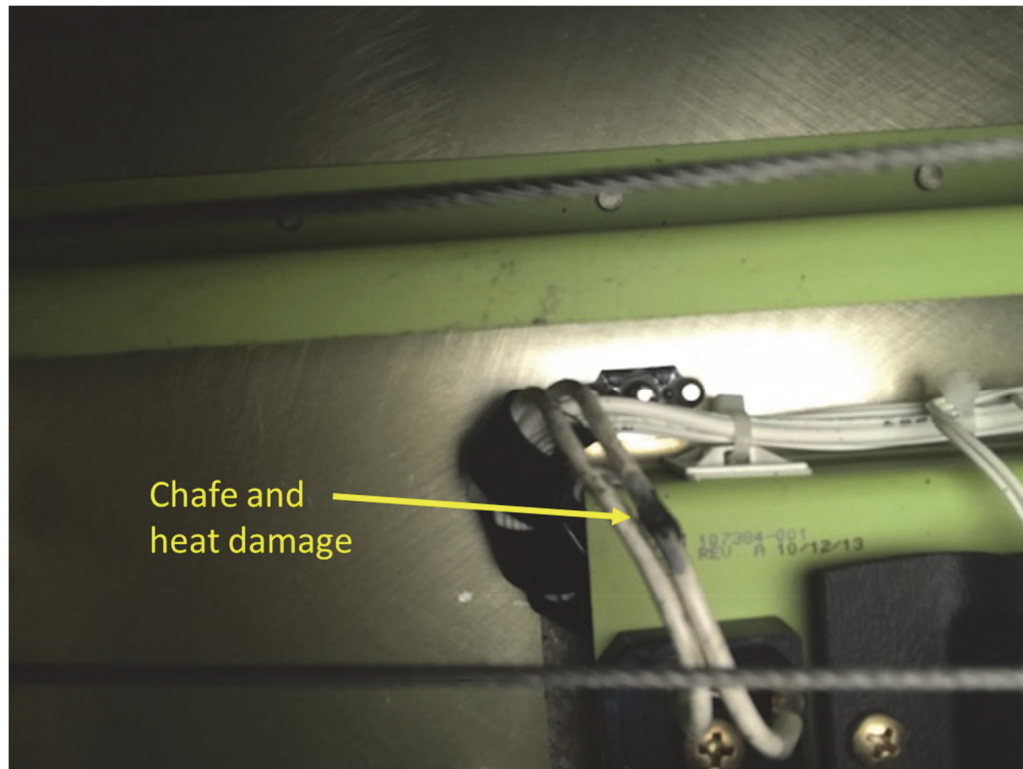
Figure 2

Chafe on the standby battery wiring

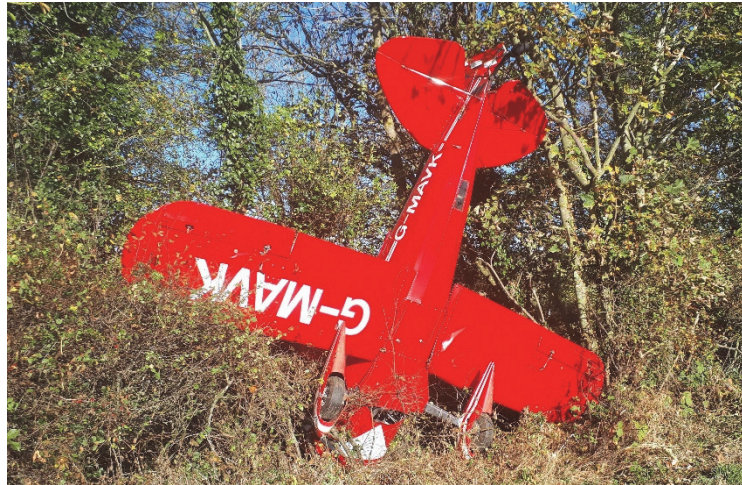
Figure 1

a halt (Figure 1). The impact damaged the wings, but the pilot was able to exit the aircraft unharmed.

The final position of G-MAVK
(Photo used with permission)

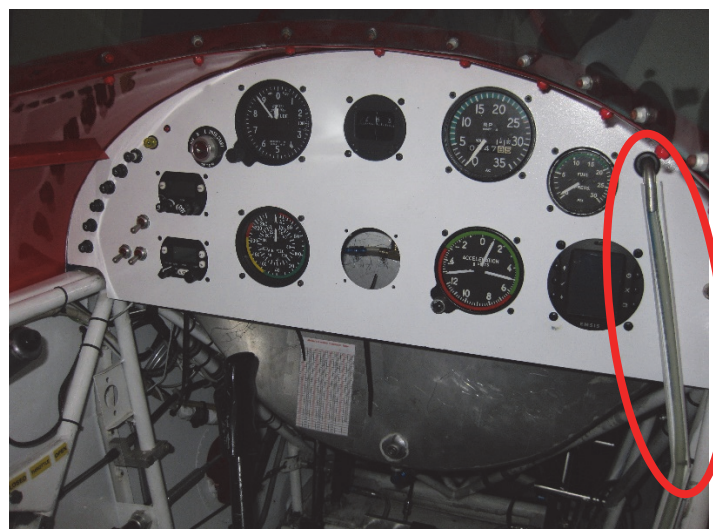
Figure 2

The fuel tank capacity was 72 litres (20 gal US) and was fitted with a sight-level fuel gauge. The pilot had recently fitted a new instrument panel and at the time of the accident there were no quantity markings on the fuel gauge (Figure 2).

Cockpit of G-MAVK with the unmarked fuel gauge highlighted

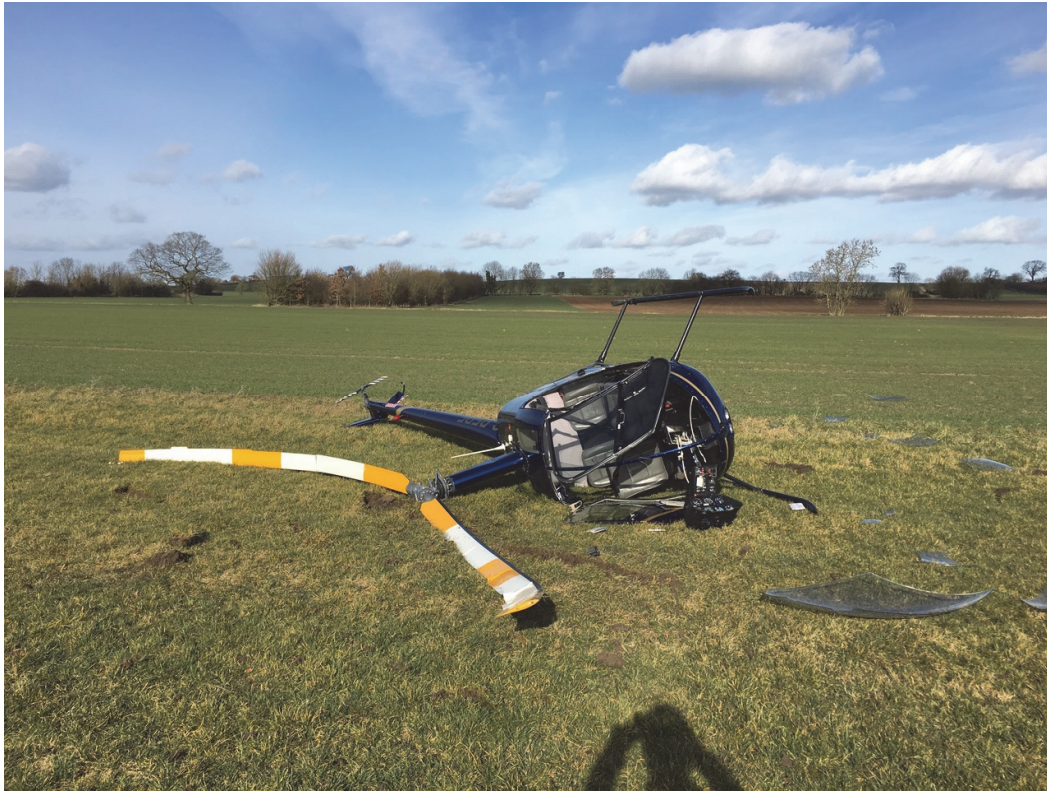
Figure 1

the front right portion of the skid on the ground. The helicopter rolled to the right and came to rest on its right side (Figure 1).

G-PERE After the accident

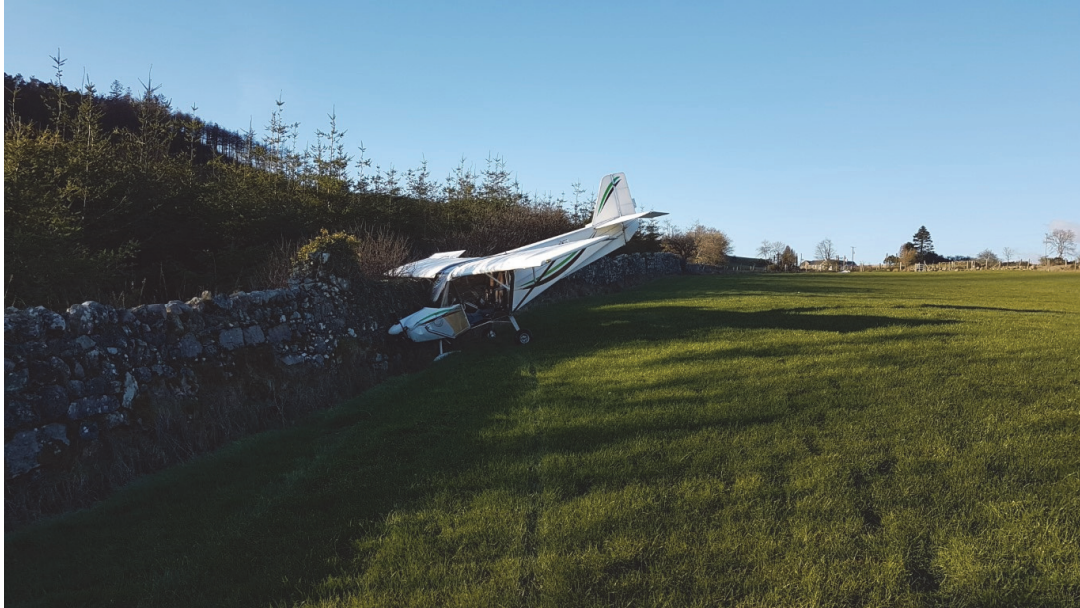
Figure 2

The surface was soft and wet from melted overnight frost and as the aircraft touched down the pilot maintained some power to compensate for the upslope and to keep the nosewheel lightly loaded and prevent it from digging in. As the landing roll continued, the ground to the left side of the runway started to slope away. The pilot noticed the aircraft veering to the left and responded by lowering the nose to increase steering authority and applying full right rudder. It was at this point that the left main landing gear wheel may have caught a rut or depression, which caused the aircraft to swing rapidly to the left. This motion caused the pilot to inadvertently increase the engine power, increasing the rate of turn. By now the aircraft was fully off the runway where it struck a wall and sank into a ditch (Figure 2). The damage to the wing struts, propeller and other structural damage were all sustained from the impact with the wall. Both the pilot and passenger were able to exit the aircraft unaided and without injury.

G-UPHI after impacting the wall, showing sloping ground to the left.

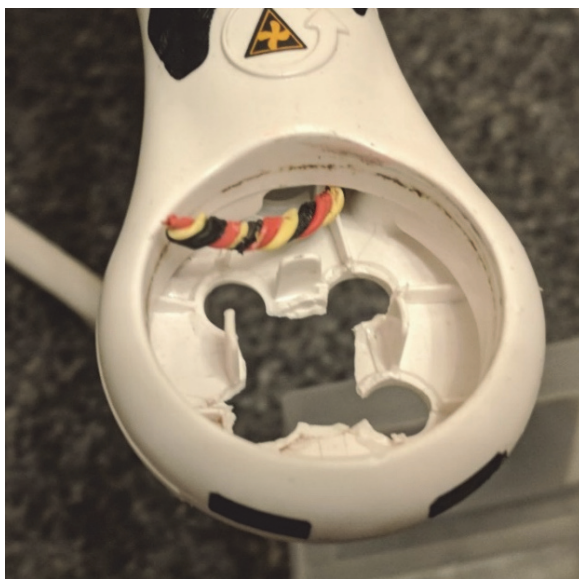
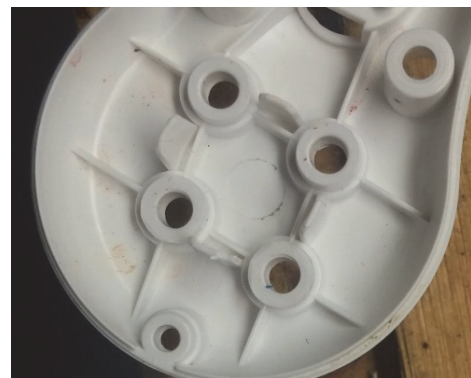
Figure 2

Examination of the structure around the motor attachment point indicated multiple cracks which had amalgamated and resulted in the attachment bosses detaching from the main structure (Figure 2).

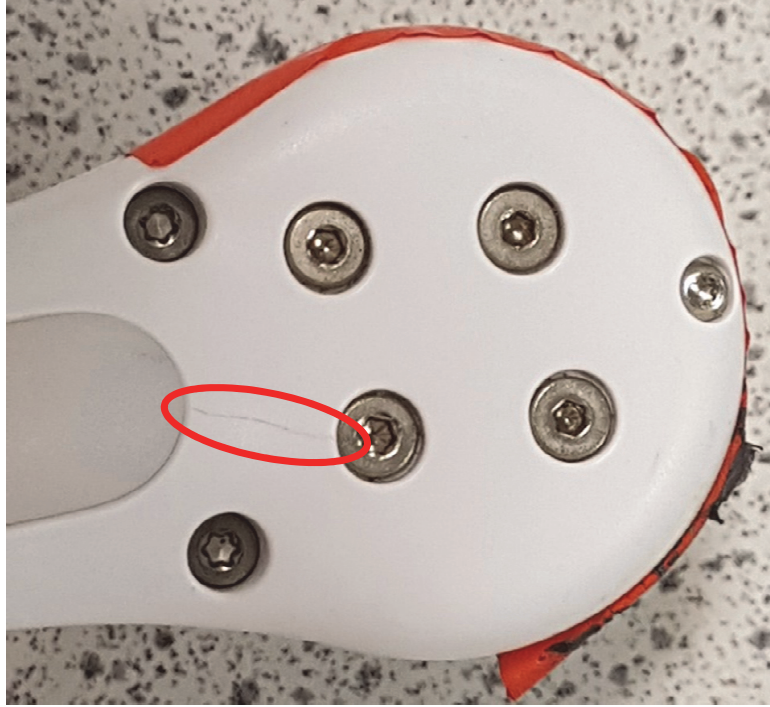
Figure 4

Example of motor attachment cracking
