AAIB Bulletin

6/2019

Published 13 June 2019

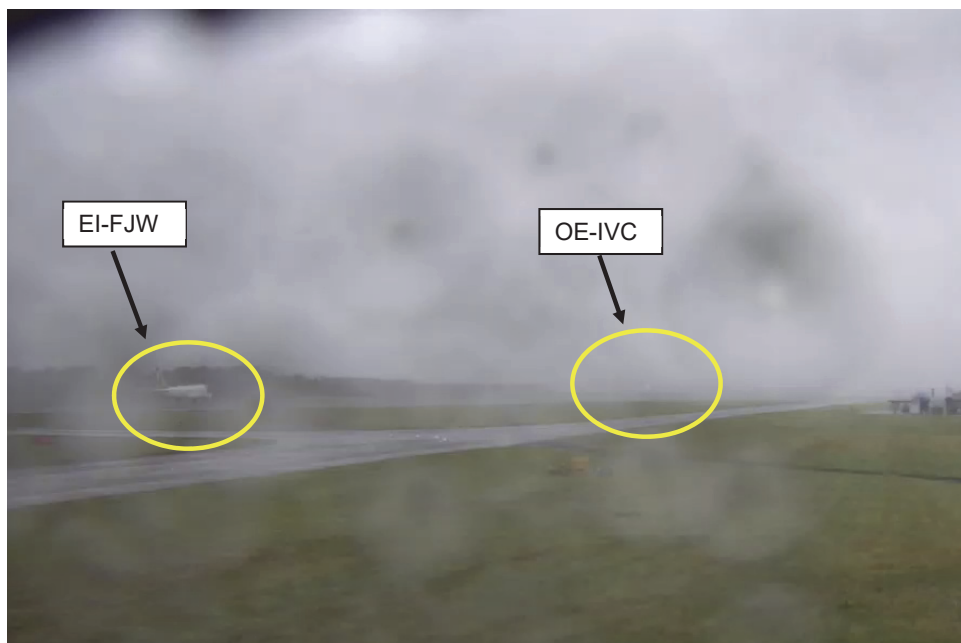
As EI-FJW was over the runway at the same time as OE-IVC was completing its takeoff roll, the event was classed as a runway incursion by the air navigation service provider (ANSP). At the closest point of approach, the two aircraft were separated by approximately 875 m, with OE-IVC being at 60 ft aal when EI-FJW touched down. Figure 2 shows a CCTV view looking down the runway which, although partially obscured by rain on the camera, shows both EI-FJW and OE-IVC visible in the frame.

CCTV showing both aircraft over the runway

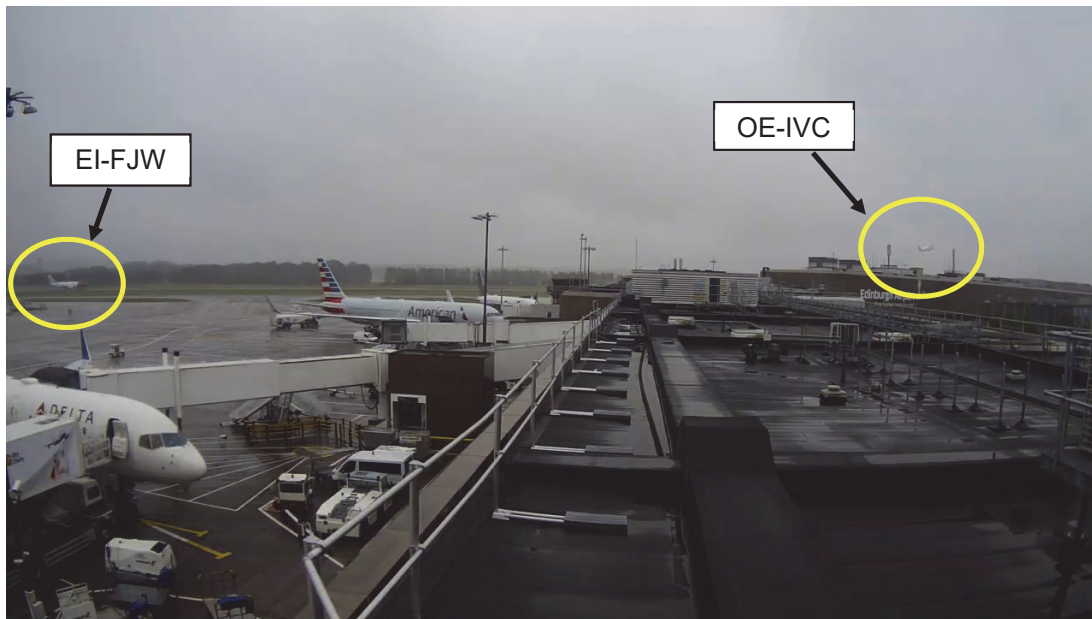
Figure 6

CCTV screenshot of the event showing both aircraft

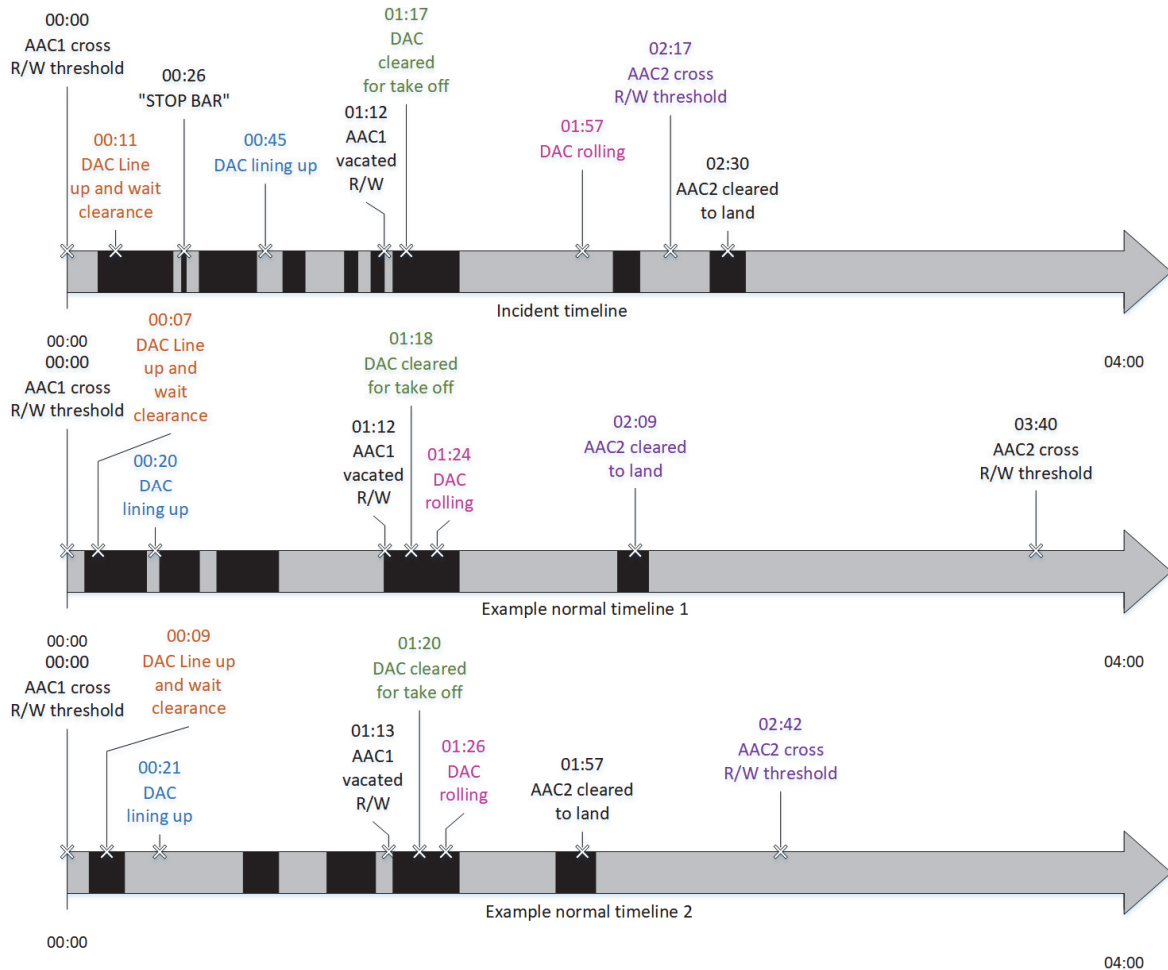
Figure 7 shows the incident timeline compared to two uneventful examples. In both examples there was a 6 nm gap between the landing aircraft and another aircraft which departed in the gap without incident. The comparison examples were taken from a training session with the trainee controller conducted with Runway 24 in operation, in the evening in dark conditions, without low visibility procedures (LVPs) or safeguarding³ in operation. The Stop Bars were in use because it was dark. Although the examples are for Runway 24, the layout of the holding points in relation to the runway at Edinburgh is symmetrical.

Incident timeline compared to normal examples

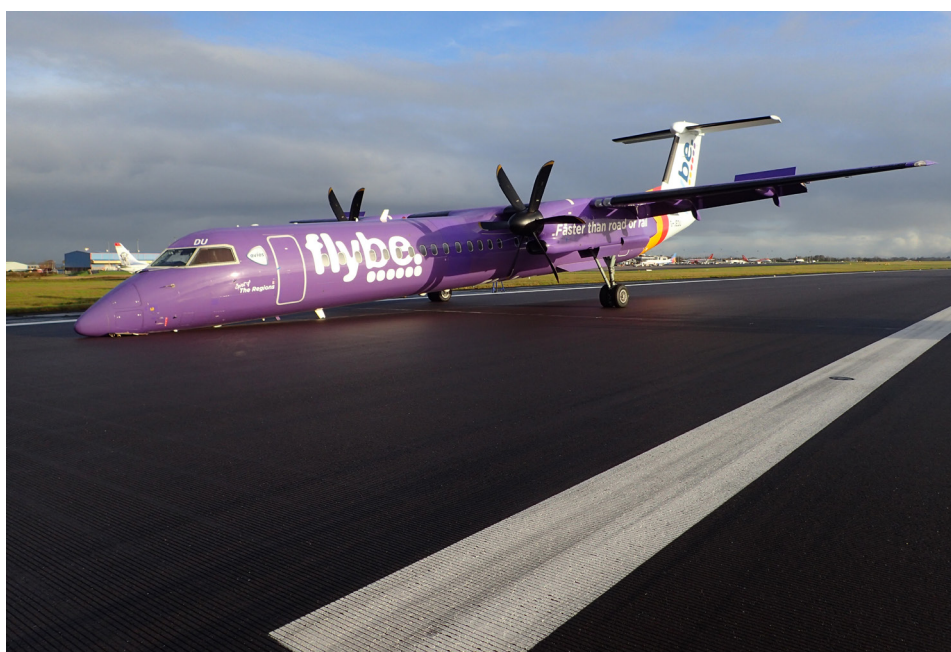
Figure 1

The aircraft had suffered abrasion damage to skin panels and structure on the lower surface of the forward fuselage and the VHF antenna. The NLG forward doors had also separated from the fuselage.

G-JEDU on Runway 25 at Belfast International Airport

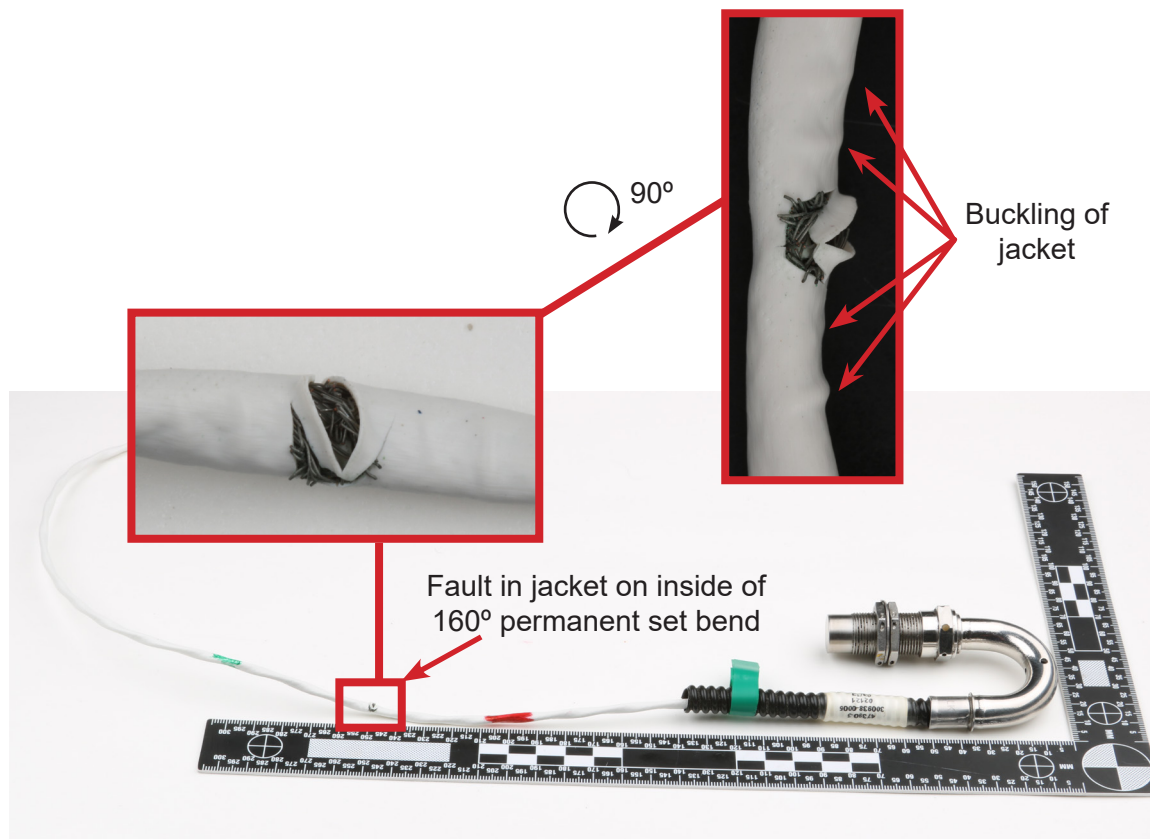
Figure 10

braiding were visible protruding through the split and the line of fractures was consistent with the point of maximum compression of the bend. Scratch marks were noted on the inner surface of the corrugated conduit, indicating that the exposed strands had made contact in this area and that the cable was moving relative to the conduit.

NGLK1 harness partially disassembled showing split in polymer jacket

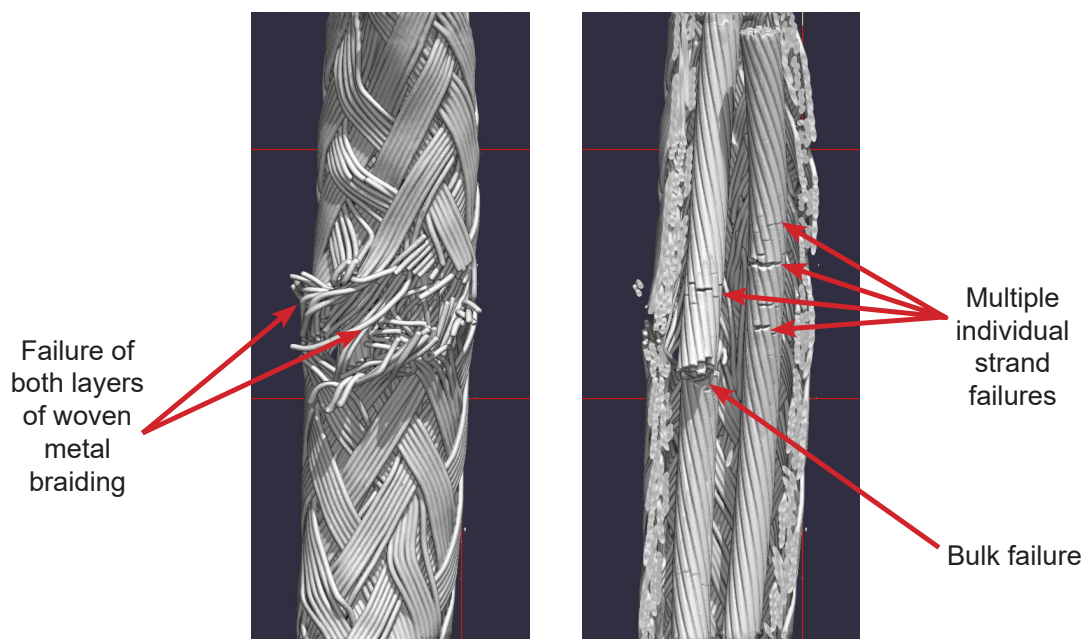
Figure 11

from the outer six-strand layer, however on the inner five-strand layer, striation spacing was approximately 0.3 μm , suggesting that over 330 cycles would have been required to fail one strand.

CT images of the concave side of the wire, orientation sensor down.

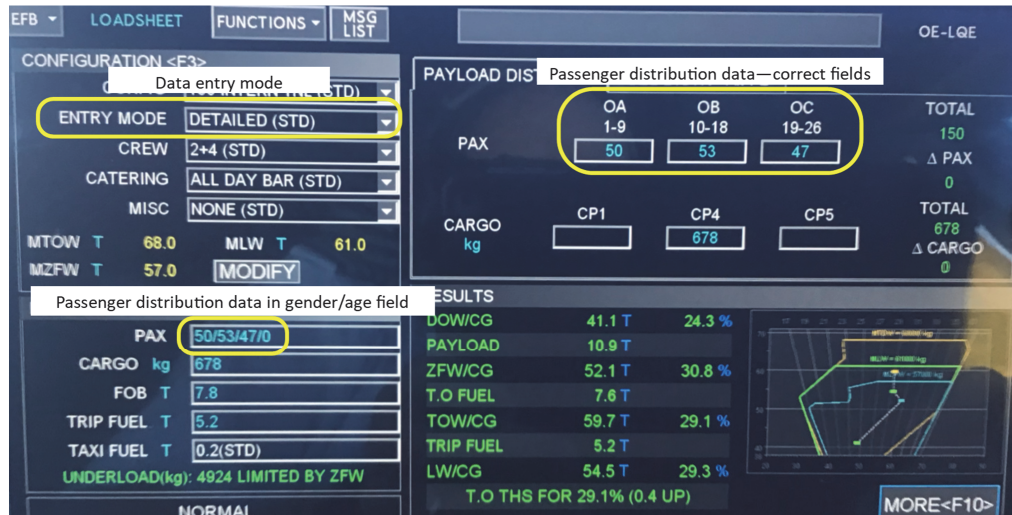
Figure 2

Once established in the cruise, the crew re-checked their loading calculations. They discovered that the Males, Females and Children data fields in the loadsheet application had been incorrectly populated. They contained the passenger cabin zone distribution figures (Figure 2) rather than the correct gender/age data (Figure 3). The resulting incorrect gender/age profile meant that the total passenger weight was underestimated by 1,962 kg. The flight continued to destination without further incident, whereupon the commander reported the loadsheet error to the Company Duty Pilot.

Software screenshot with passenger distribution data in gender/age data box

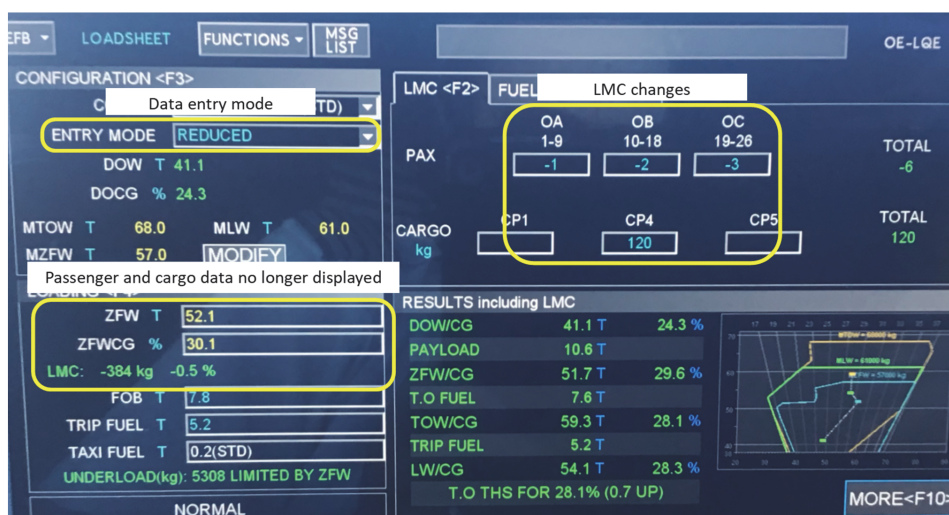
Figure 4

The crew commented that once they had entered Reduced mode to input LMC data, the passenger gender/age profile information was no longer visible (Figure 4). The commander considered that this was not helpful when trying to find the reason for the ZFW anomaly.

Loadsheet app in Reduced mode

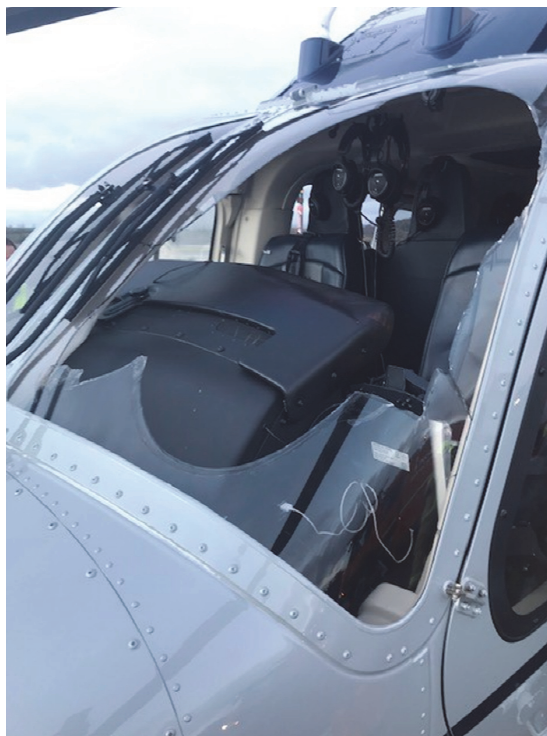
Figure 1

The left windscreen had shattered and remnants of the acrylic material were found throughout the cockpit and passenger area (Figure 1).

Left windscreen damage

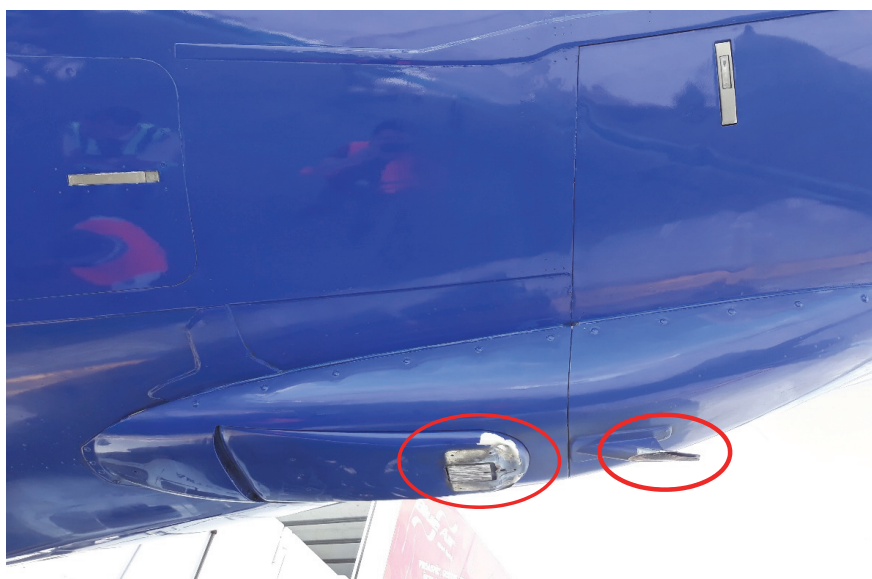
Figure 1

After landing the commander asked the aircraft engineers to examine the aircraft for evidence of a tailstrike. They discovered damage to the aircraft’s tail skid and APU drain mast (Figure 1).

Damage to underside of aircraft

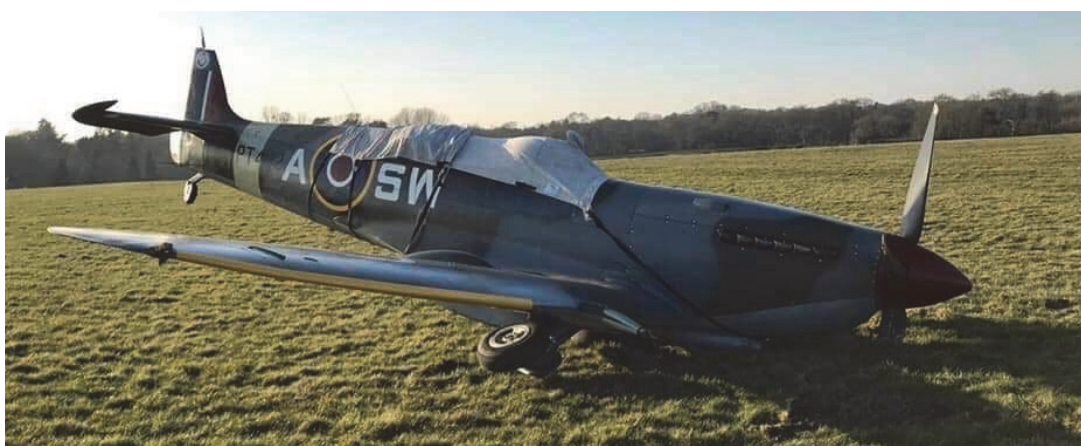
Figure 7

At the accident site it was confirmed that the right undercarriage leg was not locked down and subsequently on landing, had retracted back into the wing. The left undercarriage leg had been locked down but the leg had folded underneath the fuselage during the landing sequence. The aircraft came to rest on the left undercarriage leg (Figure 7).

G-CTIX after landing

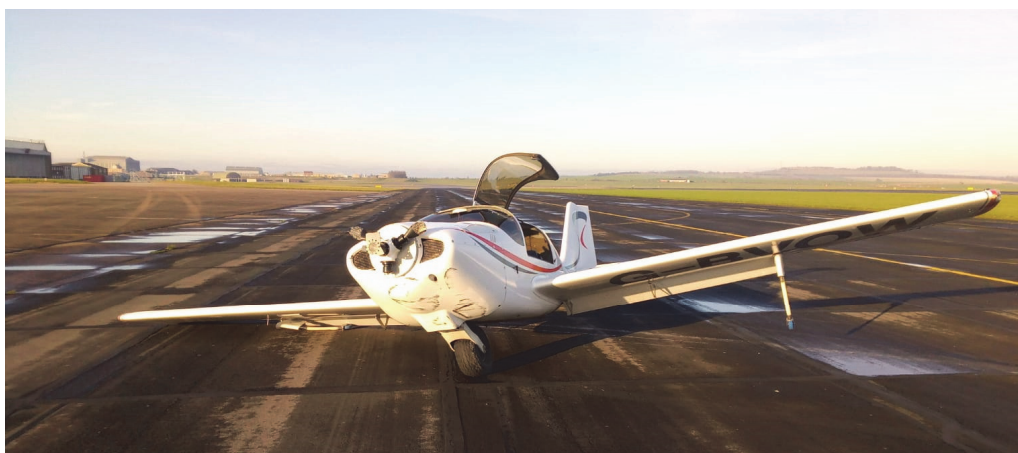
The pilot planned to perform some circuits on the grass Runway 35. The weather was fine and the wind was calm. During the takeoff roll, as the airspeed reached approximately 40 kt, the tail lifted and the aircraft began deviating to the left. The pilot reported applying right rudder, but the aircraft continued to deviate to the left, transitioning from the grass to a tarmac section, after which it rotated further to the left. The pilot was wearing a full harness and was uninjured.

Figure 1
G-BVOW after the accident

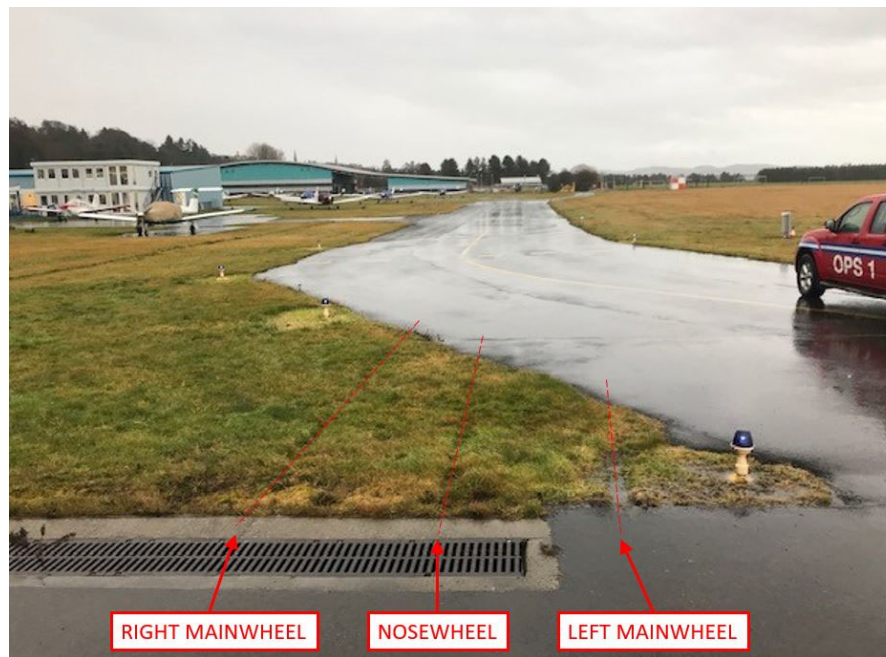
Figure 2

Witness marks made by the aircraft as it departed Taxiway E showed that it had continued taxiing straight and had not turned left along the curved portion of the taxiway where it met the main apron, Figure 2.

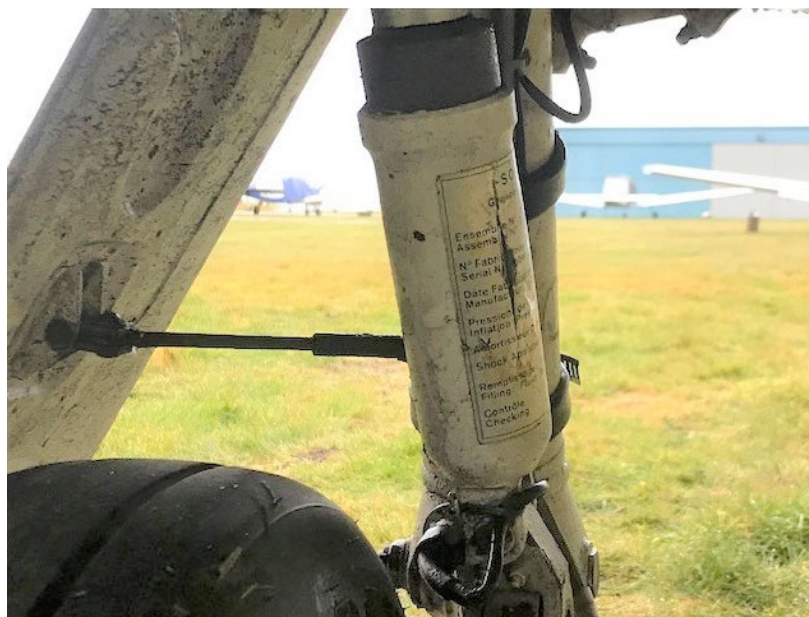
Figure 3

The left main landing gear leg had sunk into the grass beyond Taxiway E and had then been subjected to an overload when the aircraft rode over the paved edge of the main apron. The overload caused the left main landing gear oleo to burst, Figure 3, releasing hydraulic fluid from the oleo. No other damage to the aircraft occurred during the accident.
