AAIB Bulletin

7/2019

Published 11 July 2019

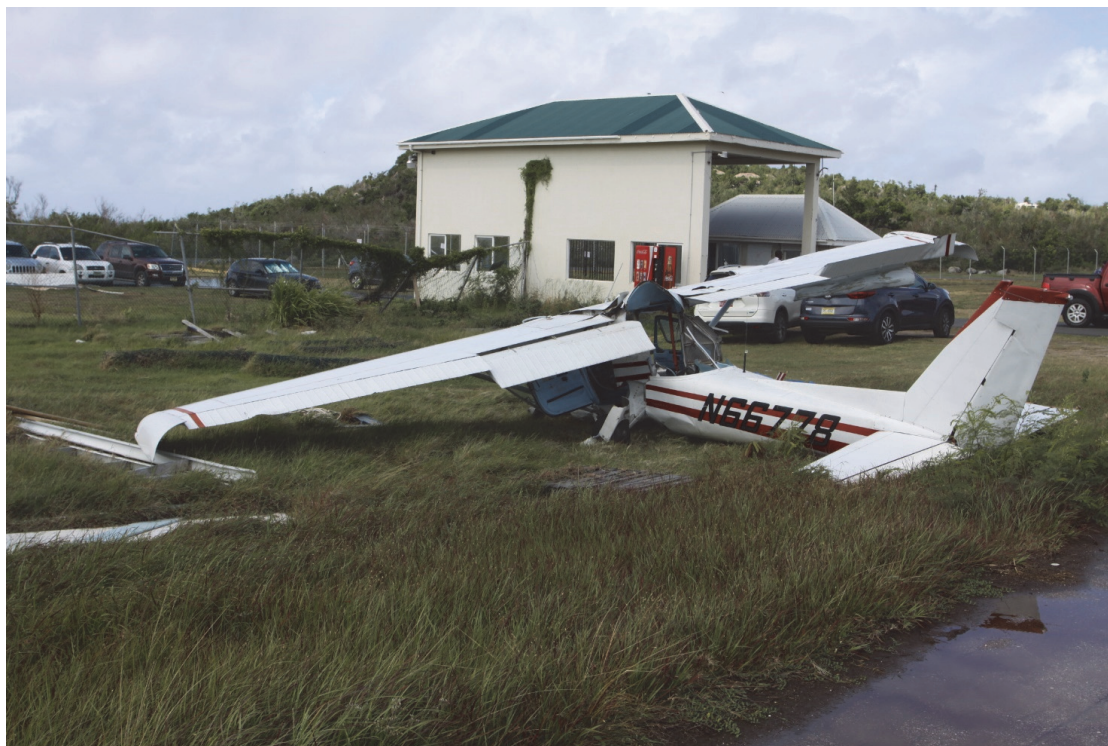
Figure 4

The aircraft had been recovered to an area of grass within the airport grounds (Figure 4). The rear fuselage structure had separated from the front fuselage aft of the seats and was only connected by control cables. Significant leading edge crumpling on the right wing

was consistent with the aircraft striking the water at a near vertical attitude, right wing first. Hydrostatic forces were sufficient to rupture the lower surface of the right wing as it struck the water.

N66778 after recovery

The right-wing flap was up and left-wing flap was down. The synchronisation cable connecting the left and right flaps had snapped at the left-wing root. Examination of this cable indicated that it had failed in overload and was consistent with the impact. The right flap was fixed and remained connected to the flap actuator which was in the retracted position. The flap position was therefore determined to have been UP at the time of the accident.

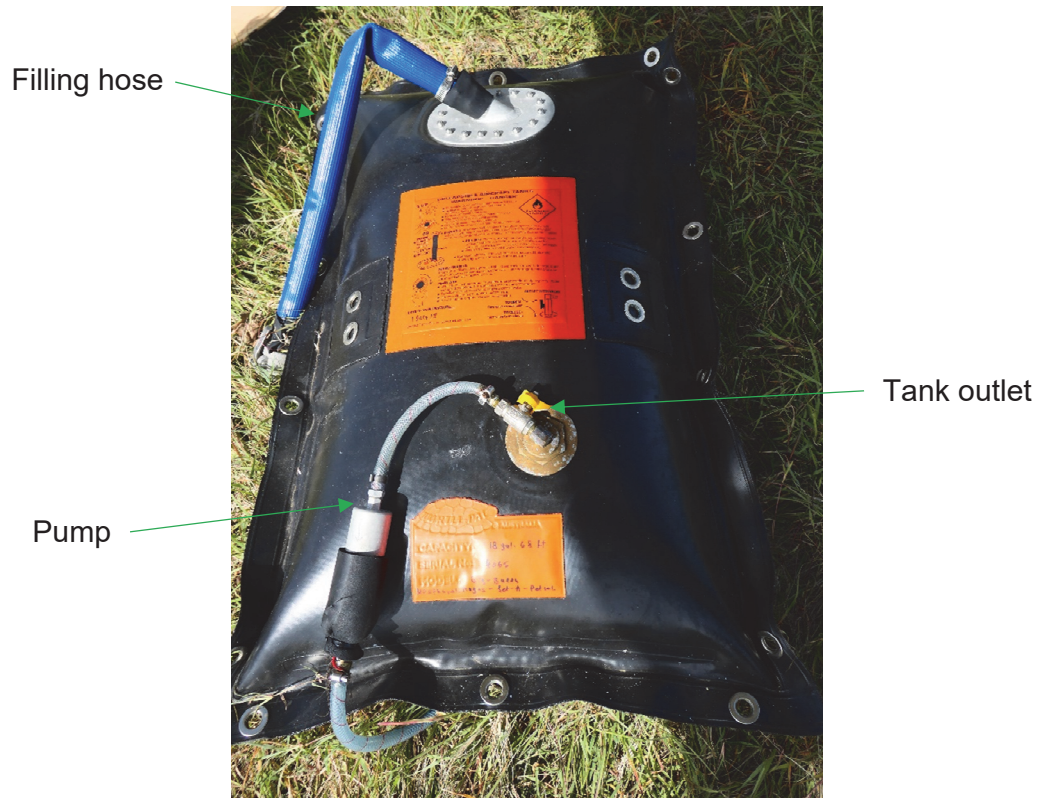
Figure 5
Auxiliary fuel tank

An auxiliary fuel tank was recovered with the wreckage (Figure 5). It was of rubberised fabric construction and was fitted with an electric pump to allow transfer of its contents to the aircraft's integral fuel tanks during flight.

The pump outlet was connected to an inline filter which in turn was connected to tubing that ran under the left door sill, up the left door forward pillar, through the left cockpit air vent and out of the air scoop on the leading edge of the left wing. The tube then ran from the leading edge to an elbow union connected to a modified over wing fuel tank cap (Figure 6). The tubing was still in position, however during the accident the auxiliary tank became dislodged from its original location, becoming disconnected at the fuel filter outlet.

The weight of the tank when filled with fuel to its rated capacity of 68 litres (18 USG) should be 124.6 lbs; however, the tank on N66778 was found to weigh 137.6 lbs. This equated to containing approximately 76 litres (20 USG) of fuel. The auxiliary tank manufacturer advised that although the tank can be filled to 80 litres it is only rated to 68 litres to allow for expansion and shock loading in the event of an accident. The guidance leaflet provided with the auxiliary tank states *'Only fill to the lesser rated capacity and the maximum allowed by weight & balance data or specific operational approval'*. The outlet valve was found to be open, so the possibility of water entering the tank or fuel leaking from the tank whilst it was submerged was considered. When the tank was recovered, no fuel leaked from the tank and it was concluded that it was unlikely that the contents of the tank had changed since the accident.

The pilots of the other aircraft flying with N66778 identified that the tank had been positioned in the storage location to the rear of the pilot's seat and was orientated so its long edge was along the length of the compartment. Examination of the cabin area did not identify any evidence of the tank being secured into the aircraft. A tank carry bag⁴ was located within the aircraft. It was found to contain webbing ties supplied with the tank to secure it to the aircraft; however, their condition suggested they had never been used. The floor of the luggage compartment was carpeted. This would not have provided any significant friction to restrain the tank during aircraft manoeuvring.

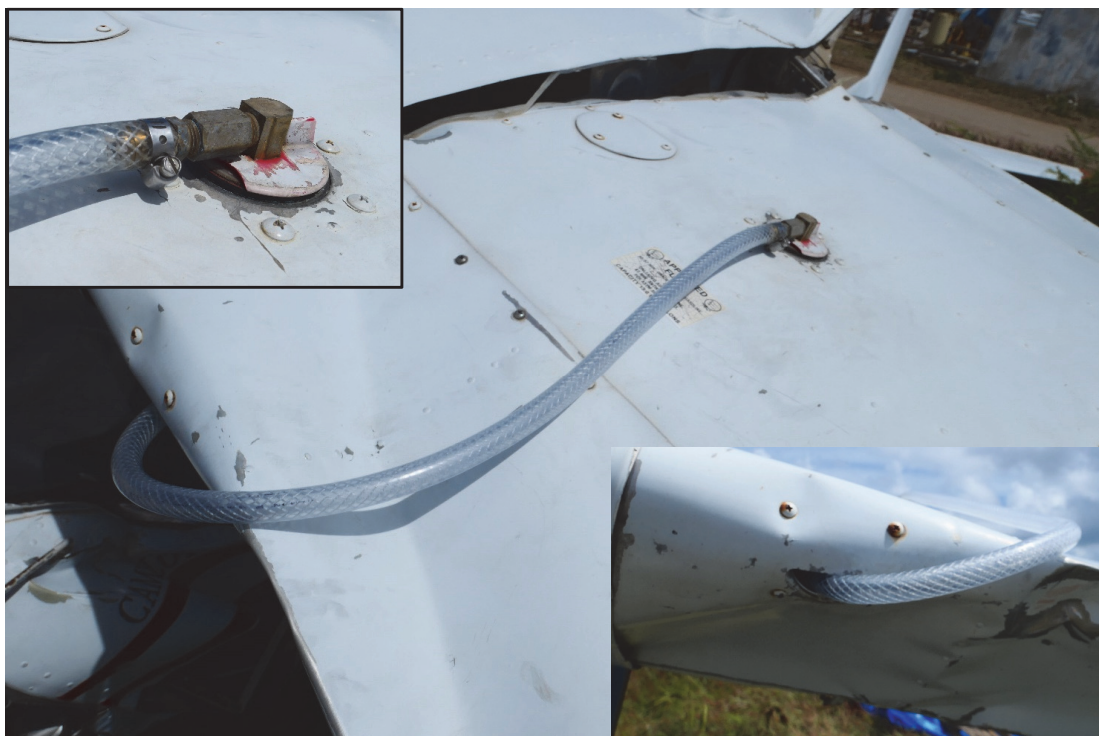
Figure 6

Routing of auxiliary fuel tank tubing over leading edge of the left wing into the left fuel tank

N66778 had a fuel pipe positioned over the leading edge of the left wing. This pipe would disturb the airflow over the left wing and could affect the stall speed of the aircraft. If the aircraft stalled in balanced flight it is possible that this modification would cause the left wing to stall first resulting in a wing drop to the left.

When the aircraft commenced a turn, in level flight, the stall speed would have increased. The fuel pipe running over the leading edge of the left wing might also have increased the stall speed. The aircraft was also seen to 'pitch up' during the turn which would cause the airspeed to decrease. The aircraft's speed instability at these low speeds would cause the speed to further reduce. These effects are likely to have combined to cause the stall during the turn.

The aircraft contained an auxiliary fuel tank which had not been installed to any approved FAA standards for repairs or modifications. This installation included a tube that ran over the wing leading edge to the fuel filler cap; the pilot’s pre-flight checks could have been an opportunity to question the installation.

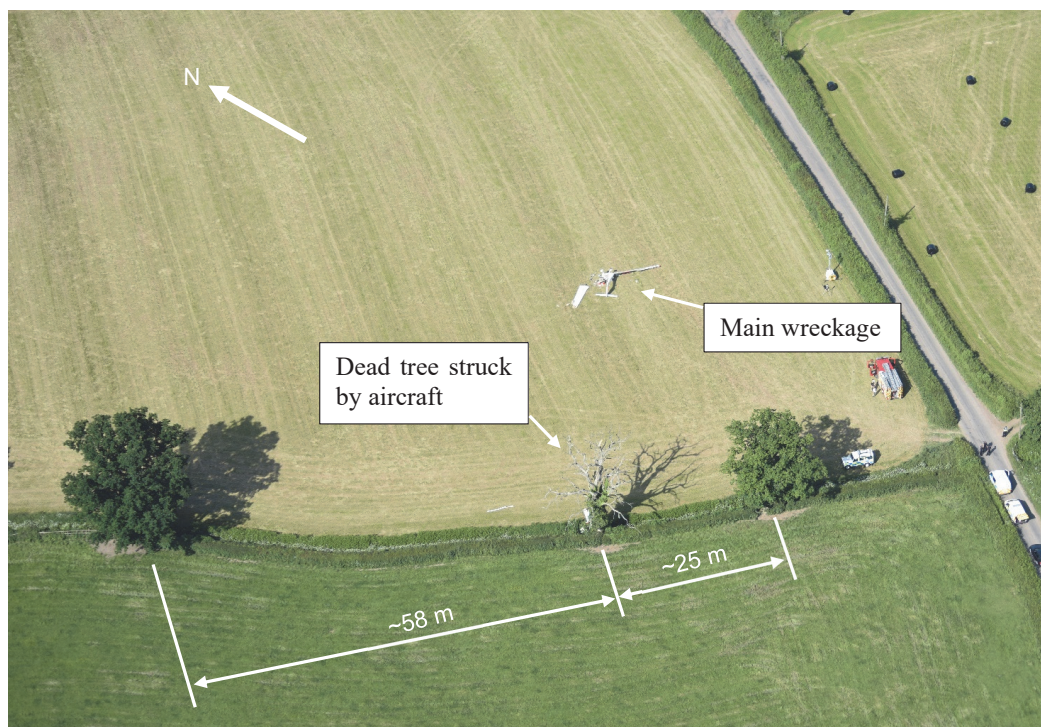
The field in which the accident site was located had a hedge running along its south-western perimeter in which there were several mature trees, one of which was a dead oak tree (Figures 2 and 3). A 2 m section of the aircraft's right wingtip was found in this tree suspended together with a broken bough, both having been entangled in the tree by some aircraft wiring. Photogrammetry assessment of the dead tree and examination of the damage to the right wing determined the height of the impact with the tree was approximately 57 ft agl.

Figure 2
Accident site
(image courtesy of South Wales Police)

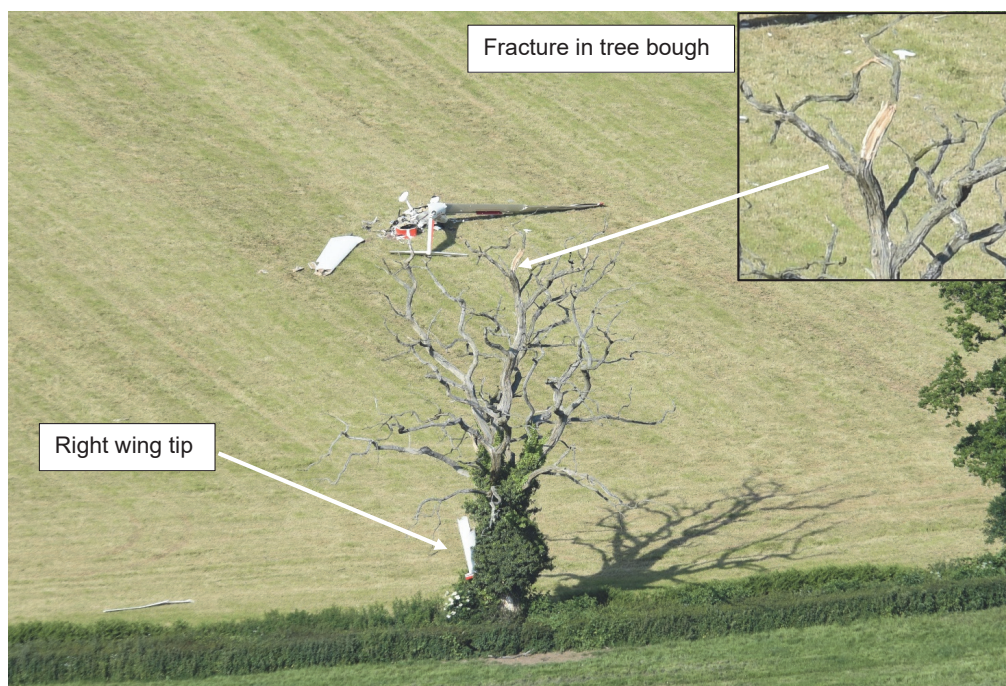
Figure 3

Accident site showing impact point with tree and wreckage
(image courtesy of South Wales Police)

The aircraft had come to rest, inverted, approximately 55 m from the hedge line. There was no post-impact fire. Impact marks showed that the aircraft had struck the ground at a steep angle, inverted. The right wing, which had separated during the impact sequence, was found close to the fuselage.

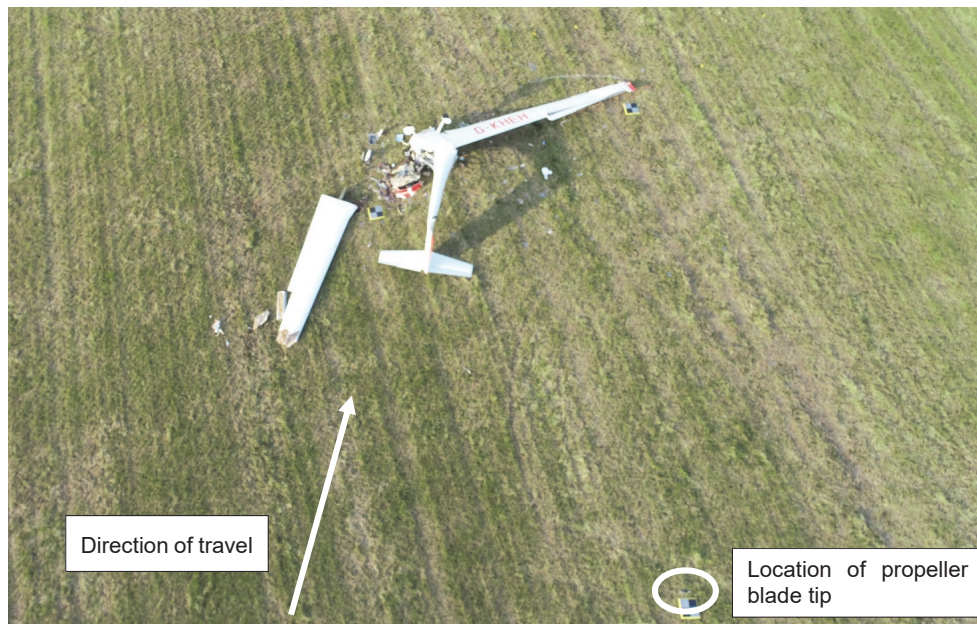
**Figure 4**

Ground marks at the main impact location indicated that the propeller was rotating at the time it contacted the ground. The composite wooden propeller had fragmented and one of the propeller blade tips was located 16 m from the initial impact point (Figure 4), indicating that the engine had been producing power at the time of impact.

Location of propeller blade tip in relation to wreckage

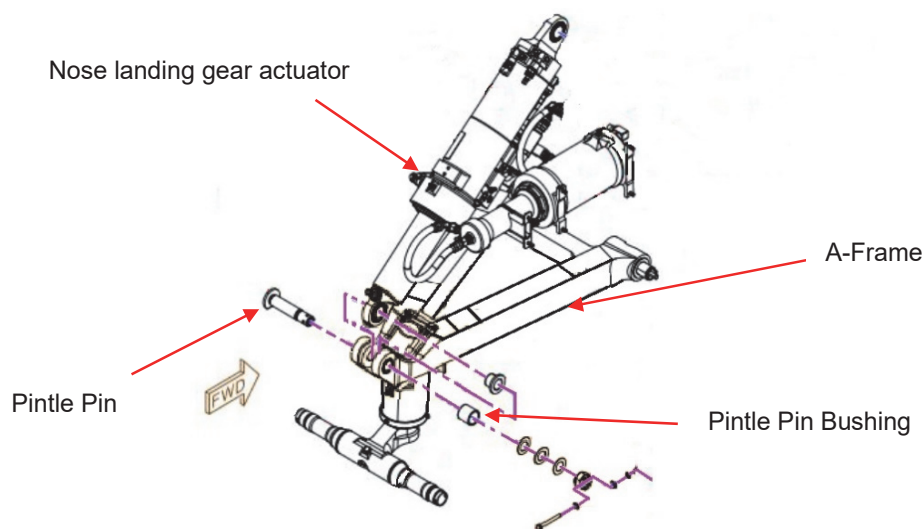
Figure 1

A subsequent examination, carried out by the operators engineering organisation, identified that the separation of the A-frame from the actuator had been caused by failure of the pintle pin which secured the A-frame to the landing gear actuator (Figure 1). The head of the failed A-frame lower pintle pin was identified during an inspection of the landing site. The pintle pin bushing was found to be missing from the installation.

Approximately 50 hours prior to the incident flight, on 7 June 2018, the A-frame (Figure 1) had been replaced during a routine maintenance input following reports of “notchy” steering.

EC175 Nose landing gear actuator and A-frame

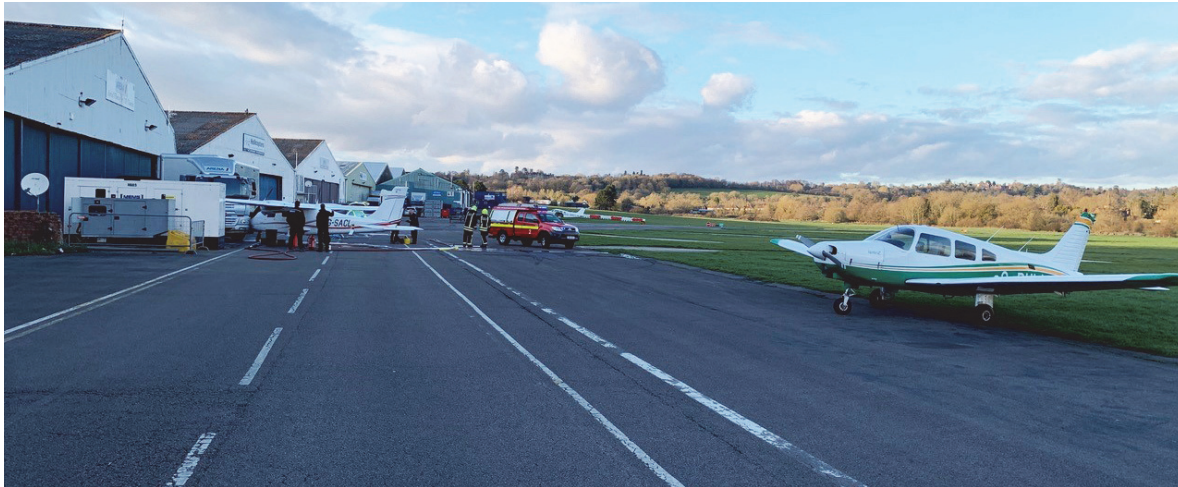
Figure 1

evacuated safely. The fire service arrived to make the area safe as there was fuel leaking from the fractured left wing tank.

Apron markings and location of parked Piper PA-28 on the right; location where the Tecnam (G-SACL) came to rest against the generator and lorry is at the left

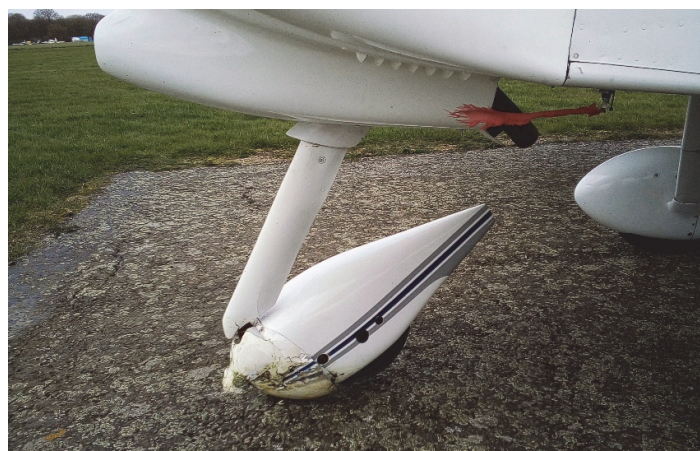
Figure 1

Damage to nose landing gear

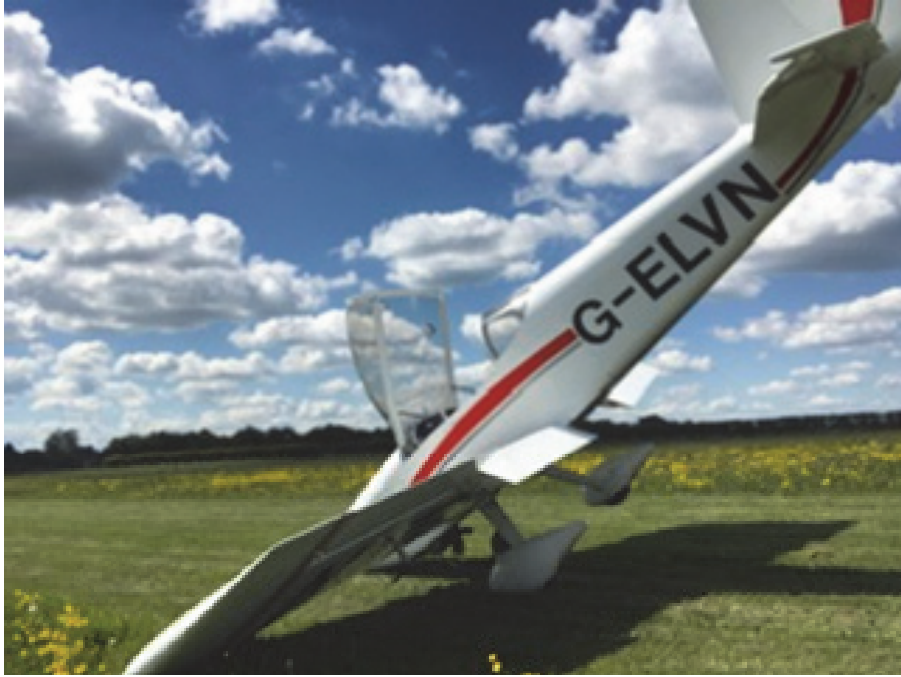
The pilot reported that as he was about to land on grass Runway 24, the aircraft struck a medium sized bird at a height of approximately 20 ft agl. This surprised the pilot who momentarily pitched the aircraft up and to the left, before adjusting the aircraft's flightpath back towards the runway centreline to land with about 300 m of runway remaining. When the aircraft touched down it bounced and became airborne. The pilot decided to land rather than go around, due to the possibility that the aircraft may have sustained damage from the bird strike. The aircraft subsequently touched down heavily on the nose gear which collapsed. The aircraft came to a stop and the pilot vacated the aircraft unaided.

Figure 1
G-ELVN nose gear collapsed

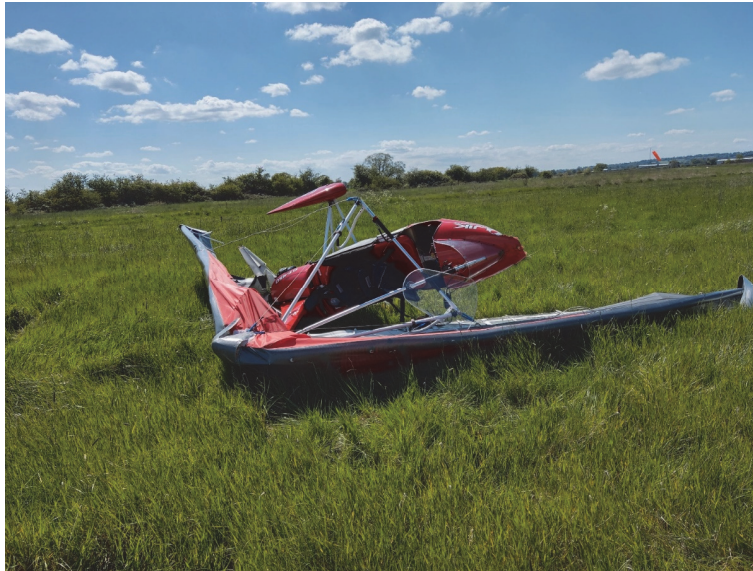
The pilot decided to land on Runway 31 and reported that the approach was normal, but shortly after moving the throttle lever to idle and at a height of about 10 to 15 ft above the runway a "burst of wind" caused the left wing to lift and the aircraft veered to the right. The pilot levelled the wing but the aircraft was now parallel to the runway and it touched down heavily into long grass. After a short landing roll the nose tipped forward before the aircraft rolled onto its right side. The pilot was unhurt and vacated the aircraft unaided.

Figure 1
G-TPWL after the accident
