Air Accidents Investigation Branch
Farnborough House
Berkshire Copse Road
Aldershot
Hants GU11 2HH

Published 8 August 2019

Beagle B121 Series 2 Pup	G-TSKY	12-Jul-18	3
Reims Cessna F172N Skyhawk	G-BGSV	10-Oct-18	16

AS350B2 Ecureuil	G-PLMH	13-Jun-18	31
------------------	--------	-----------	----

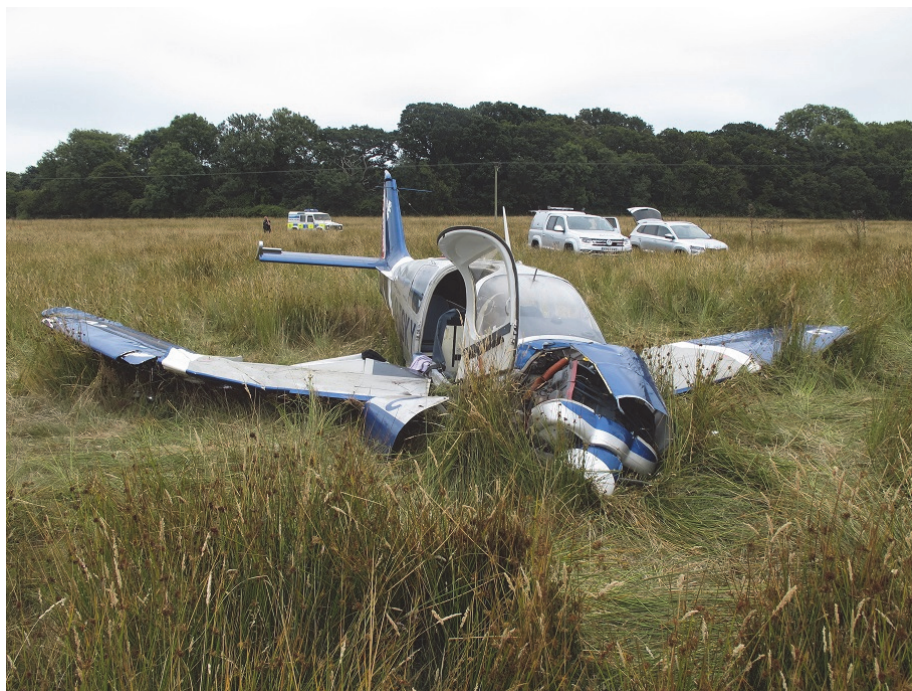
Figure 2

The aircraft had struck the ground on a track of about $310^{\circ}(M)$ and then bounced 13 m before coming to rest. The damage to the aircraft indicated that it had struck the ground with a high vertical descent rate and with the right wing low (Figure 2). One of the propeller blades was undamaged, while the other blade was bent aft. There were about 3 litres of fuel remaining in the left inboard wing tank and about 1 litre remaining in the right inboard wing tank. The fuel strainer bowl on the underside of the aircraft had been dislodged and showed evidence of impact damage. Soil samples revealed high concentrations of volatile organic compounds in the area where the engine was located. A environmental company contracted to examine the site estimated that approximately 35 litres of Avgas had entered the subsurface, but it stated that this figure could have been higher.

Accident site, view towards the south-east

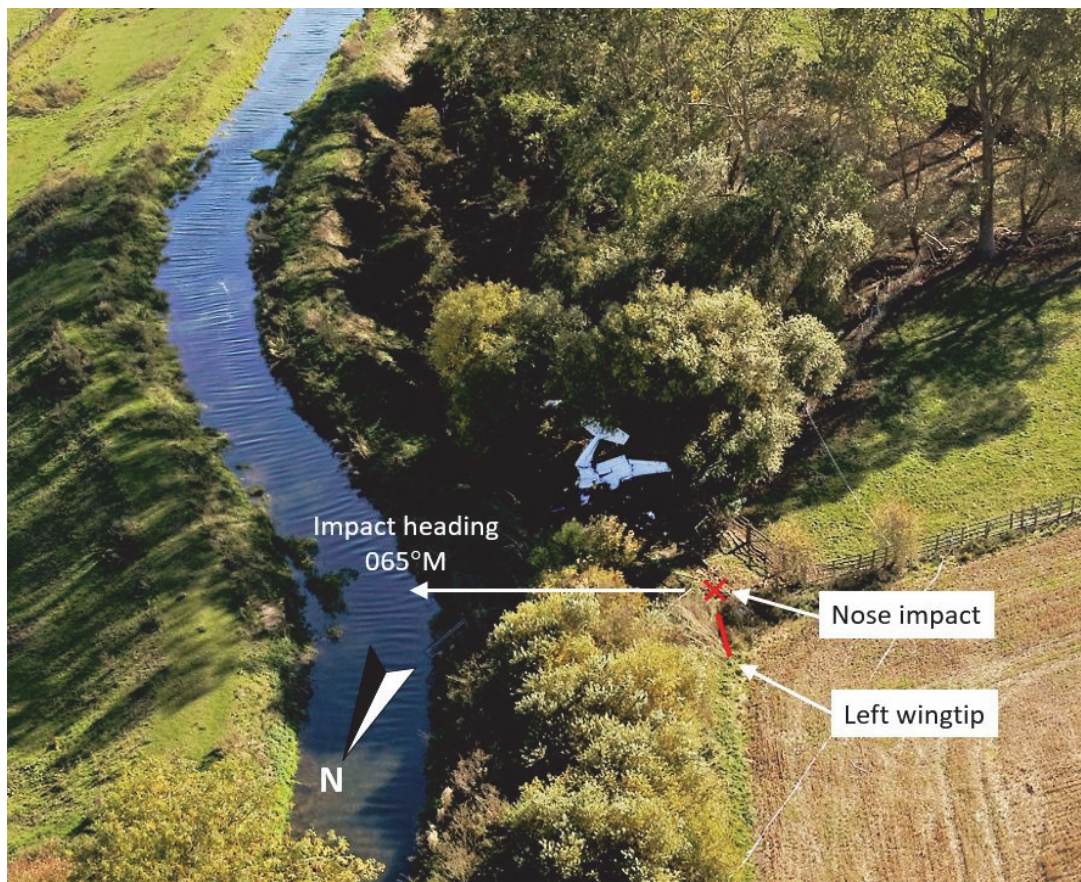
The accident site was located in a copse adjacent to a stream (Figure 3). The aircraft had struck the ground in a nose-low, left bank attitude and the impact heading was approximately 065°M. Following the initial impact, the aircraft had travelled a further 20 m, coming to rest against a tree. Due to its severity, the initial impact was not survivable for the aircraft occupants.

Figure 3
Accident site

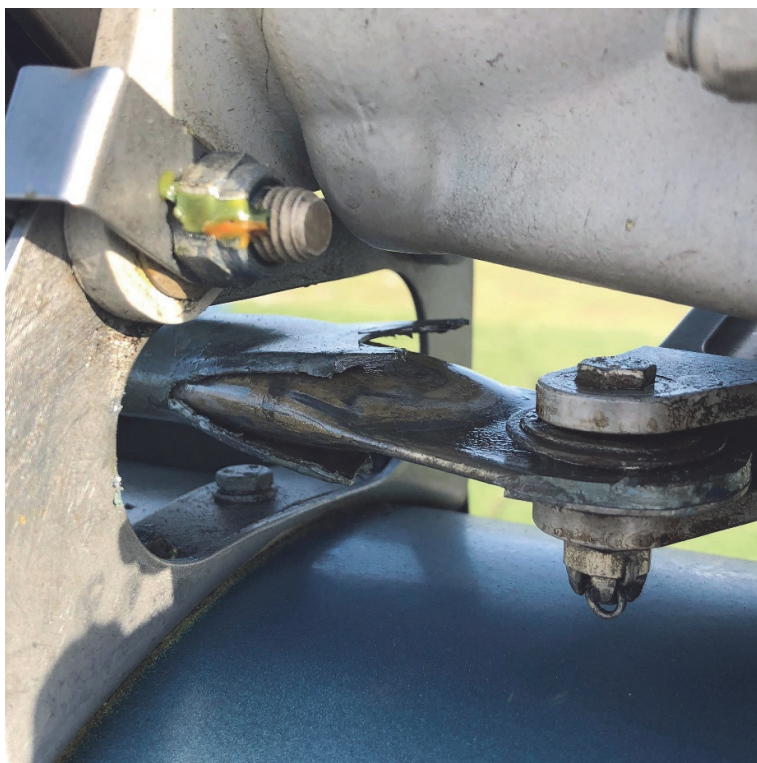
Figure 1

During examination of the helicopter it was found that the TGB actuating rod (part number 350A27191003) had ruptured at the aft end (Figure 1). No other damage was evident from the in-depth inspections of the airframe and flight controls requested by the helicopter manufacturer. The manufacturer reported that this was the first such event on the AS 350 that they were aware of.

Photo showing rupture at aft end of TGB actuating rod
