AAIB Bulletin

9/2019

Published 12 September 2019

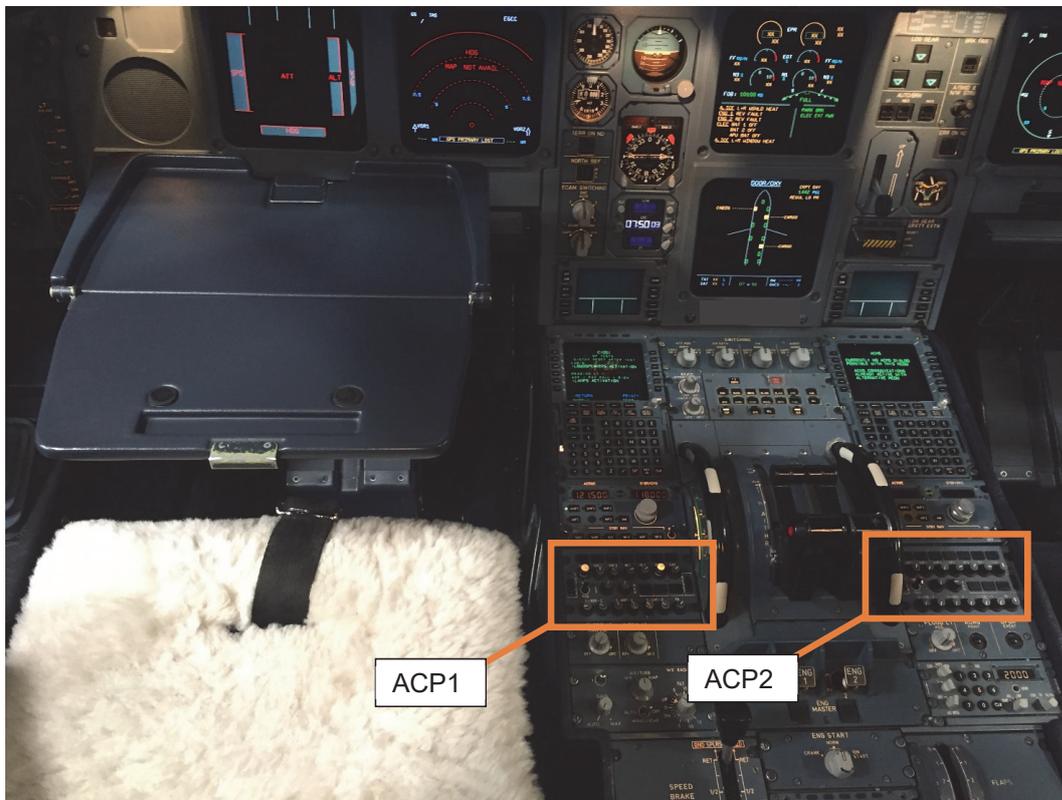
Figure 2

The commander was pilot monitoring. He put the coffee on his tray table while he completed tasks required due to approaching a waypoint. At approximately 1620 hrs, the cup was knocked over. Most of the liquid fell onto the commander's lap and a small amount spilled onto the commander's ACP (ACP1, see Figure 2).

The coffee on the centre console was dried quickly but resulted in immediate malfunction of ACP1 that affected VHF transmissions and public address announcements from this unit. The crew attempted to isolate ACP1 but it was not possible to do this from the flight deck. Subsequently, at approximately 1700, the ACP1 unit became very hot and failed and there was an electrical burning smell in the cockpit.

At approximately 1720 hrs, approaching N5600.0 W03000.0, the audio control panel on the co-pilot's side (ACP2) became hot enough to start melting one of its buttons, and failed. A small amount of smoke was observed coming from the ACP1. The commander decided to divert to Shannon, Republic of Ireland. During the diversion, the flight crew alternately used supplementary oxygen, with one pilot on oxygen at all times.

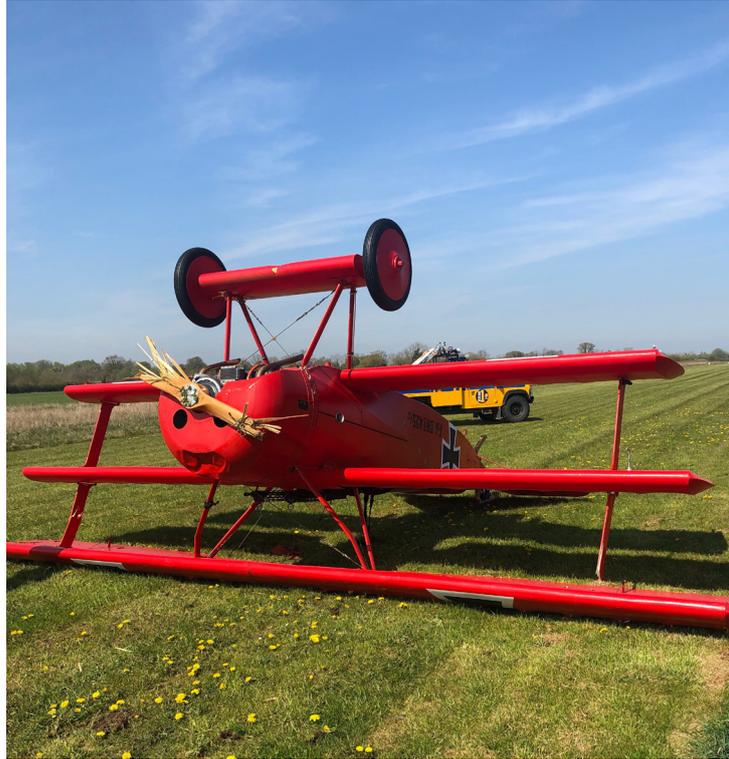
Figure 2
G-DREI inverted on Runway 02

The accident occurred because the aircraft started its takeoff roll on the right side of Runway 02 and collided with an edge marker. The limited forward visibility from the tri-plane meant that the pilot could not see the edge markers.

The air/ground operator had tried to assist the pilot in aligning with Runway 07 but this advice had been misinterpreted by the pilot. He thought he was advised to move to the right side of the runway. This confusion resulted in the pilot aligning with the edge of the runway.

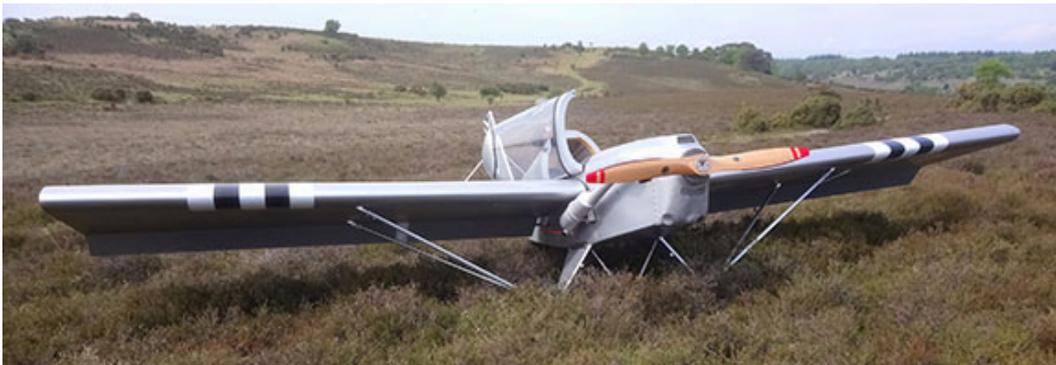
Figure 2

Having rolled out into the light north-north-easterly breeze the pilot reduced speed and achieved a gentle touchdown. As G-BZOR came to a halt its front axle fouled in heather and the aircraft tipped forwards, resulting in minor damage to the airframe (Figure 2) and a brake cable.
