<b>Aircraft Type and Registration:</b>	Boeing 737-4Q8, G-JMCR	
<b>No &amp; Type of Engines:</b>	2 CFM56-3C1 turbofan engines	
<b>Year of Manufacture:</b>	1992 (Serial no: 25372)	
<b>Date &amp; Time (UTC):</b>	12 October 2018 at 0155 hrs	
<b>Location:</b>	En-route to East Midlands Airport	
<b>Type of Flight:</b>	Commercial Air Transport (Cargo)	
<b>Persons on Board:</b>	Crew - 2	Passengers - None
<b>Injuries:</b>	Crew - None	Passengers - N/A
<b>Nature of Damage:</b>	None reported	
<b>Commander's Licence:</b>	Airline Transport Pilot's Licence	
<b>Commander's Age:</b>	50 years	
<b>Commander's Flying Experience:</b>	8,418 hours (of which 6,314 were on type) Last 90 days - 112 hours Last 28 days - 46 hours	
<b>Information Source:</b>	AAIB Field Investigation

The aircraft was operating a night flight to East Midlands Airport, with the left engine generator disconnected, and had just commenced its descent when the crew faced an unusual array of electrical failures on the flight deck. Despite the loss and degradation of a number of systems, the aircraft landed safely at East Midlands.

The electrical failures were caused by the right engine Generator Control Unit (GCU) which had been inco

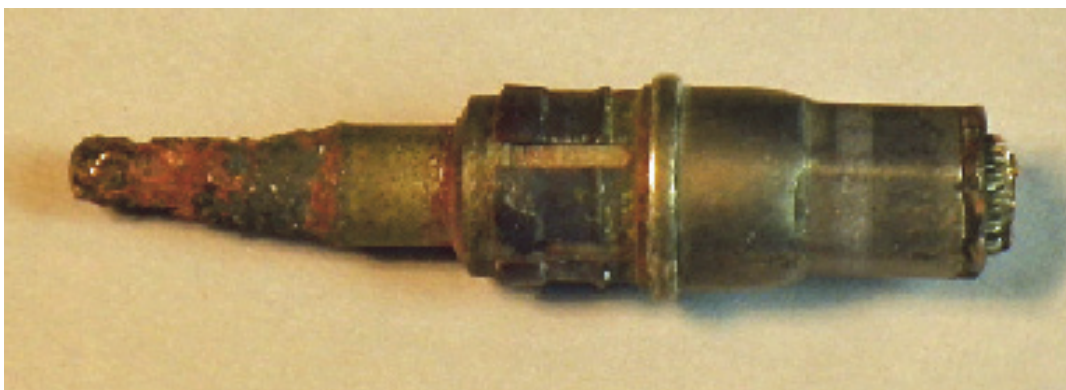
**Figure 4**

The fault in the left engine electrical generation system was traced to an open phase on one of the three power feeder cables that run from Gen 1 to its generator circuit breaker. The cause of the open phase was a burnt pin on connector C at the wing / pylon disconnect (Figure 4 and 5). The operator reported that there was no evidence of arcing between the pin and either the adjacent pins or the body of the connector; both the socket and pin appeared to be formed correctly at the crimp. Due to the extensive damage to the pin, it was not possible to establish the cause of the damage.

Burnt pin from connector C

The aircraft manufacturer advised that previous occurrences of burnt pins had usually been caused by the connector having not been correctly torqued, or because the wire spacer was missing, which created excessive load on the connector pins. When incorrectly torqued, vibration can cause the connector shell to move in relation to the receptacle connector shell. Relative motion between the connector shells would allow similar motion between the pin and socket contacts. This promotes wear and fretting corrosion that degrades the pin to socket contact interface, resulting in increased resistance and a rise in temperature. The aircraft manufacturer issued a Service Letter<sup>6</sup> to operators with suggested actions to ensure the best possible connection of these pins and connectors. This was a known problem.

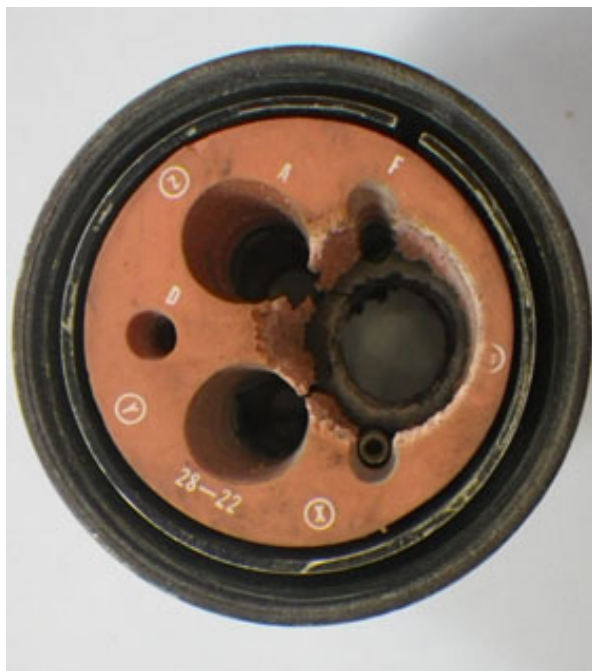
**Figure 5**

Burnt pin receptacle at connector C

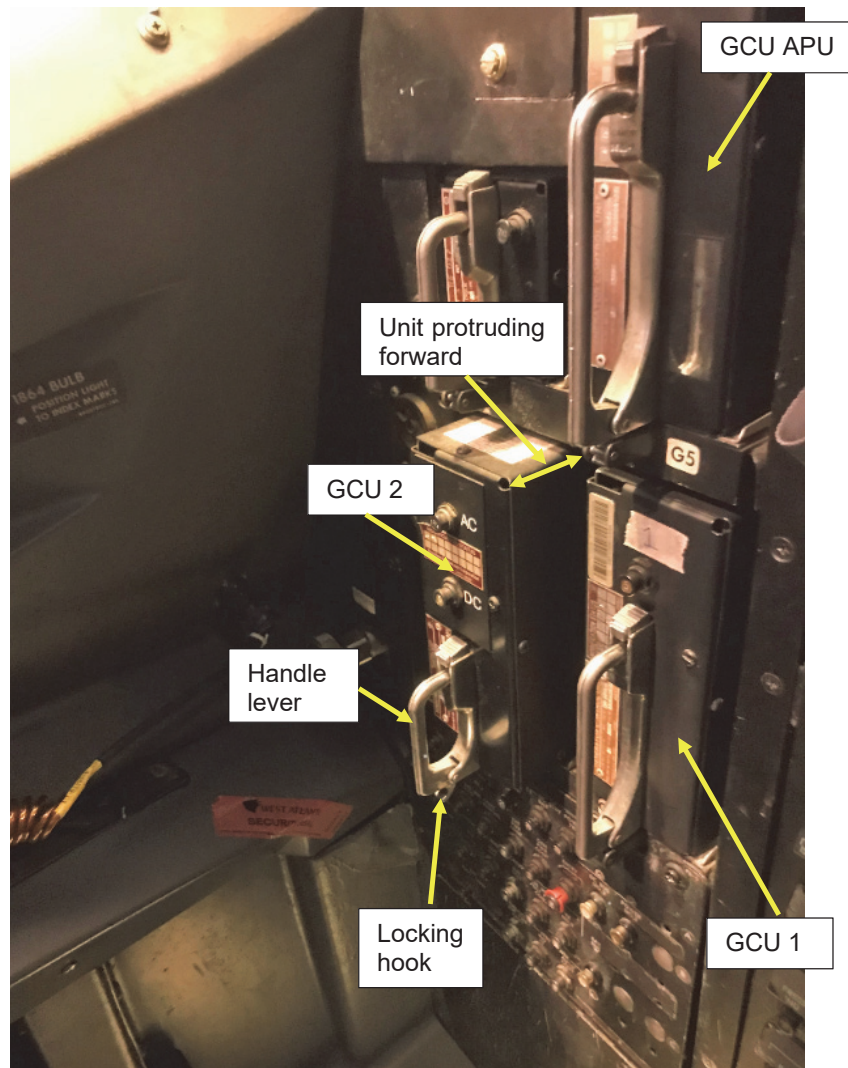
**Figure 6**

After the incident flight, GCU 2 was found to be protruding from the equipment shelf by approximately 3 cm. This would have been sufficient for the contacts at the rear of the electrical unit to disengage with the contacts in the shelf (Figure 6). The handle lever, which was in the locked position, was found to be serviceable and the locking hook and fork intact. There was no visible damage to the electrical shelf, tray or its connectors. The electrical unit was re-racked and the right engine electrical generating system was tested and found to be serviceable.

GCU 2 protruding forward

The electrical failures that occurred during the landing at Amsterdam and on the subsequent flight to East Midlands were caused by GCU 2 moving forward in its rack far enough to cause the electrical connectors to disconnect. The flickering lights and screens indicate that initially there was a partial connection that was intermittent, but on landing at East Midlands the GCU appears to have moved forward sufficiently for the connector to fully disconnect. This would have resulted in the loss of: Gen 2; Gen Bus 2; Transfer Bus 2; 115V AC Electronic Bus 2; 28V DC Bus 2; and 28V DC Electronic Bus 2. Electrical System 1 would still have been powered by the APU generator through Gen Bus 1.

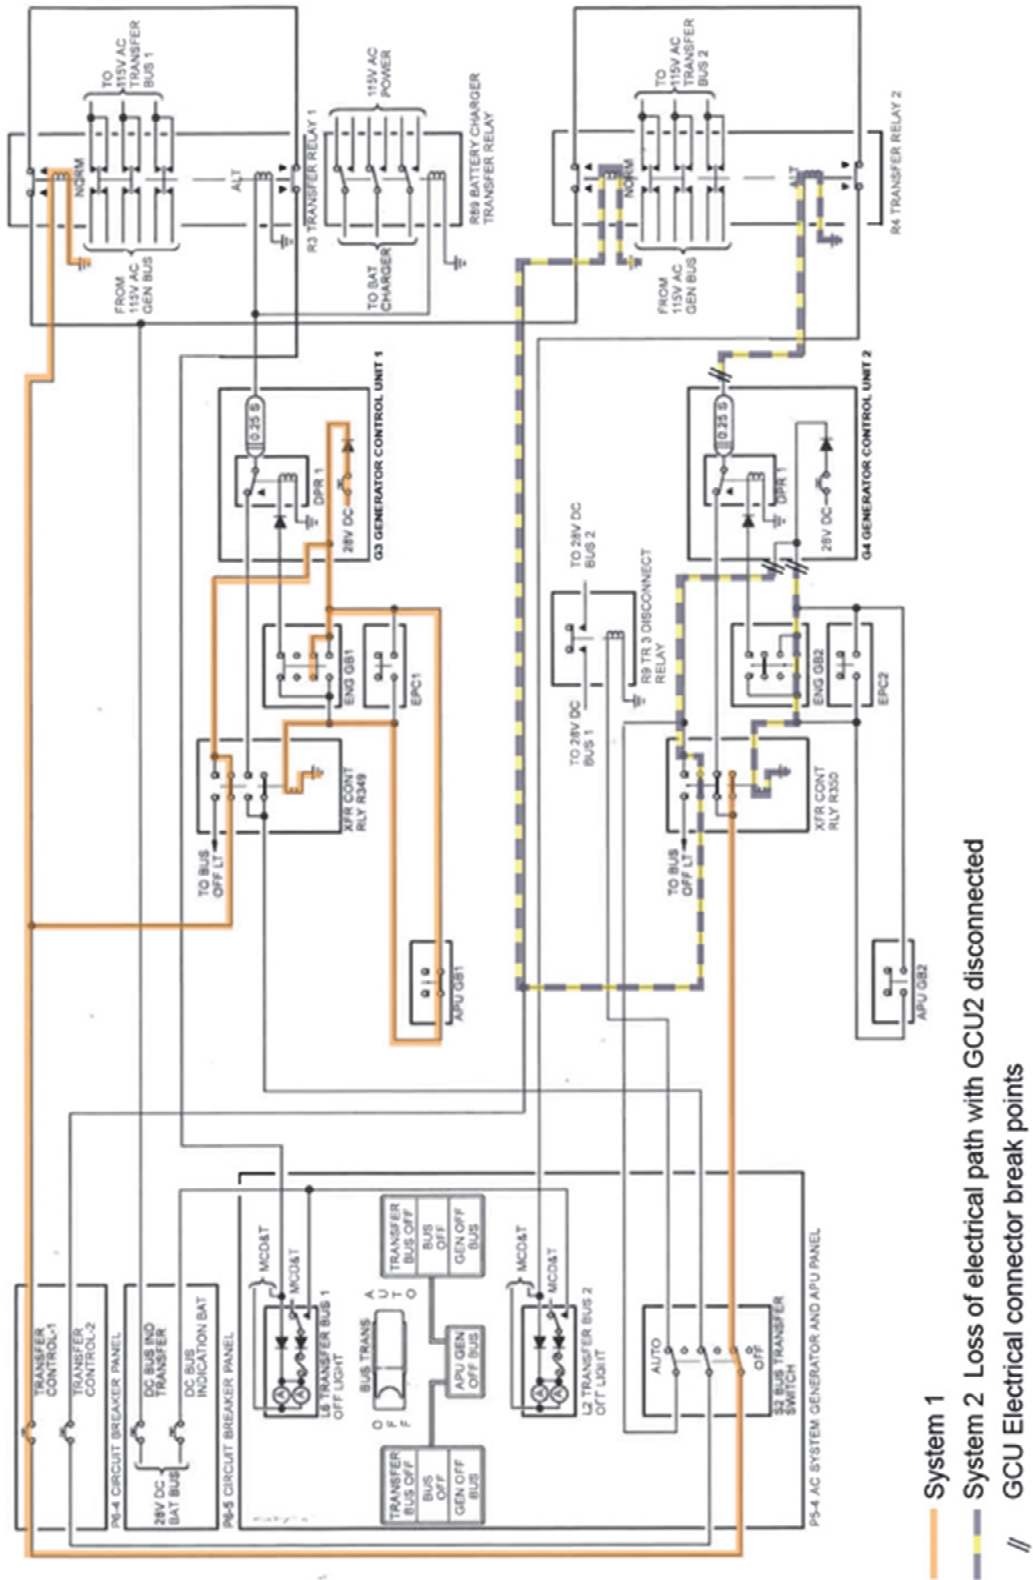
Figure 8

Routing for electrical pwr after disconnection of GCU2

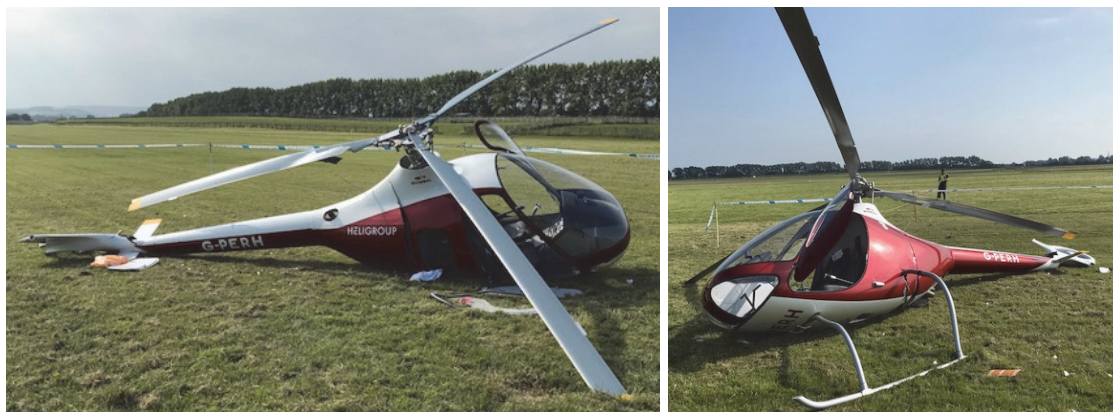
**Figure 1**

The accident site occurred in the Helicopter Training Area at Goodwood Aerodrome. The helicopter came to rest upright with the right side of the fuselage in contact with the ground and pointing in a north-east direction. The landing gear had penetrated the fuselage on the left side and the right passenger door had broken and become detached. The fenestron tail rotor had detached from the tail boom and there was evidence that two of the main rotor blades had struck the ground (Figure 1). Both landing skids had dug into the ground with no evidence of movement after contact.

G-PERH at the accident site

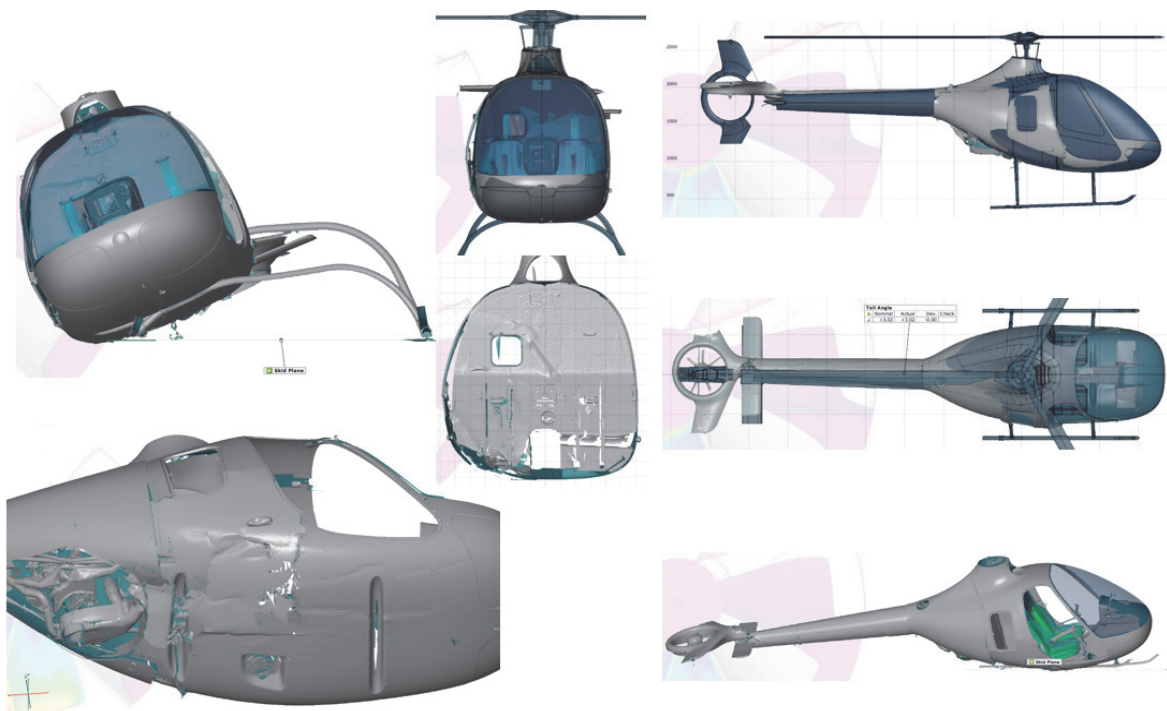
**Figure 4**

The airframe was subjected to a visual examination at the AAIB facilities to assess the damage sustained during the impact. The monocoque structure was largely intact with evidence of crushing on the aft right underside. All access panels were in place except for the luggage door and right passenger door, which was broken in two pieces. There was evidence on the underside of penetration from the landing gear bows at both mounting locations. The front landing gear bow had caused minor damage to the central console in the cabin and the aft bow had penetrated the luggage bay and the fuel tank volume. The flexible fuel tank liner had deformed around the bow without perforation and no fuel had leaked. The Fenestron had detached from the tail boom and there was impact damage to the tips of two main rotor blades.

Following the visual examination, the helicopter was digitised using a '3D' structured light scanning system to quantify the structural deformation. All exterior surfaces were scanned, as well as the landing skids, engine bay and cabin interior. The results of the scan were then compared with the original design data obtained from the helicopter manufacturer (Figure 4).

Digital analysis of G-PERH

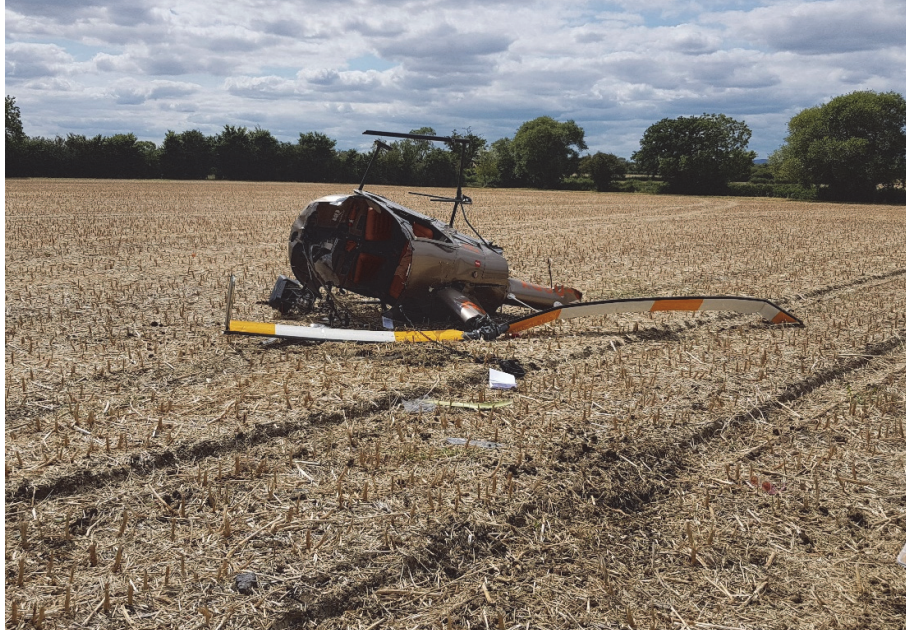
**Figure 1**

G-OODX after the accident (provided by the operator)

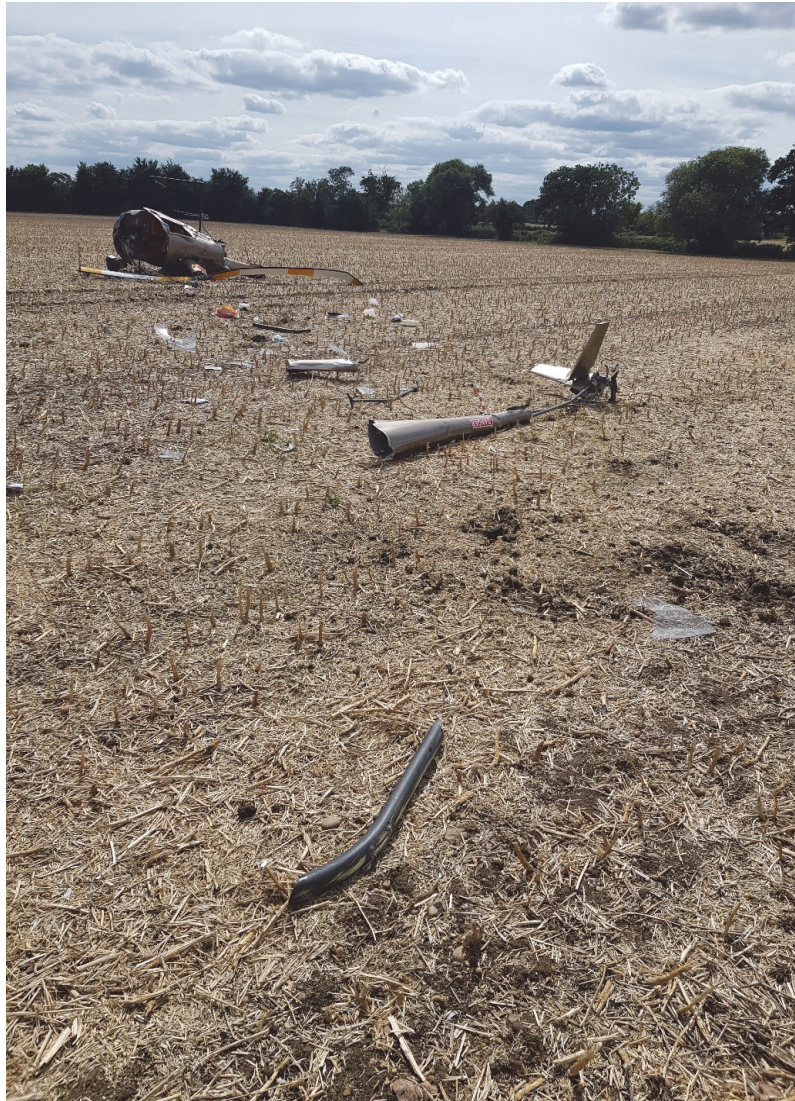
**Figure 2**

G-OODX after the accident (provided by the operator)

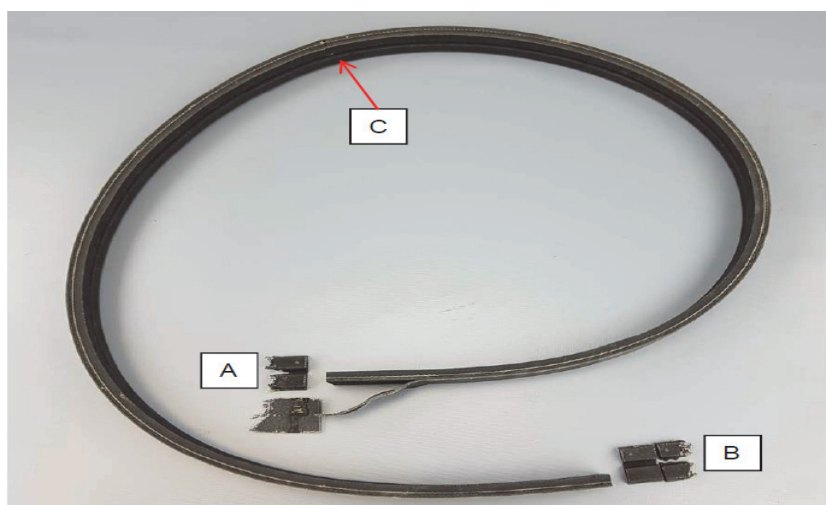
**Figure 7**

The belt found in a field sometime after the accident was examined and found to be complete but fractured (Figure 7). Although some slight wear was identified within the v-groove, there was no evidence that the belt was running other than correctly on both the engine drive pulley and the driven pulley on the tail rotor drive shaft. No damage or witness marks were visible on the running surfaces of the belt. There was similarly no evidence that the strength of the belt was significantly reduced. Evidence suggested that the failure was one of simple tensile overload.

Damaged belt with fractured ends detached for analysis

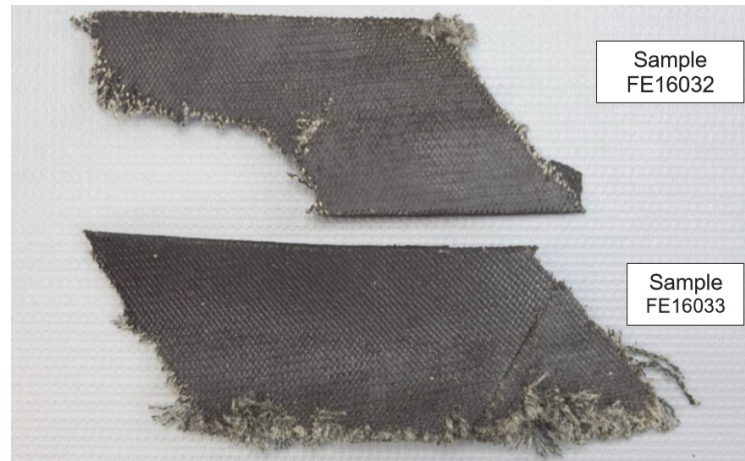
**Figure 8**  
Belt fragments

The fragments of the other belt found with the helicopter wreckage, represented small lengths and in each case were ground away such that all the material defining the side running surfaces and the v-groove was no longer present; only the external tie band and some tensile reinforcing chords, with associated rubber matrix material, remained (Figure 8). This was consistent with the belt having been operated whilst no longer aligned in the pulleys.

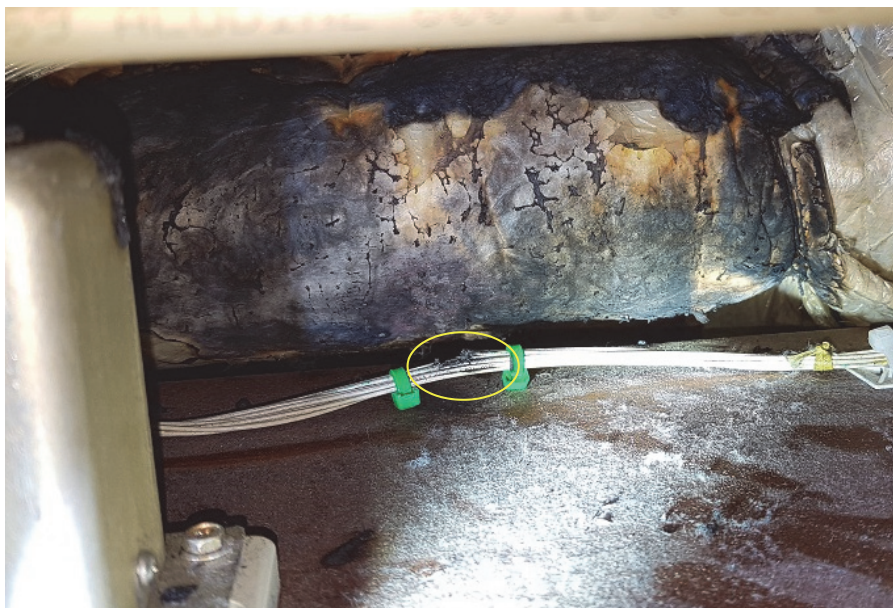
**Figure 1**

One of the passengers on the flight reported that they had seen a momentary flash above the overhead ceiling panels near Row 20. The operator carried out an examination of the area and identified the source of the smoke and haze. Wiring in the cabin ceiling lighting harness above Row 19/20 on the left side showed evidence of electrical arcing and heat damage. There was also soot on the insulation surrounding a section of wiring, as shown in Figure 1.

Damage to the wiring harness and surrounding material

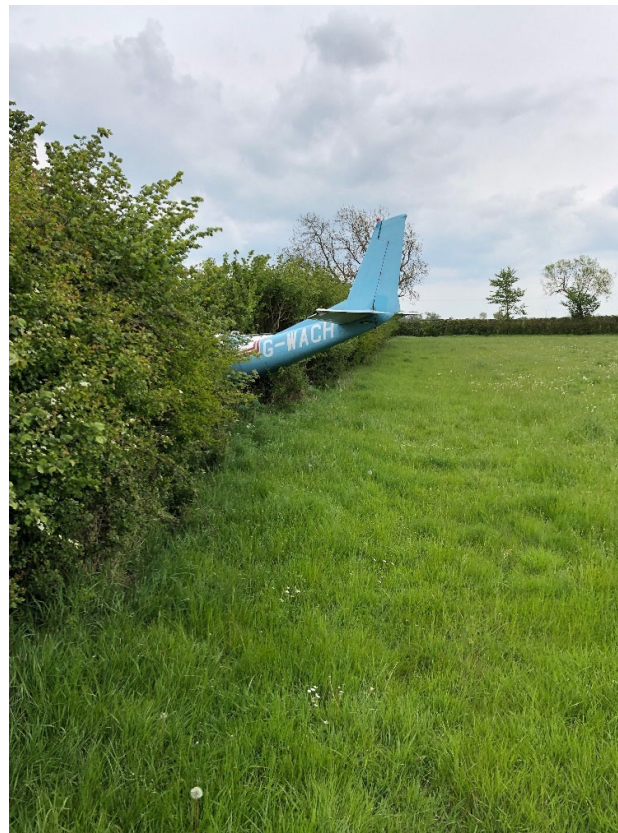
After avoiding telegraph wires in the selected field, the instructor carried out an uneventful touchdown. Despite applying braking, its effectiveness was limited by damp grass and he was unable to stop the aircraft before it struck the perimeter hedge and a concealed ditch (Figure 1) at low speed. Both occupants were uninjured and exited the aircraft without assistance.

**Figure 1**  
G-WACH after coming to rest

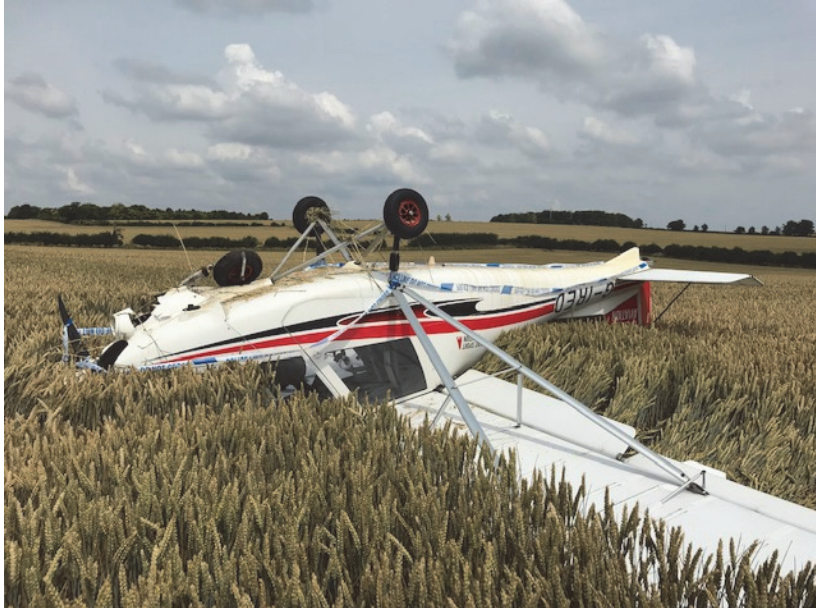
The aircraft was being flown from Clench Common Airfield (near Marlborough) back to its home base at Deanland Airfield after engine maintenance. The pilot carried out a five minute engine run and completed preparations for takeoff during which everything was normal. Approximately 16 minutes after takeoff the pilot observed the engine oil pressure fall to zero on the gauge. The pilot informed ATC of his intention to divert to Popham Airfield. After a further 30 to 45 seconds the engine abruptly stopped, and the pilot carried out a forced landing in a wheat field. During the landing the aircraft nosed over and came to rest inverted as shown in Figure 1. The pilot vacated the upturned aircraft uninjured.

**Figure 1**  
G-IRED accident site

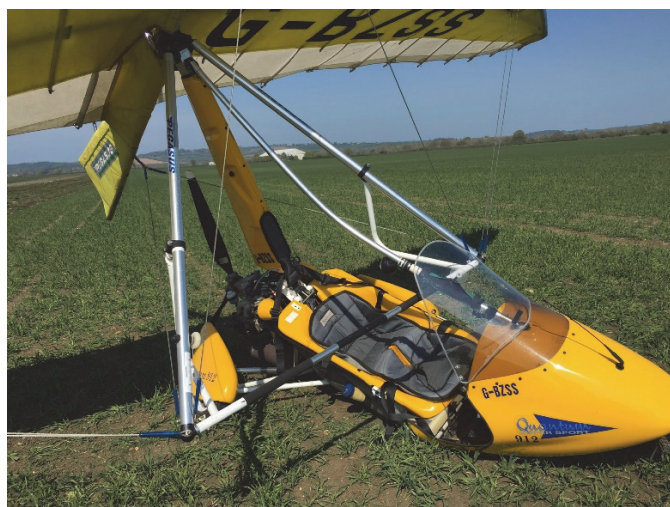
**Figure 1**

During the approach to Holmbeck Farm Airfield, the aircraft encountered 'sink' on final approach. The pilot was unable to arrest the high rate of descent despite adding power and flaring. The aircraft made a hard landing that caused substantial damage; including to its base tube, front strut, right main and nose landing gear, Figures 1 and 2. This damage resulted in the foot throttle becoming jammed at a high power setting.

Damage including bent front strut and displaced right main landing gear

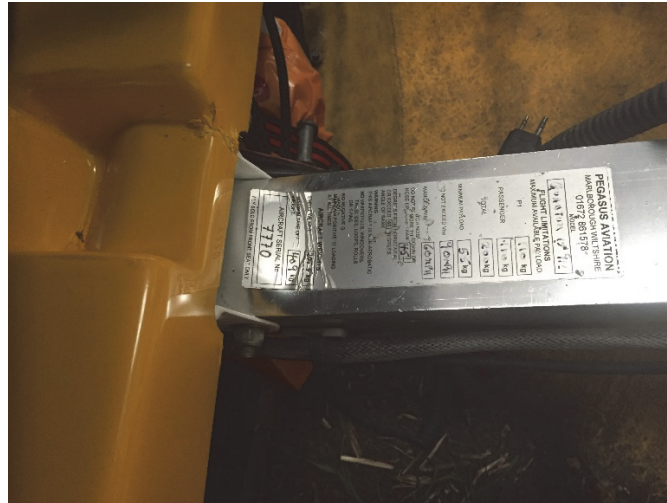
**Figure 2**  
Damage to base tube
