Published 14 November 2019

Aircraft Type and Registration:	Luton LA4A Minor, G-AWMN	
No & Type of Engines:	1 Volkswagen 1800 piston engine	
Year of Manufacture:	1987 (Serial no: PFA 827)	
Date & Time (UTC):	3 February 2019 at 1145 hrs	
Location:	Near Belchamp Walter, Essex	
Type of Flight:	Private	
Persons on Board:	Crew - 1	Passengers - None
Injuries:	Crew - 1 (Fatal)	Passengers - N/A
Nature of Damage:	Aircraft destroyed	
Commander's Licence:	UK Private Pilot's Licence	
Commander's Age:	55	
Commander's Flying Experience:	317 hours (of which 150 were on type) Last 90 days - n/k Last 28 days - n/k	
Information Source:	AAIB Field Investigation

The pilot was conducting a test flight in G-AWMN to renew the aircraft's Permit to Fly. Whilst climbing away from the runway, the aircraft was observed to bank to the right and then descend steeply to the ground.

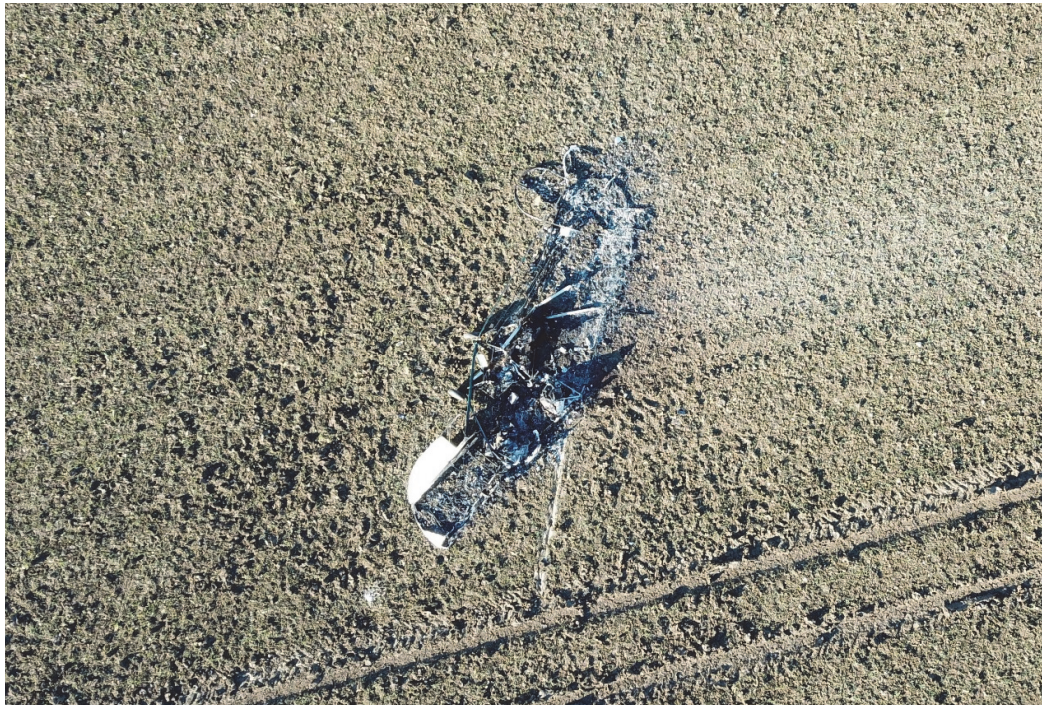
Figure 3
Accident site

The aircraft crashed in a harvested arable field close to the extended centreline of the landing strip from which it had departed (Figure 3). The surface of the field was bare earth which was extremely soft and wet. Activity of emergency services had disrupted the surface around the wreckage and obscured some impact marks.

The engine was partly buried by the force of the impact, but its final orientation was consistent with the aircraft having descended steeply nose-down with the left wing hitting the ground just before the right wing. An intense post-impact fire had destroyed almost all the wooden structure, leaving only the extreme outboard section of the right wing and aileron unburnt. There was no evidence of impact damage in these unburnt areas. Charred remains of curved wooden members indicated that the tail-plane, rudder and elevators were present at the site but nothing identifiable as the wooden structure of the fuselage or of the left wing survived the fire. Numerous metallic components did survive including the highly disrupted fuel tank and various steel struts, brackets, hinges, bracing wires and control cables. The aluminium alloy cowling panels were severely disrupted and fire-damaged; a number of molten lumps of aluminium alloy were found at the scene.

One lightly damaged propeller blade protruded visibly upwards from the engine to which it was still attached, whereas the other blade, recovered from underneath the engine, had broken off at the root.

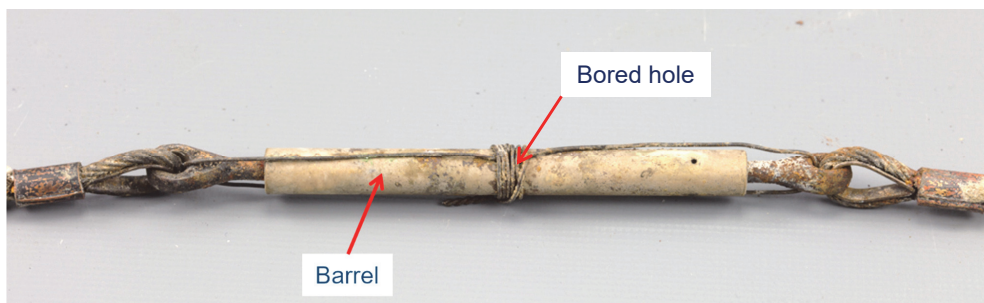
Figure 6

A typical turnbuckle recovered from G-AWMN

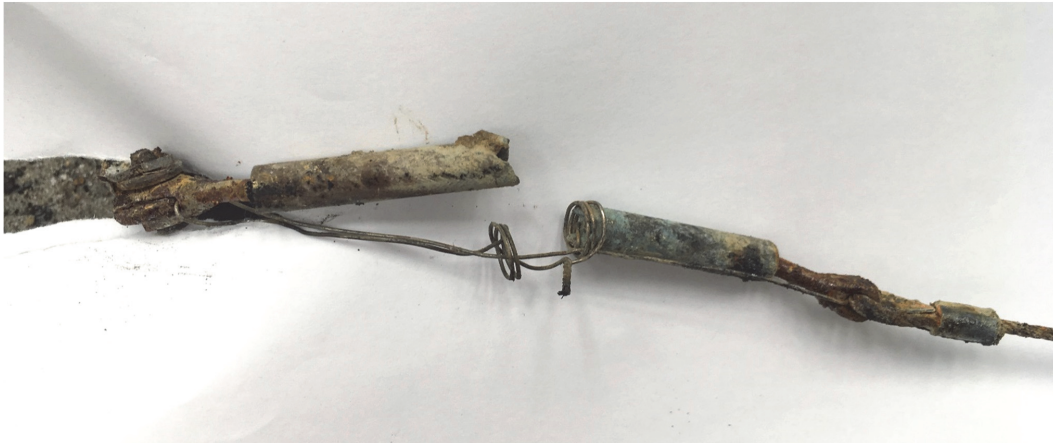
Figure 7

The cables for the flying controls were severely disordered and only two of the many pulleys had survived the fire. The rudder control cables were identified as being complete from the rudder bar in the cockpit to the rudder bell crank, which is normally attached directly to the rudder. It was noted, however, that a turnbuckle barrel had fractured at mid-length (across the bored hole) but the turnbuckle remained capable of transmitting force as a result of the wire locking remaining intact (Figure 7).

column to the elevator. The barrel had fractured as a result of bending and was severely affected by heat; all features which are consistent with impact and the effects of the post-impact fire.

Fractured barrel in a rudder flying control turnbuckle

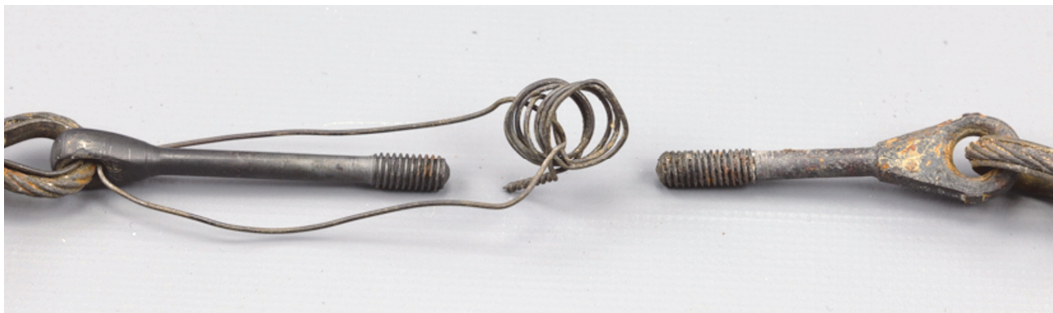
Figure 8

Examination of the roll control system revealed that, for the turnbuckle on the aileron balance cable, both eye-bolts and most of the locking wire was present but the barrel was absent (Figure 8).

Aileron balance turnbuckle (barrel missing)

Neither threaded eye-bolt showed evidence of significant oxidation, and thus appear not to have been overheated. Lubricating grease was found on both threads but there were no traces of any metal from the barrel. Both corresponding cable ends appeared correctly swaged. The locking wire of one eye-bolt to the missing barrel was present and attached to the eye-bolt. It appeared to have been correctly routed through the hole in the now-absent barrel with multiple coils and the wire end visible where the mid-length bored hole in the barrel would have been. The portion of locking wire extending from the central hole to the other eye-bolt and back was absent. Both wire ends showed the characteristics of tensile failures and both failures were in the area where the mid-length hole in the barrel would have been.

The condition of the two eye-bolts, and in particular the absence of the significant oxidation seen on components of other turnbuckles known to have been severely fire affected, was not consistent with this assembly having been excessively heated in the post-impact fire. The presence of lubricant grease on the threads of both eye-bolts also indicated that the assembly had not been greatly affected by the fire. Therefore, it is unlikely that the turnbuckle barrel had melted and was thus absent.

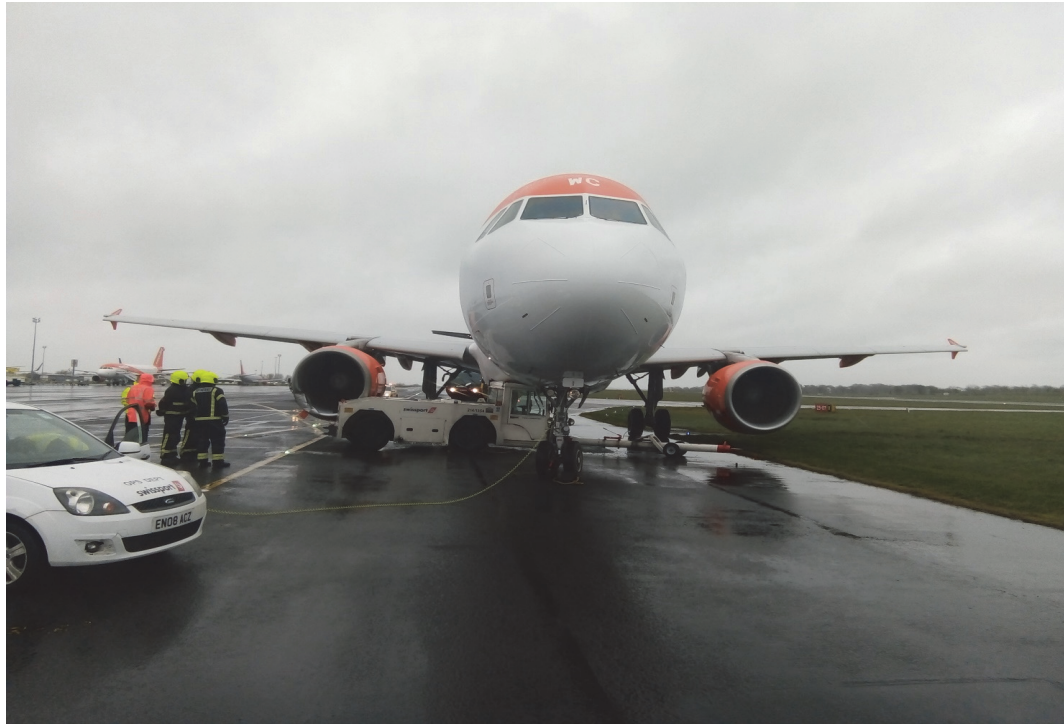
Figure 2

Both engines were started during the pushback, which appeared normal to the flight crew until, part of the way around the 90° turn to face west, the commander became aware that the aircraft was close to the edge of the apron. He questioned the situation with the member of the groundcrew on the headset and was told the situation was “ok”. The aircraft stopped at an angle to the taxiway centreline with the nose pointing towards the grass area beyond the edge of the apron. It then started to move forward which the commander thought was to align it with the taxiway centreline, but he quickly became concerned about the direction of travel, which was towards the grass, and called the groundcrew to “STOP, STOP, STOP”. There was no reply to his instruction, but he did not apply the aircraft’s wheel brakes because the operator’s SOPs prevented him from doing so while under tow (to prevent damage to the nose landing gear by the tug pushing or pulling against the aircraft brakes). Shortly afterwards the aircraft stopped, accompanied by an unfamiliar noise which was the underside of the aircraft contacting the roof of the tug cab (Figure 2).

The aircraft with the tug beneath it showing the close proximity to the edge of the apron

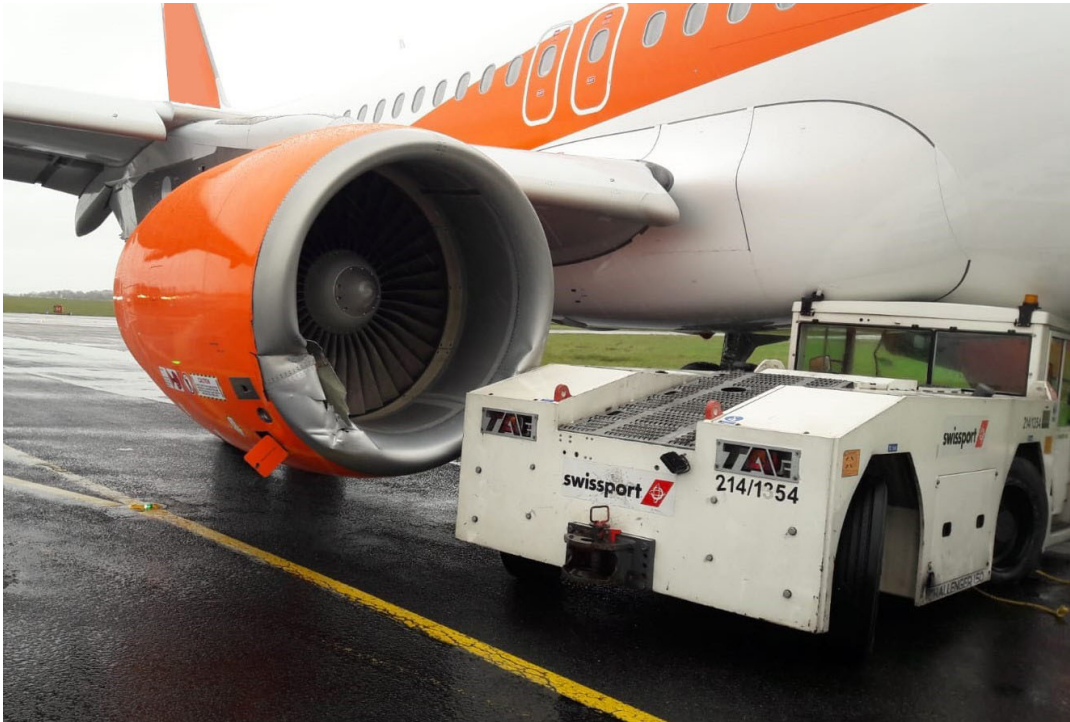
Figure 3

The damage to the right engine intake caused by the initial impact with the tug

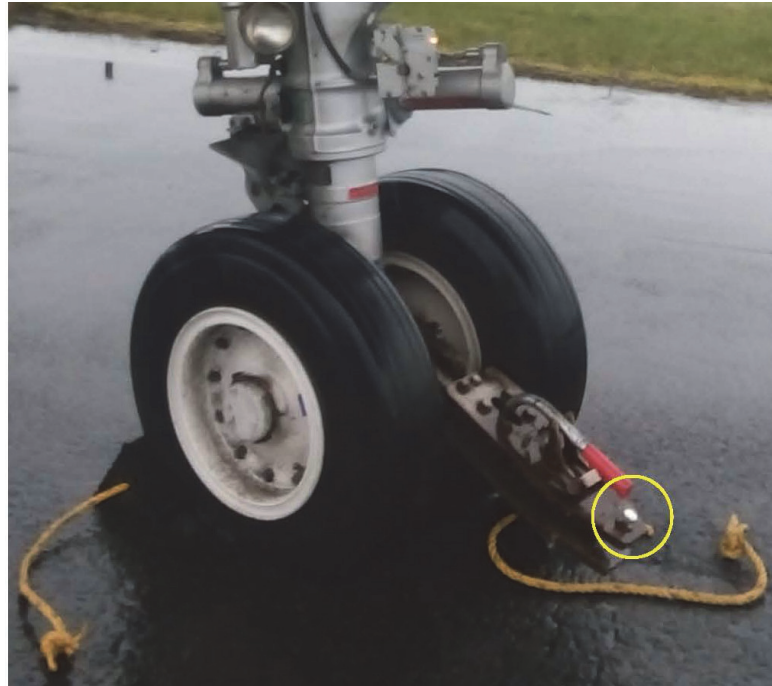
Figure 5

The tug driver attempted to correct the situation by stopping the pushback and selecting a lower gear on the tug. When the pushback was stopped, the tug was at an acute angle to the aircraft and the tow bar angle was possibly close to the 75° maximum angle to the aircraft's centreline. The aircraft, which was at idle power and facing down-slope, moved forward and, at some point, the shear pin in the tow bar failed disconnecting the tow bar and tug from the aircraft (Figure 5).

The tow bar to nose landing gear attachment unit with the shear-bolt circled

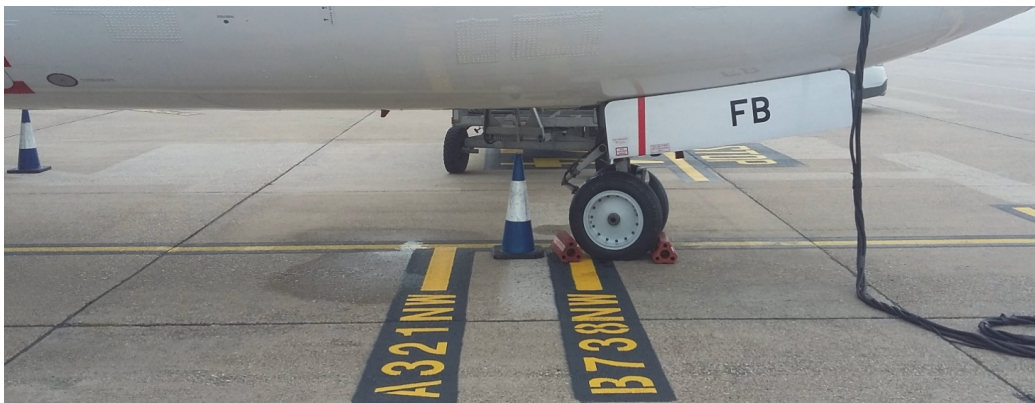
Figure 2

G-GDFB nosewheel position after the collision

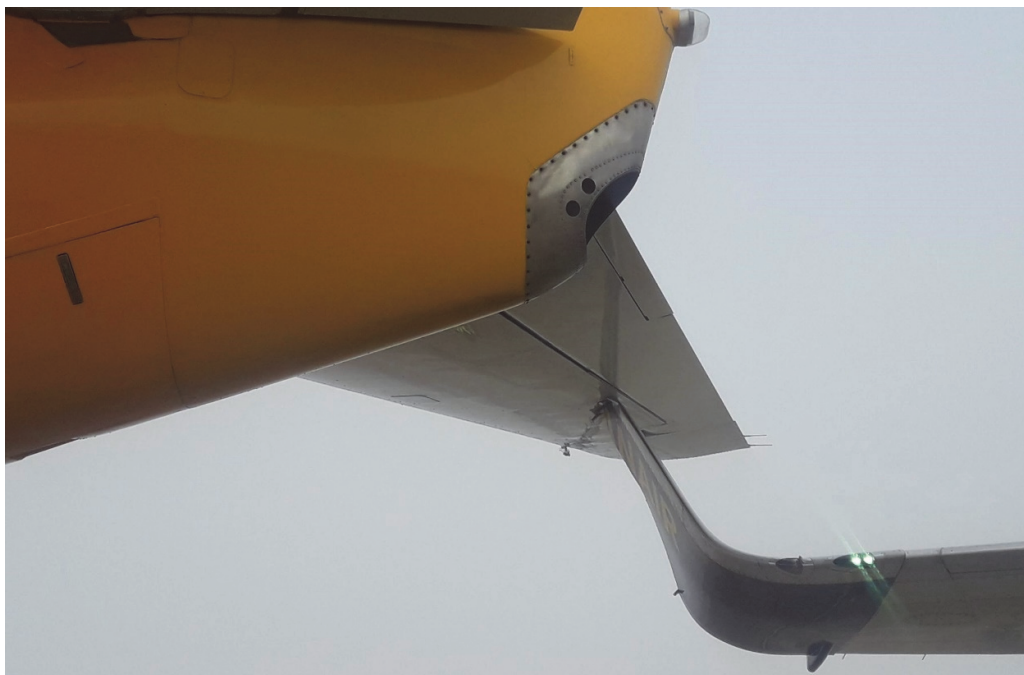
Figure 3

As EI-SEV crossed behind G-GDFB the commander brought the aircraft to a slow walking pace and the co-pilot monitored the right wing tip. From his perspective it appeared to be clear, but as they overlapped EI-SEV’s winglet struck G-GDFB’s right horizontal stabiliser (Figure 3). The commander brought the aircraft to a halt and reported the collision to ATC.

EI-SEV’s winglet in contact with right horizontal stabiliser of G-GDFB

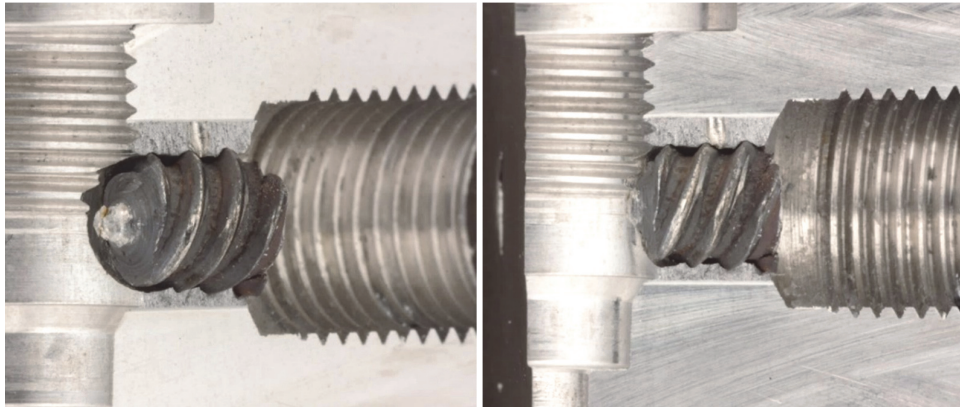
Figure 6

The regulator body was further sectioned along the axis of the port and revealed the debris to have a left-hand thread and that it had cut into the smooth bore section of the crew oxygen supply port (Figure 6). The debris was tapered and was approximately 6 mm in length.

Debris blocking port [7] (regulator sectioned)

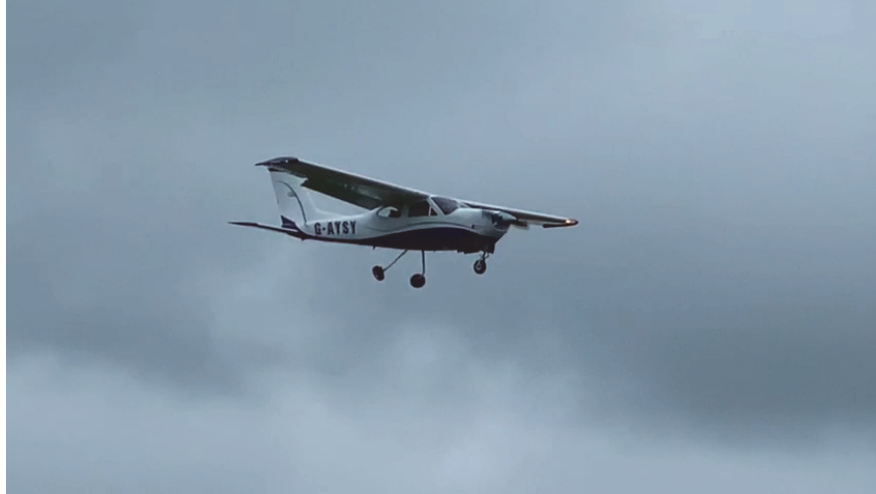
Figure 1

Leicester, he completed a low approach and go around so that people on the ground could confirm the position of the landing gear, which was seen to be hanging down but not locked, as shown in Figure 1.

Photograph showing the landing gear position

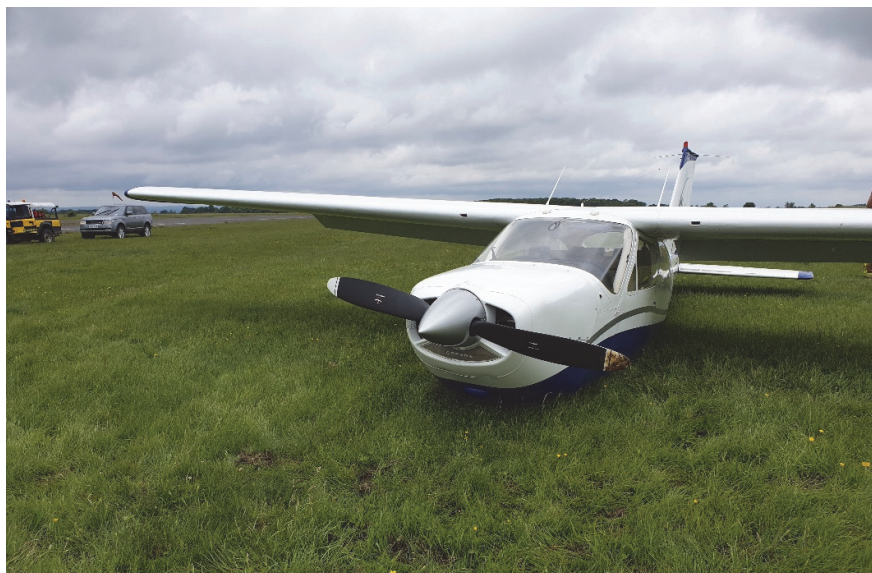
The pilot then commenced an approach to land onto grass Runway 16. At approximately 100 ft aal he shut down the engine but the propeller continued to windmill. The touchdown was smooth, but the exhaust and propeller dug into the runway bringing the aircraft to an abrupt stop. The pilot received minor injuries and was taken to hospital as a precaution. Figure 2 shows the final position of the aircraft.

Photograph showing the final position of the aircraft

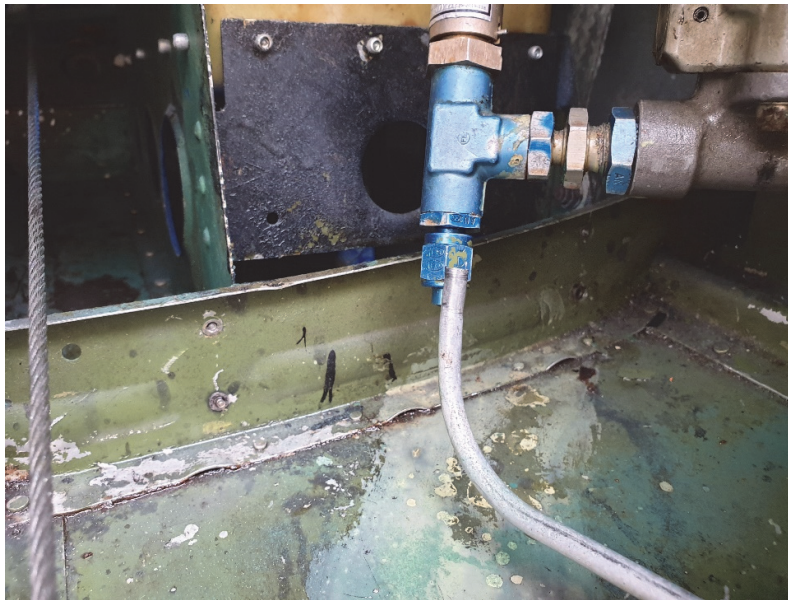
Figure 3

The aircraft was recovered to a local maintenance facility where an examination revealed that the landing gear-up pressure line had separated from its fixing, as shown in Figure 3. The hydraulic pipework is aluminium and uses flare fittings with flare nuts to attach them to the power pack.

Hydraulic line separated from its fixing
