AAIB
Air Accidents Investigation Branch

AAIB Bulletin

12/2019

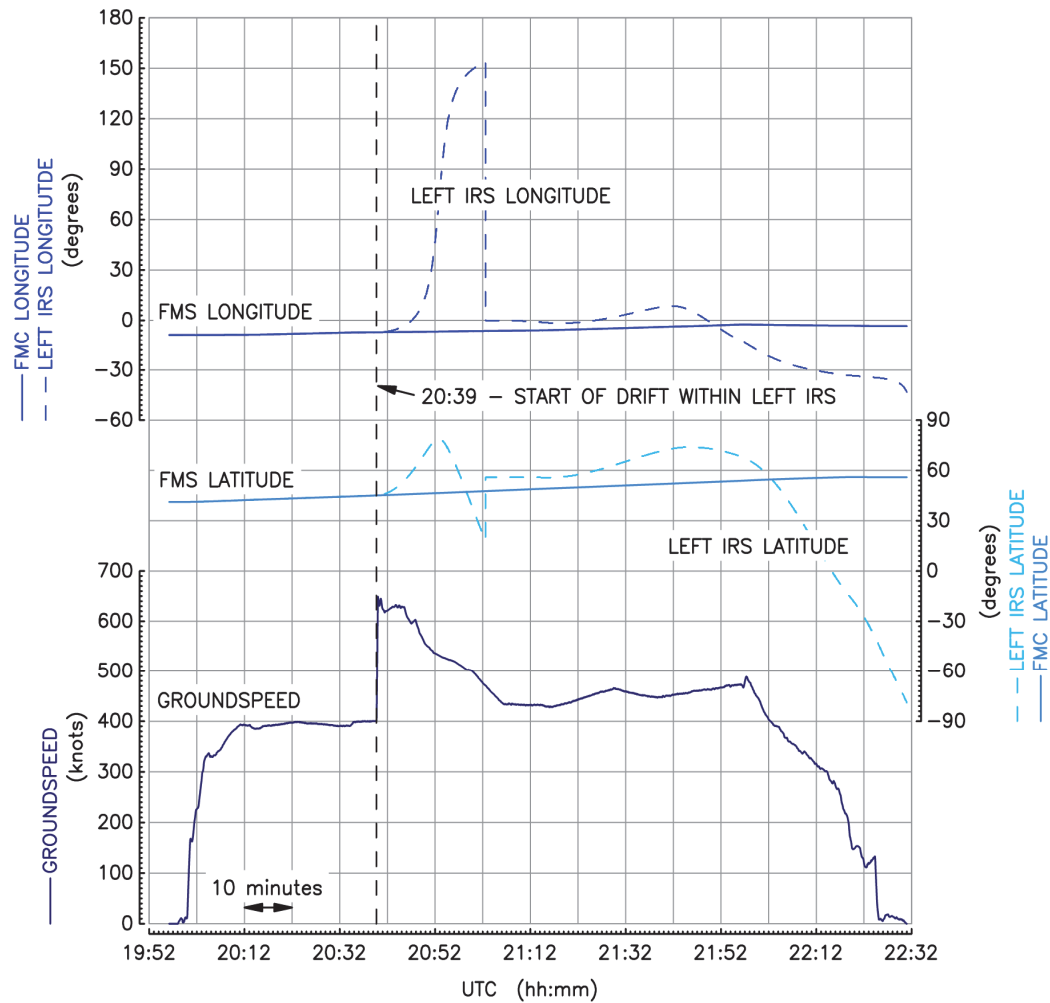
Figure 1 is a plot of the aircraft's latitude and longitude, recorded from the Flight Management Computer (FMC) and the left IRS, together with the groundspeed indicated on the commander's PFD. The figure shows that at 2039 hrs the latitude and longitude in the left IRS began to drift with a corresponding 250 kt jump in the indicated groundspeed.

Left IRS latitude and longitude drift during the flight

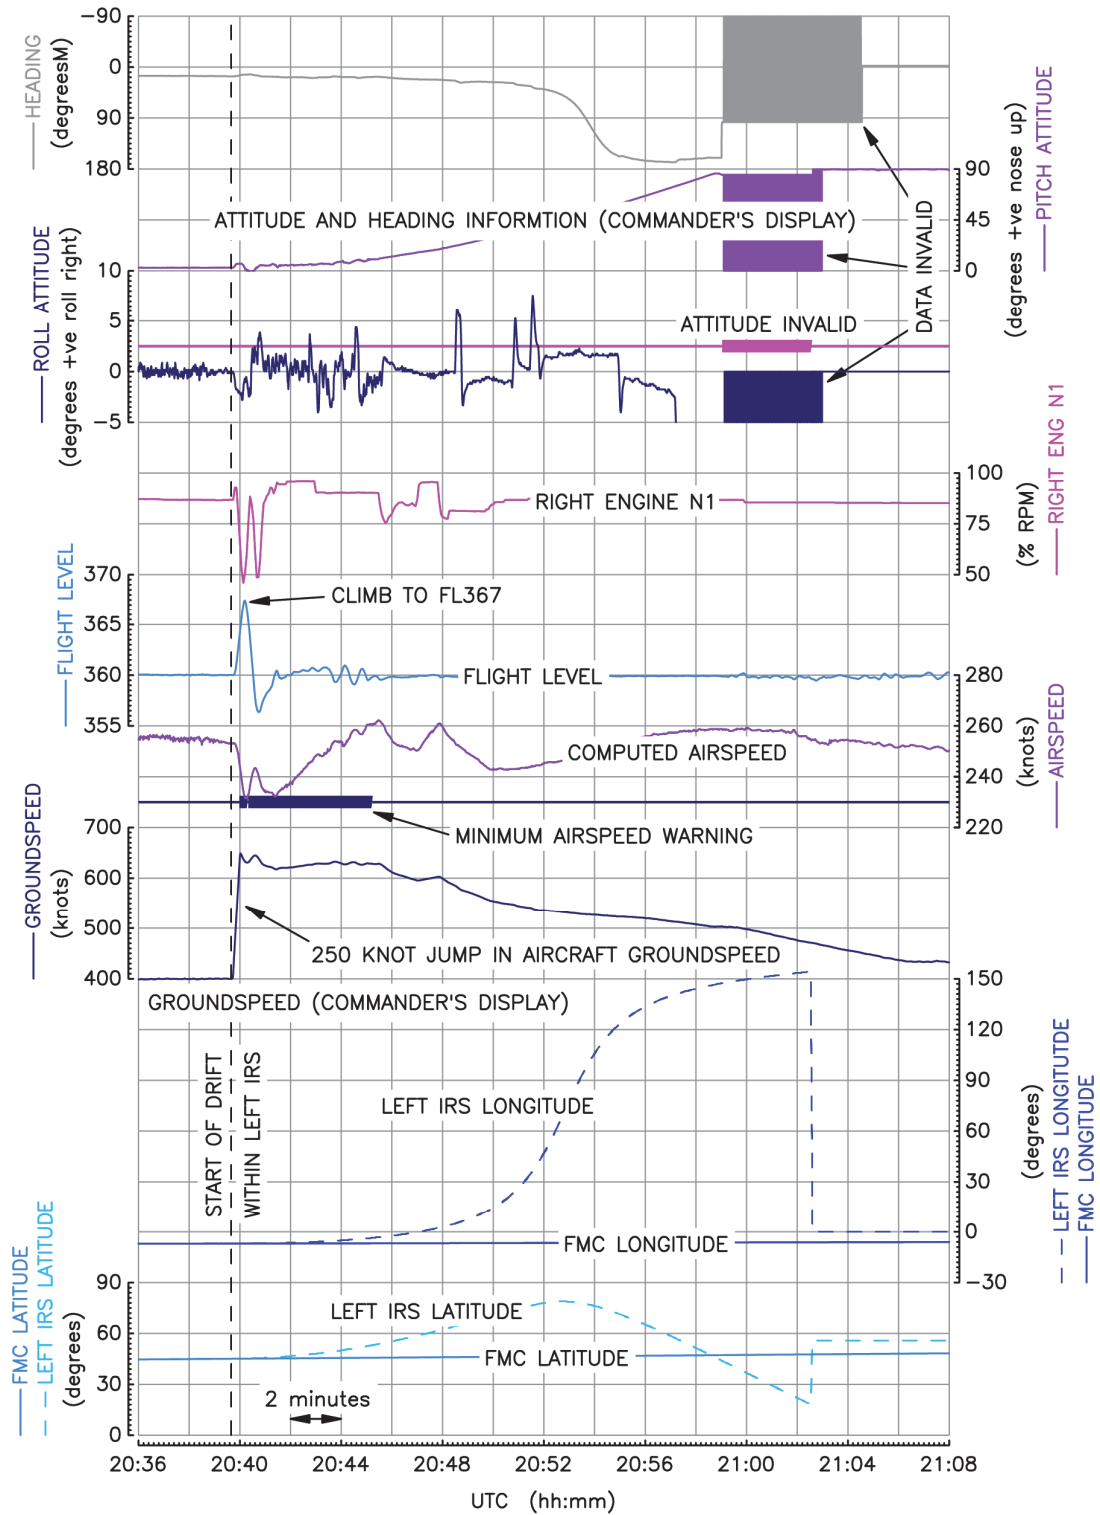
Figure 2 is a closeup of salient parameters recorded on the FDR from when the left IRS started to drift until just after the failed attitude indication was given. Highlighted in the figure shortly after the drift started are the climb to FL367 from FL360, the increase in N_1 to 95%, the pitch up, and the decrease in airspeed from about 250 kt to below 232 kt when a minimum airspeed warning was triggered. The erroneous attitude, heading and groundspeed information presented to the commander are also plotted and show the pitch attitude increasing to 90° and the heading changing by nearly 180° over a period of about 20 minutes, after which the aircraft issued an indication of invalid attitude information.

Figure 2
Salient FDR data during left IRS drift event

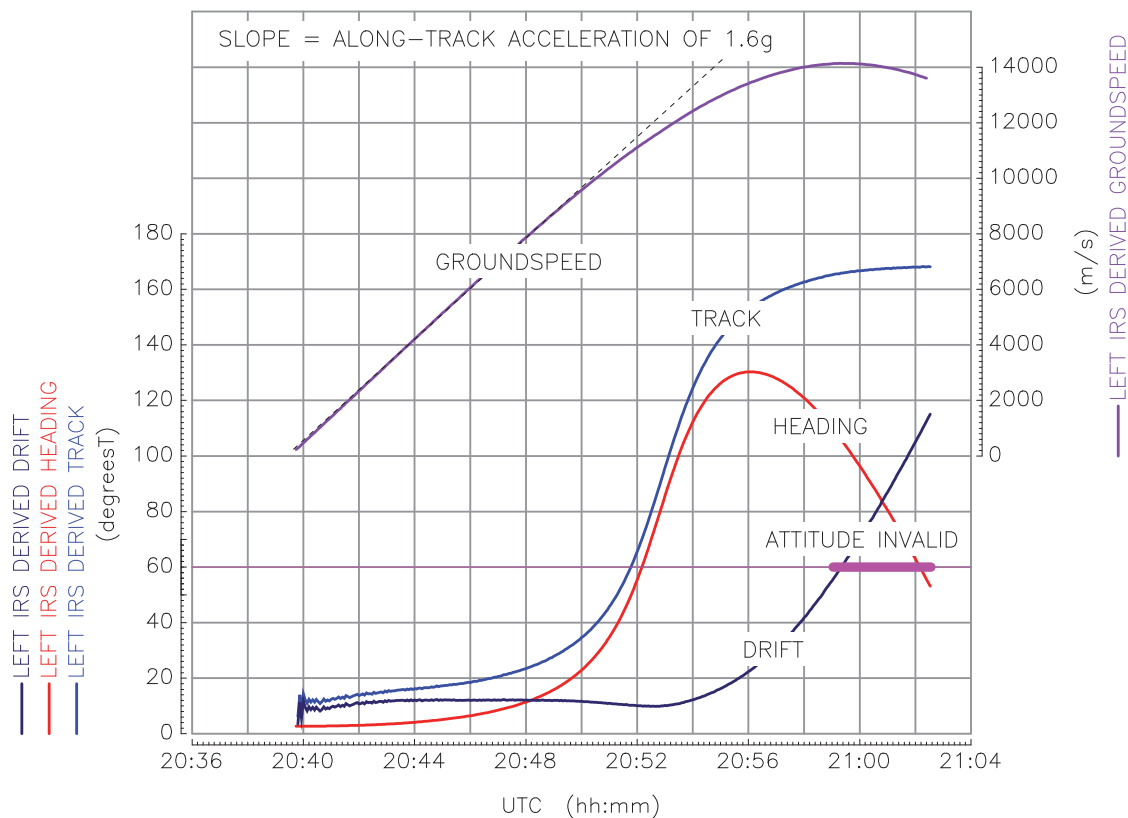
parameters are reproduced in Figure 3 and show that the drift in latitude and longitude was initially driven by an along-track acceleration of about 1.6 g. The figure also shows that when the aircraft issued an indication that the attitude information was invalid, the left IRS drift had just reached 60°.

Left IRS derived data based on its recorded latitude and longitude

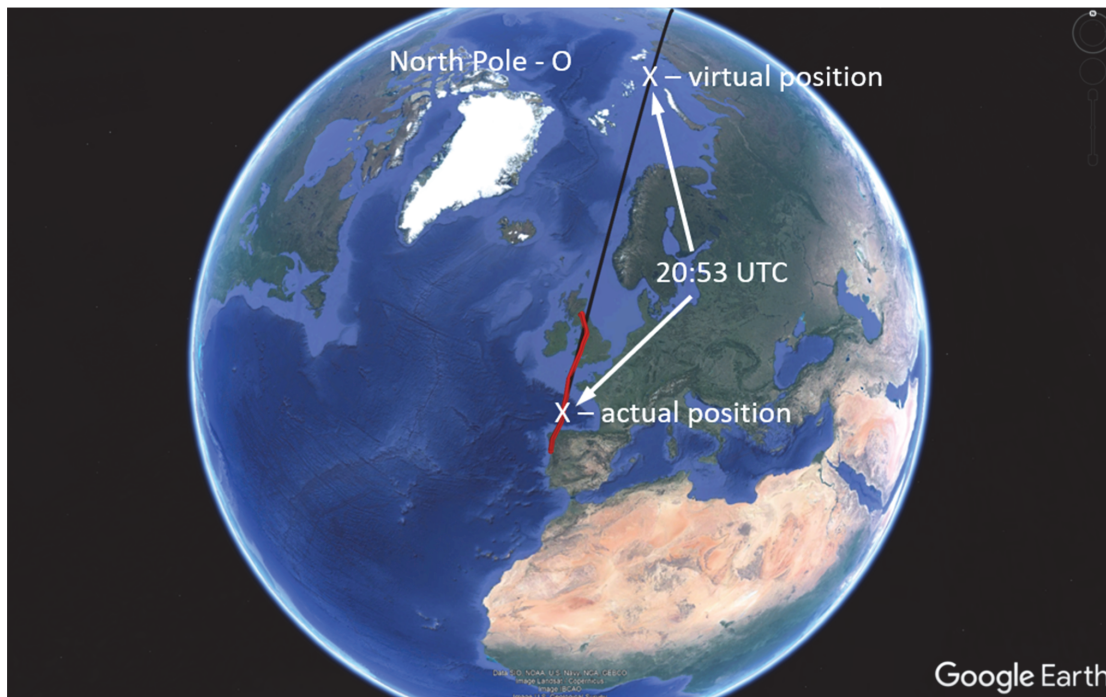
Figure 4

FMC ground track (red) and left IRS ground track (black)

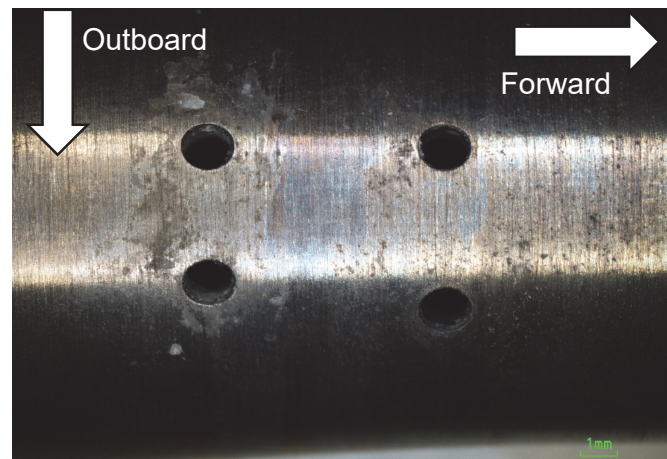
Figure 4

Under microscopic examination trace amounts of a white residue was visible around the two aft and the inboard forward static holes (Figure 4). Inside the outboard rear static hole enough residue remained to allow for a sample to be taken for chemical analysis. No holes were fully blocked. A videoscope was inserted into all the probe holes and no blockages were observed, with only trace amounts of environmental debris found.

Left pitot static probe – note white residue inside static holes

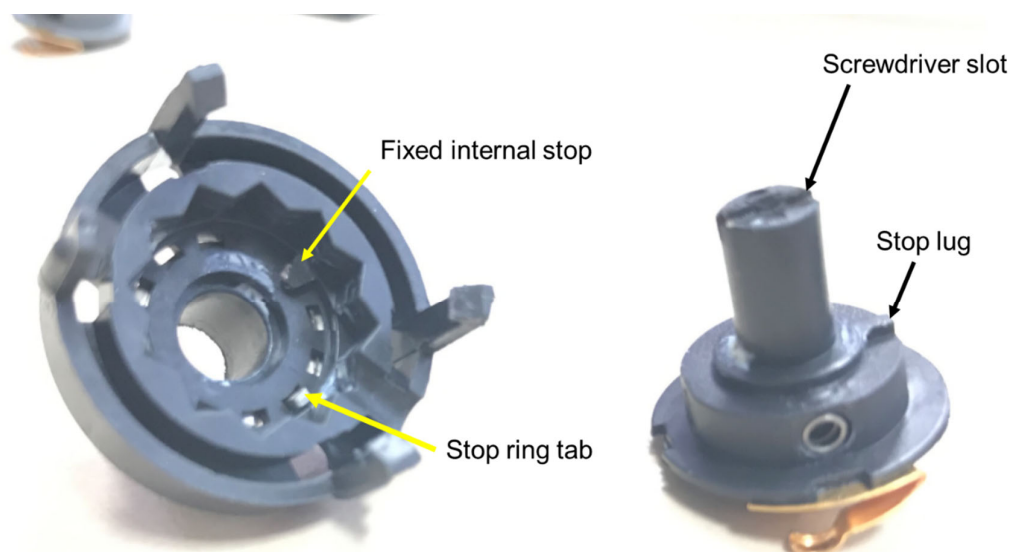
Figure 2

These effects were compared to the original adjuster removed from G-POLA. The screwdriver slot showed superficial wear and the lug on the rotating part of the adjuster was undamaged (Figure 2).

N_2 adjuster fixed casing and spindle.

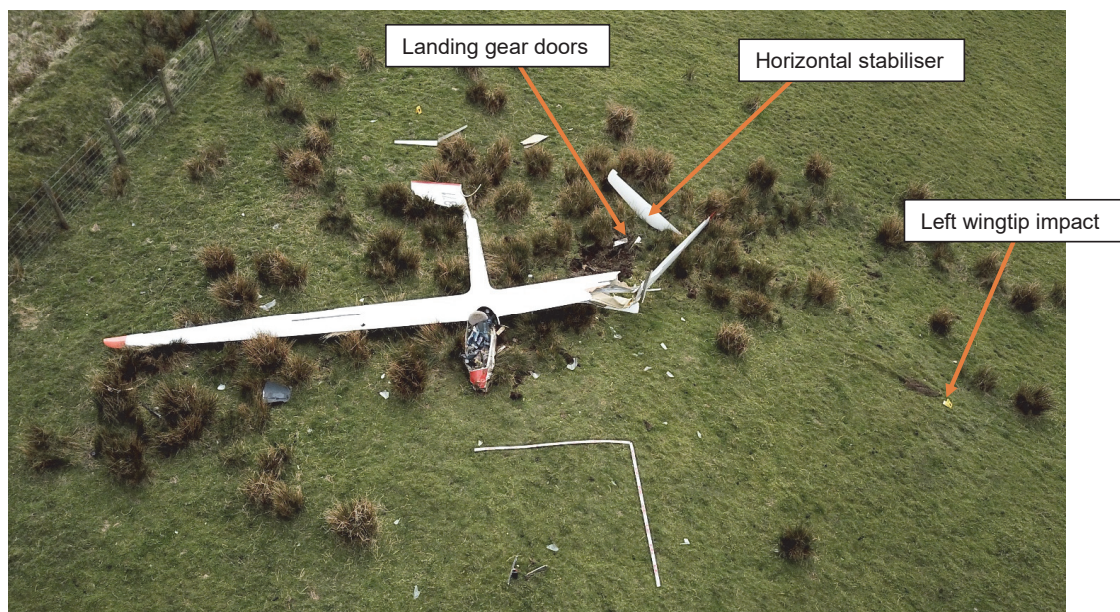
Both wings were found to be still attached to the fuselage, but the left wing was broken because of forces imparted during the accident. The glider had bounced in a counter-clockwise direction when viewed from above before coming to rest (Figure 4). The right wing was largely undamaged with the airbrake slightly deployed. The tail boom was broken, and the horizontal stabiliser and elevators had detached. Broken remnants of the canopy acrylic were found throughout the accident site. The furthest forward item was part of the canopy frame and was found approximately 16 m forward of the glider.

Figure 4
Aerial view of the accident site

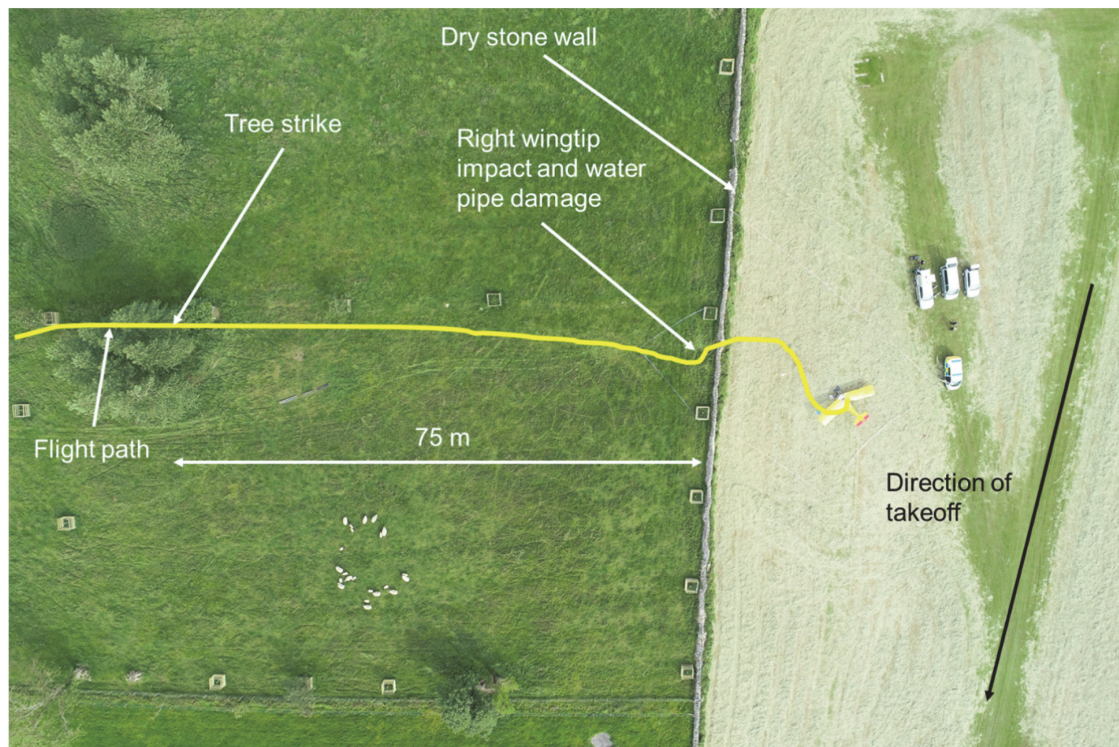
Figure 2

The aircraft then descended, striking the ground and a dry-stone wall next to the airfield. The aircraft came to rest, on the airfield side of the wall (Figure 2). The pilot was seriously injured.

Final aircraft flight path and impact points¹

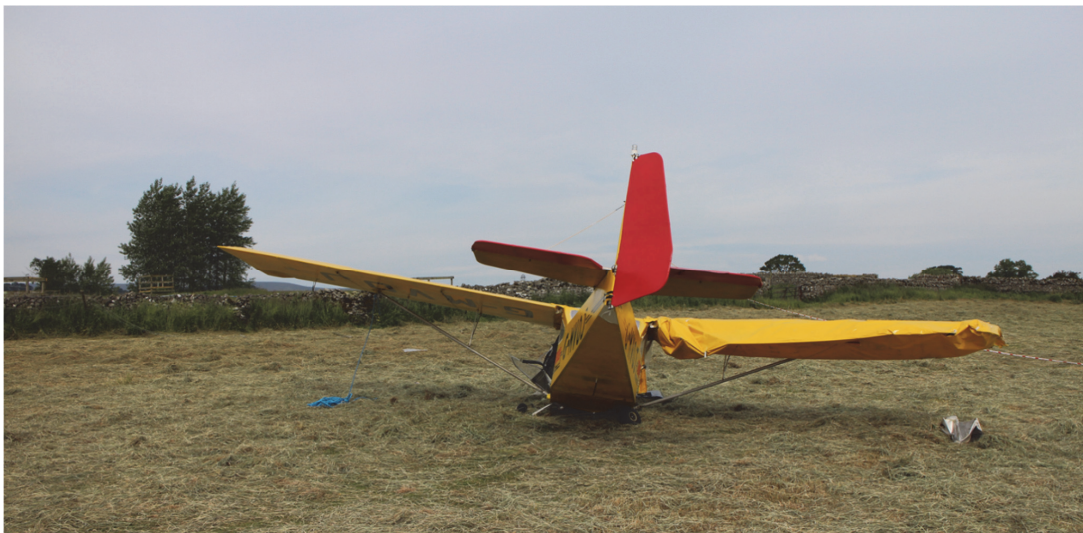
Now within the airfield boundary, the aircraft hit the ground on the right side of its nose which displaced the engine and caused significant distortion to the right side of the cockpit. The aircraft bounced, rotated about its nose and came to rest upright facing the direction from which it came. Both propeller blades had broken off from their roots and there was a loss of coolant. The right wing, although still attached, had been bent rearwards during the impact sequence. There was no fuel or oil spillage. Figure 3 shows the aircraft at the accident site.

Aircraft accident site

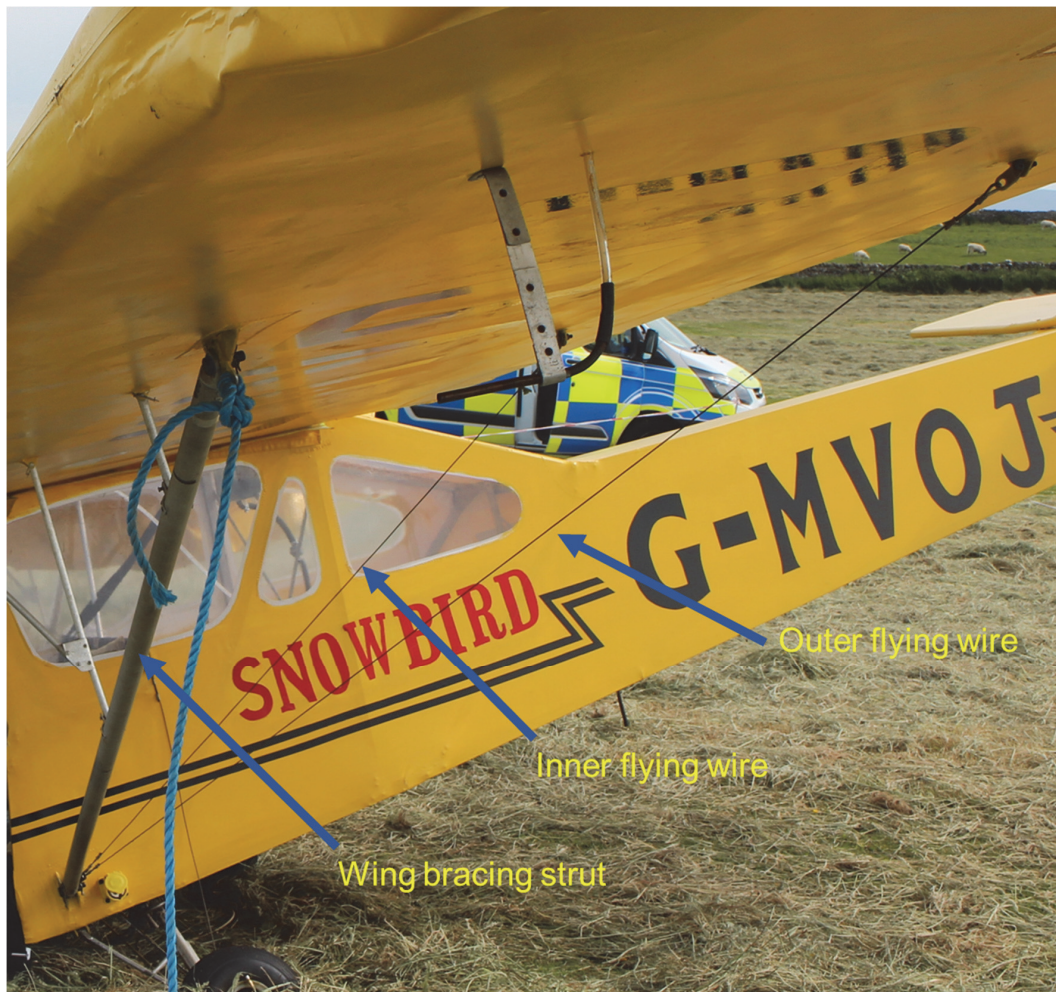
Figure 4

Flying wires and the bracing strut under the left wing
(The blue rope was attached after the accident to stabilise the aircraft)

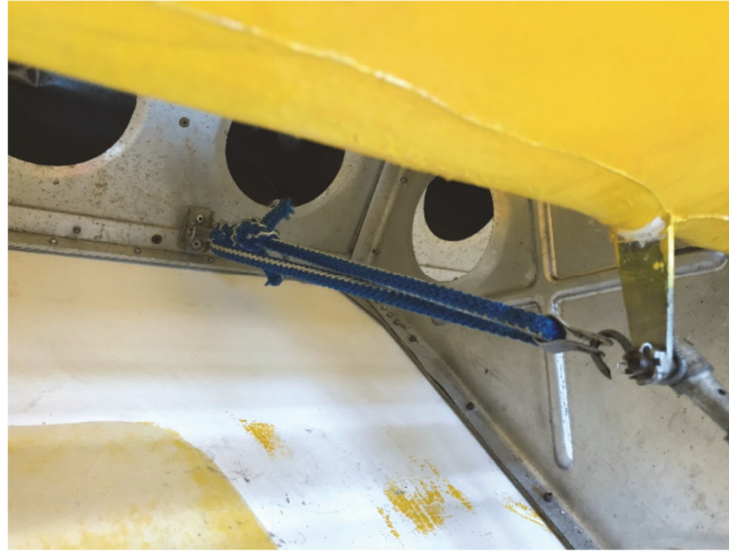
Figure 5

Left spoiler looped bungee cord

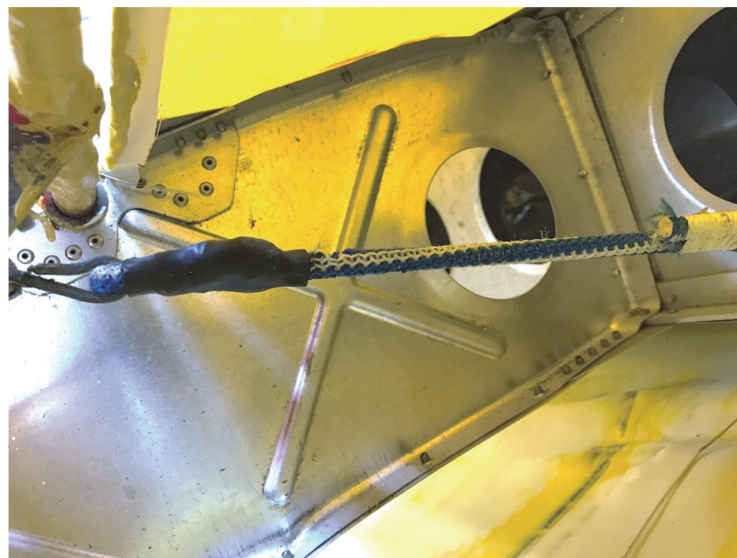
Figure 6

Right spoiler whipped bungee cord

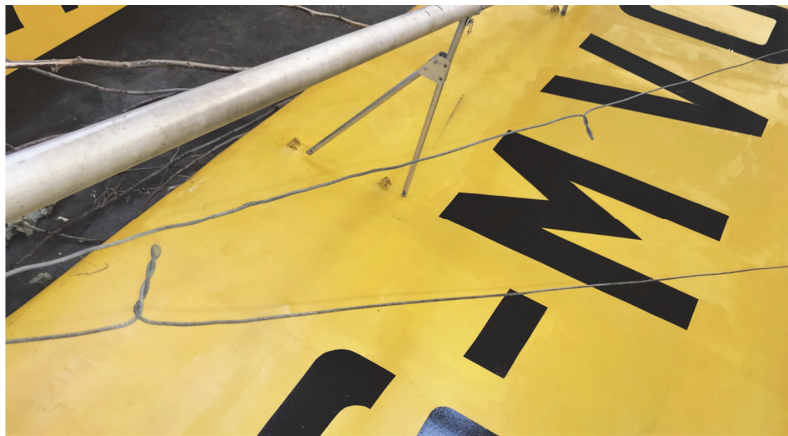
Figure 7

The flying wires were not disconnected from the struts or their spar attachments at the accident site. On later examination, it was noted that the right wing flying wires, in their relaxed state, were slack and in good condition. However, the two left wing flying wires were very different in their relaxed condition. They both had multiple tight loop twists and kinks indicating that they had been 'wound up' at some point during assembly. In the absence of tension, the wind-up had released and, because they are restrained at each end, twist loops were formed. The eye plates on which the cables were fitted had not been undone and were still attached correctly. It was also noted that the left pair of cables were made from galvanised steel and the right pair of cables were made from stainless steel. Figures 7 and 8 shows the wind-up twisting and kinks on the left flying wires, compared the right flying wires shown in Figure 9.

Left wing flying wire distortion

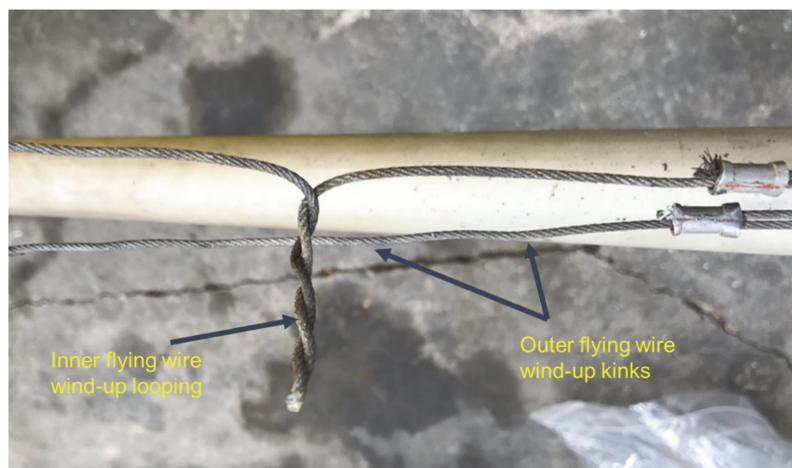
Figure 8

Close up of the distortion to the left inner and outer flying wires. In addition to the kinks, the outer wire also showed identical wind-up looping further along the cable (out of shot)

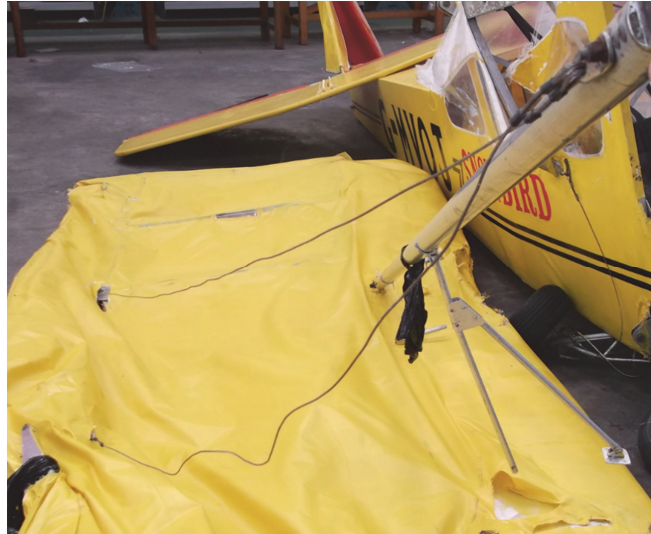
Figure 9

Right wing flying wires

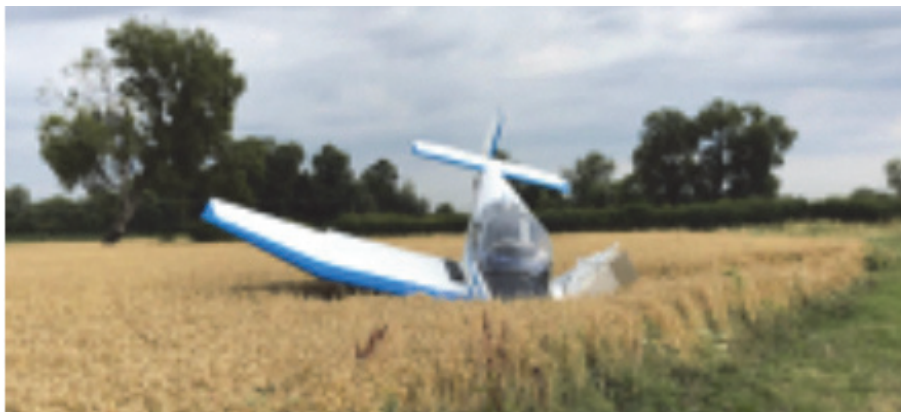
Figure 1

Shortly after the aircraft departed Marsh Hill Farm Airstrip, the pilot realised he had left his car unlocked with the keys in view. He decided to return to lock his car. He levelled off at 600 ft and positioned for landing. Carburettor heat was selected ON but was returned to OFF shortly after, when the aircraft was on its final approach. As the threshold hedge was crossed, 'sink' was apparent, and the pilot added power to counter it. The engine did not respond as quickly as normal and the aircraft landed "very hard" and bounced in to crops adjacent to the runway, Figure 1.

Final position, in crops adjacent to runway

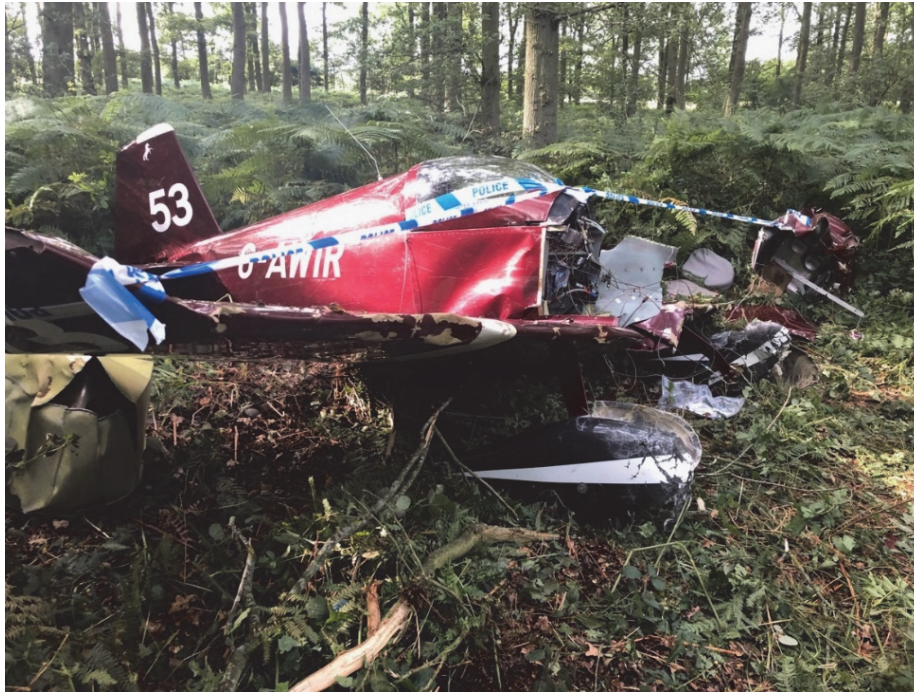
The pilot was flying from Leicester Airfield to Sibson Airfield and on the way, he flew over Spanhoe Airfield to check the windsock and decide whether he was going to land there to visit friends. He flew overhead at approximately 600 to 700 ft and then pulled up and banked left. The next thing he remembers is hitting the tree canopy. The pilot sustained serious injuries and the aircraft was destroyed, Figure 1.

Figure 1
Aircraft post-accident

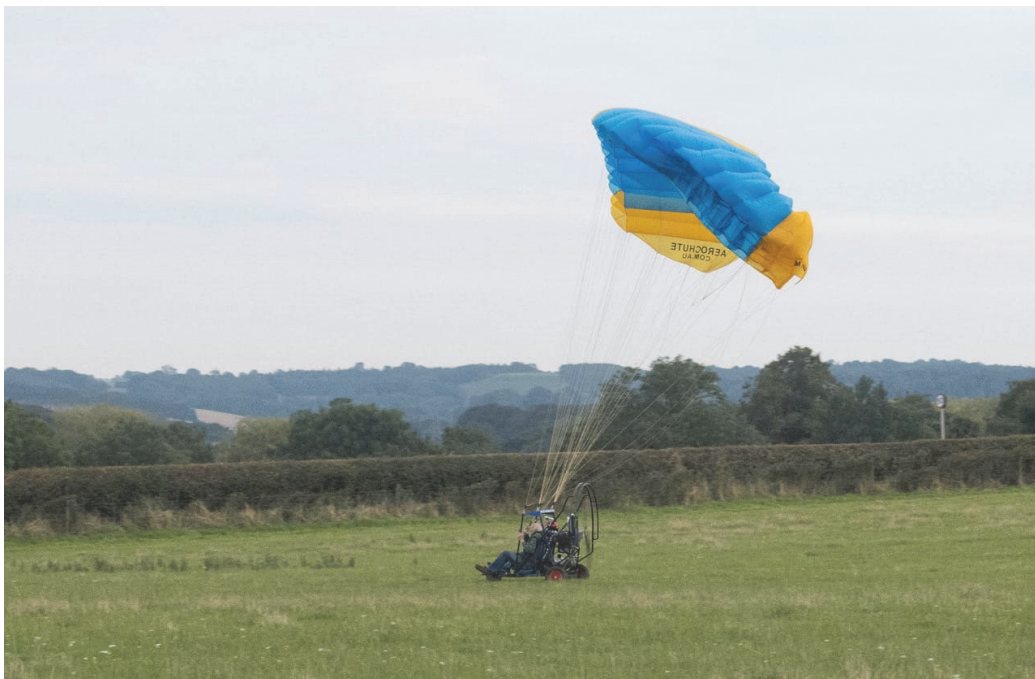
Figure 1

G-CJTI at start of the takeoff roll with left side of canopy incorrectly inflated

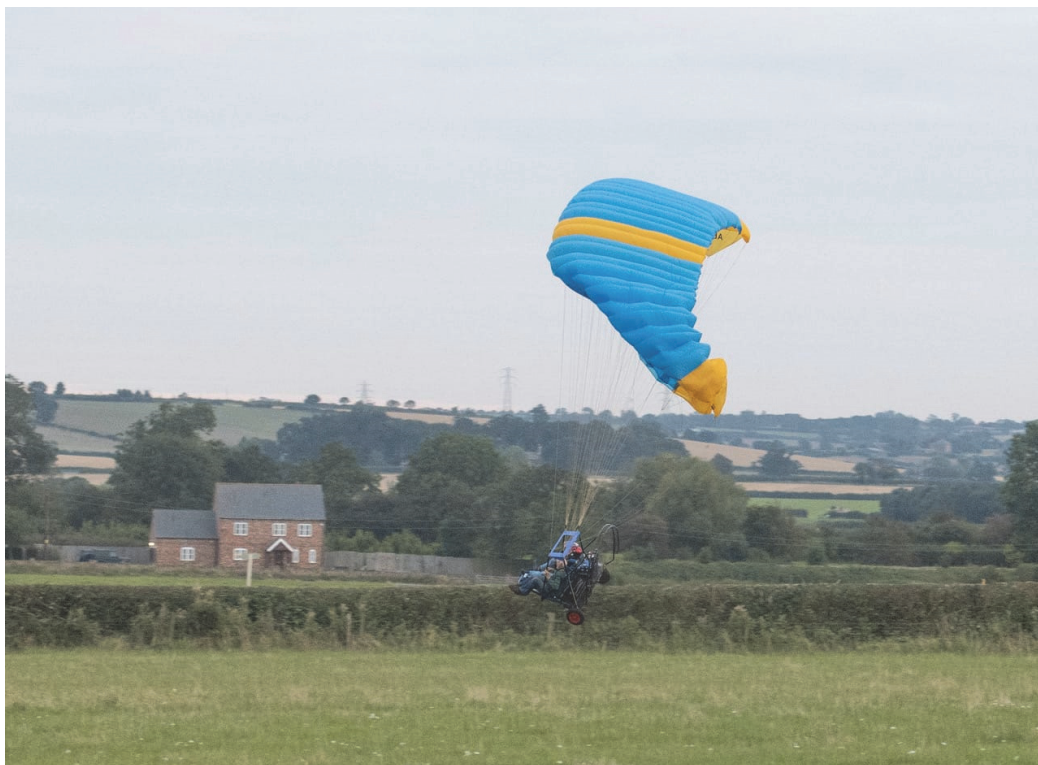
Figure 2
G-CJTI as it lifted off the ground and rolled left

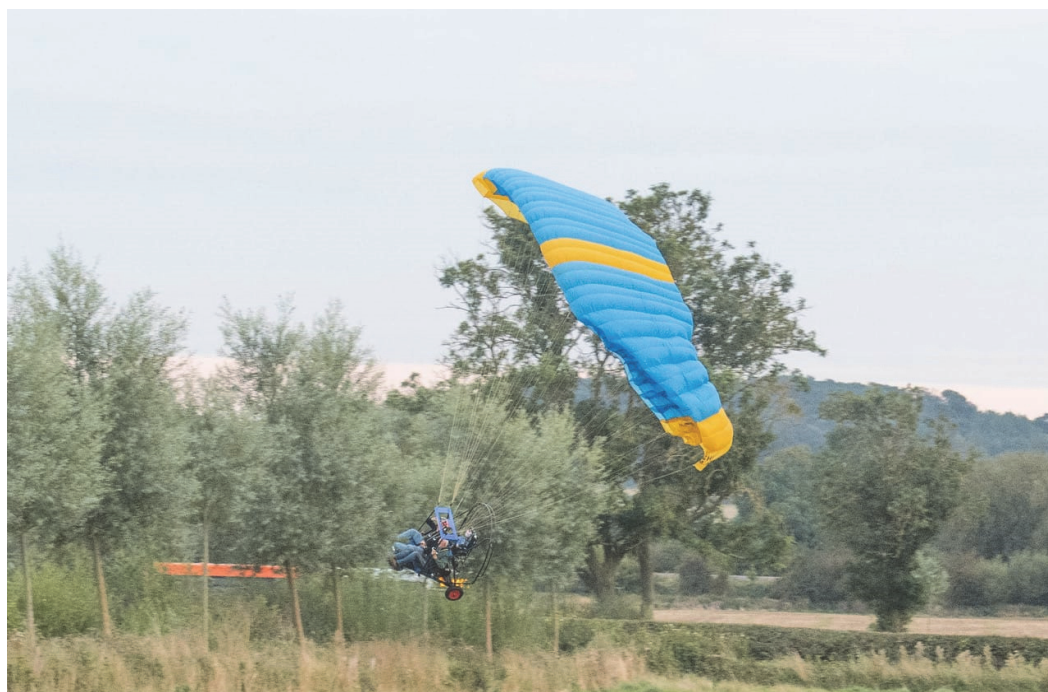
Figure 3
G-CJTI rolling left before colliding with bushes

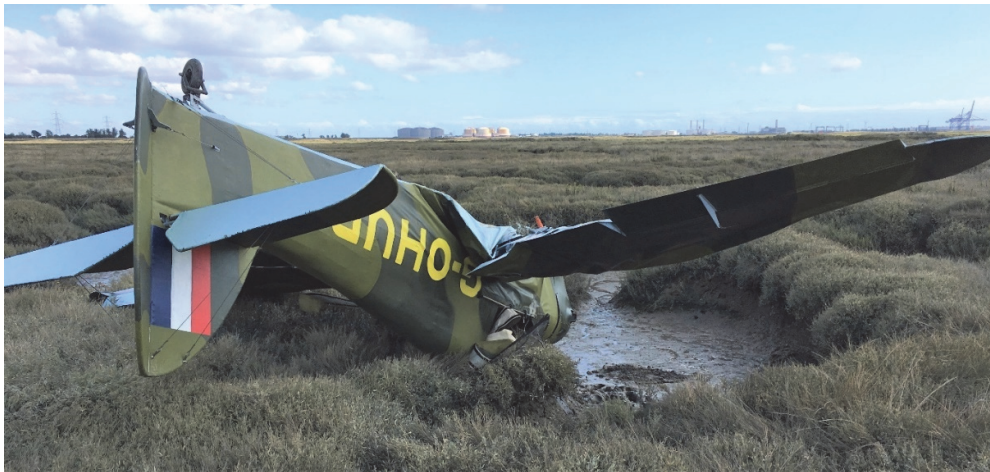
Figure 1

On landing, one or both the mainwheels dug into the ground causing the aircraft to gently pitch over, coming to rest inverted (Figure 1). The pilot was initially trapped but was assisted out of the cockpit by a passer-by. During the accident the propeller detached, and the aircraft sustained extensive damage to the landing gear, fuselage and left wing. The canopy was distorted making it difficult to vacate the aircraft.

G-OHUR inverted on the salt marshes (picture courtesy of the owner)
