AAIB Bulletin

1/2020

Aircraft Type and Registration:	Eurocopter EC135T1, VP-CPS	
No & Type of Engines:	2 Turbomeca Arrius 2B1A turboshaft engines	
Year of Manufacture:	1999	
Date & Time (UTC):	26 February 2019 at 1631 hrs	
Location:	Owen Roberts International Airport, Cayman Islands	
Type of Flight:	Training and search	
Persons on Board:	Crew - 3	Passengers - None
Injuries:	Crew - 3 (Minor)	Passengers - N/A
Nature of Damage:	Damage to tail boom, landing gear and transmission deck	
Commander's Licence:	Commercial Pilot's Licence	
Commander's Age:	58 years	
Commander's Flying Experience:	7,842 hours (of which 3,879 were on type) Last 90 days - 56 hours Last 28 days - 22 hours	
Information Source:	AAIB Field Investigation

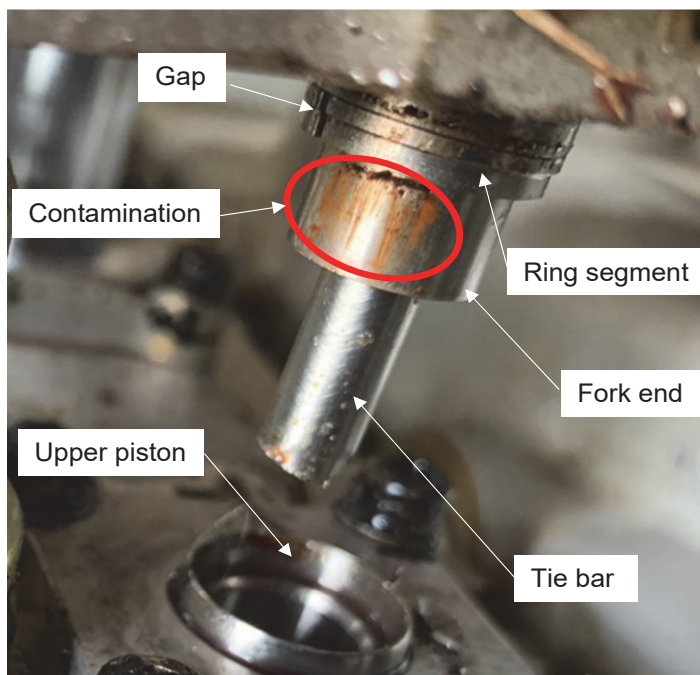
Two half-segments are used to remove the need to fully disassemble the actuator at the final stage of manufacture and no sealant is applied, to ensure ease of removal. The dimensional tolerances of each segment result in a gap between the segments of 1.6 mm to 0.7 mm on each side (Figure 4) when installed into the upper piston (Figure 5).

Figure 5
Compression ring segments gap

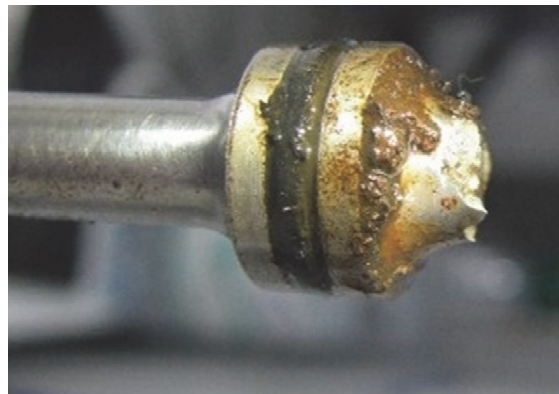
Figure 7

Analysis of the material found adjacent to the fracture on the tie bar (Figure 7) revealed a high sodium and chlorine content, amongst other chemical elements, with similar deposits found on the other actuator tie bars. There was evidence of the same material on the part of the fork end located within the upper piston (Figure 5).

Material adjacent to tie bar fracture surface

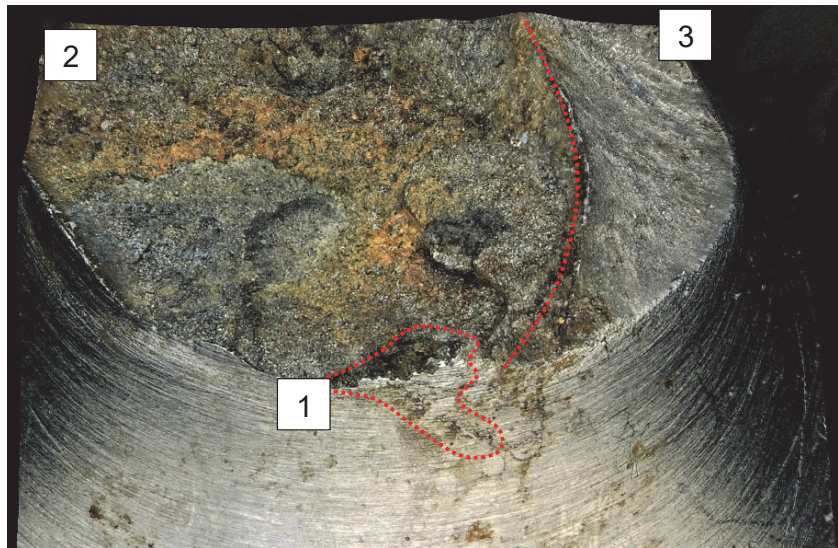
Figure 8

The failed tie bar was removed from the actuator and the fracture surfaces were examined using Scanning Electron Microscopy with semi-quantitative Energy Dispersive X-ray (SEM-EDX) spectroscopy (Figure 8). On the surface of the tie bar local to the fracture there was evidence of pitting corrosion, with several pits extending into the material [1]. On the fracture surface there was evidence of intercrystalline corrosion with crack propagation covering approximately $\frac{3}{4}$ of the fracture surface and the fracture surface was lightly corroded [2]. The remaining region of the fracture surface demonstrated failure through overload [3]. The tie bars from the lateral and collective axis actuators also showed evidence of surface pitting corrosion but to a lesser extent. Pitting corrosion was also identified on the internal bore of the upper piston coincident with the location of the failure in the tie bar.

Microscope photograph of the fracture surface (Airbus)

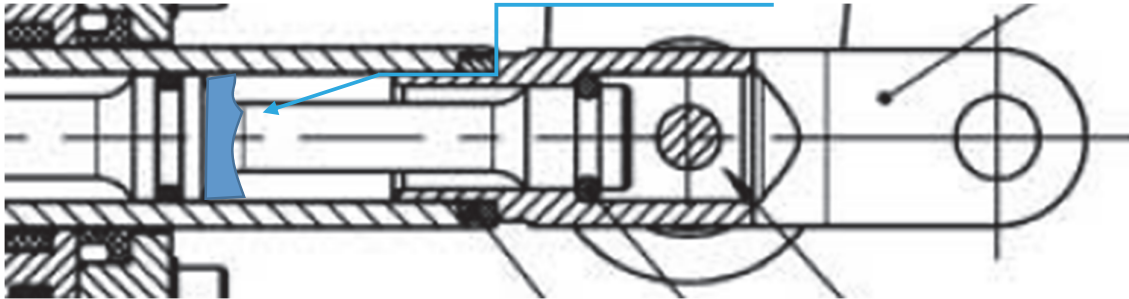
Figure 9

The combination of the installation orientation of the main rotor actuator and an unsealed gap between the compression ring segments could lead to moisture penetrating into the upper piston. This moisture would then collect by the first 'O-ring' seal at the end of the tie bar and, over time, cause the tie bar and piston to corrode. Analysis of the material found adjacent to the fracture surfaces showed elevated levels of sodium chloride. The helicopter's normal operating environment over the Cayman Islands and its waters would expose it to high levels of salt. It is likely that this deposit caused the pitting corrosion found on the surface of the tie bar. The deposit would then cause further corrosion within the material along the intercrystalline boundaries. Normal operating loads on the tie bar would cause these small intercrystalline corrosion cracks to coalesce, leading to a reduction in cross-sectional area. This would happen gradually over time, as evidenced from the light corrosion seen on the fracture face in VP-CPS. Finally, the remaining material would fail through overload.

Possible moisture ingress path (rotated)

Following this accident, where longitudinal control of the helicopter was lost at low level, it was discovered that a tie bar within a main rotor actuator had fractured. This fracture was caused by the reduction in area of the tie bar through the propagation of a crack initiated by pitting corrosion. It is highly probable that the corrosion pits were caused by the accumulation of salt moisture in the end of the actuator, which had penetrated into the actuator through a gap.

To issue instructions for continued airworthiness in the form of a mandated (by EASA EAD) Alert Service Bulletin to inform all operators to inspect the main rotor actuators. If evidence of tie bar corrosion is found, or the time in service exceeds a defined period, then the tie bar is to be replaced.

To initiate a review of the actuator design with the equipment supplier to identify changes that could be made to prevent moisture ingress and a corrosion-initiated failure of the tie bar.

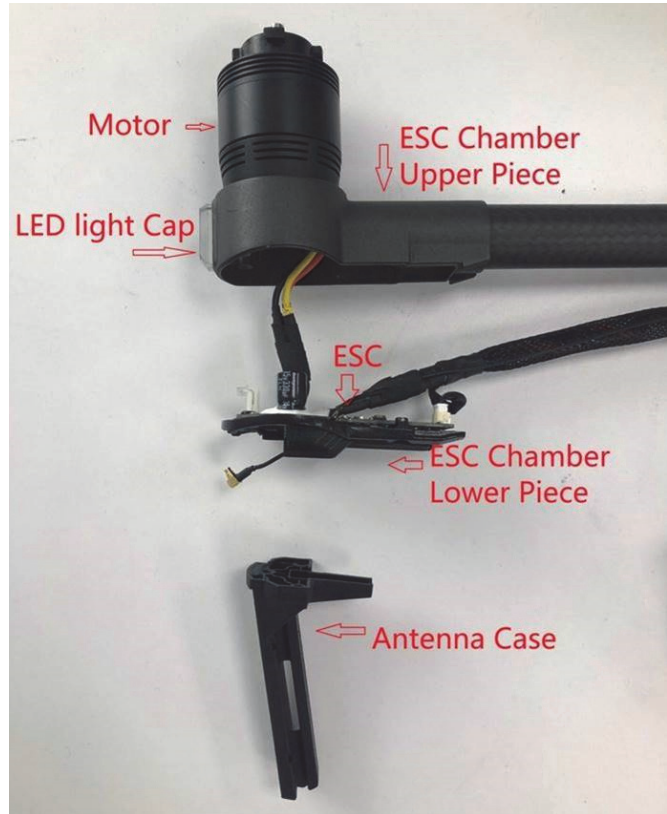
Figure 5

To prevent moisture and dust⁶ ingress into the ESC chamber the UAS manufacturer advised that most of the chamber was sealed using adhesive and gaskets, but the attachment holes and seam between the antenna case and lower chamber were not sealed. The

Motor, ESC, chamber and antenna

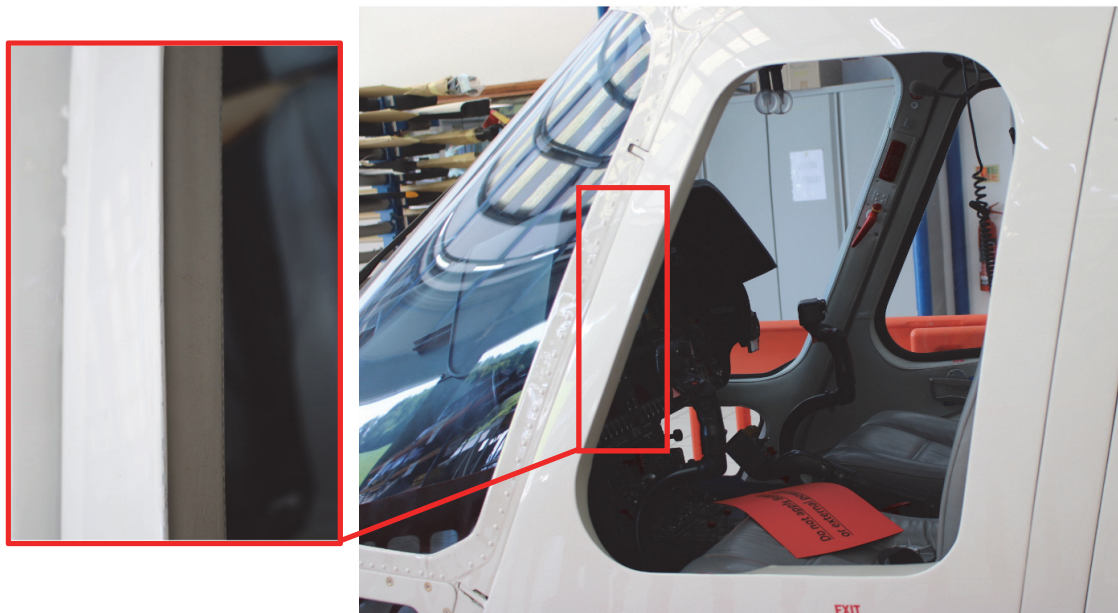
Figure 2

The left cockpit door was inspected and the associated maintenance worksheet stated that the inspection '*...did not reveal sufficient (residual) presence of adhesive on the door structure.*' The engineer performing the inspection also noted the presence of a greasy residue around the window aperture. A photograph taken during the inspection (Figure 2) shows no evidence of adhesive residue. The window and retaining seal were not recovered following the incident, so it was not possible to confirm whether sufficient adhesive had been applied to the window side of the seal.

Window aperture of left cockpit door, showing no evidence of adhesive

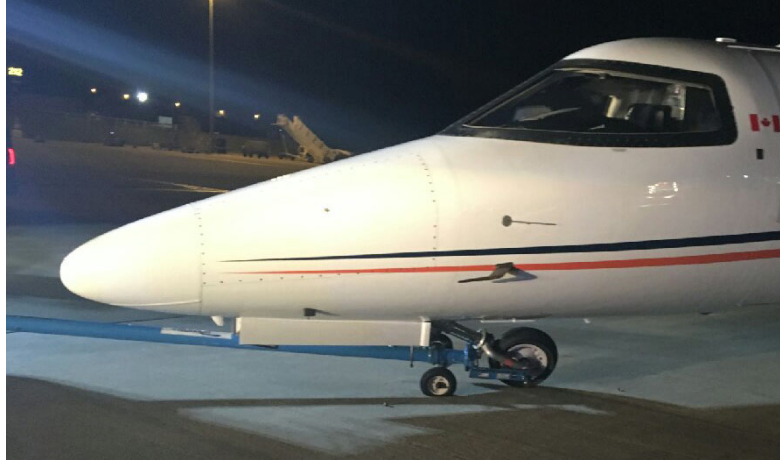
Figure 1

C-GMCP nose gear collapse

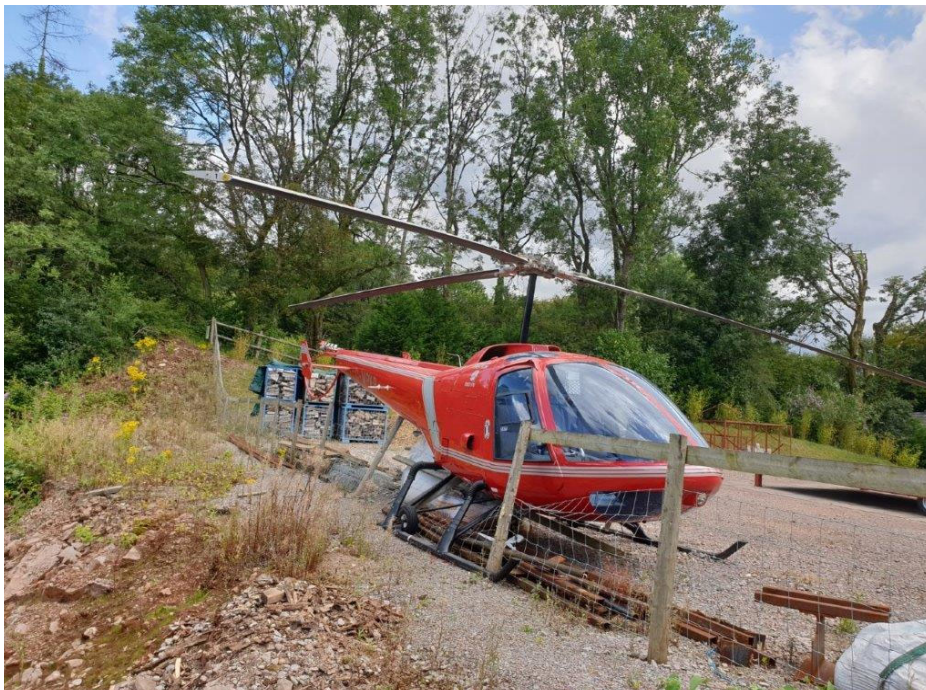
Figure 1

Based on his assessment of the damage sustained by the helicopter, the pilot believes it may have pivoted backwards causing the tail rotor blades to strike the fence and the helicopter to come to rest partly on the fence and partly on the ballast bags (Figure 1).

G-WPKR after coming to rest on the lip of the quarry

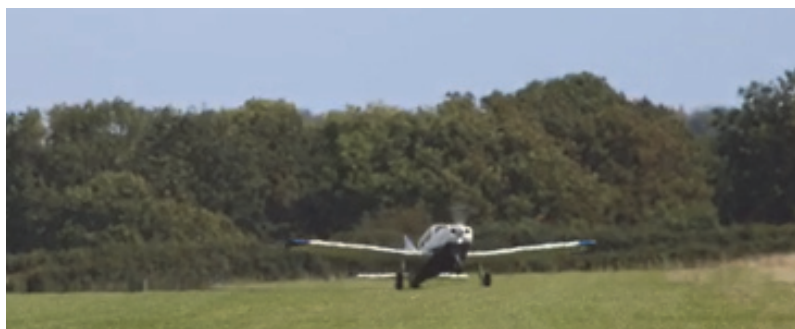
Figure 1

As the takeoff commenced the pilot's directional control of the aircraft was not steady, and the nose of the aircraft lifted at low speed. The aircraft then became briefly airborne and 'weathercocked' in to the wind and towards the airfield boundary hedge. The pitch angle continued to increase, and the aircraft sank back on to its main wheels and its tail contacted the ground, Figure 1.

G-BSIM 'weathercocked' and at a high pitch angle, during the takeoff

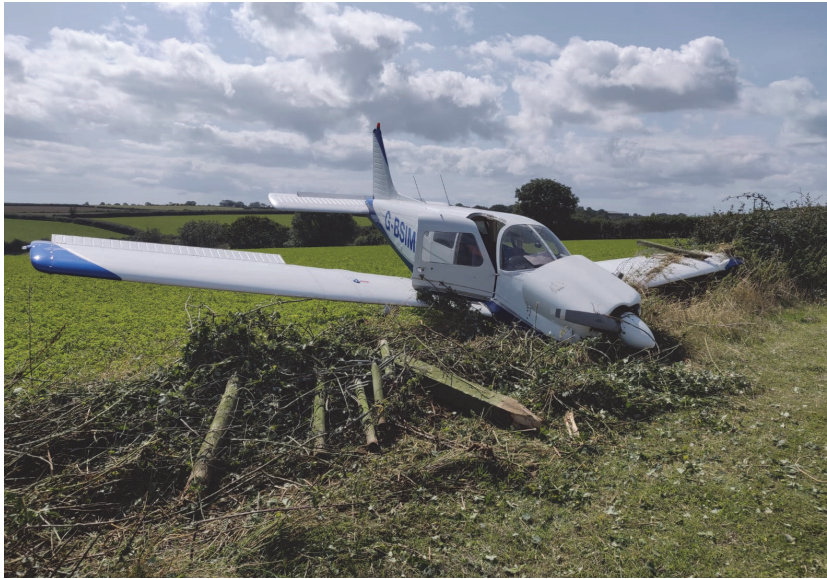
Figure 2

The aircraft's position after impact with the hedge

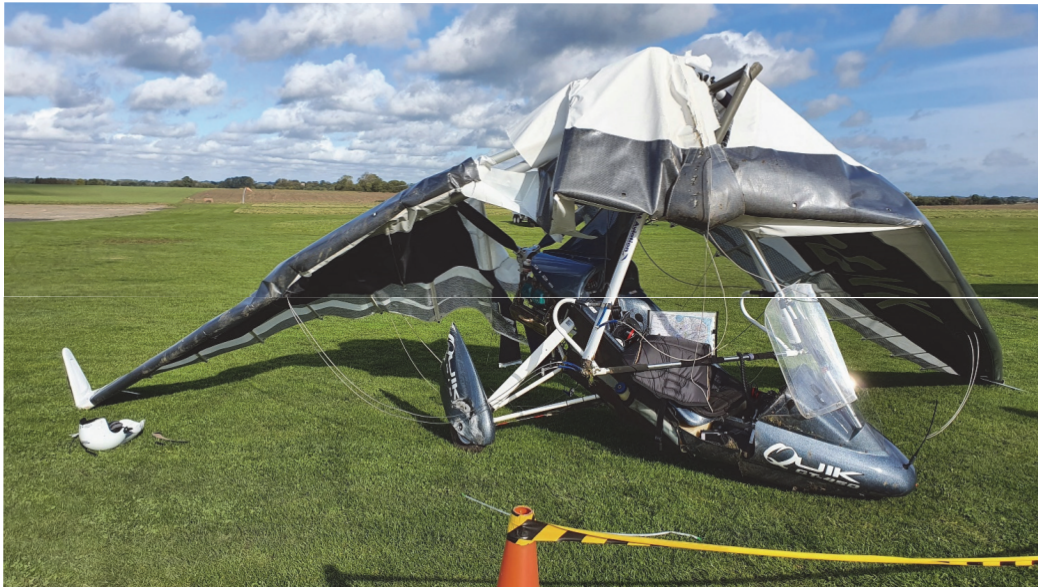
Figure 1

G-CGNK after being recovered from the runway

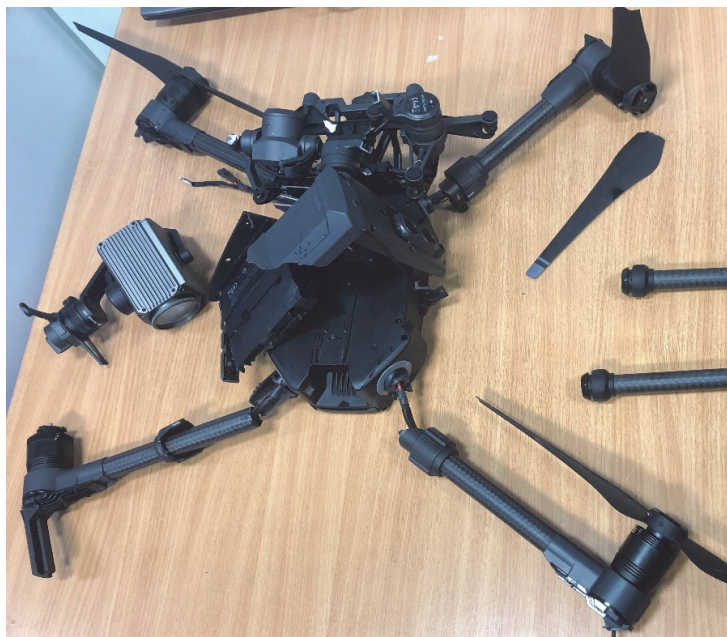
pilot brought the aircraft to a hover about 50 m above the roof of a shopping centre building. About one minute later, the aircraft suddenly dropped vertically and crashed into the roof of the building (Figure 1). The pilot had not made any control inputs and it was stated that there had been no warnings on the controller. The aircraft suffered severe damage (Figure 2).

Figure 2
Damage to the aircraft

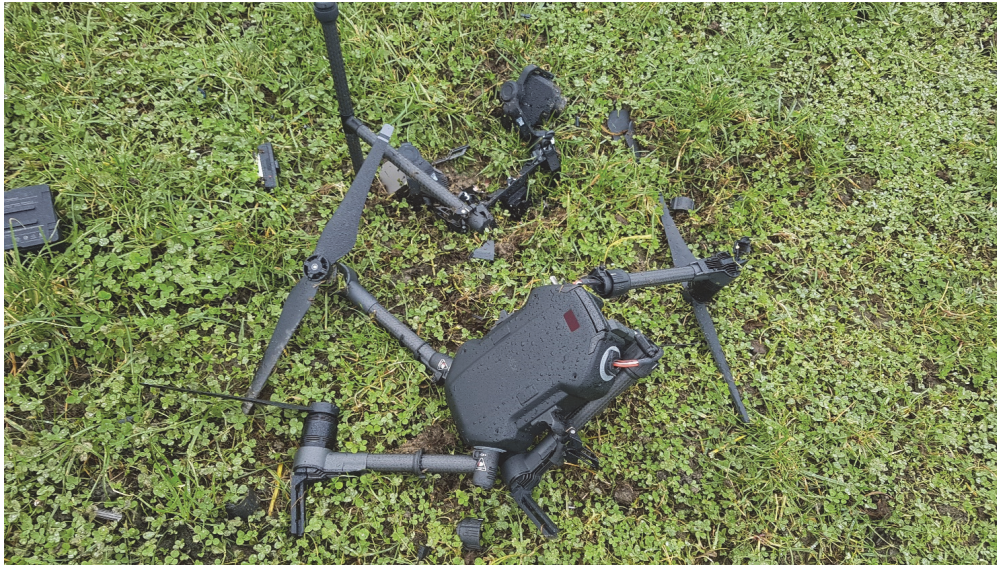
Figure 1
Wreckage of the SUA

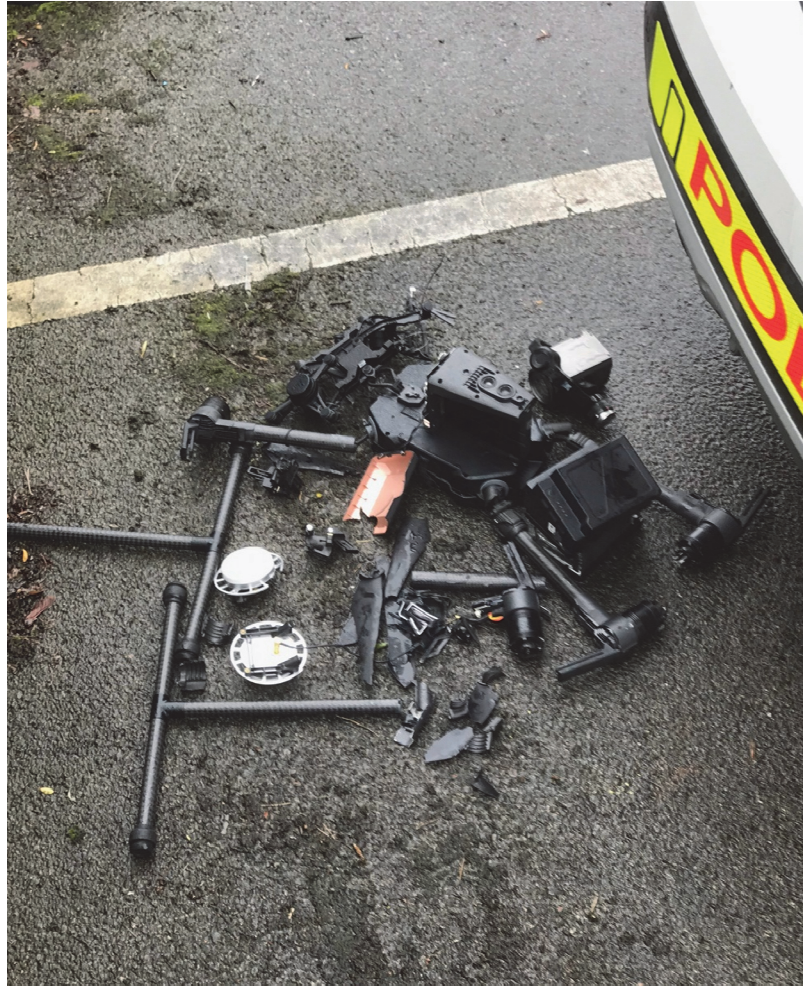
Examination of the recorded data showed that a MOTOR BLOCKED warning message had been activated and the No 3 (rear left) motor had failed.

Figure 1
Wreckage of the SUA
