# ***AAIB Bulletin***

# ***2/2020***

Published 13 February 2020

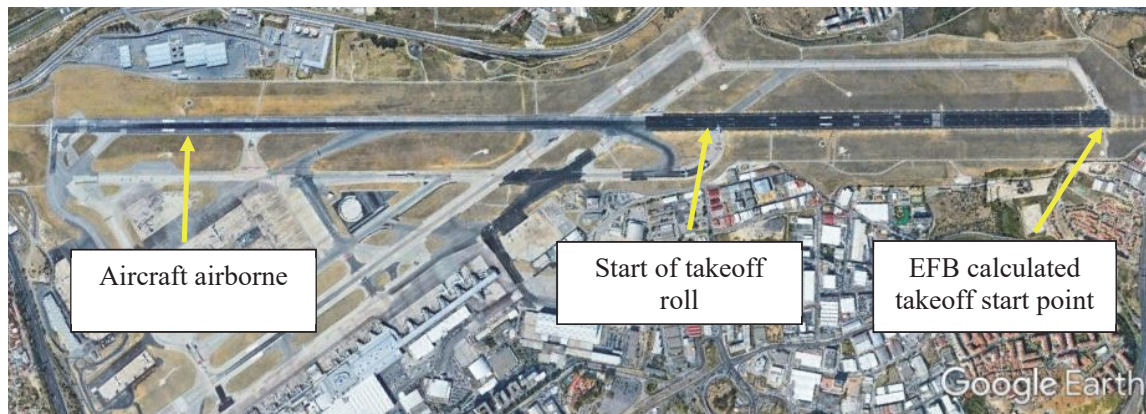
**Figure 2**

The aircraft departed from the Taxiway U5 intersection (TORA 2,410 m) at 2034 hrs using an engine thrust setting based on performance figures calculated for the full length of the runway (TORA 3,805 m) (Figure 2). With the reduced power setting, the commander commented subsequently that the takeoff "felt wrong", but Takeoff/Go-around (TOGA) thrust was not selected. The aircraft passed the upwind threshold of the runway at a height of approximately 100 ft. During the flight, the crew realised what had happened and reported it to the operator after landing.

Image of Lisbon Airport showing the calculated and actual takeoff points

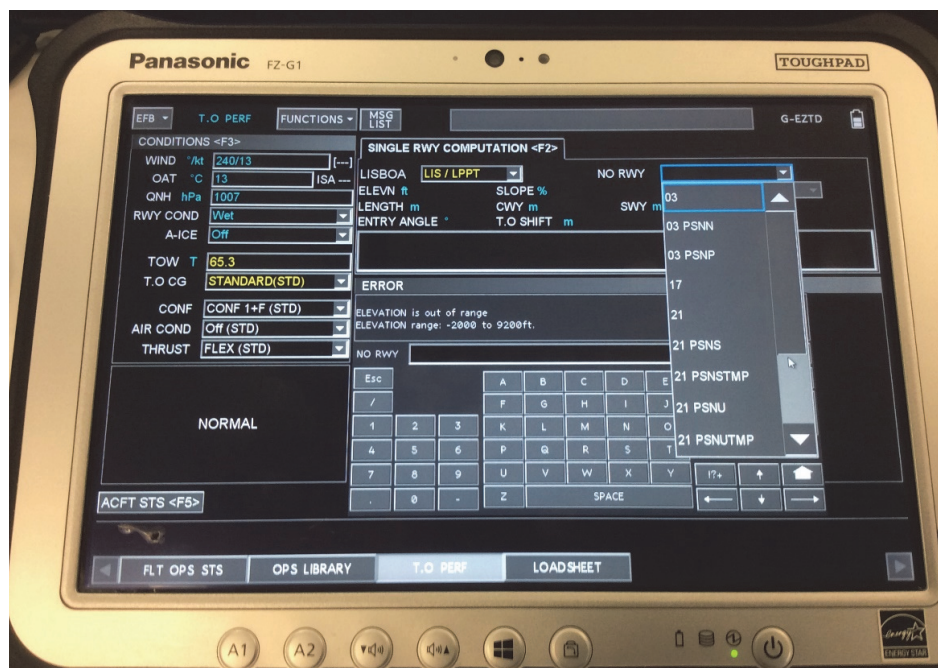
**Figure 4**

At the time of the incident, there was a NOTAM affecting the takeoff performance calculation (referring to an obstacle in the climb-out zone). This meant that the data supplier had inserted two further temporary selections for the two takeoff positions for Runway 21, which were labelled PSNUTMP and PSNSTMP as shown in Figure 4.

EFB dropdown menu showing the all the intersections available

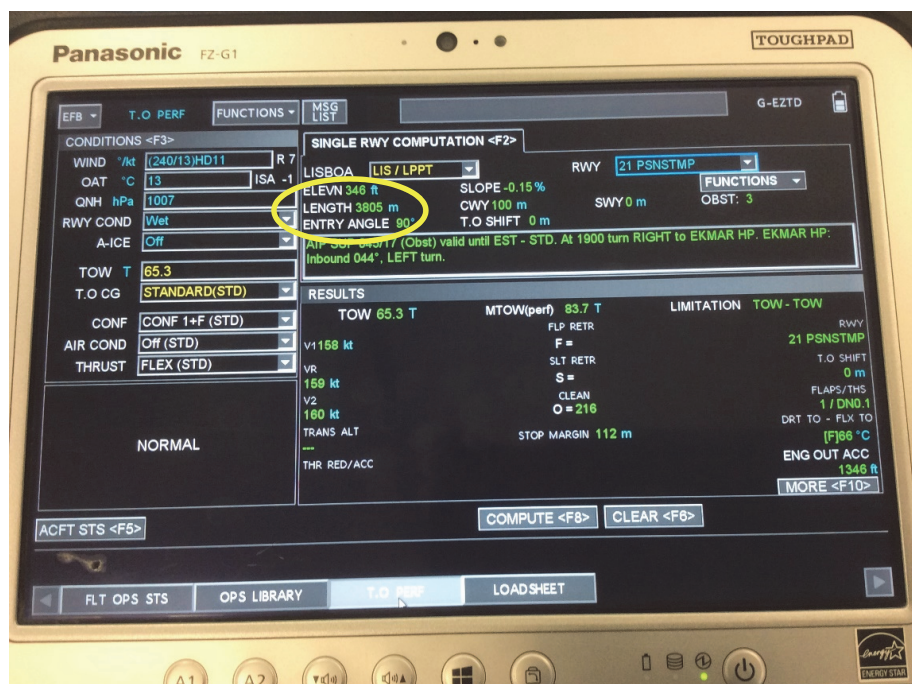
Figure 5

Performance calculation from the temporary Position S showing the distance display

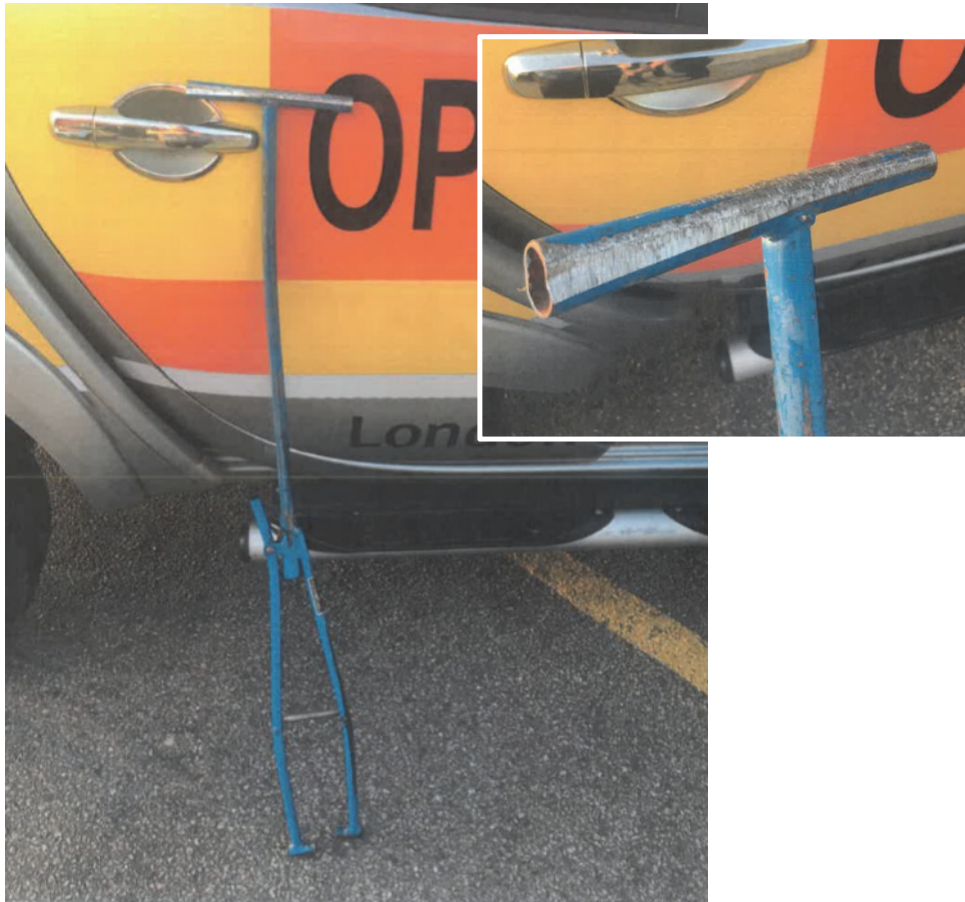
**Figure 1**

The commander reported the sighting to ATC who requested a runway inspection, which found a general aviation towbar (Figure 1) on the runway. There were no indications of any damage to the aircraft, so the commander continued to taxi the aircraft to stand. After the passengers had disembarked, both pilots inspected the aircraft but found no damage.

ATC reported that it was not possible to see the towbar from the control tower due to its size, shape and colour. They also reported that at the time of the event the location of the evening sun made it harder to see objects on the runway.

Towbar recovered from the runway

It is recommended that the Civil Aviation Authority communicate to the general aviation community the importance of increasing the visibility of ground equipment.

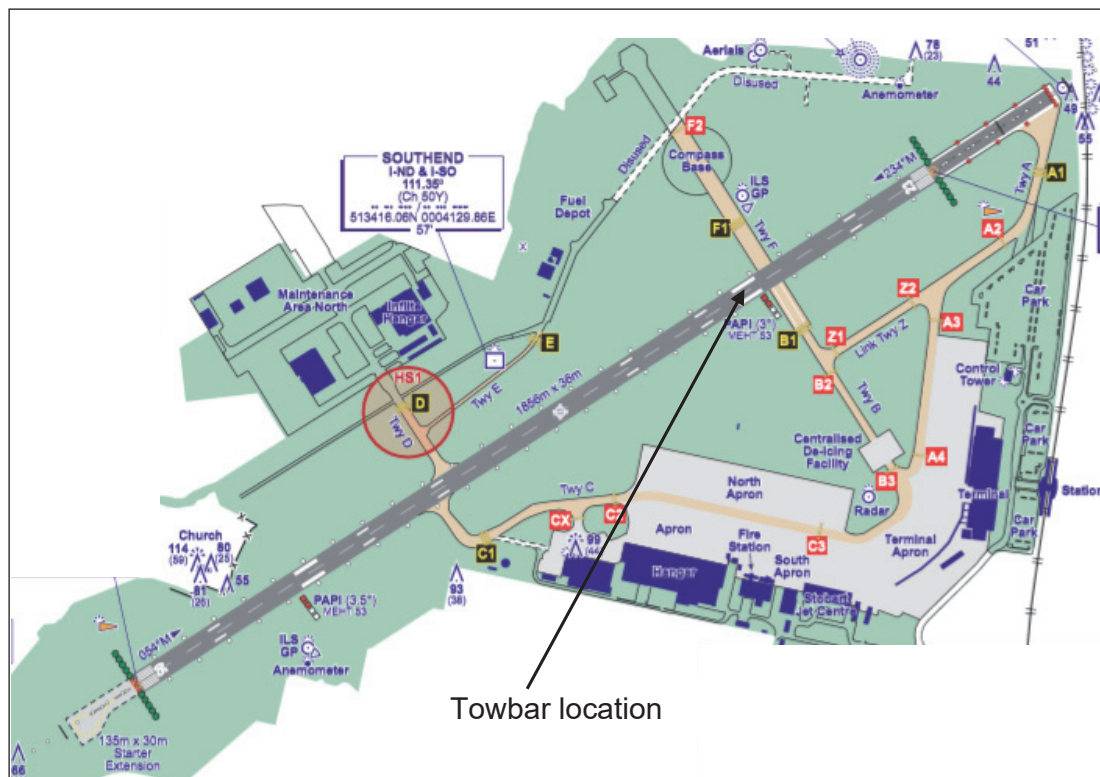
**Figure 2**

London Southend Airport Chart showing approximate location the towbar was found.

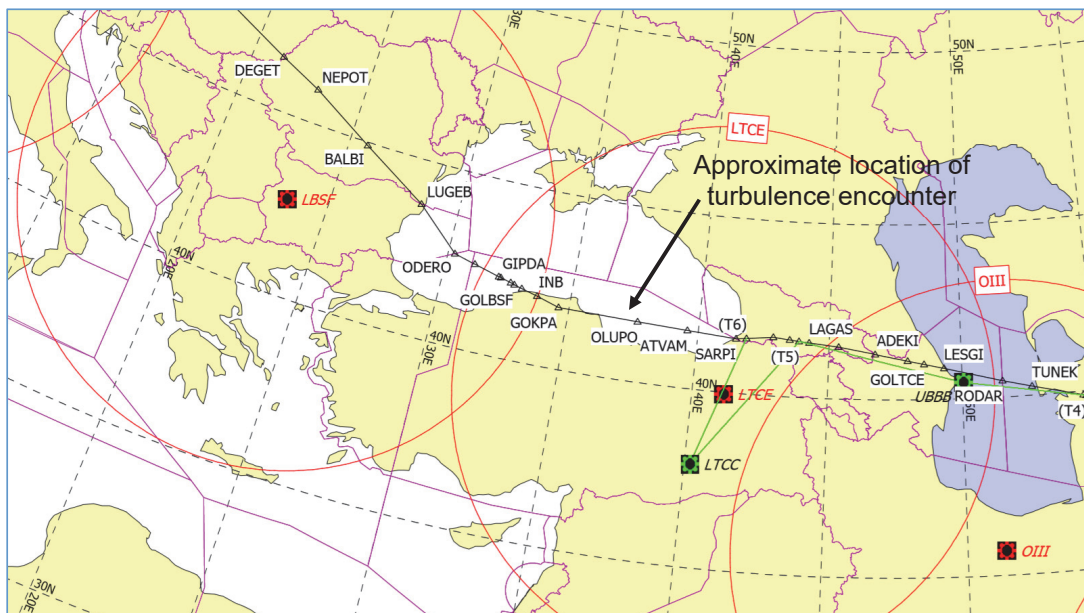
**Figure 1**

The commander reported that as they approached waypoint OLUPO (Figure 1) he saw a single "non-threatening" cloud on their track which was not showing on the aircraft's weather radar. There were cumulonimbus clouds on the horizon but no other clouds in their immediate vicinity. The aircraft was then cleared from OLUPO direct to waypoint ODERO on the Turkey/Bulgaria border, which took the aircraft clear of the single cloud. However, as the aircraft passed abeam the cloud, they encountered moderate to severe turbulence. The

G-VFIT route through Turkey showing location of turbulence event

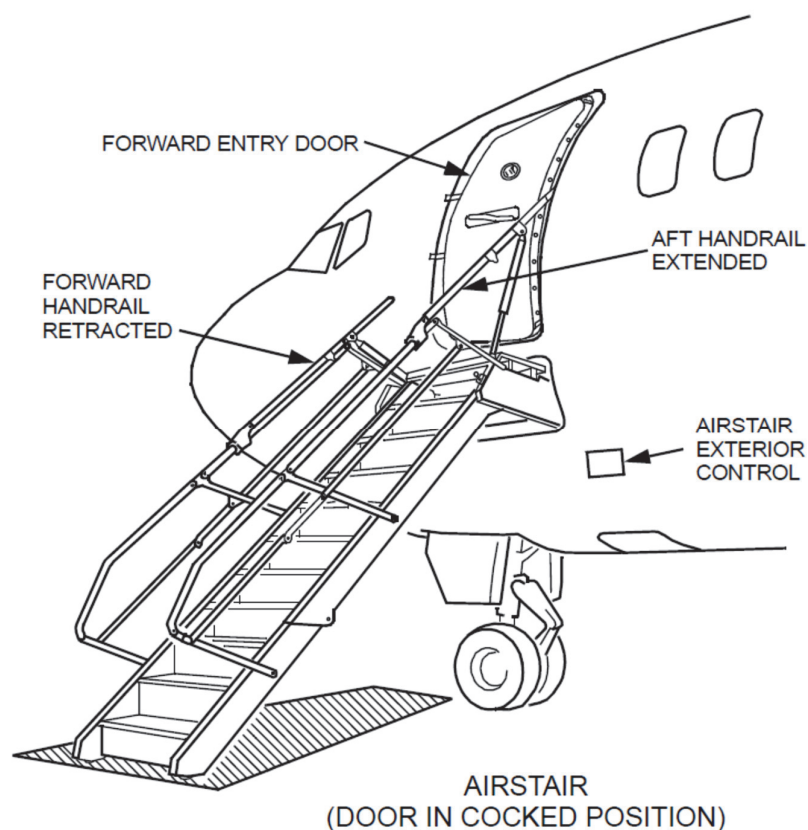
**Figure 1**

The airstairs include an integral two-rung handrail on either side. These rise into position during deployment of the stairs, but due to the geometric restrictions imposed by the retraction mechanism design, they do not extend to the fuselage side. In order to bridge this gap between the top of the handrails and the fuselage, a manually extendable handrail is fitted to each of the integral rails. After deployment of the airstairs, these are extended and secured to points in the entry door frame (Figure 1). Each extendable rail is supported by a strut extending from the side rail of the airstairs.

Boeing 737 forward airstairs
