AAIB

AAIB Bulletin

3/2020

Aircraft Type and Registration:	Sikorsky S-61N Sea King, G-ATBJ
No & Type of Engines:	2 General Electric Co CT58-140-2 turboshaft engines
Year of Manufacture:	1965 (Serial no: 61269)
Date & Time (UTC):	1 February 2018 at 1100 hrs
Location:	Marchwood, Hampshire
Type of Flight:	Commercial Air Transport (Non-Revenue)
Persons on Board:	Crew - 2 Passengers - None
Injuries:	Crew - None Passengers - N/A
Nature of Damage:	Damaged beyond economical repair
Commander's Licence:	Air Transport Pilot's Licence
Commander's Age:	60 years
Commander's Flying Experience:	11,233 hours (of which 1,501 ¹ were on type) Last 90 days - 26 hours Last 28 days - 0 hours
Information Source:	AAIB Field Investigation

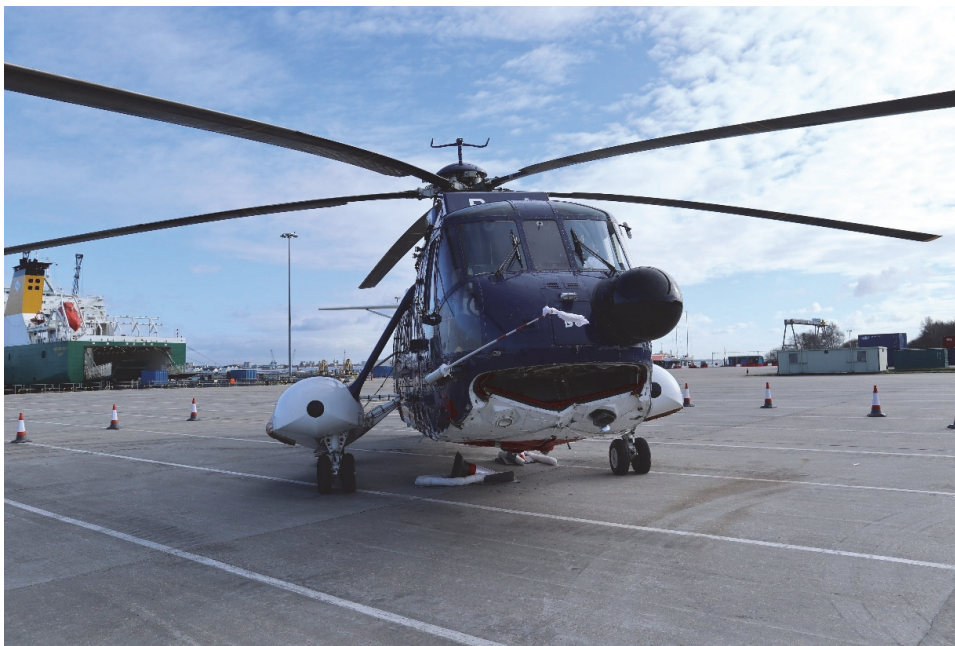
Figure 1

The front of the helicopter had struck the ground during the accident sequence. The front equipment bay was crushed, (Figure 1) resulting in the detachment of the bay door. Scuff marks on the concrete surface, 9.5 m from the centre of the helipad, indicated the location that the helicopter initially struck the ground (Figure 2). The tailwheel strut had been driven through the upper stops, with buckling of the skin around frame 493 at the rear of the fuselage.

G-ATBJ after accident (transport ship in background)

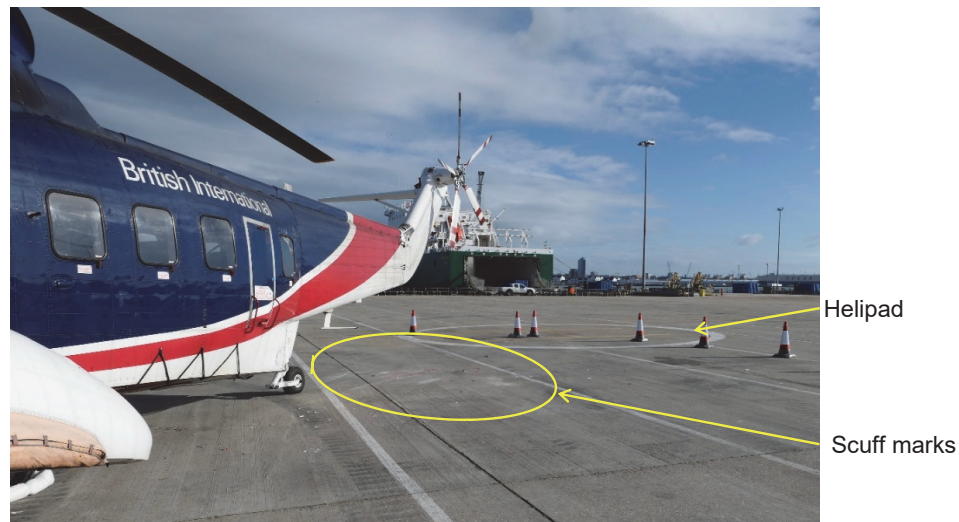
Figure 2

G-ATBJ impact mark (note: cones positioned after accident)

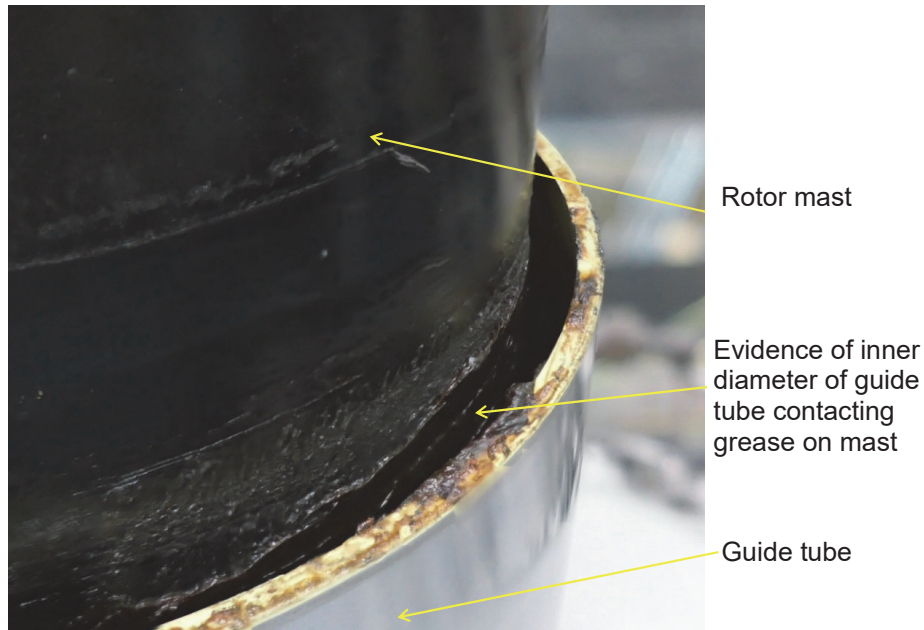
Figure 9

deflected during operation as grease on the mast had come into contact with the inner surface of the guide tube (Figure 9); however, there was no evidence of metal-to-metal contact between the mast and guide tube. Once it had been removed, examination of the swashplate assembly confirmed that the spherical bearing could not articulate in any direction. The swashplate (Figure 10) was transported to the manufacturer's facility for further disassembly.

Flattening of grease between rotor mast and guide tube

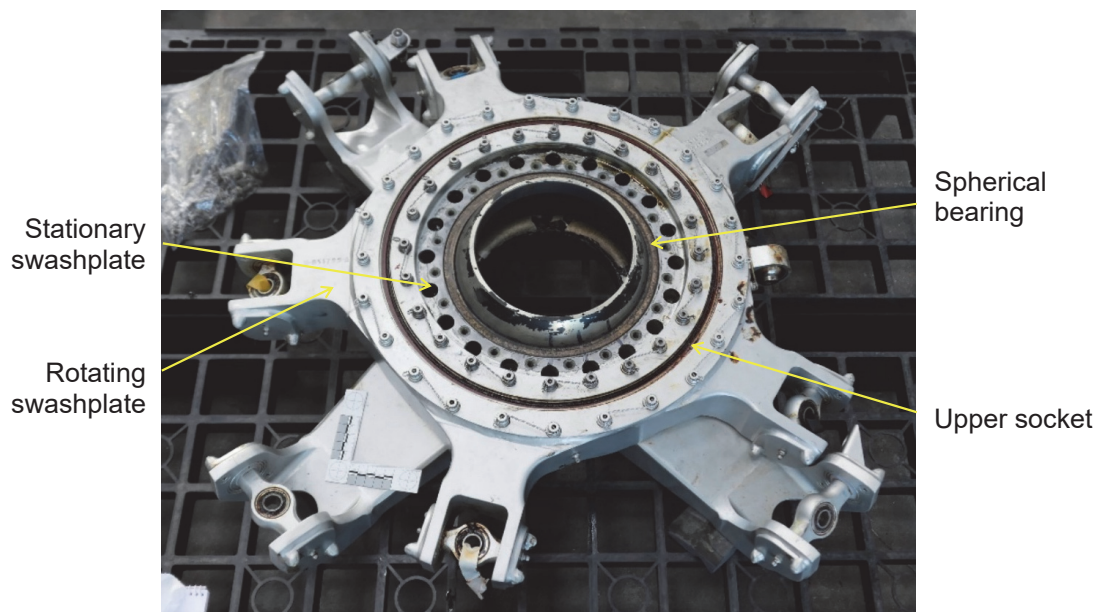
Figure 10

During the removal of the primary servos it was identified that the spherical bearing within the stationary swashplate assembly was seized. The swashplate was able to translate up and down the guide tube but could not tilt. There was evidence that the guide tube had

G-ATBJ swashplate after removal from the helicopter
(retainer, shim and spacer already removed in this image)

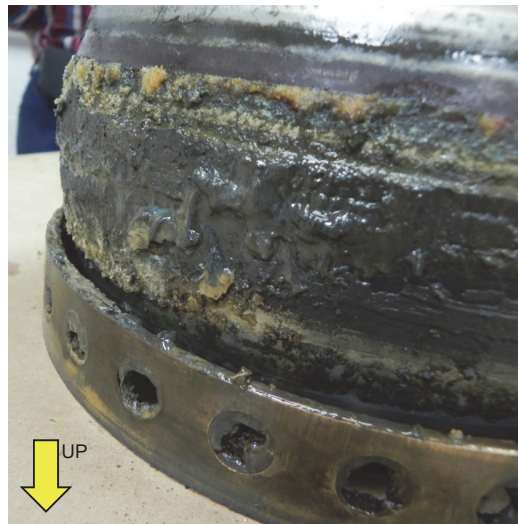
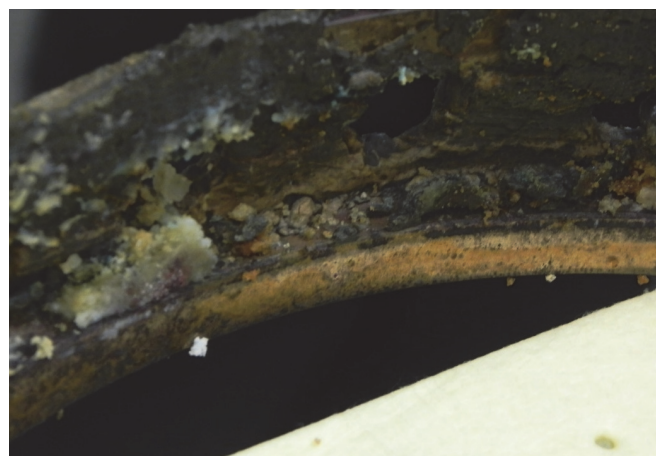
The grease between the sockets and the spherical bearings was in very poor condition, with crystalline deposits within it (Figures 11 and 12). Elemental analysis of the deposits found them to contain aluminium, chlorine, sodium, copper, tin and oxygen. This indicates that the aluminium spherical bearing had corroded, and deposits had been retained within the grease. A section of the grease was cleaned from the bearing to reveal areas of corrosion pitting to a depth of 0.018 in (Figure 13). A build-up of plaque-like material was adhered to the bearing. Analysis of this material found it to be bronze material that had released from the socket, combined with the grease and adhered to the bearing surface.

G-ATBJ spherical bearing once removed from swashplate

G-ATBJ upper spherical bearing socket showing corrosion product adjacent to bearing surface

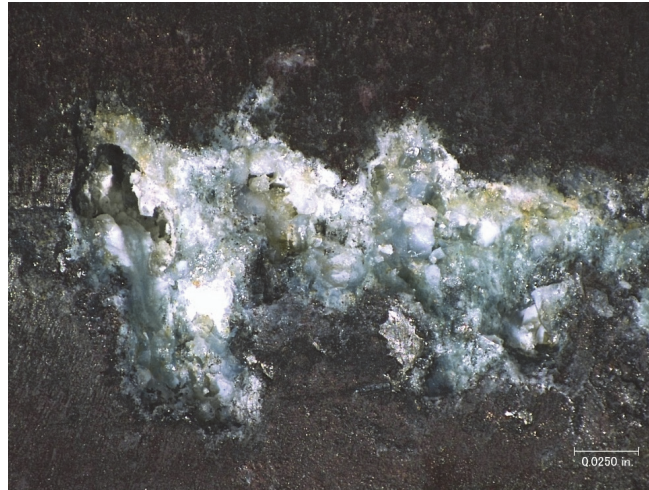
Figure 13

G-ATBJ example of spherical bearing corrosion pit

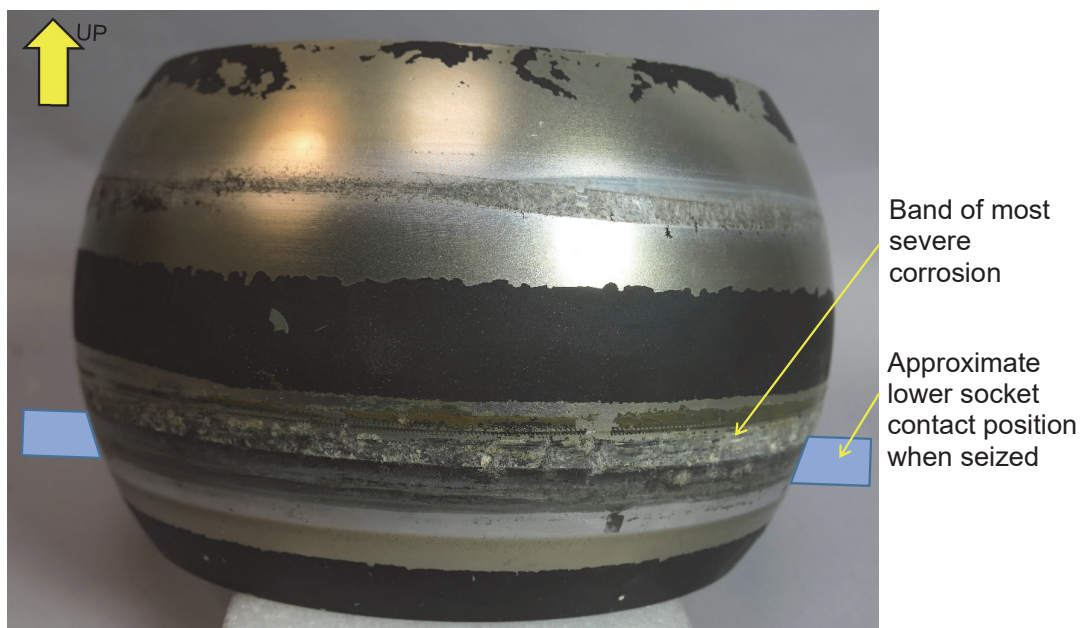
Figure 14

Once the spherical bearing was cleaned, a ring showing signs of severe corrosion was identified around the location where the lower socket had been. Closer inspection identified that a number of deep corrosion pits were located along the intersection between spherical bearing and where the top of the lower socket bearing face made contact (Figure 14).

Spherical bearing showing area of heavy corrosion above the location of the lower socket

The cyclic control restriction was found to be as a result of seizure of the spherical bearing with the swashplate. The seizure was determined to be as a result of corrosion build-up within the bearing sockets. Prolonged inactivity during the transportation of the helicopter from the Falkland Islands allowed corrosion to develop sufficiently to cause the bearing to seize. Following the helicopter's arrival in the UK, Safety Inspection checks detailed in the S-61N Equalized Inspection and Maintenance Program, SA 4047-13 were not carried out; it is likely that the seized swashplate would have been identified if they had.

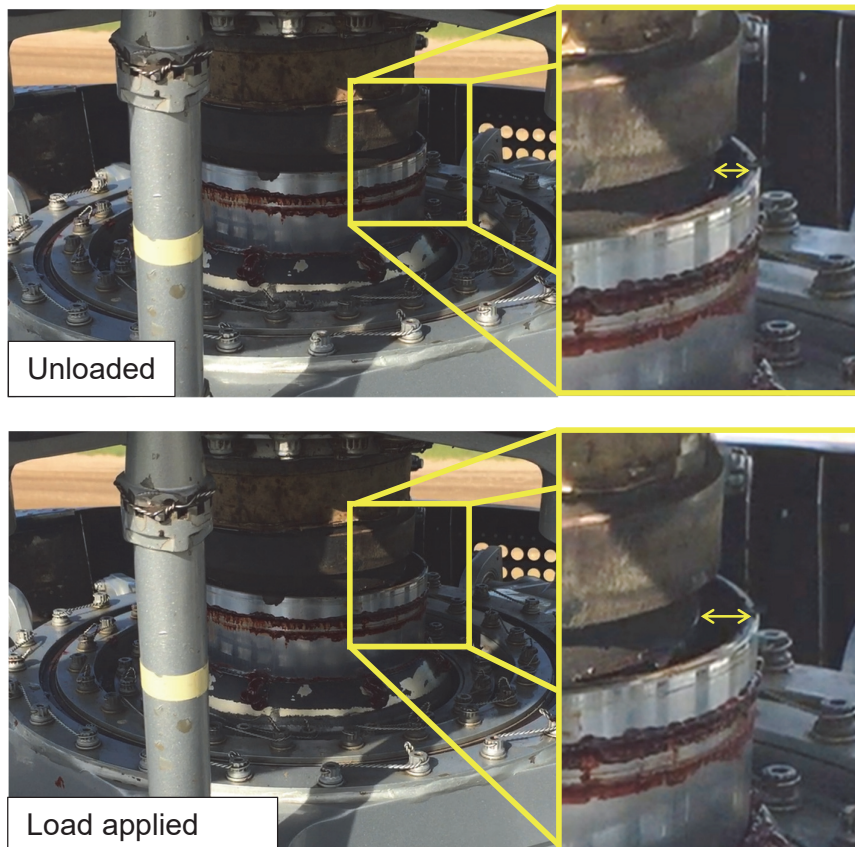
Figure 15

With the spherical bearing within the swashplate seized, the torque load applied to the swashplate from the servos would cause the guide tube and supporting structure to flex until the servos stalled. This flex would allow some relative movement of the swashplate about its centre in relation to the rotor head and would subsequently allow the rotor blades to move in the correct sense to a cyclic input. A video taken of the manipulation of a seized swashplate from another S-61 was provided to the AAIB by the helicopter manufacturer. This confirmed that some guide tube movement is likely when a cyclic load is applied (Figure 15). This would translate into blade movement as the guide tube is flexed. From the information provided it was not possible to correlate the amount of blade pitch change in relation to the cyclic input.

Stills from video of another S-61 showing levels of guide tube deflection when cyclic was applied to a seized swashplate

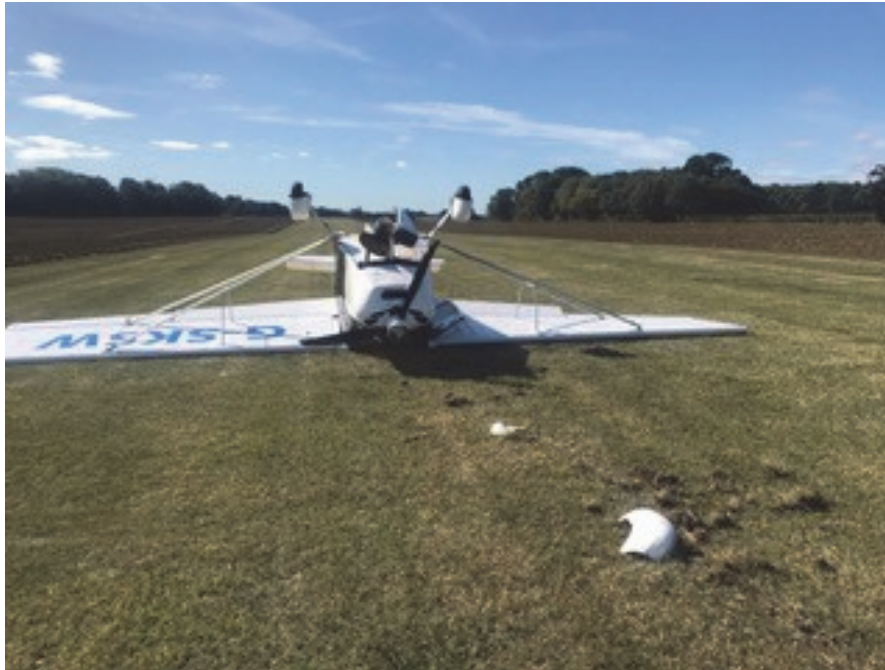
Figure 1

G-SKSW following the nose landing gear failure

The aircraft sustained damage to the nose landing gear, propeller, engine cowling and engine. The cockpit windscreen was broken and the upper surfaces of both wings were damaged.

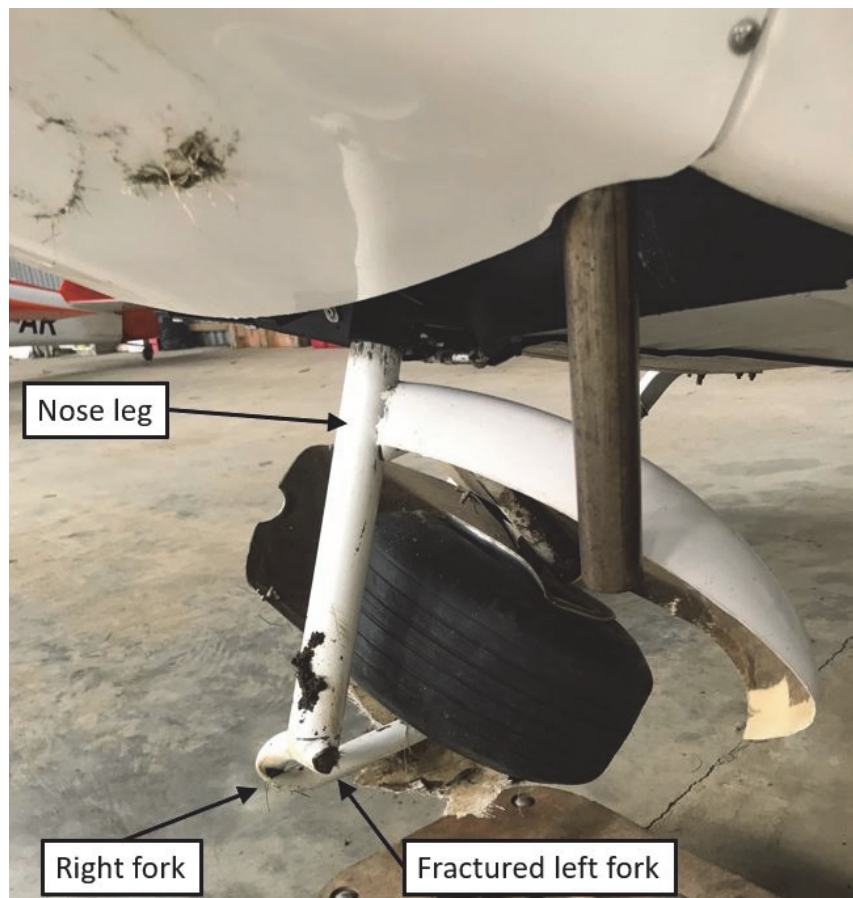
Figure 2

The left leg of the nose landing gear fork had failed at its welded joint with the nose landing gear down tube (Figure 2). The right leg of the fork remained attached to the down tube and had folded rearwards, with the nosewheel remaining attached to it. The nosewheel tyre was in good condition and no pre-accident defects were evident when it was examined.

Fractured nose landing gear left fork

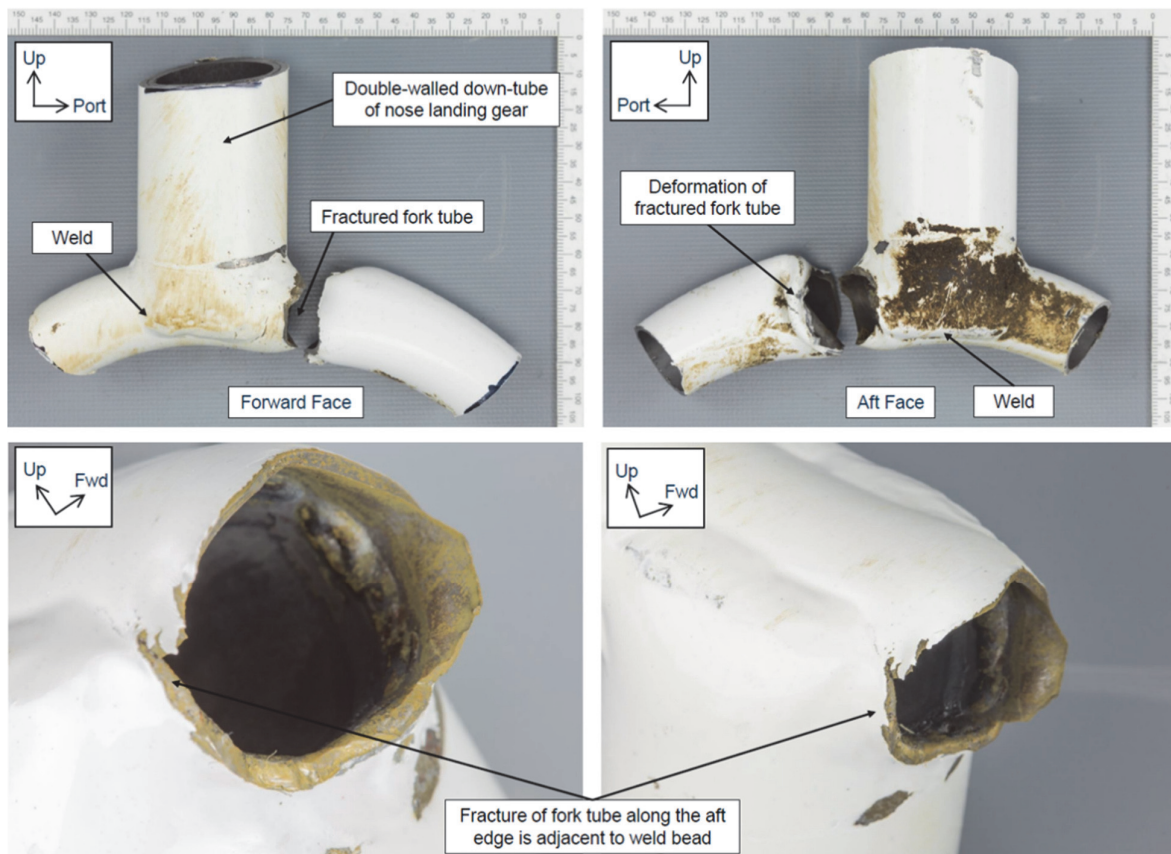
Figure 3

The fractured section of the nose landing gear fork was subjected to a metallurgical examination, which revealed that the left fork tube had bent rearwards during the failure, at the point where the fork tube was attached to the down tube by a welded joint. The rear section of the welded joint between the fork and the down tube had failed in ductile overload close to the edge of, but within, the weld bead (Figure 3). The front section of the left fork tube had failed in ductile overload outside the welded area.

Fractured section of the nose landing gear fork tube (image courtesy of QinetiQ)

Some light corrosion was evident across the fracture surface although there were no heavily corroded areas as might be expected with a pre-existing crack in the fork. There was also no evidence of progressive crack growth in the fracture surface.

The metallurgical examination of the nose landing gear left fork determined that the fork had failed in overload, due to being subjected to loads in excess of its design strength. It also found that there were no material defects or progressive cracking present that may have contributed to the failure.

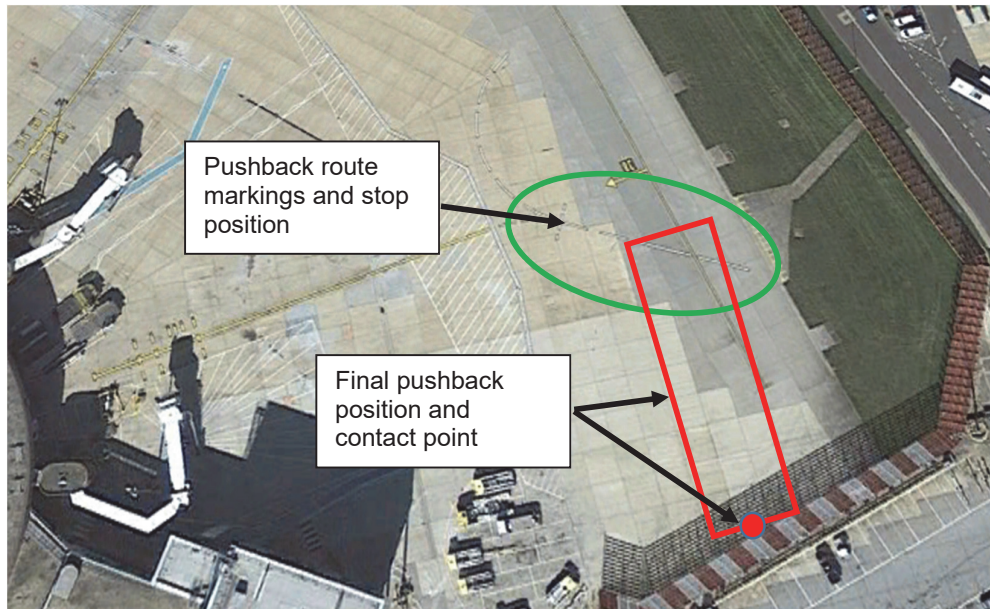
Figure 3

the intention of directing him to pull the aircraft forward into the correct position but, before this could be done, the aircraft tail cone struck the blast screen. The final position of the aircraft is shown at Figure 3.

Final pushback position

The APU exhaust fairing was subsequently found to be damaged.

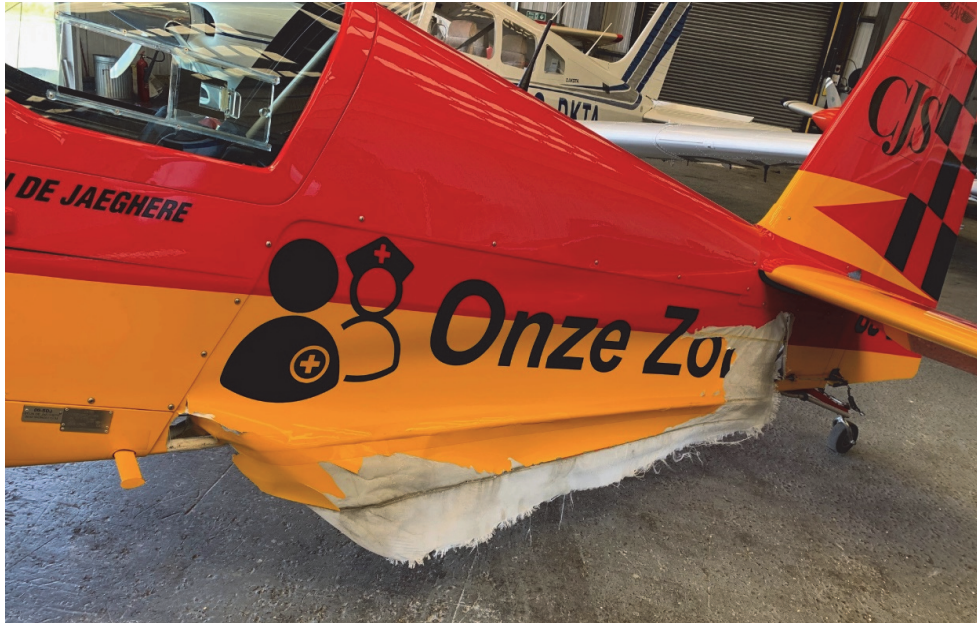
Figure 1

The pilot was performing an aerobatic flight overhead of Wickenby Aerodrome, Lincolnshire. Approximately ten minutes into the flight, whilst performing a vertical climb manoeuvre, he felt a significant vibration in the left rudder pedal. He immediately aborted the manoeuvre and brought the aircraft into level flight. He reduced the speed and monitored the level of vibration, which did not significantly diminish. He therefore decided to land the aircraft. After landing the pilot found that the fabric that covered the rear fuselage had ripped and that the loose fabric had been flapping in the airflow around the left side of the fuselage, inducing the rudder vibration (Figure 1).

Rear fuselage of OO-SDJ showing extent

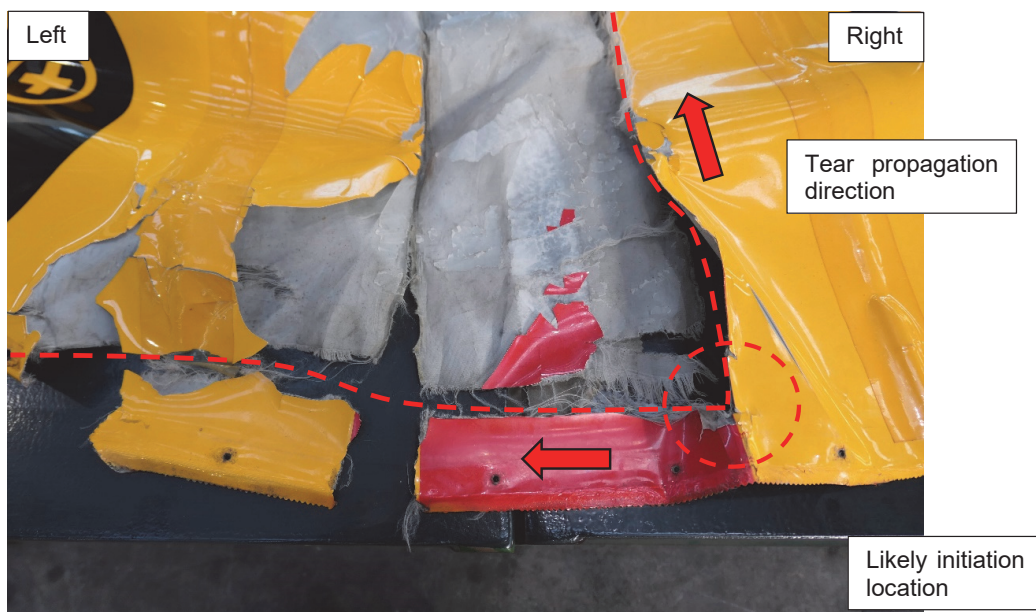
Figure 2

The Ceconite 102 fabric was removed from the aircraft and sent to the AAIB for further examination. This identified that the failure was likely to have initiated at the front of the fabric panel adjacent to the right lower stringer which runs along the tubular steel spaceframe rear fuselage. Initially a lateral and axial tear is likely to have occurred, which would have progressed rearward along the stringer (Figure 2), until it met the skin surrounding the tail cone. The cause for the initial material failure could not be positively identified.

OO-SDJ removed fabric.
