AAIB Bulletin

4/2020

Published 9 April 2020

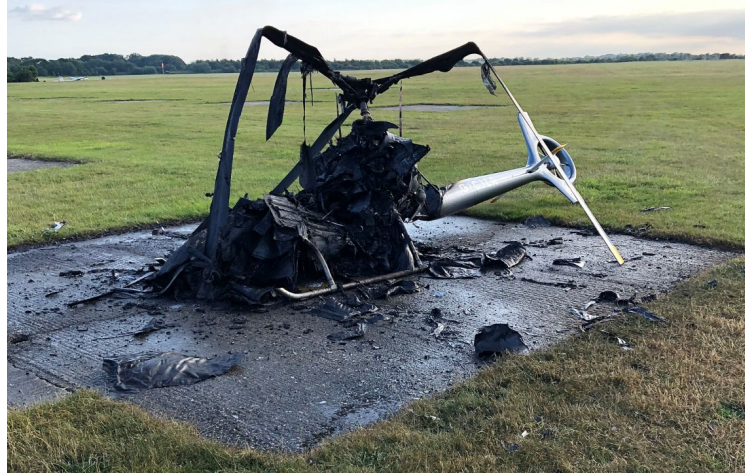
Figure 1

The helicopter was located at helicopter landing pad 10 at Wycombe Air Park. The entire helicopter, except the tail boom had been consumed by fire (Figure 1).

G-CILR prior to being moved

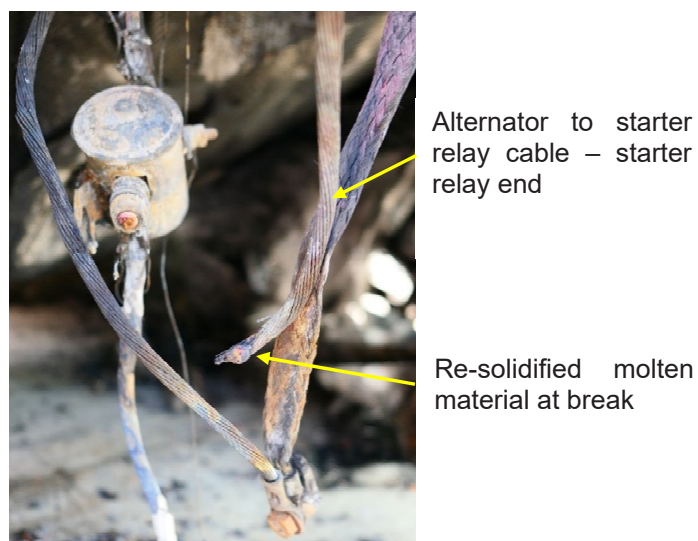
Figure 2

The engine remained attached to its support frame. The battery had been destroyed, however the electrical cables that had been connected to the battery were present. The insulation on the cables had been consumed by fire. The cable connecting the alternator output to the starter relay in the battery compartment was found to be in two pieces. Where it had broken the cable material had fused together, creating a globule of re-solidified molten material (Figure 2). Both ends of the broken cable was removed from the wreckage and taken to the AAIB for further assessment. A section of the helicopter's power generation and distribution circuit diagram can be found in Figure 3.

Helicopter cables within the wreckage

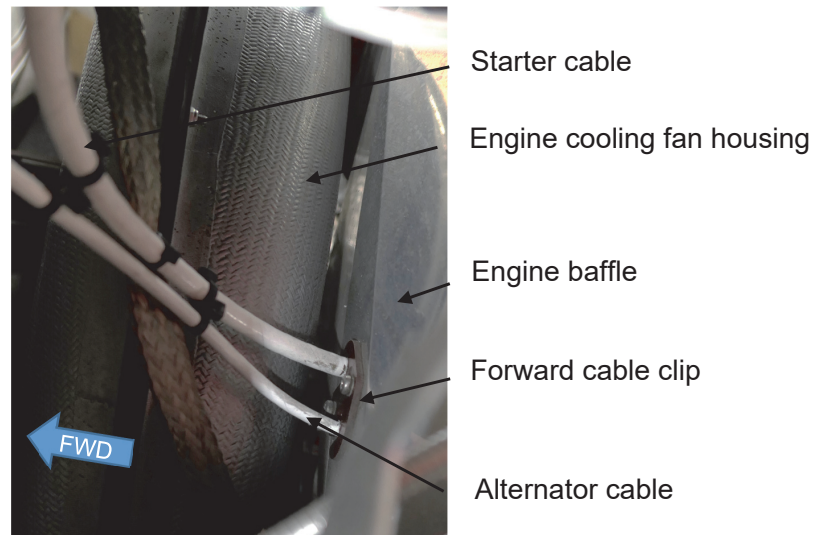
Figure 6

A cooling fan, with a carbon fibre housing, is mounted in front of the engine baffle (Figure 6).

Starter and alternator cables passing through front of engine baffle (view from below)

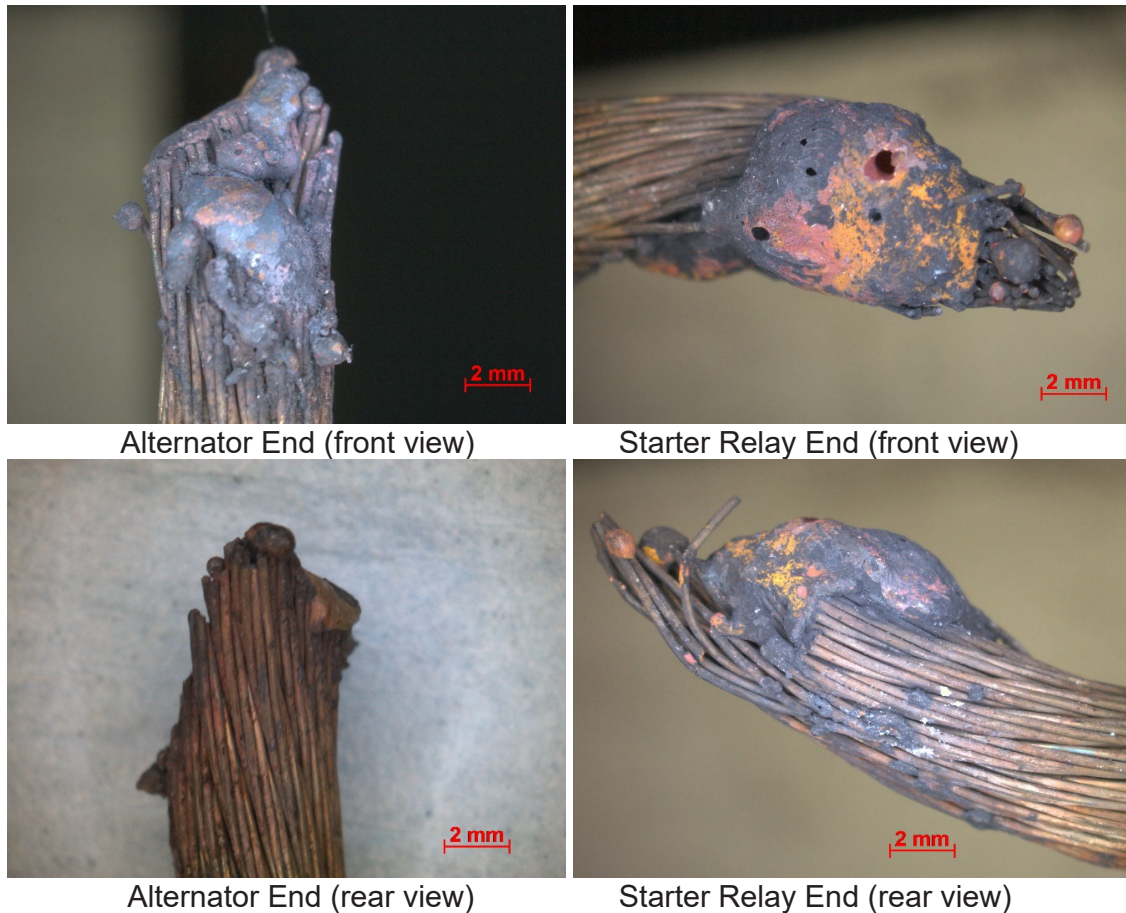
Figure 7

Laboratory analysis of the cable removed from the aircraft found that the re-solidified molten material (Figure 7) was predominantly copper and nickel, the material of the cable itself. The cause of the fusing was as a result of extreme localised heating associated with electrical arcing. There were no traces of any other metallic elements within the re-solidified molten material to identify the component that the cable had arced against.

Measurement of the cable fragments against a cable of the same part number from another Guimbal Cabri G2 identified that the location of the break was coincident with the location that the wire passed through the aluminium baffle. The baffle on G-CILR had been destroyed in the fire and therefore could not be examined as part of the investigation.

Alternator cable break location

The laboratory analysis of the failed alternator to starter relay cable confirmed that localised heating of the cable was associated with arcing. The location of the failure along the length of the cable was coincident with where it passed through the aluminium baffle; therefore, the baffle is most likely to have been the component that the cable arced against. The arcing will have heated the aluminium baffle material and generated sparks. This would have been sufficient to ignite the cotton impregnated phenolic clips and then the carbon fibre fan housing forward of the engine baffle. Once the fan housing had ignited the fire would have propagated quickly.

To allow the core of the cable to contact the aluminium baffle, the cable must have been able to move against the baffle. This could have been due to the clipping either failing, being installed incorrectly or not being present at all. Once the cable had contacted the

The subject cable uses a polymer tape insulation wound around the wire bundle. The insulation was consumed during the fire but was probably cut or worn away by contact with the edge of the hole.

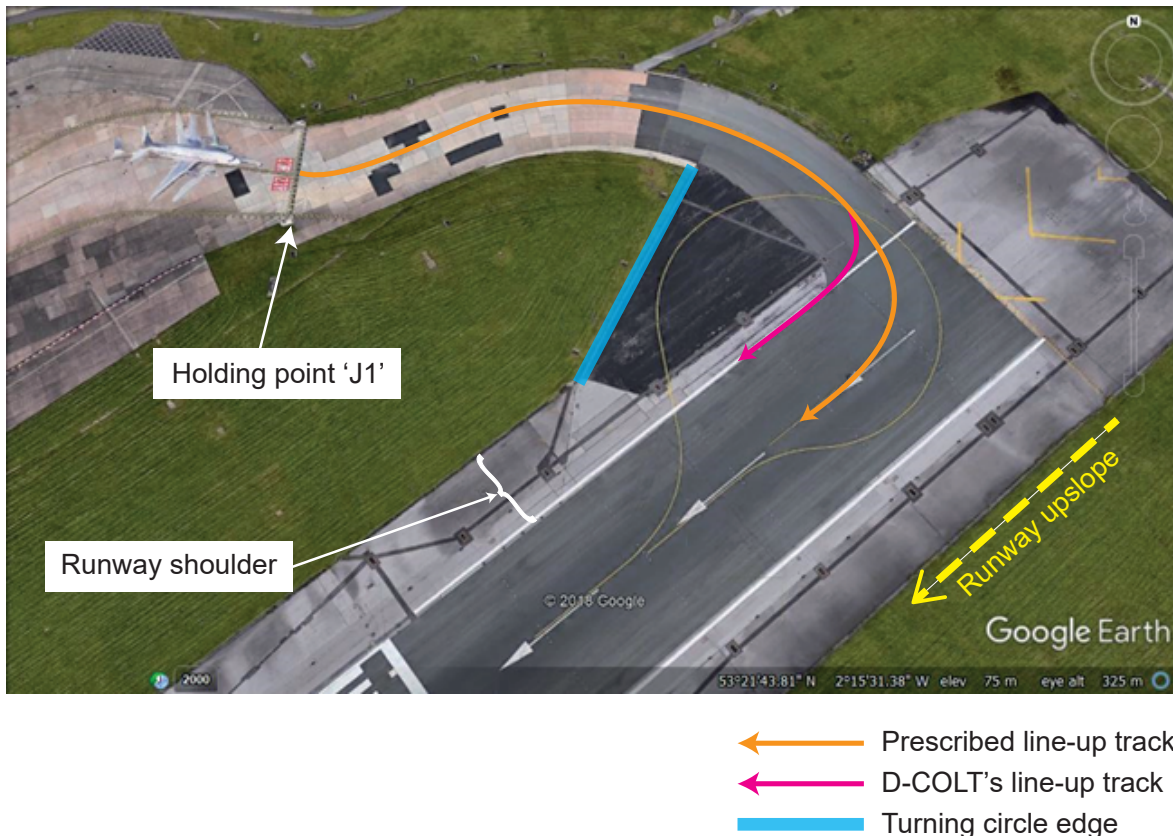
The pilot reported rain and gusty conditions. While he was lining up, the sun breaking through the clouds caused glare from the wet runway, making it difficult to see. As he taxied past the angled edge of the turning circle, he perceived it to be the edge of the runway shoulder² (Figure 1). Then on sensing that the aircraft was running over runway lights, he thought the aircraft was on the centreline. He turned the aircraft accordingly and was facing the low sun as he began the takeoff roll.

Figure 1
J1 intersection showing D-COLT's line-up track

As a result of the two occurrences the airport authority has undertaken to instate a 'runway excursion' hotspot at J1, in addition to the incursion-related hotspot 2. It is reconfiguring its lighting so that J1's lead-on lights will always illuminate when its stopbar is lowered, regardless of the ambient light conditions. It intends to apply green paint to the areas of the J1 turning circle outside of the runway edge lighting, giving the impression of grass.

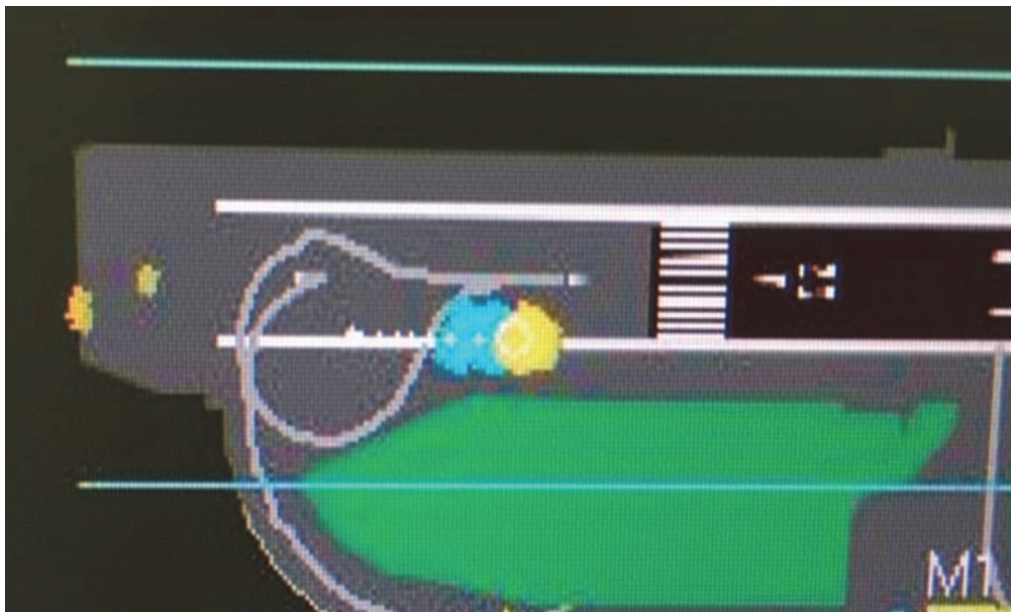
Figure 3

The ATCO reported that while he saw D-COLT moving on to the runway he was also monitoring the aircraft vacating the runway and the aircraft on final approach. The General Manager of the air traffic services unit (ATSU) reported that it can be difficult to determine the precise position of aircraft entering the runway at J1, which is some distance from the VCR and involves a large expanse of tarmac. The ATCO stated that in both occurrences he used SMR to confirm the aircrafts' positions (Figure 3).

Image of SMR at the commencement of D-COLT's takeoff roll
