AAIB Bulletin

5/2020

Published 14 May 2020

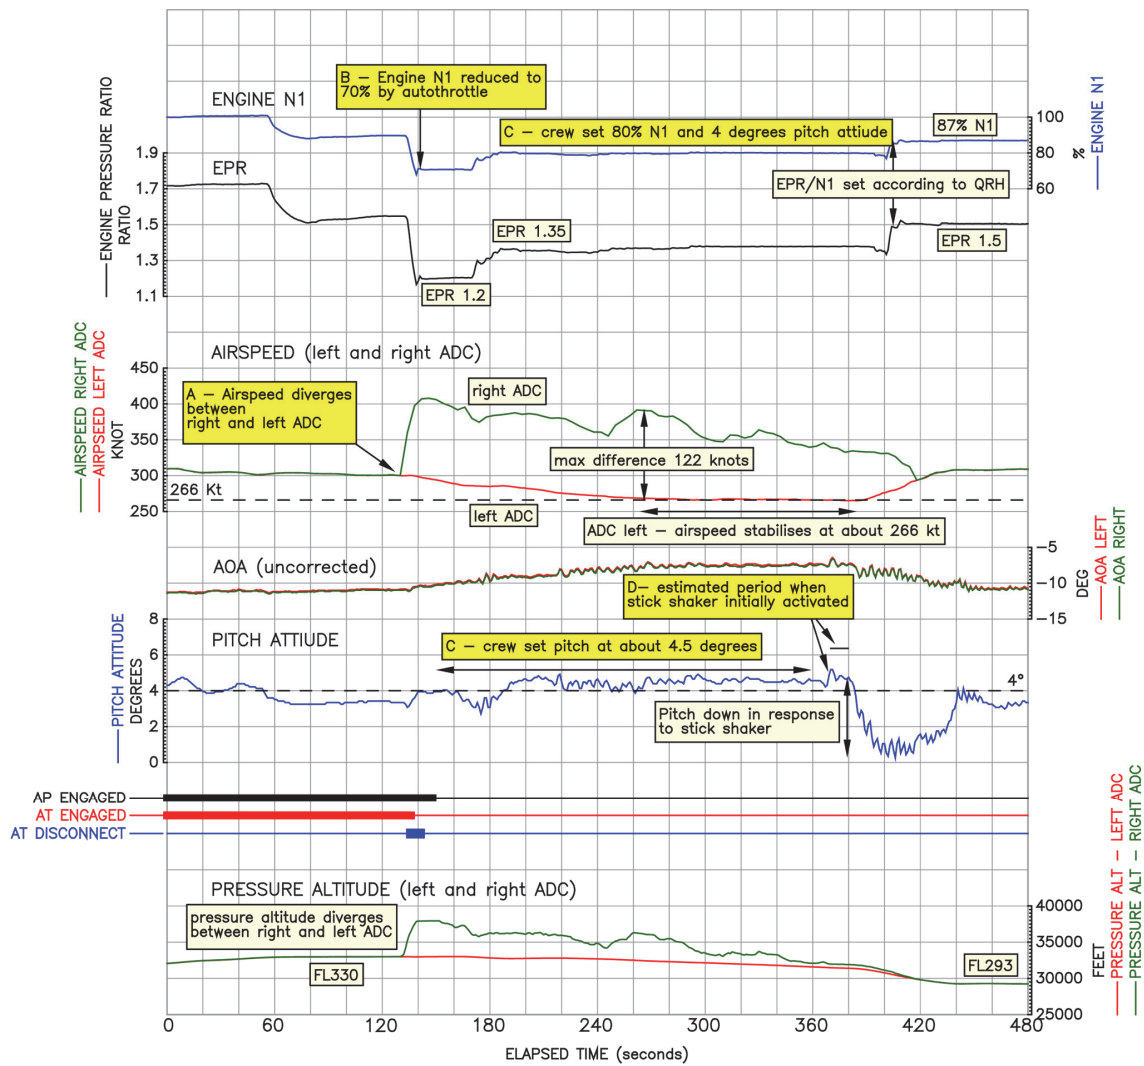
Figure 1

up with a corresponding increase in angle of attack. The airspeed and Mach number were 266 kt / 0.73 Mach respectively from the left ADC and 340 kt / 0.92 Mach from the right ADC. At about this time (Point D, Figure 1) the stick shakers were activated by the right stall warning computer. When the flight crew carried out the stall recovery manoeuvre the pitch was reduced to about 0.5° nose-up and engine thrust increased to 87% N1 (1.5 EPR). The pitch was then gradually increased to 4° nose-up, during which the airspeed and altitude deviation between the left and right ADC reduced to approximately zero. The aircraft was subsequently levelled at FL293 where the air data source was changed and the autopilot and autothrottle re-engaged.

Discrepancy between the right and left ADC

The malfunction of the right ADC was not identified despite extensive functional testing. It is likely that the false warnings had been generated erroneously as a result of an incorrect Mach number being supplied by the right ADC. This would then also have caused the stall warning system to operate erroneously at a safe airspeed.

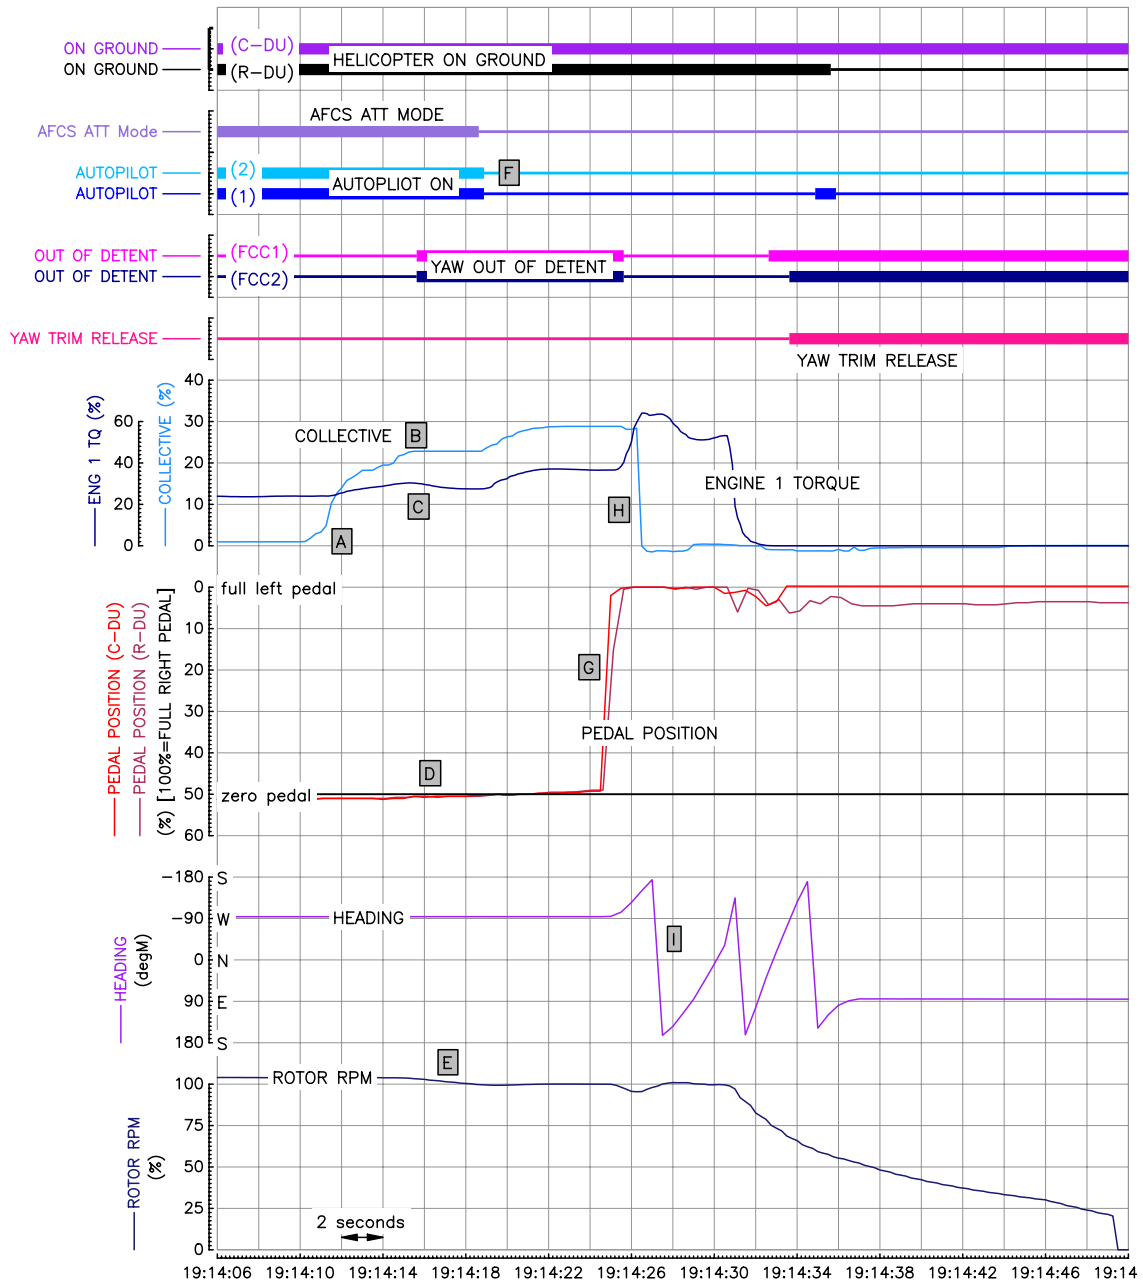
Figure 1
FDR data for 15 June 2018 event

1. The collective was initially raised [A] with the AP engaged (in ATT mode).
2. The collective was held at about 23% of its range of movement for approximately 3 seconds [B].
3. Total torque (the No 2 engine was at idle, so all torque was from the No 1 engine) exceeds 30% [C].
4. During the three seconds the collective was held at about 23%, the pedals started to drift left [D], the pedal status changed to a yaw out-of-detent condition, the rotor speed reduced to 100% [E] (rpm switch on the collective), and the AP disengaged [F].
5. The yaw out-of-detent condition remained for approximately ten seconds during which time the pedals moved to the left by about 1.5% of their full range of movement.
6. The pedals then suddenly moved to left maximum deflection [G] in about one second.

7. The yaw out-of-detent condition cleared, and the collective was lowered [H] within one to two seconds of the pedal movement.
8. The helicopter made two and a half rotations to the left in approximately ten seconds [I] during which time both engines were shut down.

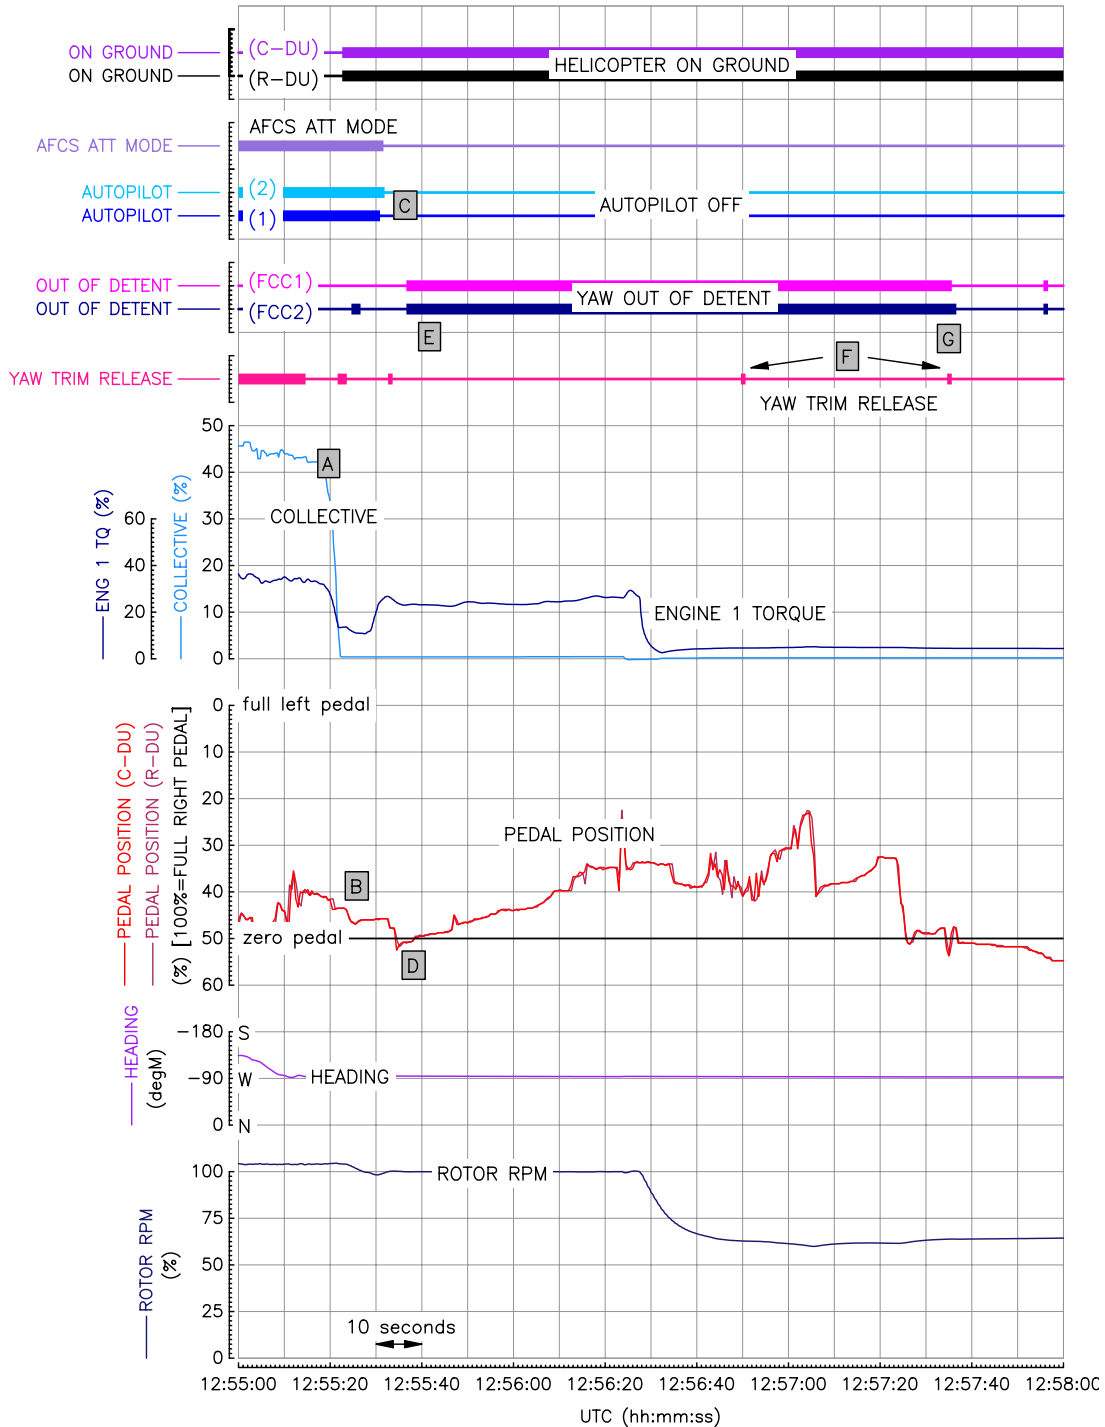
Figure 2
FDR data for 2 January 2019 event

The key points shown in Figure 2 are:

1. The collective was lowered on touchdown [A].
2. A little left pedal input was made and held [B] as the AP was disengaged [C] ten seconds after touchdown.
3. A very brief right pedal input was made [D] before the pedals moved left and a yaw out-of-detent condition was detected [E].
4. The yaw out-of-detent condition remained active for nearly two minutes during which the TRIM RELEASE button was pressed on at least two distinct occasions [F].

5. The yaw out-of-detent condition cleared after the second of the TRIM RELEASE button presses [G].

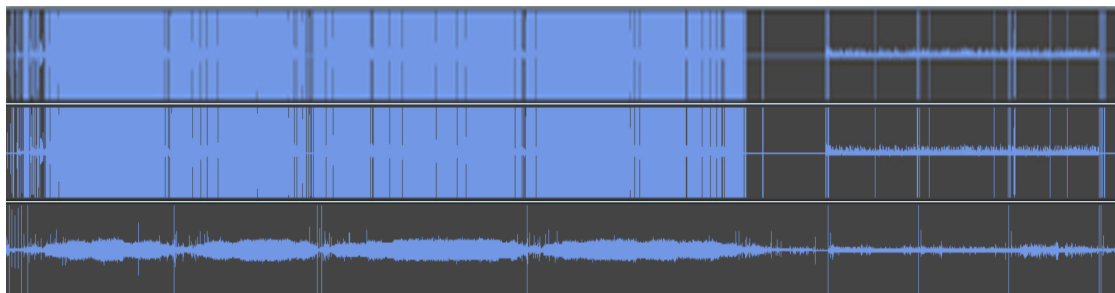
When listening to the CVR recordings for the January 2019 event, audio clipping was heard on both crew channels when the crew were speaking. Audio clipping is a form of waveform distortion where the amplitude of the signal waveform has been limited; for speech signals, this can affect the intelligibility⁴. No clipping during flight was evident on the cockpit area microphone (CAM) channel. Figure 3 shows the signal waveforms for the three channels for the two-hour duration of the CVR recording.

Signal waveforms for the three channels of CVR recording showing the two clipped crew channels (top and middle) and the CAM channel (bottom)

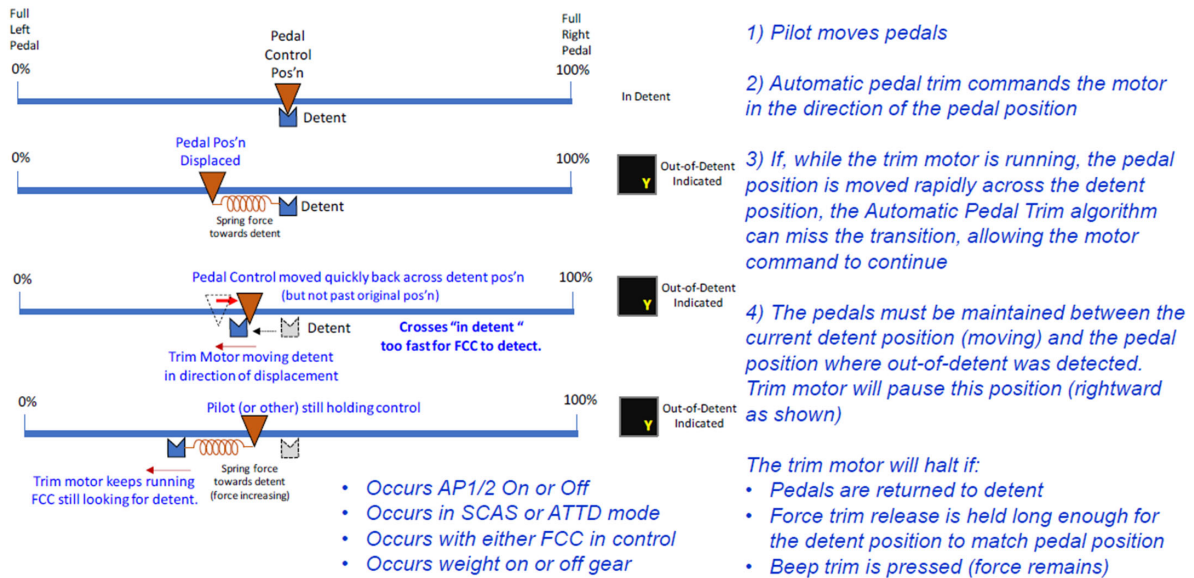
Figure 9

The manufacturer recreated the runaway scenario on another Bell 429 helicopter and, after reviewing the design, concluded that it was a feature of the AFCS logic (Figure 9).

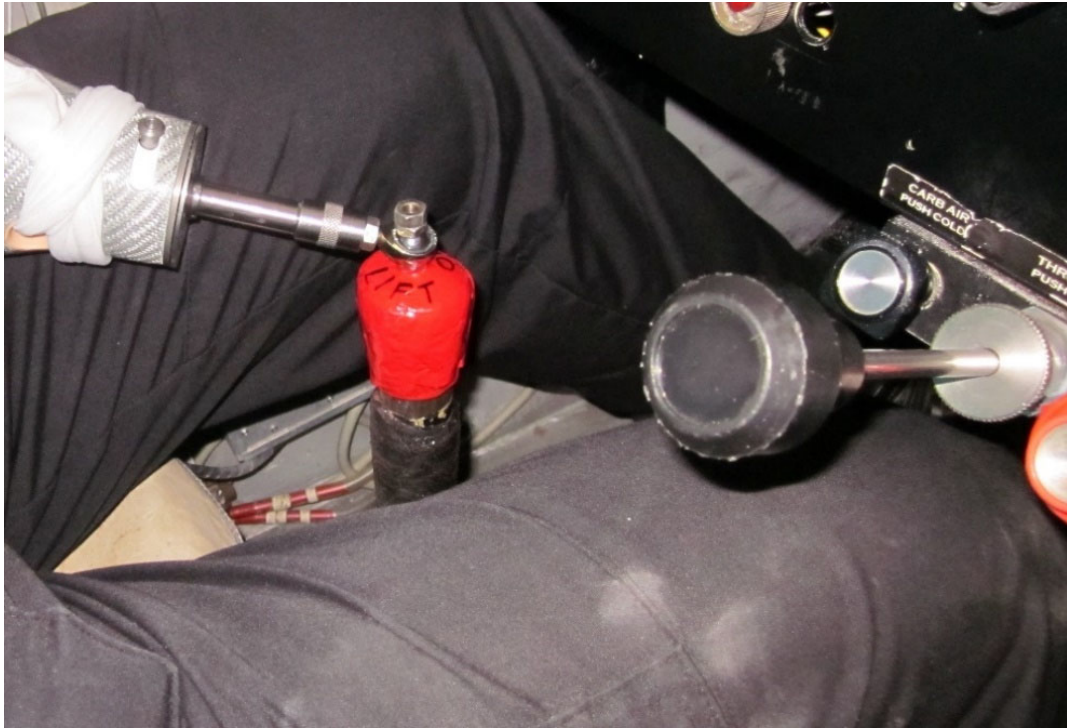
Figure 1
Prosthetic adapter in use

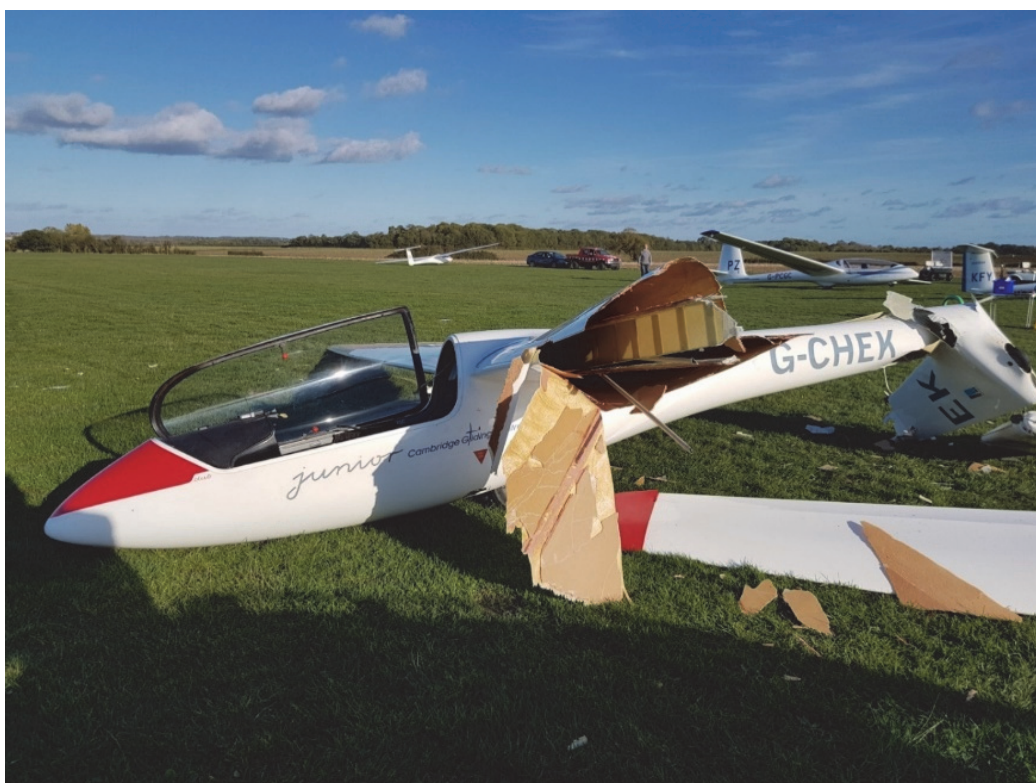
Figure 1

G-CHEK SZD-51 glider showing damage to the tail and left wing

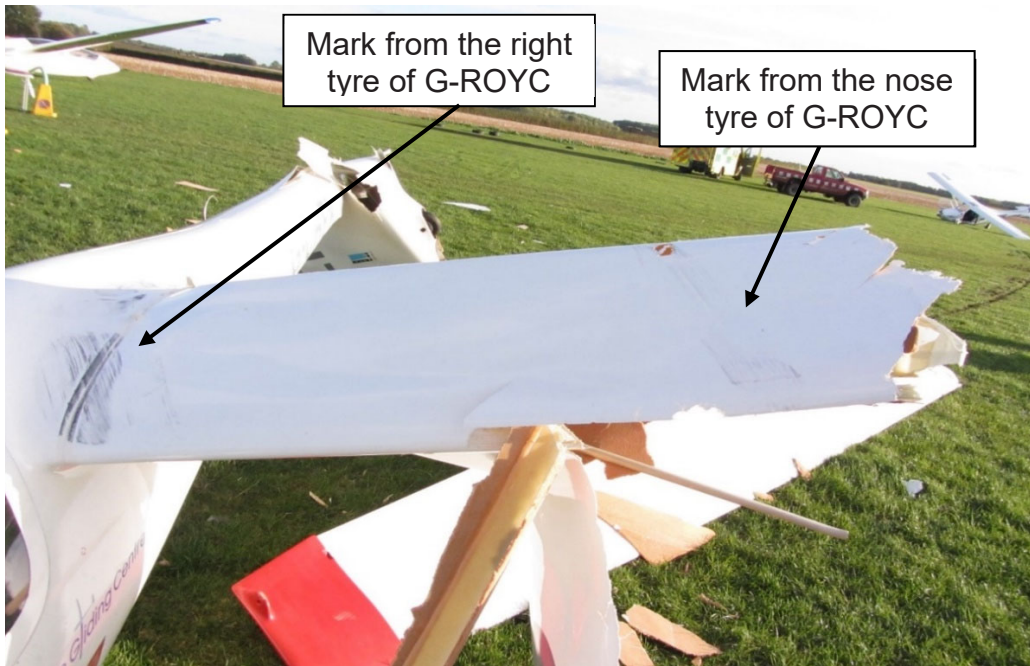
Figure 2 shows the left wing of the glider with marks from the tyres of G-ROYC. Measurement of the marks show that the right tyre of G-ROYC passed just behind the canopy of the glider. Figure 3 shows the final position of G-ROYC. Figure 4 shows G-ROYC after the accident with the flaps fully retracted.

Left wing of G-CHEK showing tyre marks left by G-ROYC

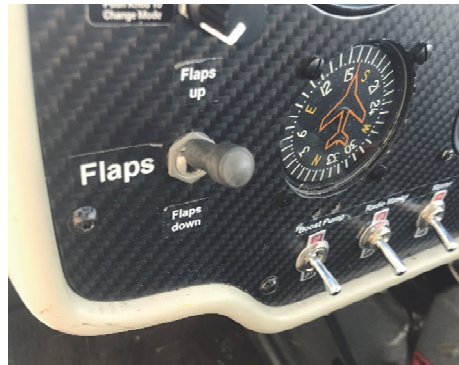
Figure 8

G-ROYC flap switch (as found after the accident)

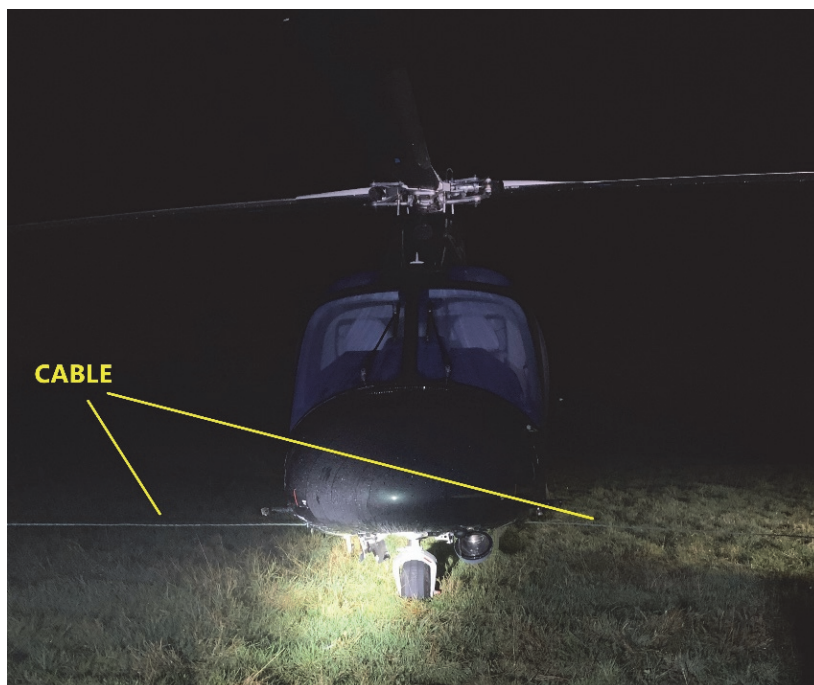
Figure1

The aircraft sank onto the cables from above at very low speed. The commander brought the aircraft to a hover, moved backwards to clear the cables and then landed. All those on board were uninjured. The commander exited through the co-pilot's door as his own door was obstructed by a length of cable which had become entangled on the aircraft. The aircraft with the cable entanglement is shown at Figure 1.

Aircraft with cable entanglement

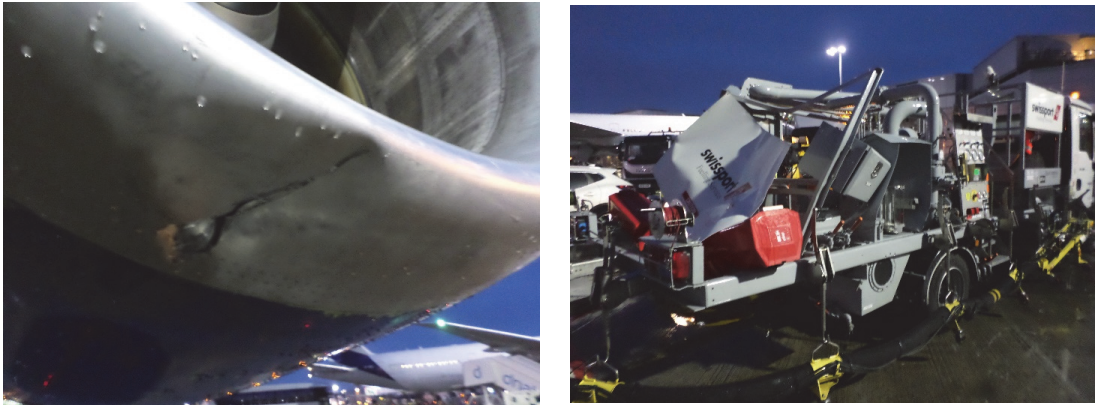
Figure 1

Damage to G-CIVU No 1 engine cowl and rear of the Fuel Transfer Vehicle

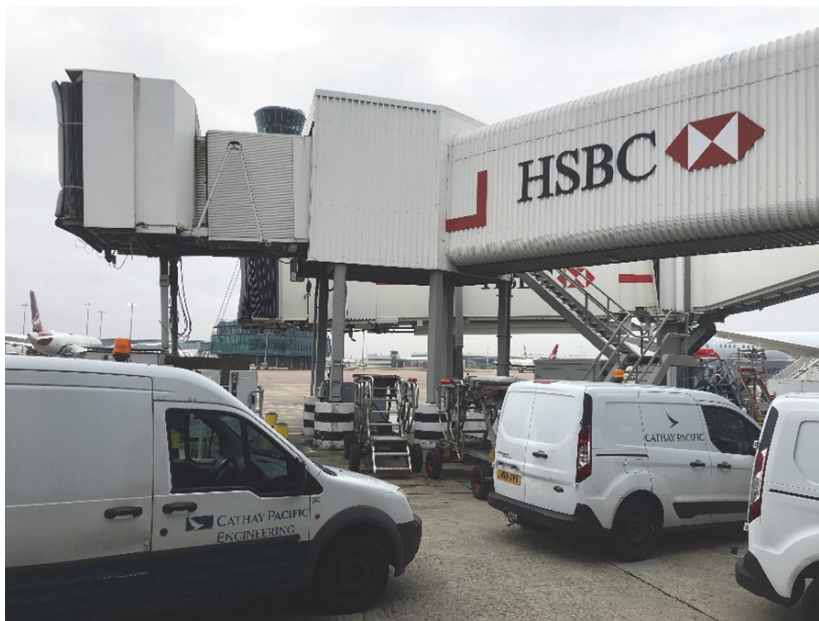
Figure 4 is a photograph taken from the emergency stop button position at the head of the stand looking towards the right where the FTV was parked. The photograph shows the obscured view in that direction.

View to the right of the stand from Emergency Stop Button Location

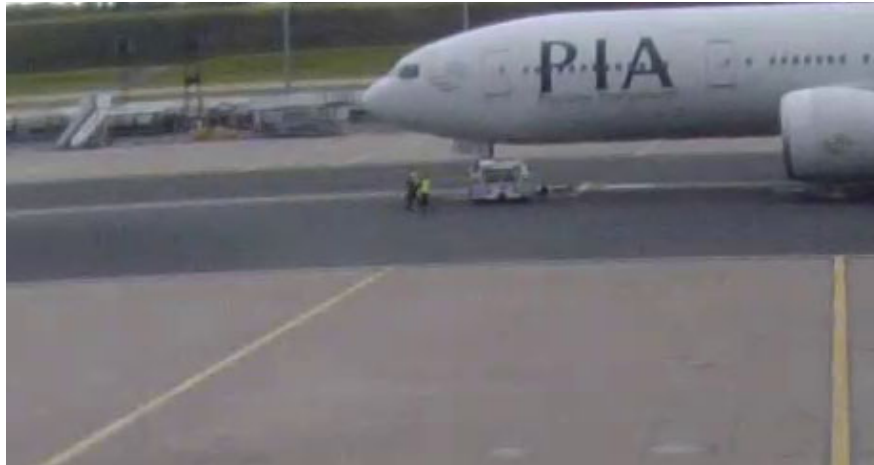
Figure 3

AP-BGZ runs over the towbar

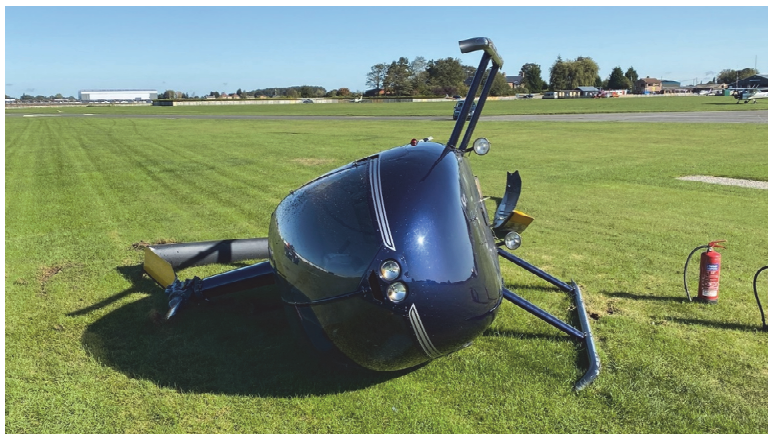
The pilot was able to vacate the helicopter via the left door although he had suffered a head injury. The helicopter was damaged beyond economic repair. Figure 8 shows G-LLIZ after the accident.

Figure 8
G-LLIZ after the accident

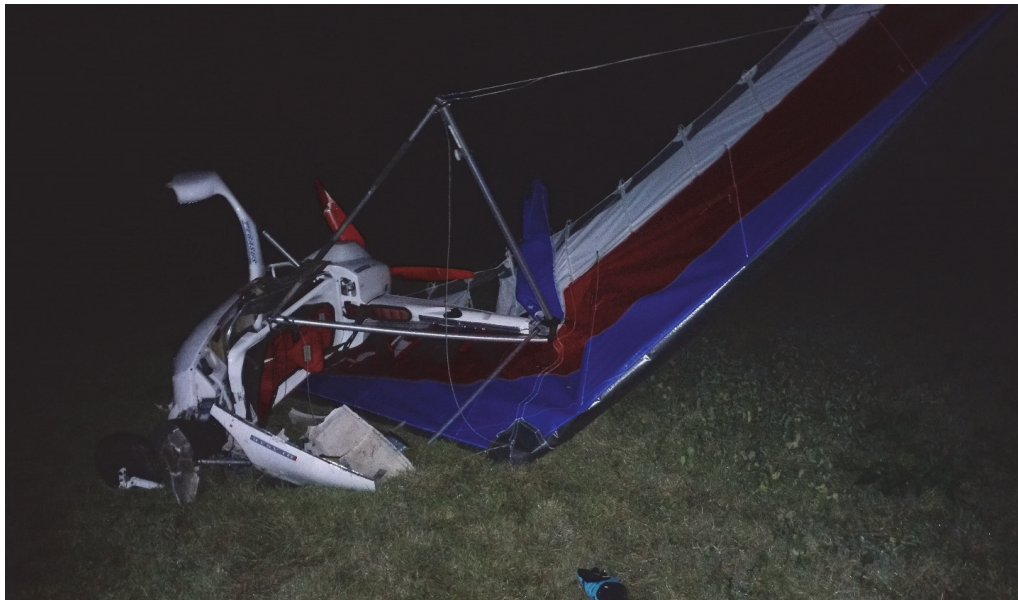
The accident occurred because the pilot departed too late in the day and was delayed by navigational difficulty until it was dark. He decided to perform an emergency landing, but it was too dark to see and avoid power lines on the approach to his chosen field.

Figure 2
G-MYJT after the accident
