**AAIB**  
Air Accidents Investigation Branch

# ***AAIB Bulletin***

# ***6/2020***

Published 11 June 2020

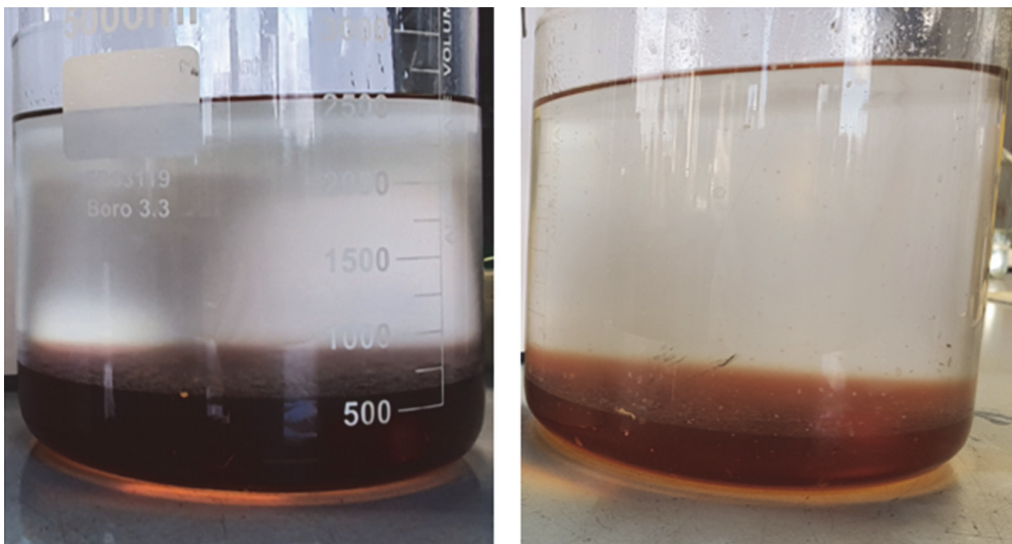
Following the serious incident, fuel samples were taken from the left and right wing fuel tank water drain valves and were subjected to laboratory analysis. When the fuel was tested it was found not to comply with the JET A-1 specification requirements<sup>2</sup> for appearance

*'The results indicate contamination with undissolved Kathon. It was noted that the bottom layer that is mostly Kathon plus some unknown products and water, suspected to be causing the darker colour than the reference Kathon sample. This is likely due to the glycol type solvent used in Kathon product dissolving polar materials from the fuel and fuel tank surfaces. This may be analogous to observations with another similar glycol additive, FSII (Fuel System Icing Inhibitor), which is used in military jet fuels. It is colourless but forms brown additive/water layer in tank bottoms.'*

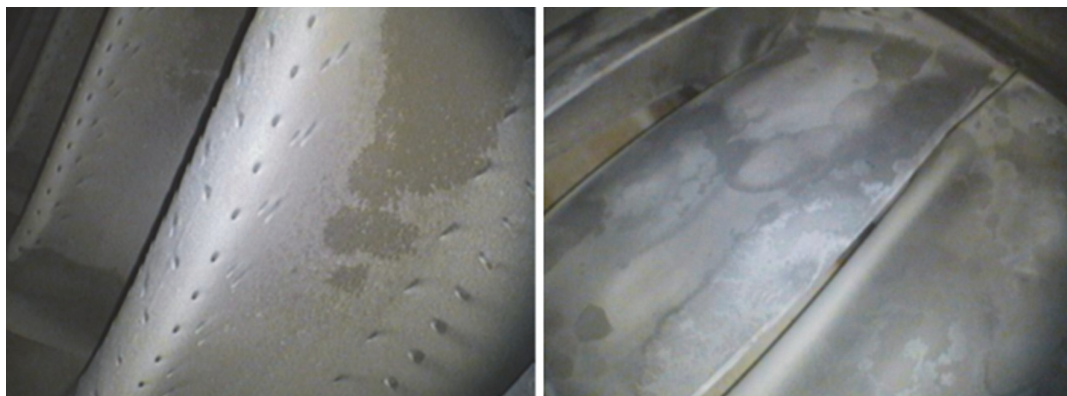
**Figure 5**

The aircraft's engines were examined visually using a borescope and both exhibited similar findings. There was no significant damage evident to the fan, low-pressure compressor or high-pressure compressor components, and any minor defects that were identified were within AMM damage limits. The combustion chambers, and high-pressure and low-pressure turbine blades were coated in a thin layer of white material that was observed on the turbine blades' convex surfaces (Figure 5). The high-pressure turbine nozzle guide vanes were also coated in the white material.

White material deposits on No 2 engine high-pressure turbine blades  
(No 1 engine similar)

The excessive level of Kathon in the aircraft's fuel system is suspected to have caused the subsequent problems with the aircraft's engines, including those experienced during the incident flight. The AAIB is also aware of other events where engine performance was affected by over-dosing of fuel with biocide. Visual inspection confirmed the presence of abnormal deposits within both engines downstream of the fuel spray nozzles. The influence of the over-dosed fuel on the engines' HMUs and other fuel system components is subject to the ongoing AAIB investigation.

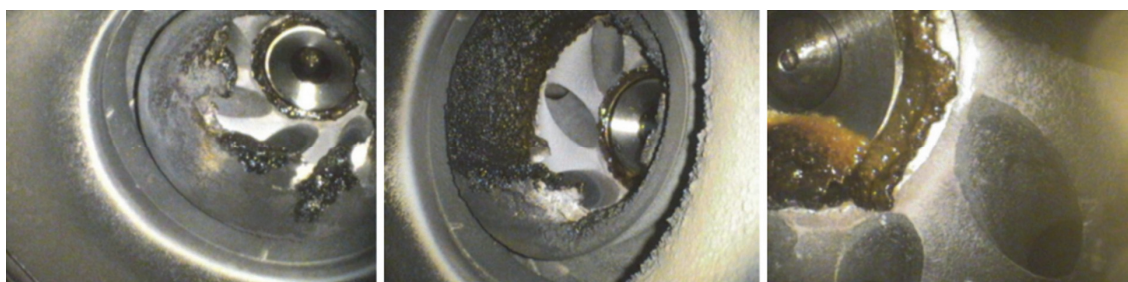
**Figure 6**

Significant deposits of a brown material were evident on all the combustion chamber swirl cups, adjacent to the fuel spray nozzles, in both engines (Figure 6).

Brown material deposits in No 2 engine combustion chamber swirl cups  
(No 1 engine similar)

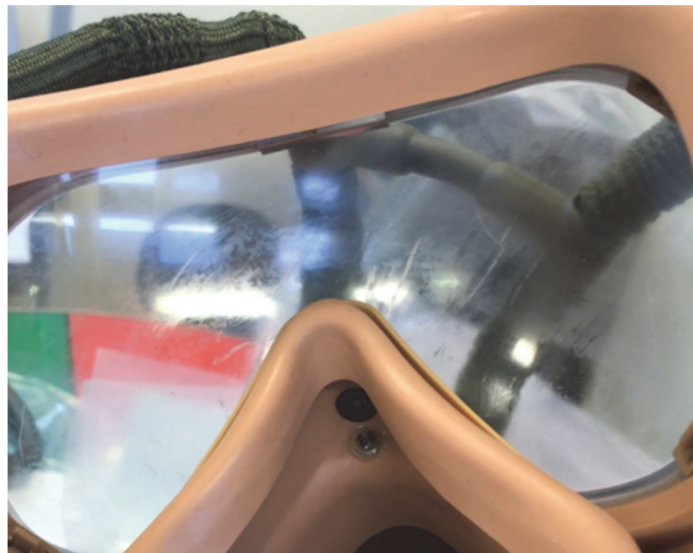
**Figure 3**

The co-pilot's external and internal lenses were reported to be in a "bad condition", with scratches present. The inner surface of the internal lens was sensitive to fogging (with non-uniform blurring reported), and fogging remained for a few seconds on the inner surface of the internal lens after exhaling on it. When fogging appeared on the inner surface of the internal lens, elongated shapes were visible that looked as though the surface had been wiped (Figure 3).

Co-pilot's mask showing fogging and marks on internal lens

The masks are likely to have misted up during the event due to a combination of the cold stowage compartment, a relatively warm cockpit, damage to the anti-fog coating and the crews' higher breathing rate.

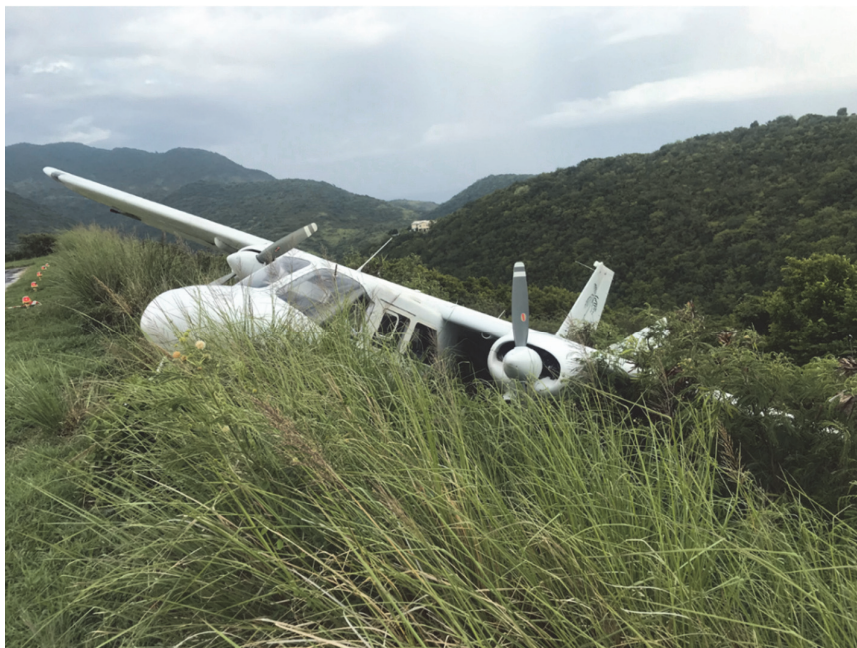
**Figure 1**  
Aircraft accident site

Faint scald marks made by the tyres on the runway showed the aircraft skidded approximately 150 m before veering on to the grass approximately 19 m from the end of the runway. The aircraft continued across the grass whilst braking, leaving discoloured tyre marks in the grass. The right main wheels struck one of the runway threshold lights. During the transit across the grass the aircraft rotated through 180° immediately before dropping backwards down the sloping side of the ravine at the end of the runway. The aircraft's rearward motion was slowed by dense reeds and bushes on the sides of the ravine. It stopped when the left tailplane and wingtip hit the barbed wire and chain link perimeter fence approximately 8 m below the level of the runway. As the aircraft stopped the Bendix-King KX165 Nav-Comm unit fell out of its rack mount onto the cockpit floor. Figure 1 shows the aircraft after the accident held by the fence and at an approximate angle of 30°.

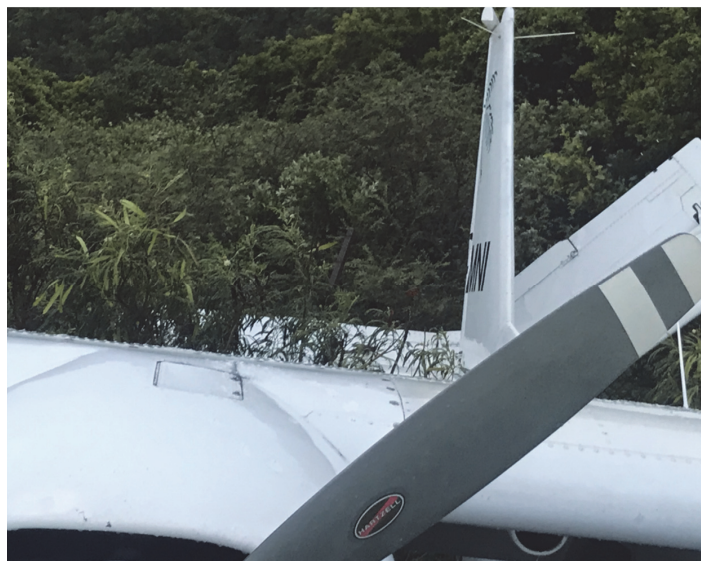
**Figure 3**  
Tailplane damage

Most of the damage was to components and structure at the rear of the aircraft. The left side of the tailplane main spar had broken at the root and was bent upwards (Figure 3). The elevator structure had also been damaged and bent in the same way. The rear anti-collision light had been displaced and was held only by its wiring. The left wingtip fairing and outer end of the aileron was dented and distorted.

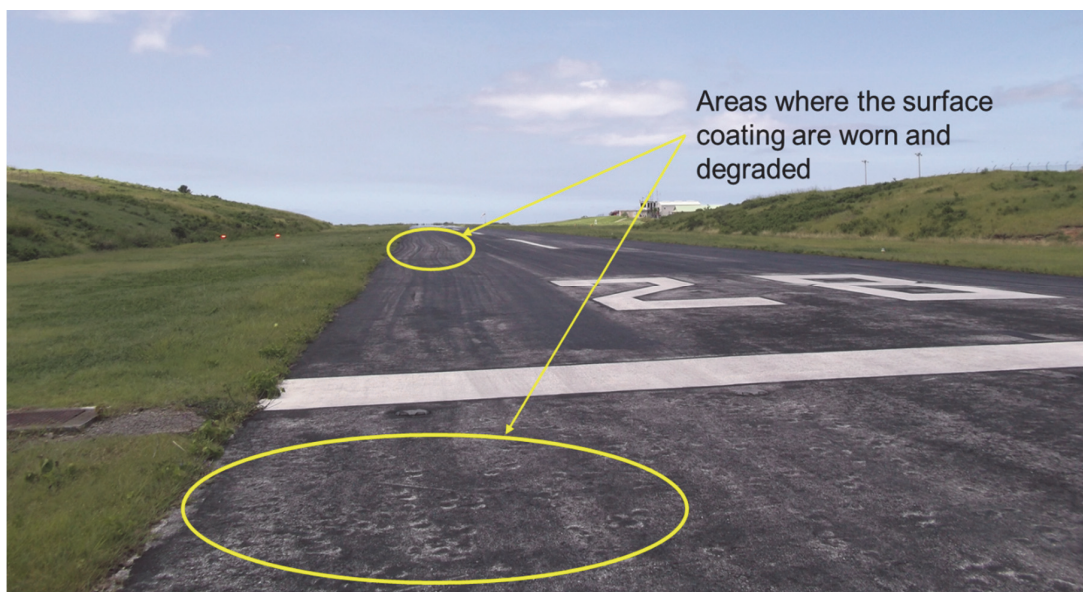
**Figure 7**

At the time of the accident the runway surface was described as ‘wet’, which is defined as the surface being soaked but with no standing water. Observers who visited the scene of the accident later in the day whilst the runway was still damp, described some of the areas at the ends and edge of the runway as “slippery under foot”.

Examples of areas of surface degradation on the runway

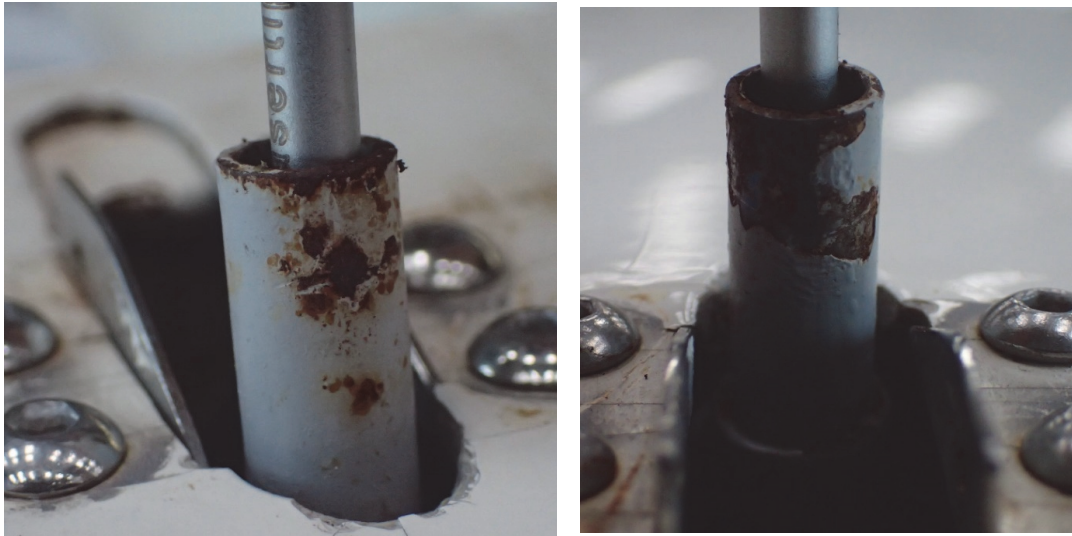
**Figure 9**

The tailplane was undamaged. The locking lever was protruding through the slot in the upper surface of the tailplane and was resting against, and forward of, the safety pin. Upon removal of the safety pin, the locking lever sprang back to its neutral position. The top of the locking lever in the area where it was in contact with the safety pin showed evidence of missing paint and surface corrosion, the extent of which was greater on the rear face of the lever (Figure 9). In normal operation the lever moves freely within the slot and does not come into contact with any other structure.

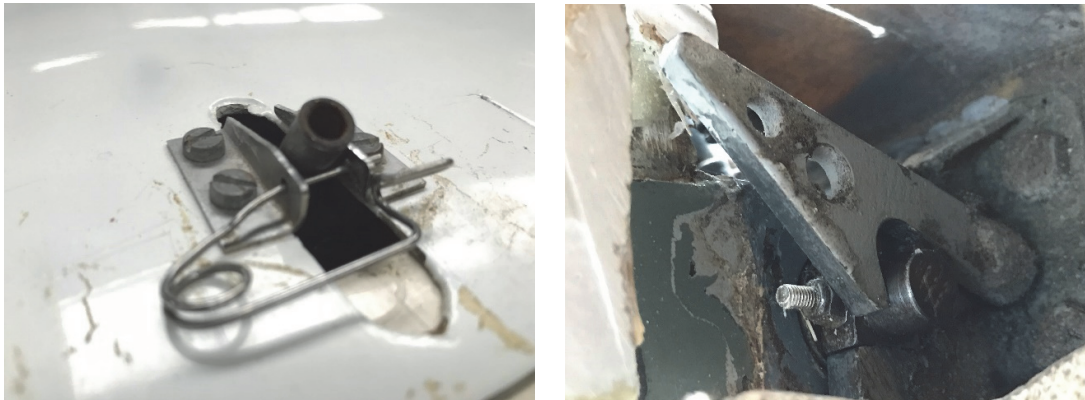
**Figure 11**

If the locking lever was moved forward instead of aft, the safety pin could be inserted behind it and the lever would then spring back to rest against the pin when released. The same condition could be achieved by installing the tailplane in the as-found condition, with the locking lever already resting forward of the safety pin. In both cases this resulted in the rear mechanism being engaged but not locked, as the pin prevented the lever from travelling aft to the fully locked position (Figure 11). In this condition the locking hooks were not fully engaged on the axle but the tailplane felt secure and could not be dislodged.

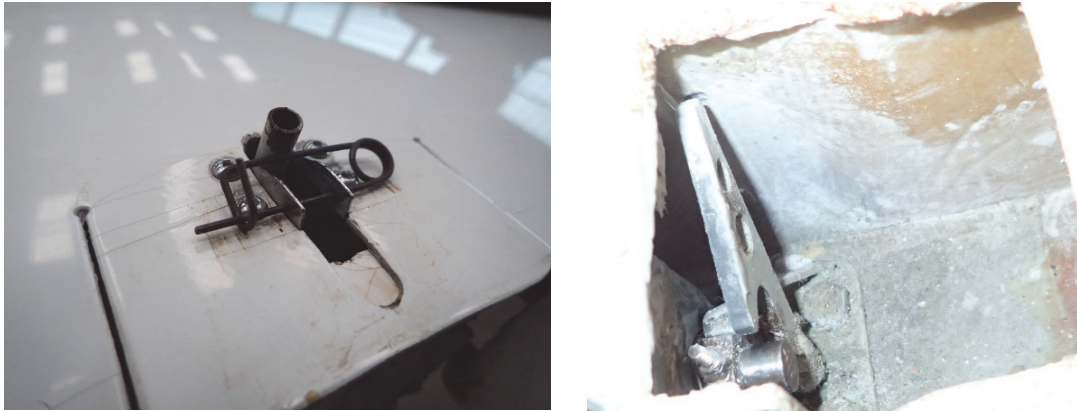
**Figure 12**

With the lever forward of the safety pin, it was possible to fold the safety pin forward such that the locking lever rested against the 'free' unrestrained arm of the safety pin (Figure 12). The lever was in a forward position and the locking hooks were not engaged on the axle, with the effect that the rear mechanism was entirely unlocked and the tailplane could easily separate from the fin. In this condition, the position of the unrestrained arm of the pin was somewhat tenuous as the spring force of the lever was acting to push it out of the way. It was demonstrated that movement or light force could cause the unrestrained arm of the pin to be dislodged, such that the lever sprung back against the restrained arm of the pin. Nonetheless a positive control check could be conducted without revealing any anomalies.

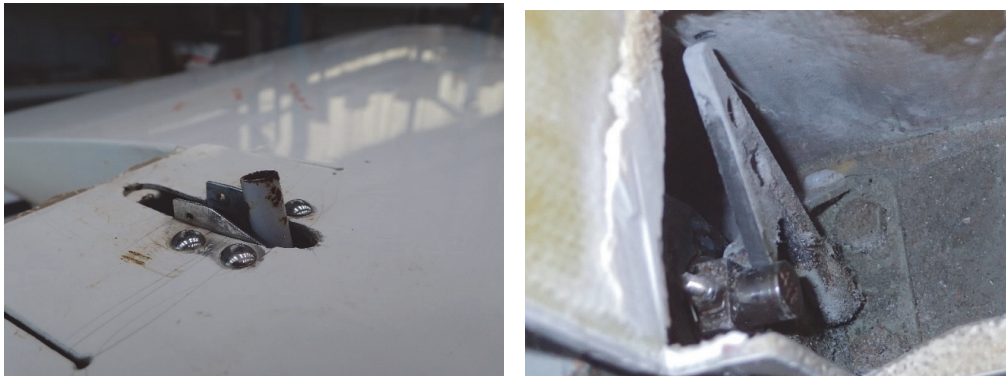
**Figure 14**

However, it was possible on G-DDGX to achieve a condition where the locking lever was in the fully forward position and the tapered bolt was only partially engaged in the front fitting (Figure 14). In this condition neither the rear mechanism nor the front fitting were properly

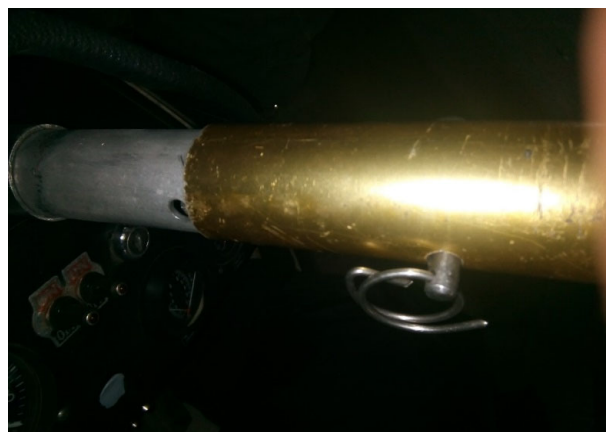
**Figure 3**  
Incorrect attachment

In this case, the pin passed through the strut tube but not through the attachment point. The holes on the attachment point would have remained visible, indicating an insecure strut, but this was not noticed either during rigging or pre-flight checks. The incorrect attachment is shown at Figure 3.

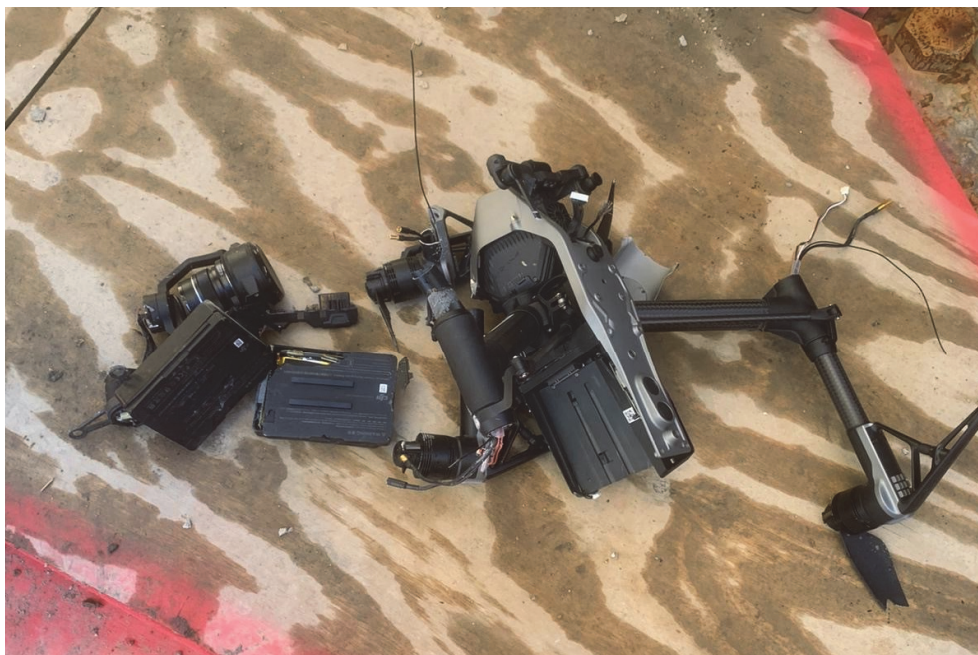
**Figure 2**  
Damage to the drone

had been set correctly. However, during the initial flight checks the drone became erratic. The remote pilot attempted to land the drone immediately but when the landing gear was lowered, control of the drone deteriorated further. An attempt was made to climb the drone and direct it towards the River Thames away from railways, roads and buildings close to the site, but it collided with a concrete core at the centre of the site where it fell within the sterile area. Figure 1 shows the TOAL for the first five flights (in blue), the TOAL used for the accident flight (in yellow), and the concrete core into which the drone collided. Figure 2 shows the damage to the drone after it fell to the ground.
