AAIB
Air Accidents Investigation Branch

AAIB Bulletin

7/2020

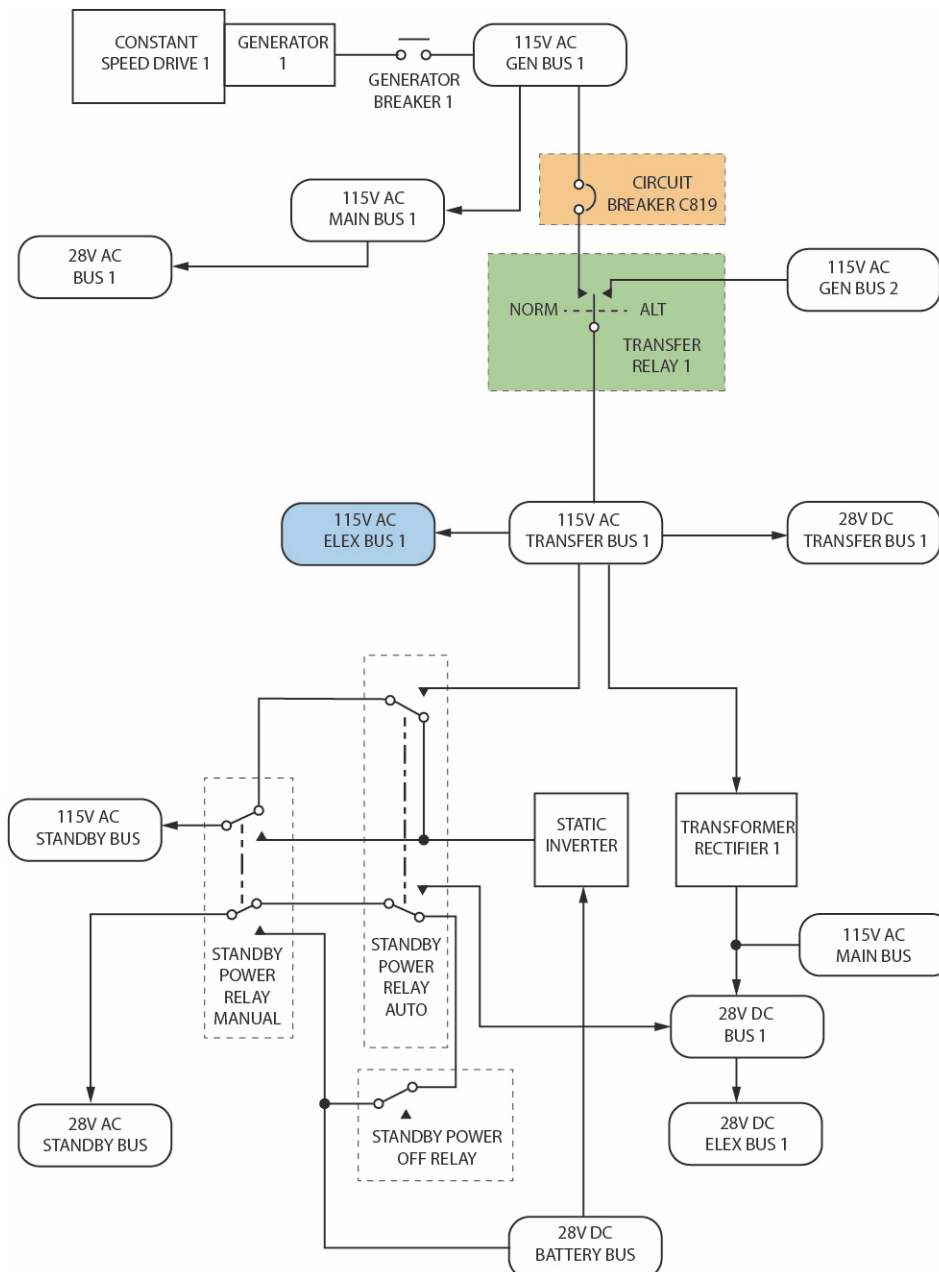
Figure 2

Schematic of electrical power system

All the aircraft systems that failed during the flight either received their electrical power directly from the 115v AC Elex Bus 1 (Figure 2) or were provided with data from Air Data Computer 1 (ADC1), which was connected to this bus. Electrical power to the EGPWS and radio altimeter would also have been lost which meant there would be no reactive windshear warnings, or automatic height call outs and alerts. The CVR and FDR also received their electrical power from the 115v AC Elex Bus 1.

The failure of the 115V AC Transfer Bus 1 resulted from a fault in the transfer relay which caused circuit breaker C819 to open with the loss of electrical power from Gen Bus 1 to Transfer Bus 1. This resulted in the loss of electrical power to ADC 1, the primary EFIS displays and analogue instruments on the left side of the cockpit.

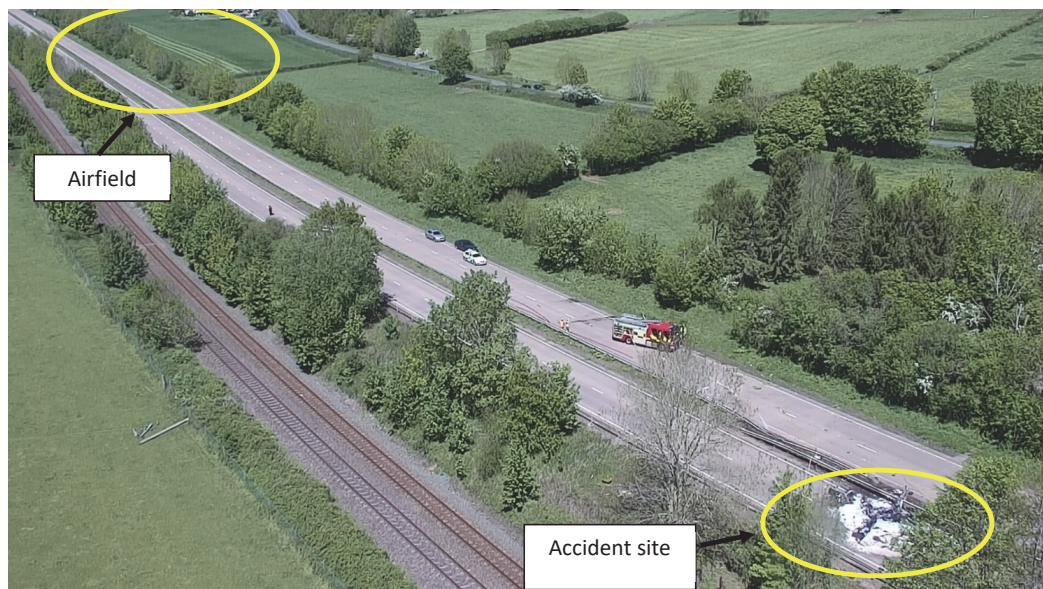
Figure 1

Accident site with Abergavenny Airfield in the background

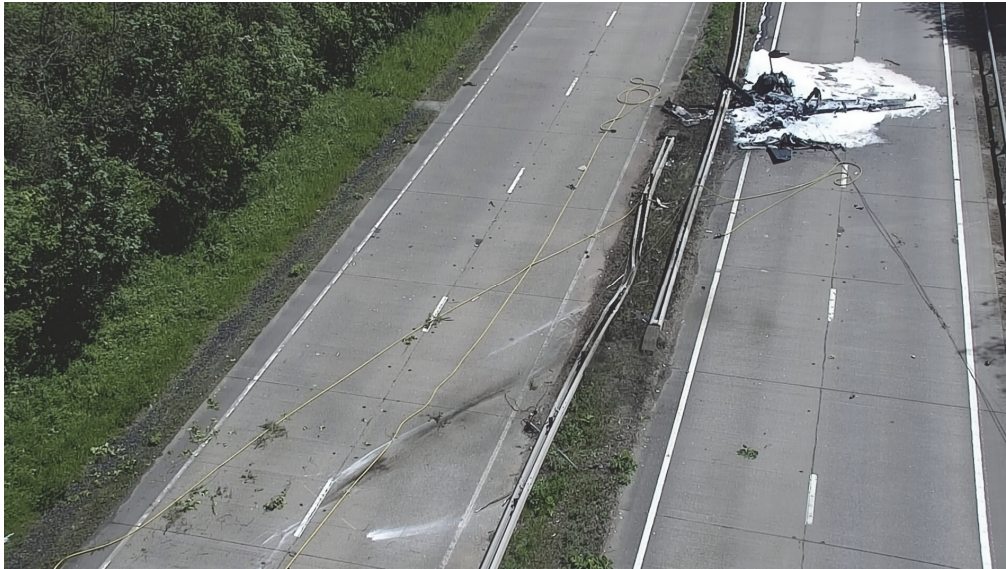
The aircraft came to rest against the central reservation barriers of the northbound carriageway of the A40 approximately one mile south of Abergavenny, Monmouthshire. There were clear witness marks on the carriageway indicating that the aircraft slid from the initial impact point to its final resting place. Figure 3 shows the accident site and the marks on the road.

Accident site showing the ground marks

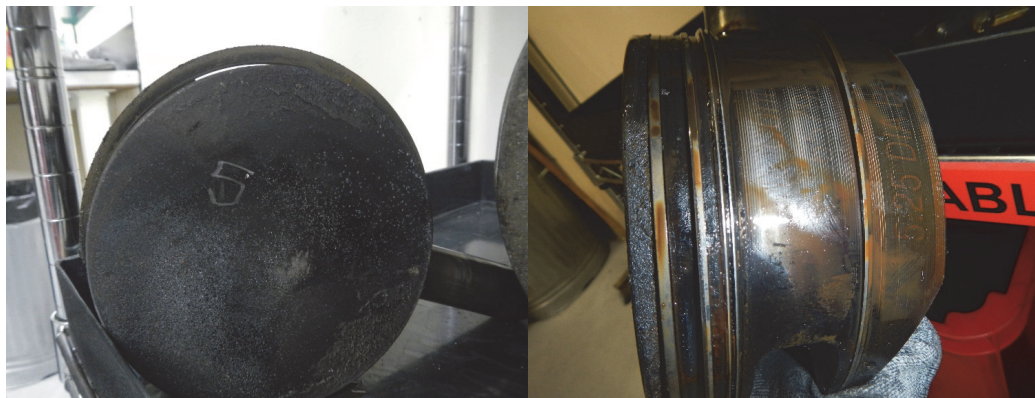
Figure 6

All six cylinders remained attached to the crankcase and produced compression when the crankshaft was manually rotated, and all rockers/valves moved normally. None of the cylinders' internal components showed any significant combustion deposits. On removal it was seen that all cylinder heads and intake valves were covered in black soot. Cylinder No 5 also displayed evidence of lean-mixture piston head and cylinder head erosion as shown in Figure 6.

Cylinder No 5 showing the dark soot deposit and the lean-mixture piston face and cylinder head erosion

The pilot’s description, together with the soot on the cylinders and intake valves, suggested the engine was running with a rich fuel mixture (over-fuelling). However, the engine itself revealed a longer-term issue with magneto timing, lean running (under-fuelling) and spark plug damage. These longer-term faults could all be linked with the magneto timing issues causing both the spark plug damage and the cylinder damage but could not explain the engine malfunction on the day of the accident. The longer-term faults may have eventually caused a loss of power on the engine, but they were not the cause of the failure on the accident flight.

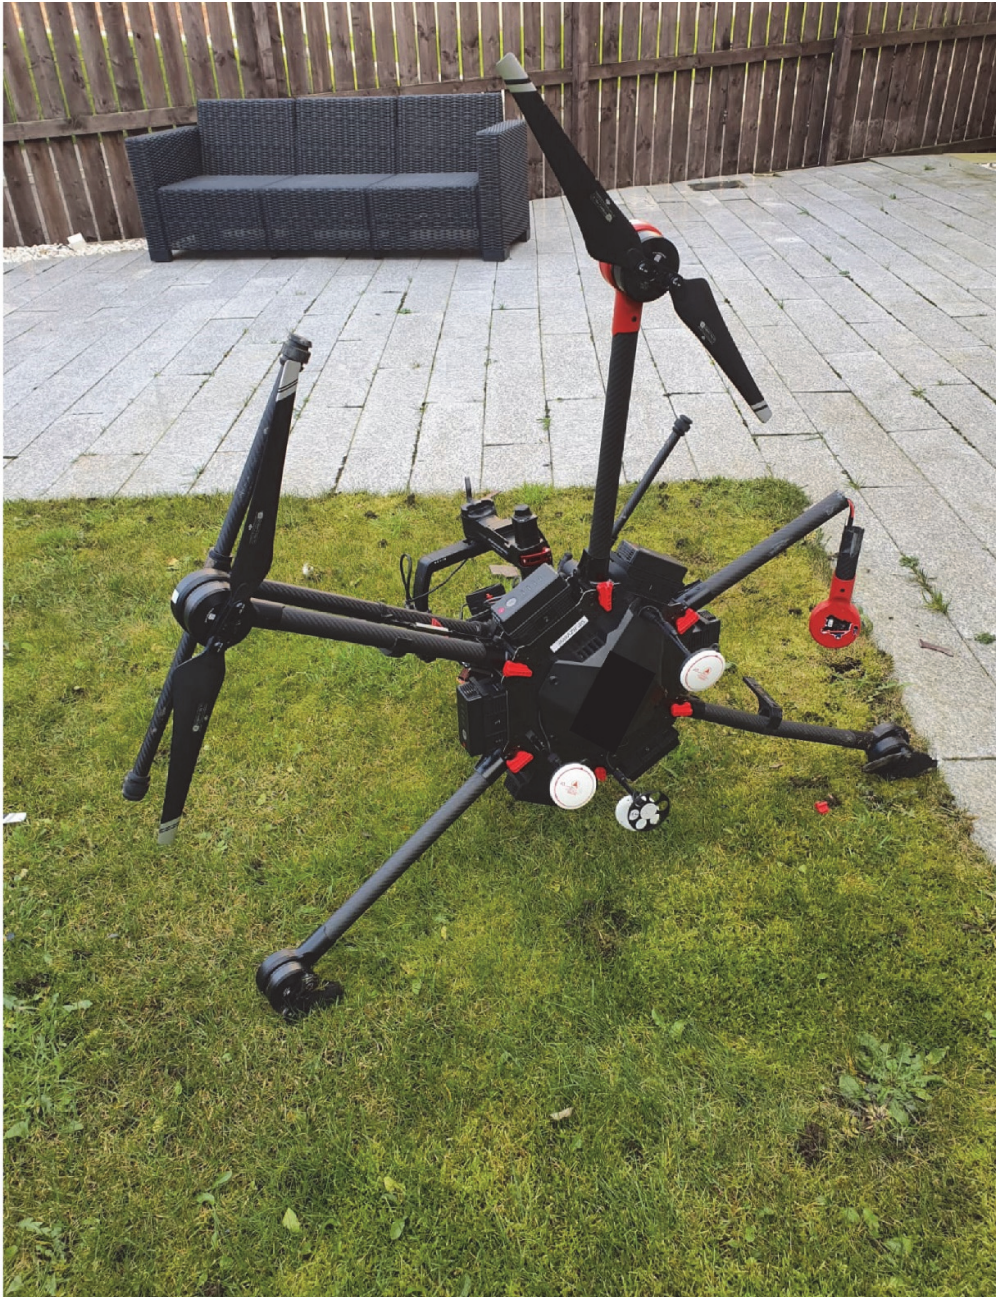
Figure 3

The aircraft after falling into the garden

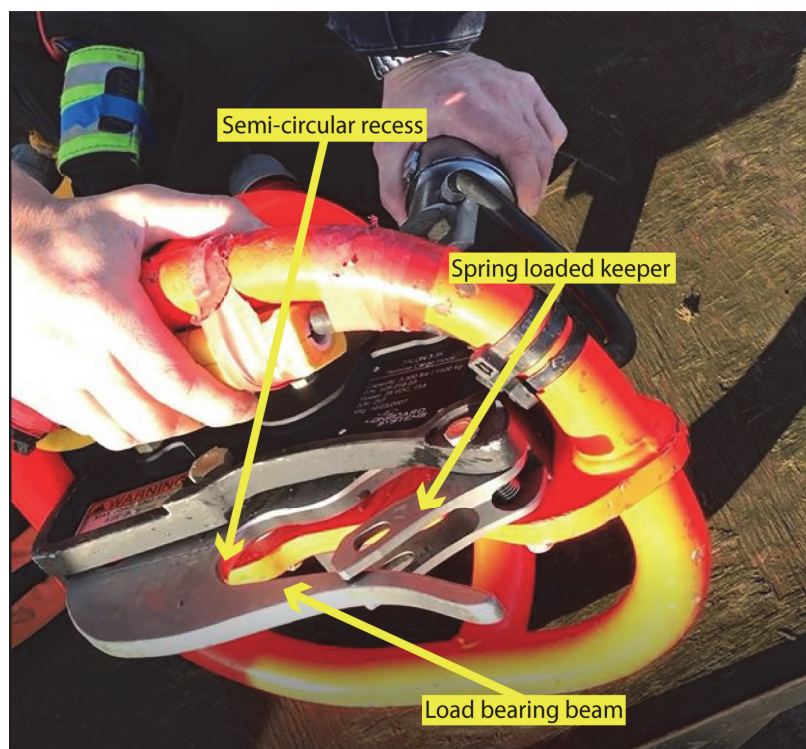
Figure 1

The design of the hook (Figure 1) consists of a load bearing beam which, when electrically actuated by the pilot, causes the beam to rotate around a pivot allowing the load to be released before then re-closing. There is a spring-loaded keeper which enables access to place the load across the beam. The beam also features a semi-circular recess where the sling, which is usually used to carry a load, should be positioned.

The spring-loaded keeper hook fitted to G-PDGF
