AAIB Bulletin

8/2020

Published 13 August 2020

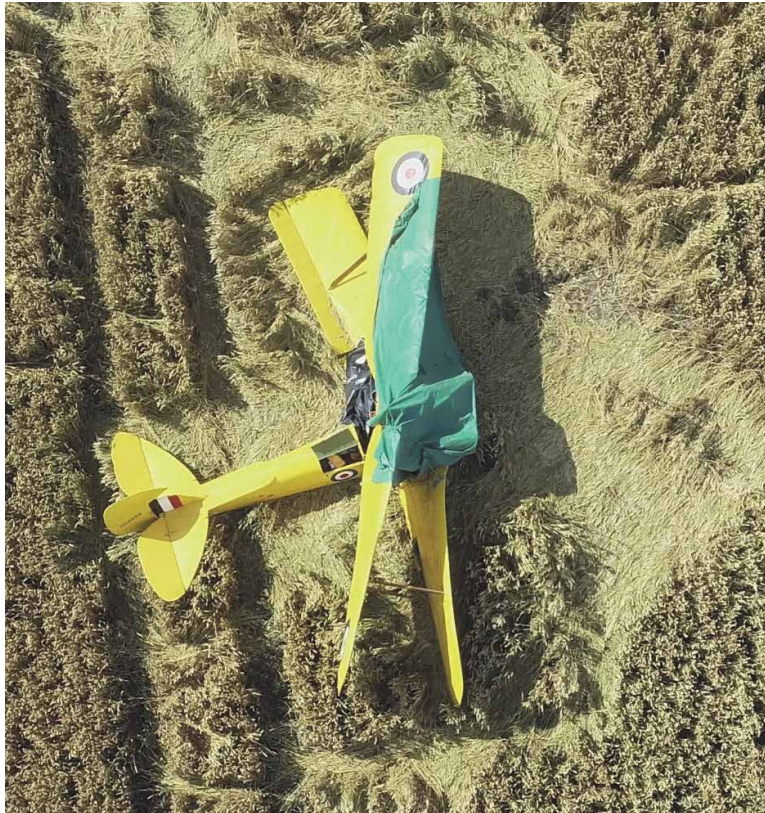
Figure 1

The aircraft struck the ground in an area of arable farmland containing a tall, dense and mature crop (Figure 1). At the time of the impact, the aircraft was complete. It was erect, in a steep nose-down attitude, with low forward speed and a significant descent rate, and was rotating to the right about a vertical axis. One blade of the wooden propeller was shattered with debris projected forwards. Fuel was recovered from the tank. Objects of only limited mass were present in the locker, which was not disrupted by the impact. After impact, the tail of the aircraft settled onto the ground, as shown in the image. The crop was flattened by first responders, not the aircraft.

The aircraft in the field

Examination of the flying controls revealed no evidence of pre-impact failure. In particular, the connecting rod between the front and rear cockpit rudder pedals was found attached at both ends; it was bent in two places but unbroken. A strip examination of the engine similarly revealed no evidence of pre-impact mechanical failure. The area containing the front seat was severely disrupted, whilst the area containing the rear seat was much less disrupted.

The features of the accident site and the degree and location of the aircraft damage were consistent with the aircraft being in an incipient or developed spin to the right at impact. The condition of the engine components, found on strip examination, coupled with the condition of the propeller, were consistent with the engine operating normally. Because the propeller was wooden, the amount of power being developed at impact could not be determined.

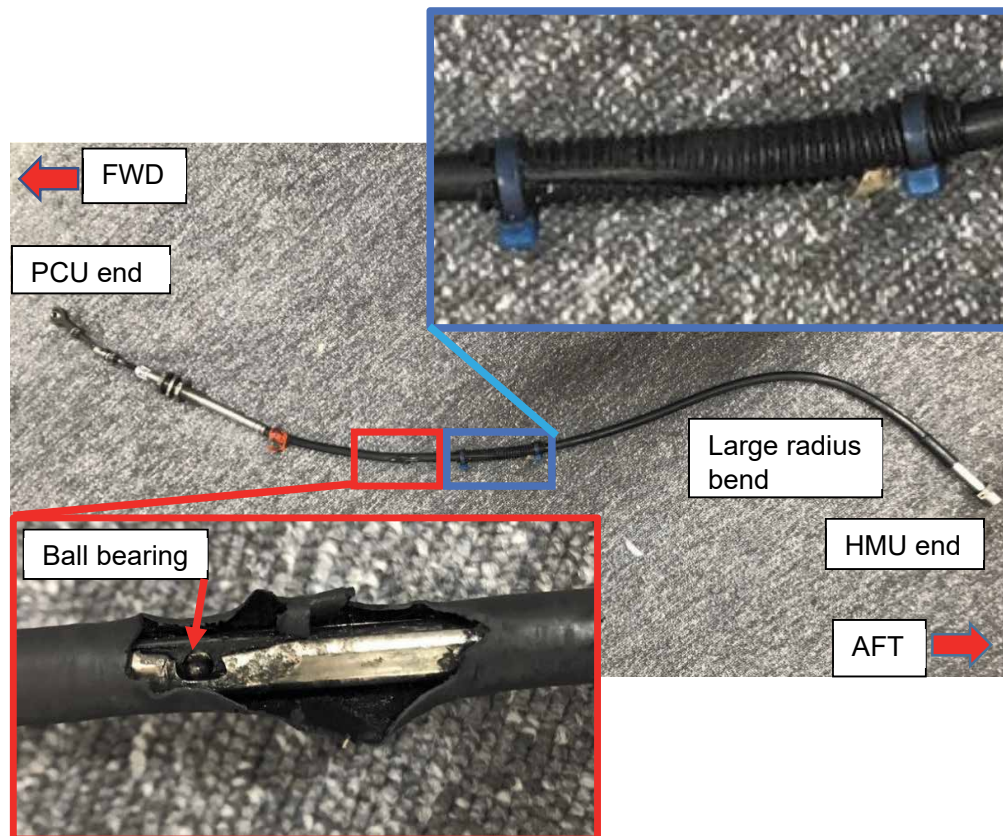
There were no photographs of the damaged condition control cable prior to it being removed from the engine but Figure 2 shows the cable after it was removed from the engine. The operator noted that a short section of plastic tubing secured by cable-ties, had been fitted adjacent to the area of visible damage.

The operator initially indicated that the cable appeared to have failed due to chafing against the accessory gearbox and attributed this to the large radius bend at the opposite end of the cable, near the HMU (Figure 3). It subsequently suggested that the cable had broken in the bend near the HMU.

ES-NSD left engine condition control cable, insets show damage and chafing protection

SB 340-76-027 described the precise location in which the chafing protection should be added to condition control cable to prevent chafing against the accessory gearbox. The chafing protection on the condition control cable from ES-NSD was installed at an incorrect location, and was adjacent to, rather than coincident with, the area where chafing damage was most likely to occur. It was not established why the chafing protection was installed in this location but there are several possible explanations: the position of the chafing protection may have been measured from an incorrect datum, for example the end of the rigid metal cable sleeve shown in Figure 5; if the cable-ties were not sufficiently tight, the chafing protection may have slipped from its original position; or, it may have been installed without reference to SB 340-76-027. Following this incident, the operator requested instructions from the manufacturer to perform SB 340-76-027 on all of its Saab 340s and introduced inspections of the cable in its maintenance programme.

The condition control cable had suffered damage due to chafing against the accessory gearbox, which most likely affected the correct operation of the cable. Although chafing protection was fitted to the cable, it was not in the correct location and would not have provided the intended protection.

The operator conducted a fleet inspection of the condition lever cables for signs of chafing; no anomalies were noted. It also created a periodic inspection of the cables in its maintenance programme.

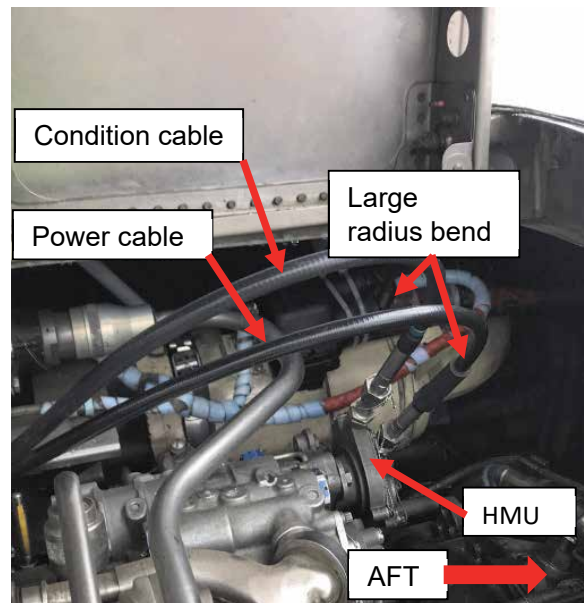
Figure 3

Bend in engine control cables near HMU
(taken after replacement of condition control cable)

In addition to the visible damage, the operator suggested that the cable had broken in the large bend near the HMU gearbox. The cable was not physically examined but it was considered possible that the cable had also suffered an internal failure at this point, which was not externally visible in the photographs provided. But the manufacturer considered that the substantial chafing damage evident in the photographs would have been sufficient to cause problems with cable operation and could have accounted for the lack of response from the condition lever during the incident.

The manufacturer stated that an important consideration when installing the HMU-PCU engine control cables is how the cables are bent. Due to the internal construction of the control cables they should only be bent in one direction when installed. Otherwise, the resulting unfavourable bend shape will cause increased friction and wear which will reduce the life of the cable. The specific cable installation requirements are described in the Powerplant Build-up Manual (PBM). When comparing the PBM with the Aircraft Maintenance Manual (AMM) the manufacturer noted that the procedure which provides detailed guidance on how the cables should be bent, was not included in the AMM. As control cables sometimes need to be replaced in-service, the manufacturer will update the AMM to include the detailed cable installation guidance.

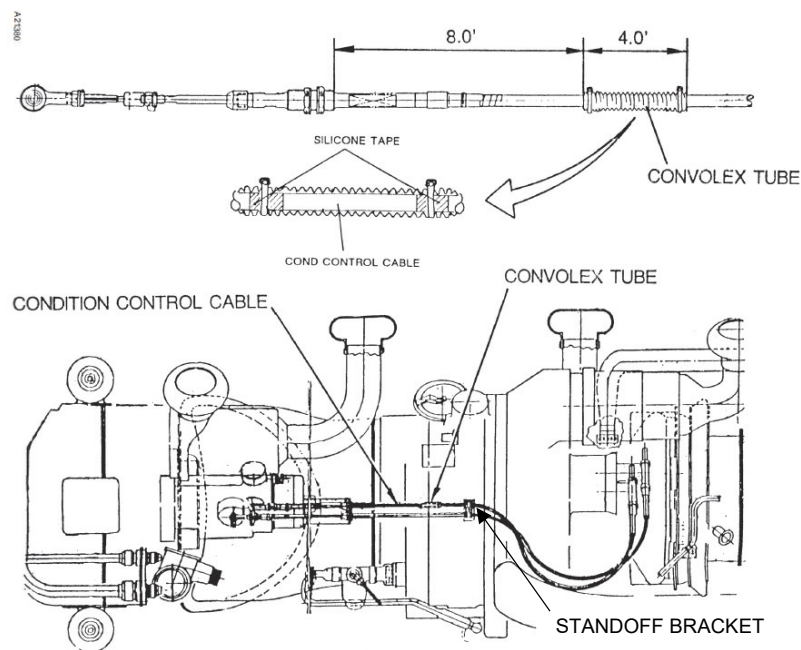
Figure 4

Location of anti-chafing protection on condition control cable from SB 340-76-027

SB 340-76-027 Revision 01 '*Engine controls – powerplant – chafing protection of engine control cables*' was issued on 12 November 1988. It described attaching silicon tape and a 4-inch long section of plastic convolex tubing at a specified location on the HMU-PCU section of the condition control cable, to prevent chafing of the cable on the accessory gearbox. Compliance with the SB was described as 'recommended'. Figure 4, taken from SB 340-76-027 shows the location in which the convolex tube should be installed.

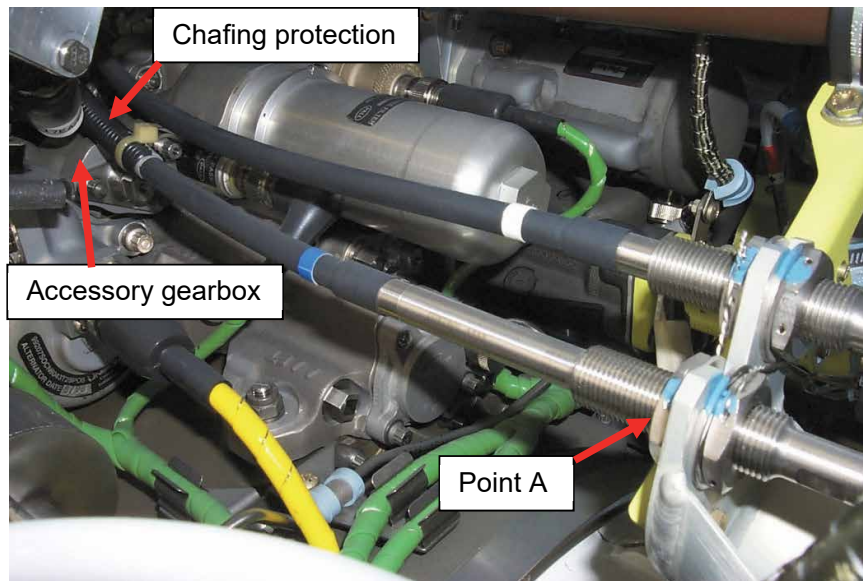
The cable from ES-NSD was not examined, but the aircraft manufacturer reviewed the photographs of the damaged condition control cable provided by the operator. It assessed that the large holes in the outer flexible stainless steel casing and vinyl covering were consistent with chafing damage. The ball guide and outer race on the affected side appeared to be damaged, such that the ball bearings were exposed. As far as could be determined from the photographs, the centre race appeared undamaged. The manufacturer noted that chafing protection, although fitted, was not in the correct position and would not have protected the cable from chafing against the accessory gearbox. The correct location is approximately coincident with the area of damage shown in Figure 2. Figure 5 also shows the correct location of chafing protection on a condition cable installed on the engine of another aircraft.

Correct location of chafing protection on condition control cable (view looking aft)

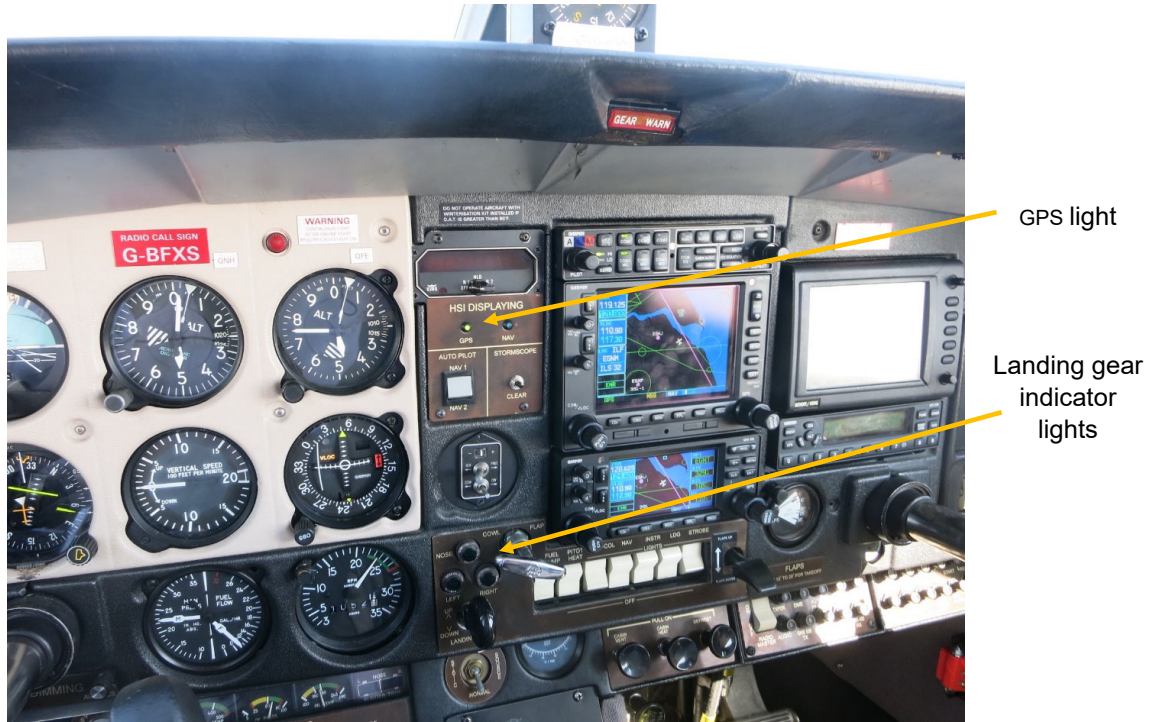
Figure 1

The pilot had not flown for several months and he thinks that the lack of recency combined with the distraction of extending the circuit caused him to forget to extend the landing gear. He believes that on final approach he glanced inside and saw the GPS green light² and mistook it for the landing gear green lights.

The landing gear warning horn did not sound because the pilot had selected only partial flap, intending to complete a touch-and-go. The landing gear warning horn sounds when the landing gear is not down and either the flaps are extended beyond 25° or when the throttle is retarded below a position corresponding to a manifold pressure of approximately 14 inches of mercury.

G-BFXS instrument panel showing the landing gear indicator lights and GPS light

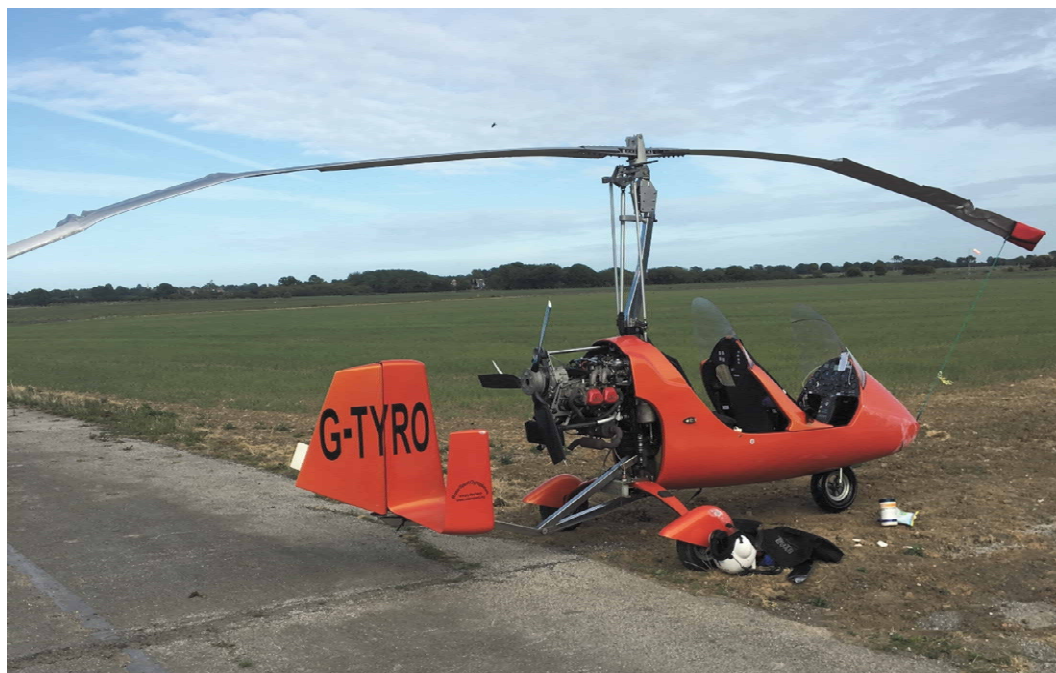
The pilot was uninjured and was able to exit without assistance. The gyroplane sustained damage to its rotor blades, propeller, nose leg and to the right side of the fuselage.

Figure 1
Gyrocopter after the accident
