AAIB Bulletin

9/2020

Published 10 September 2020

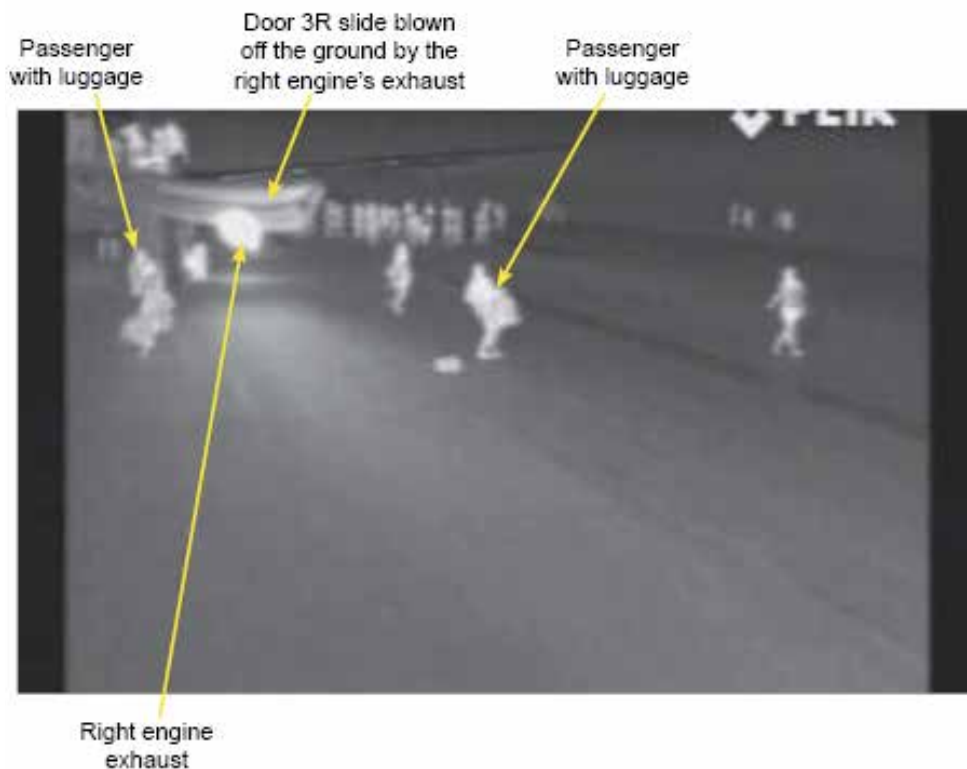
Figure 2

Numerous passengers also commented that the aisle and Doors 2L and 2R and the overwing exits, were impeded as people were trying to take their baggage from under seats and overhead bins. As a result, passengers were shouted at by some to leave their baggage behind. One passenger thought that about half of the passengers took their hand baggage with them. Images of passengers leaving the aircraft with baggage from the right overwing exit were captured by the RFFS’s onboard infrared CCTV camera (Figure 2).

RFFS infrared CCTV showing some passengers leaving with baggage

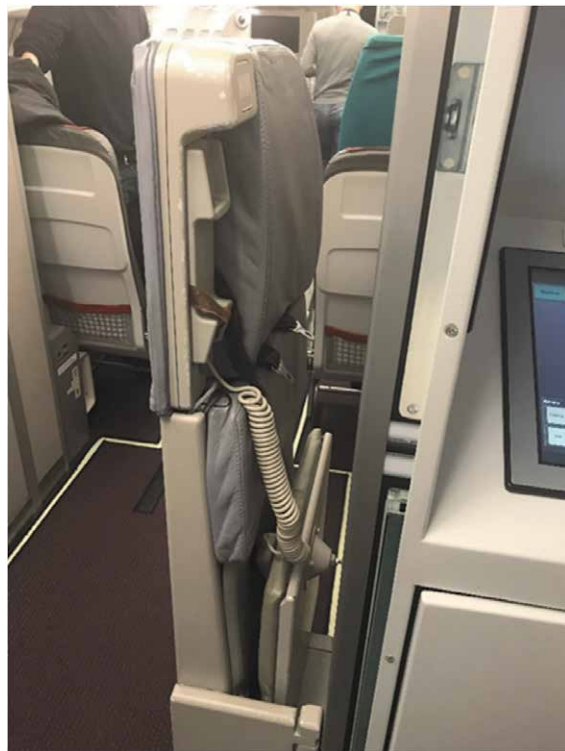
Figure 5

The SFA then tried to call FA3, in the rear of the aircraft, using the interphone, to check if everything was alright. However, when FA3 stood up, his crew swivel seat displaced the attached handset from its stowage and its cable became trapped in the now folded seat⁵. This caused the crew high/low chime⁶ in the cabin to be suppressed so it was difficult for the SFA to attract FA3's attention. There then followed an exchange between the SFA and FA3 which resulted in the SFA commanding an evacuation over the PA. See the *Flight attendants' comments* section for details of this exchange. Upon hearing the command, the FAs and passengers commenced the evacuation.

Example picture of interphone dislodged from the cradle and trapped in the stowed seat

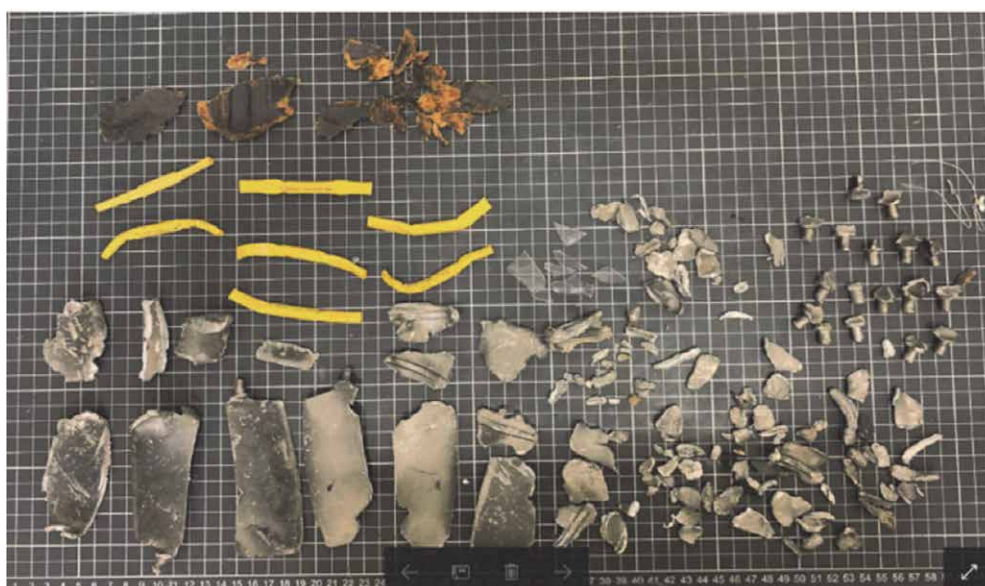
Figure 10

The aircraft had been moved from the runway but debris which had exited the left engine was collected from the runway by the Airport Authority and provided to the AAIB (Figure 10). The items collected included multiple IGVs, fragments of compressor blades and fragments of engine acoustic liner.

Items collected from the runway

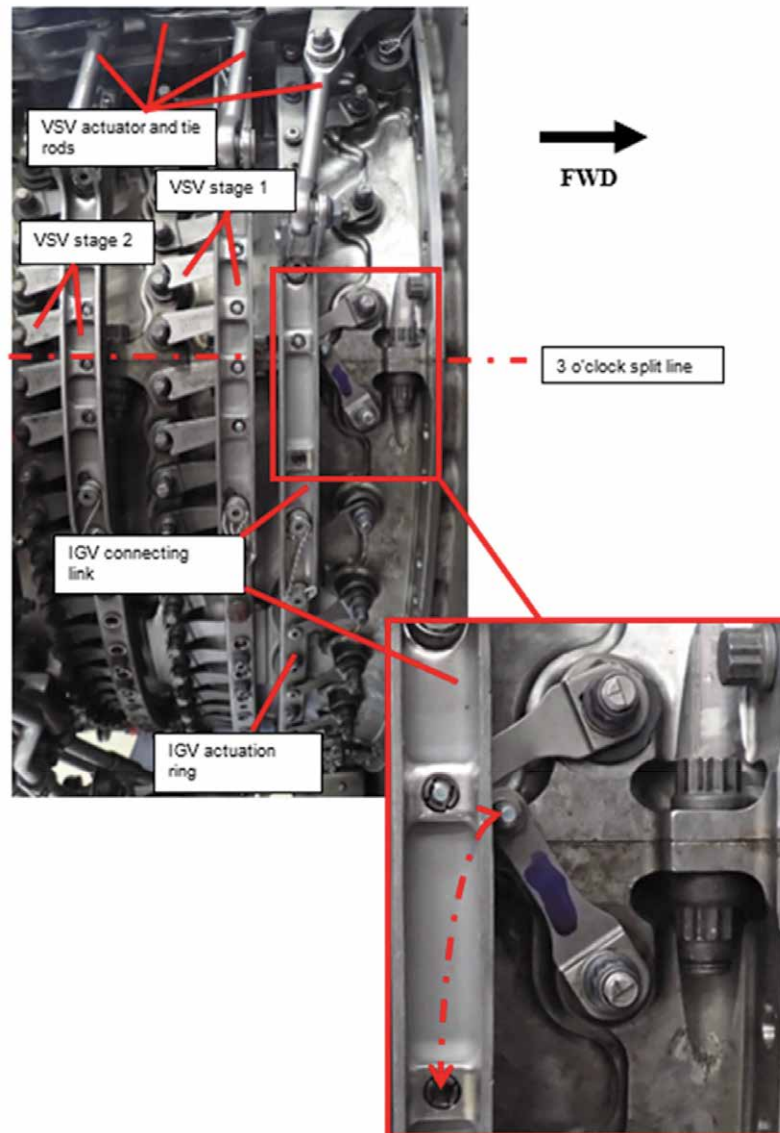
Figure 11

A single IGV lever arm in the 3 o'clock position (aft looking forward) immediately below the split-line of the HPC case, was found to be disengaged from the connecting link on the IGV actuation ring (Figure 11). This lever exhibited no distortion or damage but did have a small impact mark on its forward edge, which coincided with where the lever arm could come in to contact with the HPC case if it was not connected to the connecting link. There was no corresponding mark on the HPC case. Approximately half of the remaining IGV lever arms were bent or distorted and many of the bushings in the IGV actuation ring were absent or damaged.

Lever arm disconnected from connecting link on IGV actuation ring

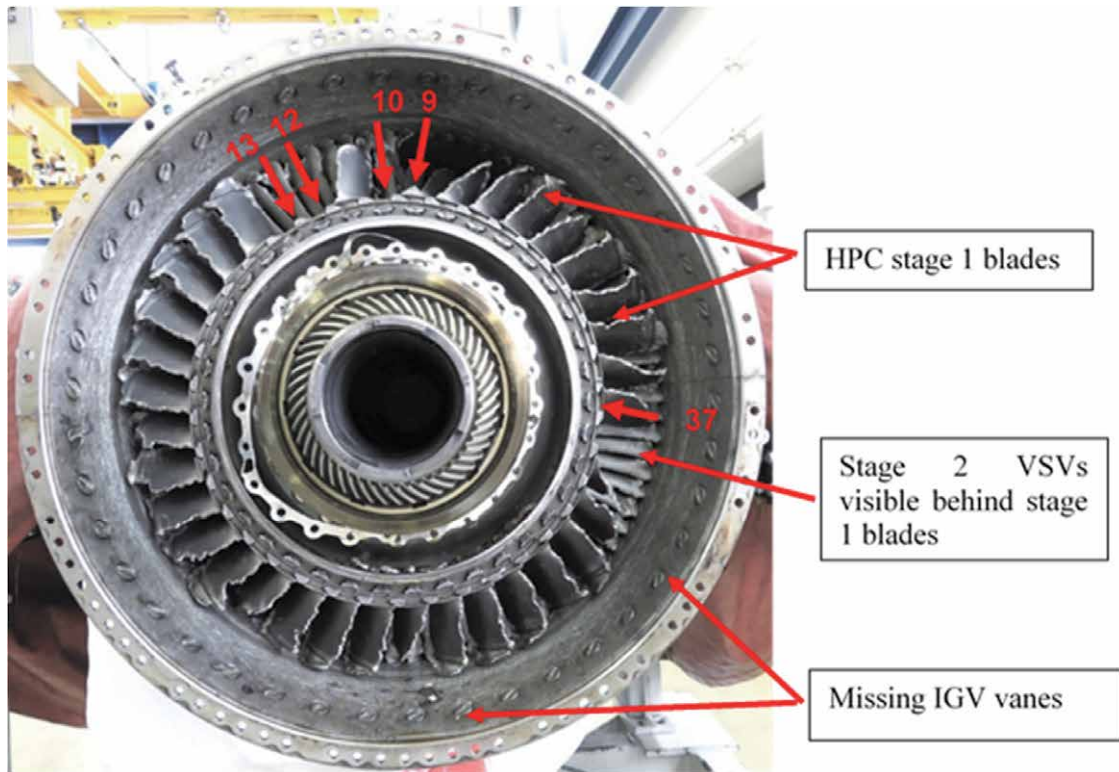
Figure 12

The damage to HPC stator vanes and blades downstream of stage 1 was consistent with secondary impact damage from the release of the stage 1 blades and the resulting rotor imbalance.

HPC module showing missing IGVs and damaged stage 1 blades

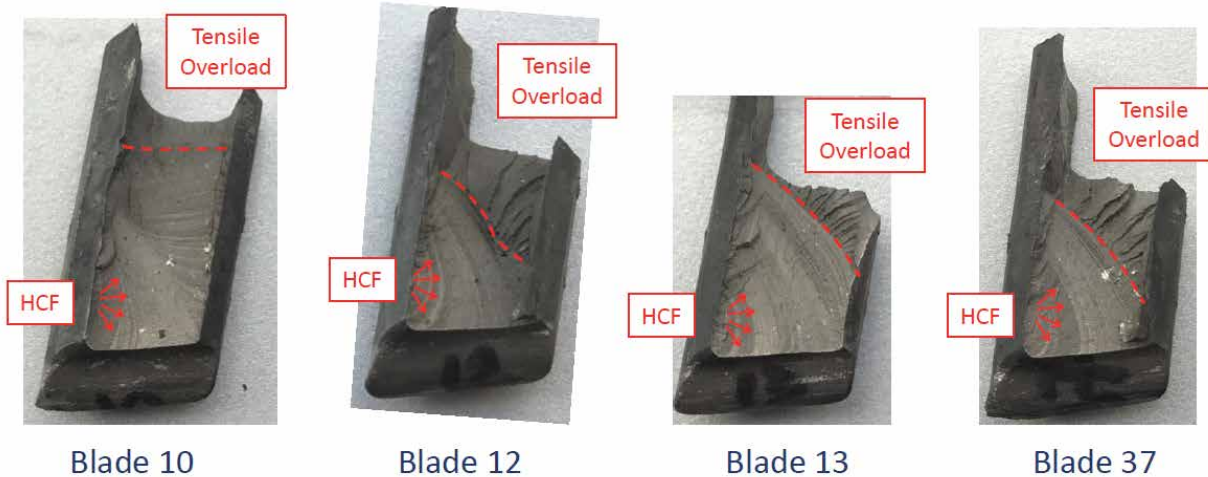
Figure 13

Fracture surfaces of blades exhibiting below-platform liberation

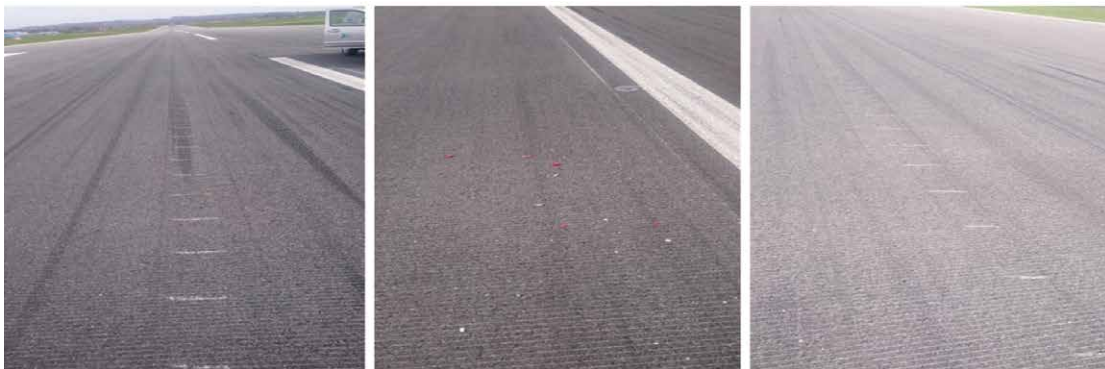
Figure 2

A runway inspection immediately after G-FLYW's go-around found the remains of an aircraft light on the runway in the vicinity of the reported touchdown point. After G-FLYW had landed a second runway inspection discovered propeller strike marks either side of the centreline that correlated with G-FLYW's earlier approach (Figure 2).

Propeller strike marks and debris from broken aircraft light (centre image)

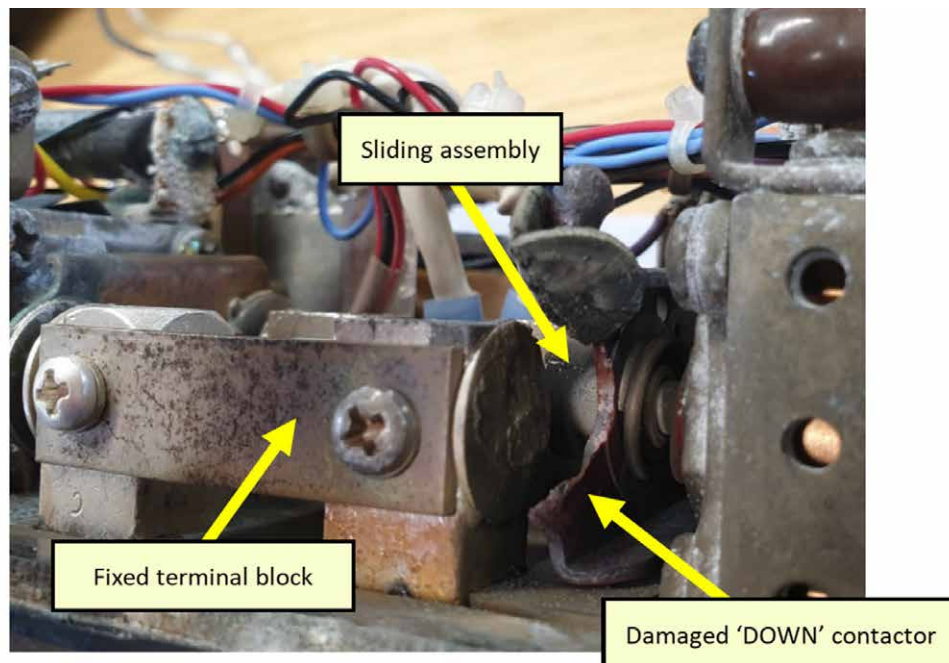
Figure 5

Damaged landing gear contactor

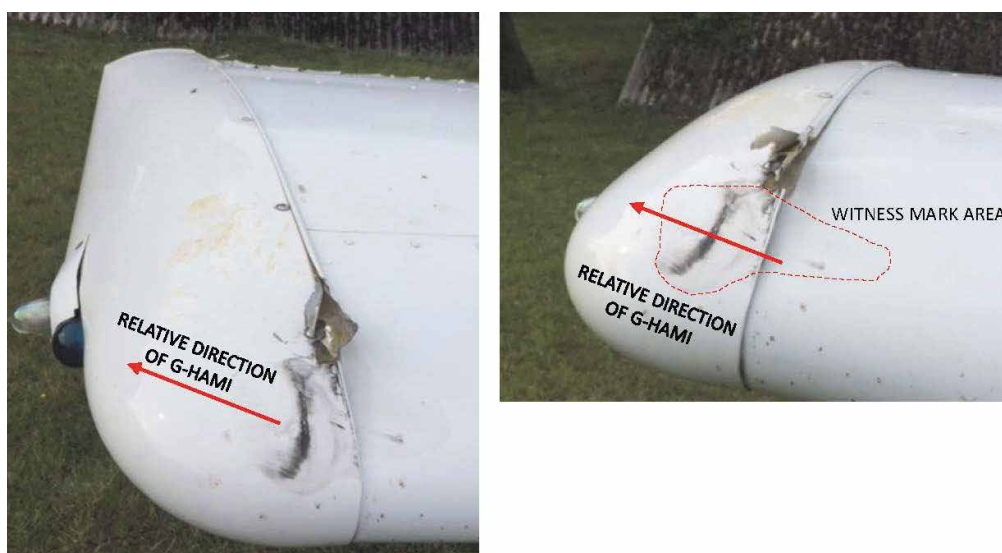
Figure 3

Both pilots then flew another flight without event. After landing, G-BXGV's pilot noticed damage to the aircraft's right wingtip (Figure 3). He then informed G-HAMI's pilot of it and that they must have collided in flight.

Damage to G-BXGV right wingtip

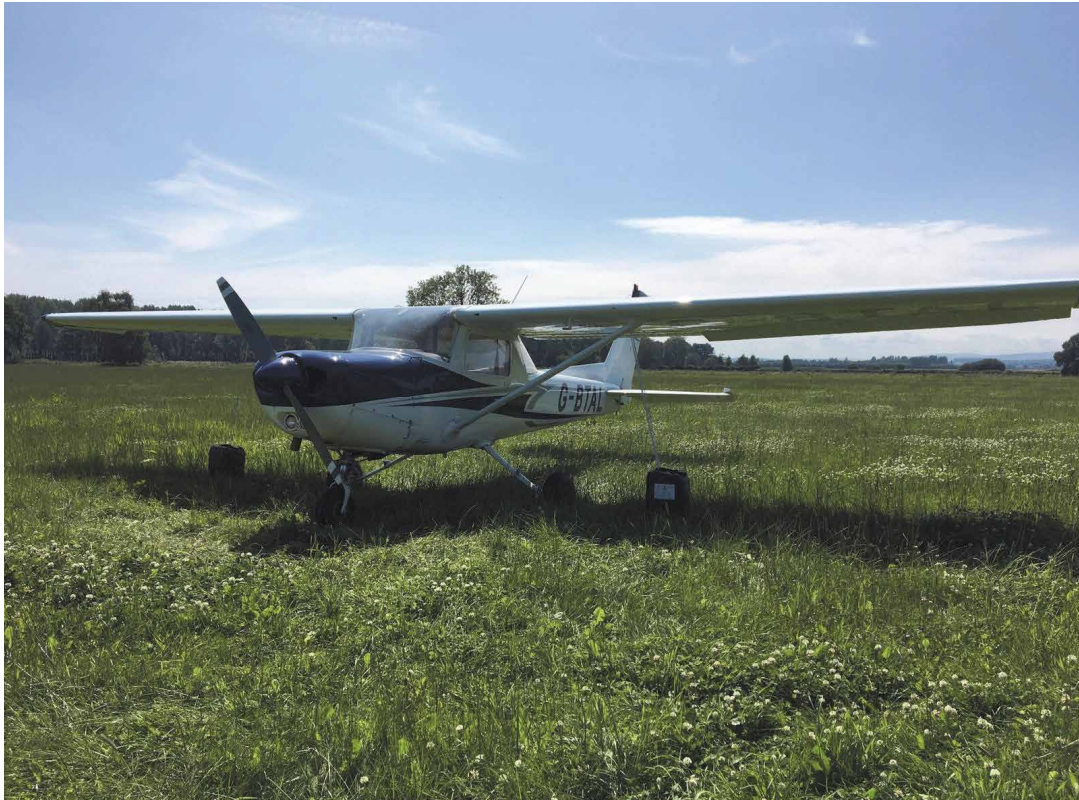
Figure 3

G-BTAL after the incident
(tie downs were installed to secure the aircraft before recovery)

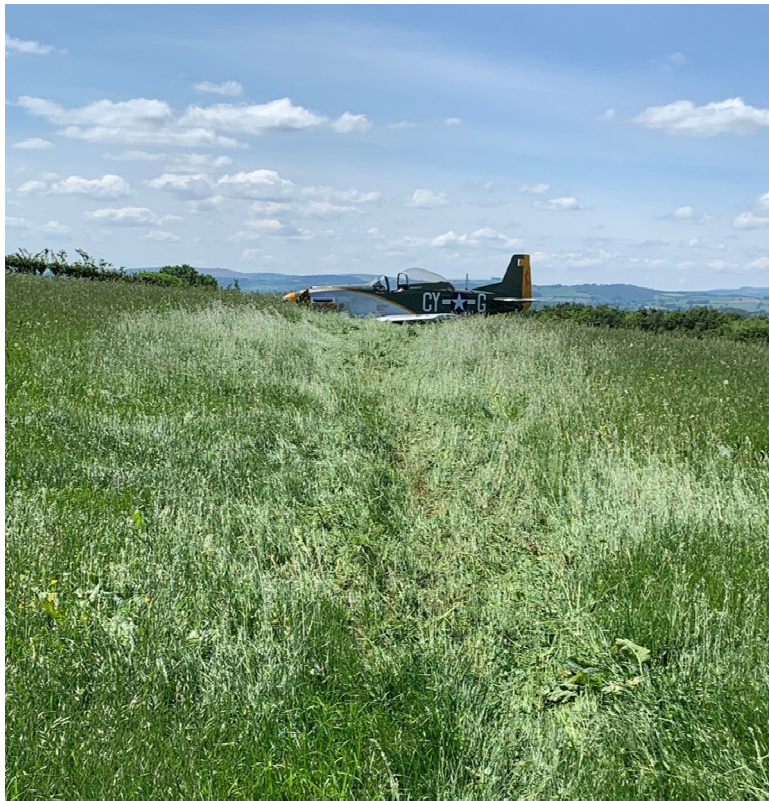
to rest. The pilot described the landing as a “very rough ride”. Figure 1 shows the aircraft in the field after the accident and clearly shows the sideways path of the aircraft.

G-TSIM after the forced landing
