# Rail Accident Report

## **Collision between mobile elevating work platforms at Rochford, Essex 25 January 2020**

Report 08/2020  
September 2020

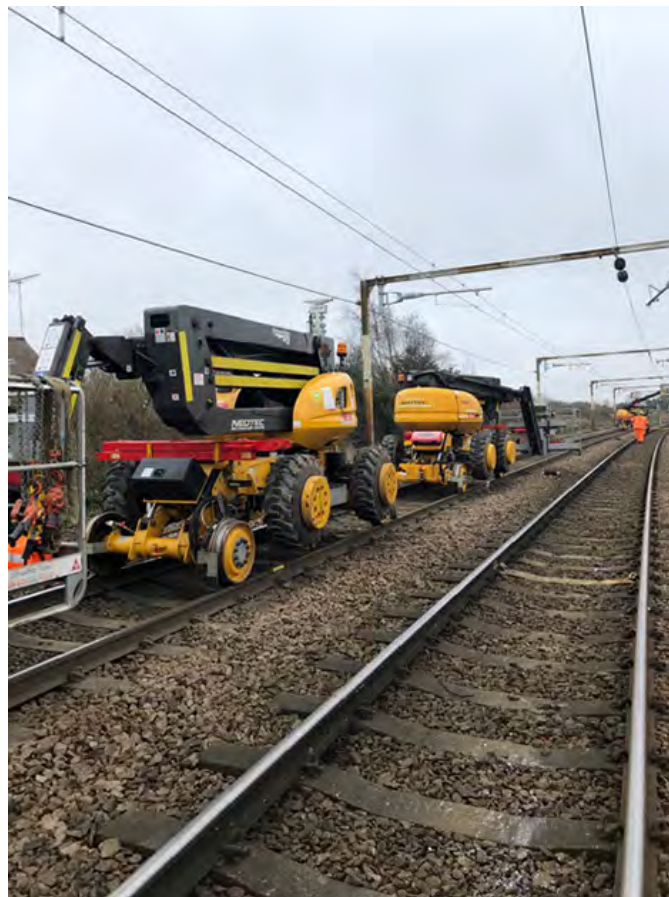
- 7 The accident occurred on the down line (the line normally used by trains travelling towards Southend), about 350 metres south from Rochford station, on a gentle right-hand curve. The track at this location is level (figure 3).

*Figure 3: MEWP 10 after its collision with MEWP 3. MEWP 2 is not shown as it had moved away to continue its work (image courtesy of Network Rail).*

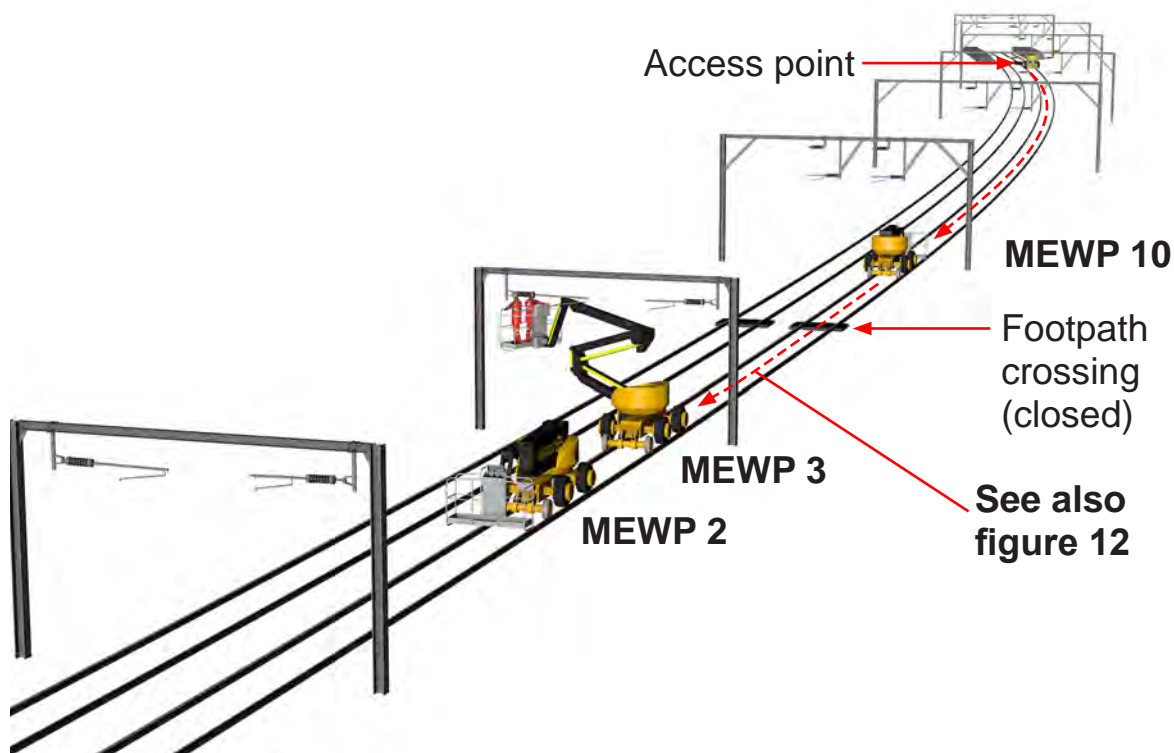
Figure 6f: Route of MEWP 10 to the collision with MEWP 3 (see also figure 12)

35 At 10:57 hrs, MEWP 10 collided with MEWP 3. Just before impact, the machine operator applied the brakes by releasing the MEWP's speed controller (figures 7 and 8). This produced a slight reduction in the speed of the MEWP before the collision, from 10 mph (16 km/h) to 9 mph (14 km/h). The machine operator of MEWP 3 (wearing headphones) and the linesman, who were working in the basket, did not hear any warnings (figure 6f).

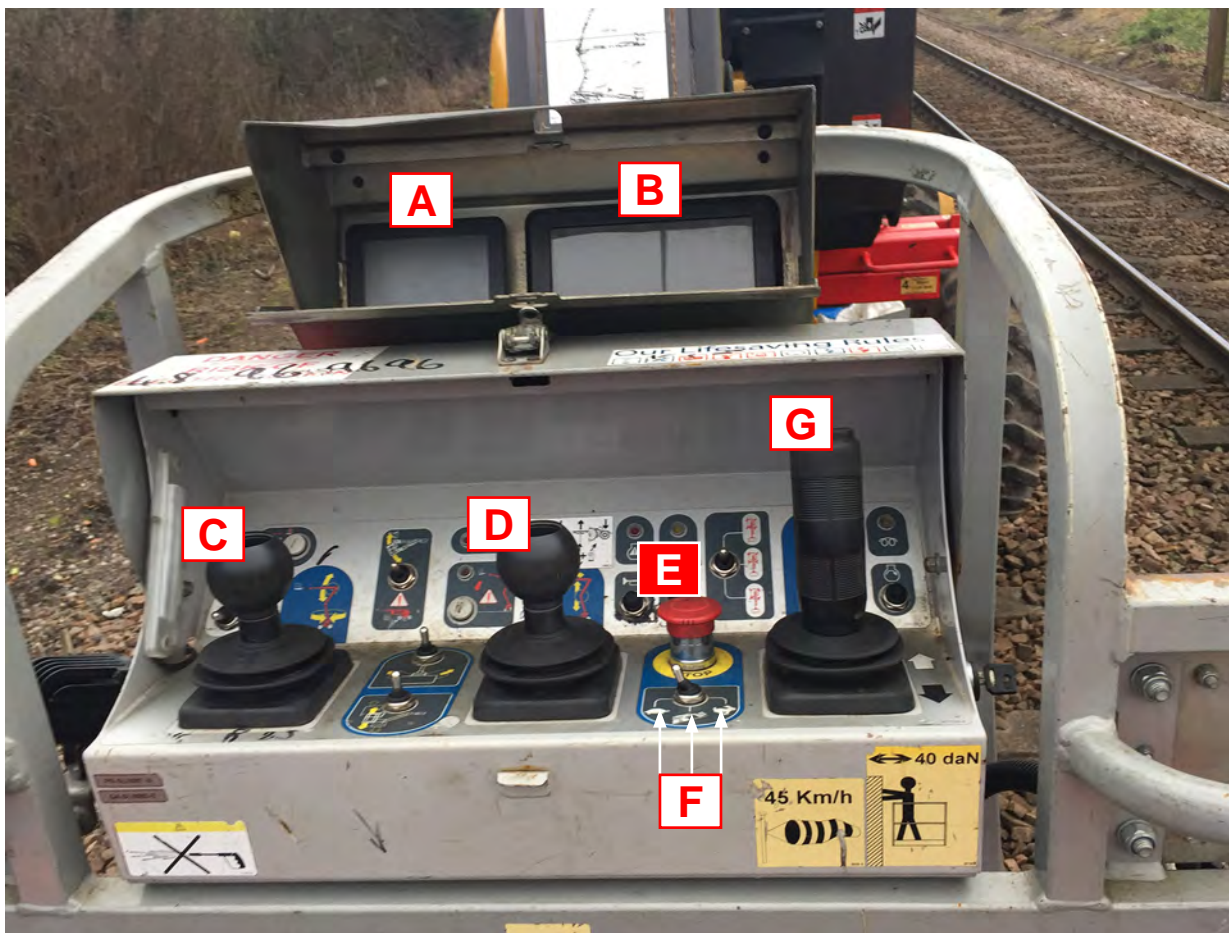
- 46 A mobile elevating work platform, commonly referred to as a MEWP, is a vehicle with a platform (known as a basket) attached to a central jib which can elevate the basket to give access to structures and equipment. The Skyrailer 440 (figure 4) is capable of operating on both road and rail, and is fitted with rail wheels which are directly driven and braked, independently of the road wheels. The basket, which can turn through 180 degrees, incorporates a control console (figure 7) with two monitors. The left-hand monitor (A) shows the machine configuration and the speedometer, and the other (B) is a CCTV monitor showing images from a camera on the front of the MEWP (see figure 4). The console has three joysticks which control the horizontal slewing of the basket (C), the height of the basket (D), and the forward and reverse movement of the machine, including braking (G). The joystick controlling the speed and braking has a button which must be depressed while holding the joystick to allow movement to take place. The operator must also have their foot inserted in the 'deadmans' control (figure 8) while the joystick is being used. Releasing the joystick or removing pressure on the footplate will initiate a hydrostatic brake application. Emergency braking can be applied by pushing the red plunger (figure 7, E).

Figure 7: The control console on MEWP 10 after the accident

- 47 The speed ranges in which the MEWP can be operated are selected by a three-position switch (F). 'Tortoise' or 'work' mode (left position) has a maximum speed of 5 mph (8 km/h). The centre position is the on-tracking or low loading mode. 'Hare' or 'travel' mode (right position) allows the machine to travel at a maximum speed of 10 mph (16 km/h). The basket must be in the lowered central position to allow the machine operator to use the machine in 'hare' mode.

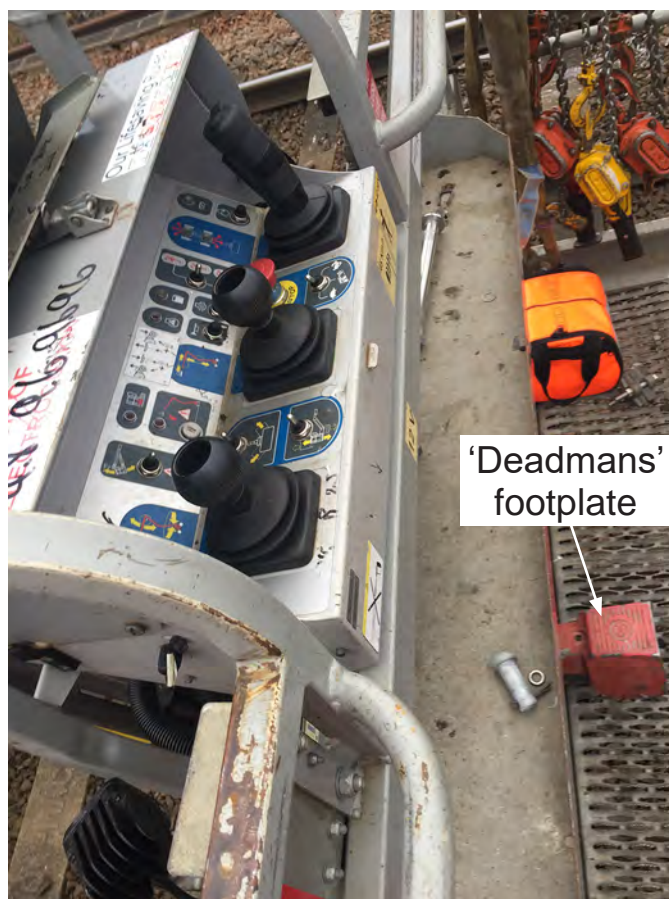
Figure 8: The control console and 'deadmans' foot control on MEWP 10

- 69 The machine operator stated that when he became ‘*aware of his surroundings*’ and the close proximity of MEWP 3, he released the forward pressure on the joystick (but could not recall if he completely let go of it), and may also have removed his foot from the footplate control (figure 8), both of which would have applied the hydrostatic brakes.

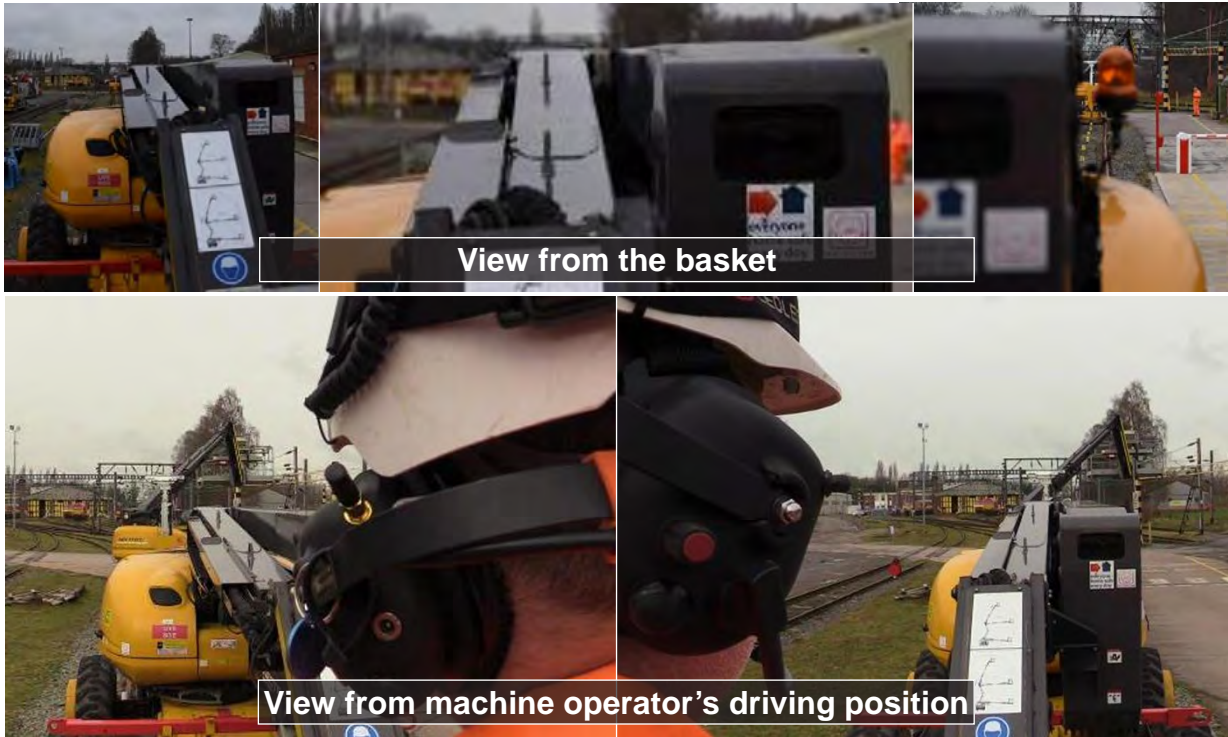
Figure 9: The view from the basket and eye level view from the machine operator's perspective on MEWP (10)

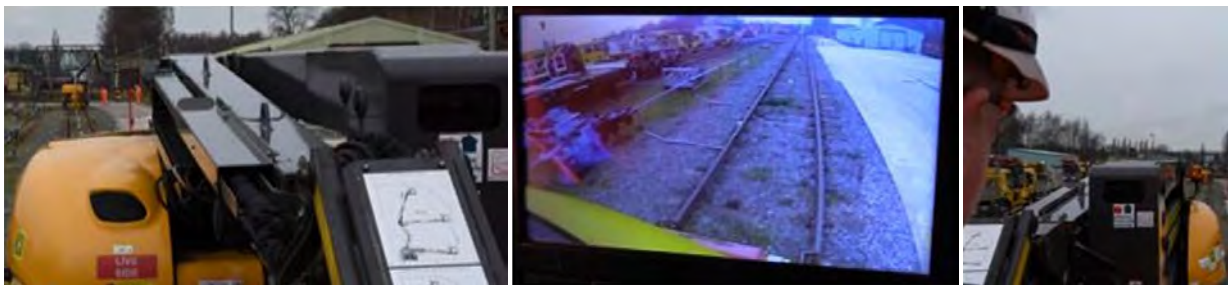
Figure 10: Images taken from MEWP 10, 107 metres from stationary MEWP 3, showing the view from the basket (left), CCTV monitor view (middle) and eye level view (right) from the machine operator's perspective on MEWP 10

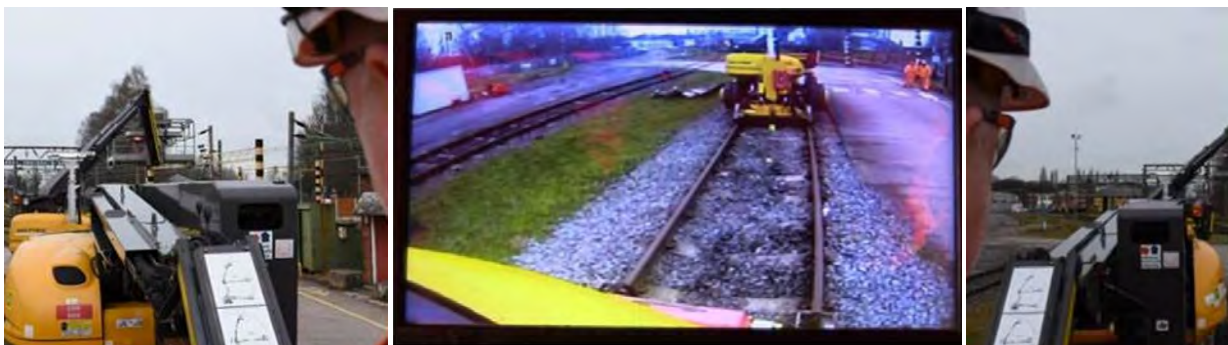
Figure 11: Images taken from MEWP 10, 15 metres from stationary MEWP 3, showing the view from the machine operator's eye level (left), CCTV monitor view (middle) and machine operator eye level view (right) from MEWP 10

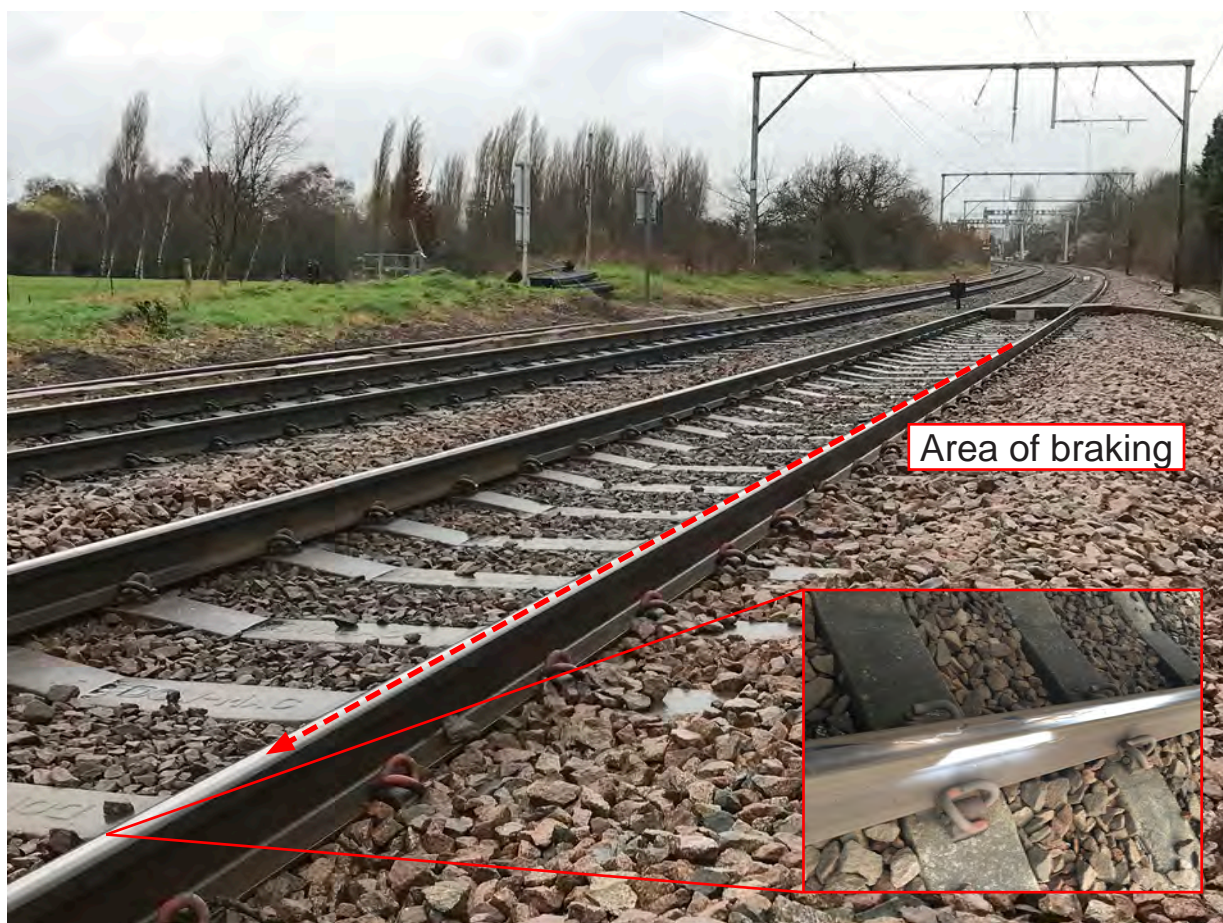
Figure 12: image showing the location of the railhead markings and impact point (inset image courtesy of Network Rail)

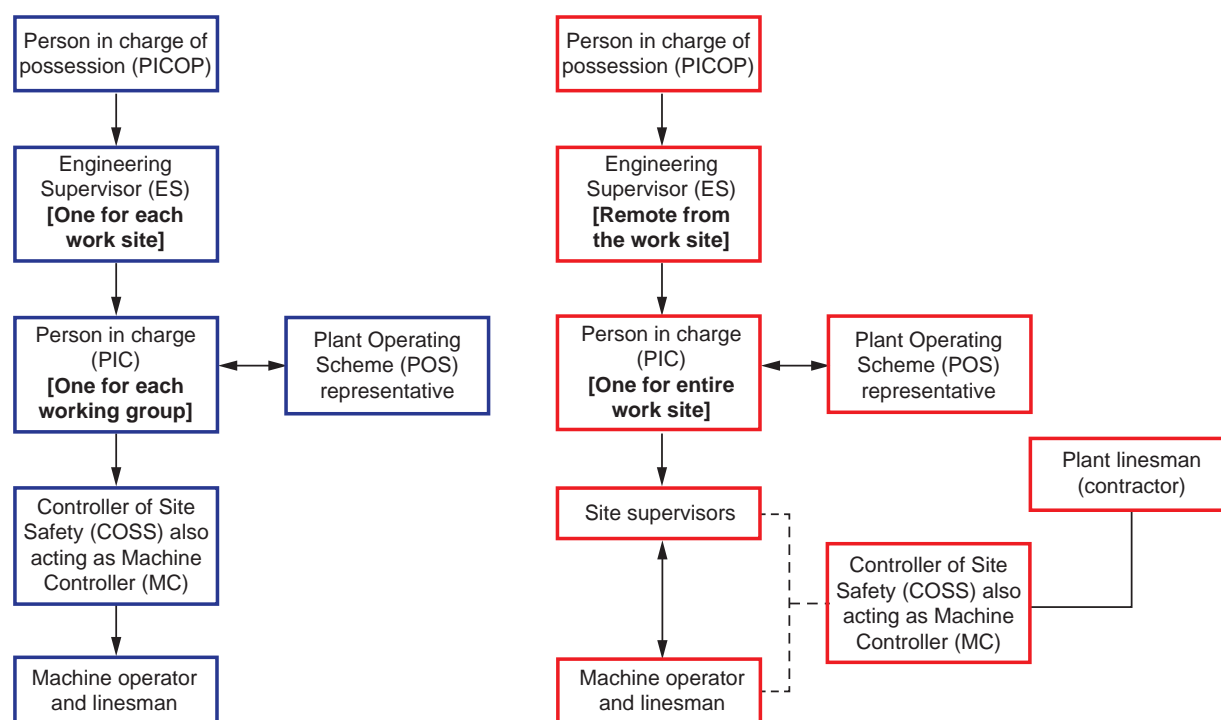
86 OCR rostered the PiC in a dual role as a site supervisor looking after two MEWPs, as well as the progress of the whole team's work. This practice is permitted by standard 019 and witness and documentary evidence show that this did not affect the safety briefings and documentation at the start of the work. The intention of standard 019, as explained by Network Rail to RAIB during a previous investigation, is that the PiC should only be supervising one work group.<sup>12</sup> As the machine controllers were not undertaking the role of PiC for the various sites of work, it is difficult to see how the appointed PiC could have undertaken his responsibilities for overall oversight and supervision of the work, supervising the safety of the work site and managing the site risks when also supervising the local work of two MEWPs. When the accident occurred, the PiC felt under pressure as he was now short of staff and machines to complete the work. As such, he did not feel he could relinquish his role supervising the remaining work. Rather than contacting the POS representative, the PiC asked the site supervisor to manage the situation and the accident scene, allowing him to continue his own work. Although the PiC had no further involvement in the accident, RAIB believes that OCR's decision to allocate the PiC in a dual role affected his ability to effectively monitor the work activities, and to manage the personnel, risks from the site activity and the movements under his control.

Figure 13: The standard structure of a possession (left) and the structure at Rochford (right)

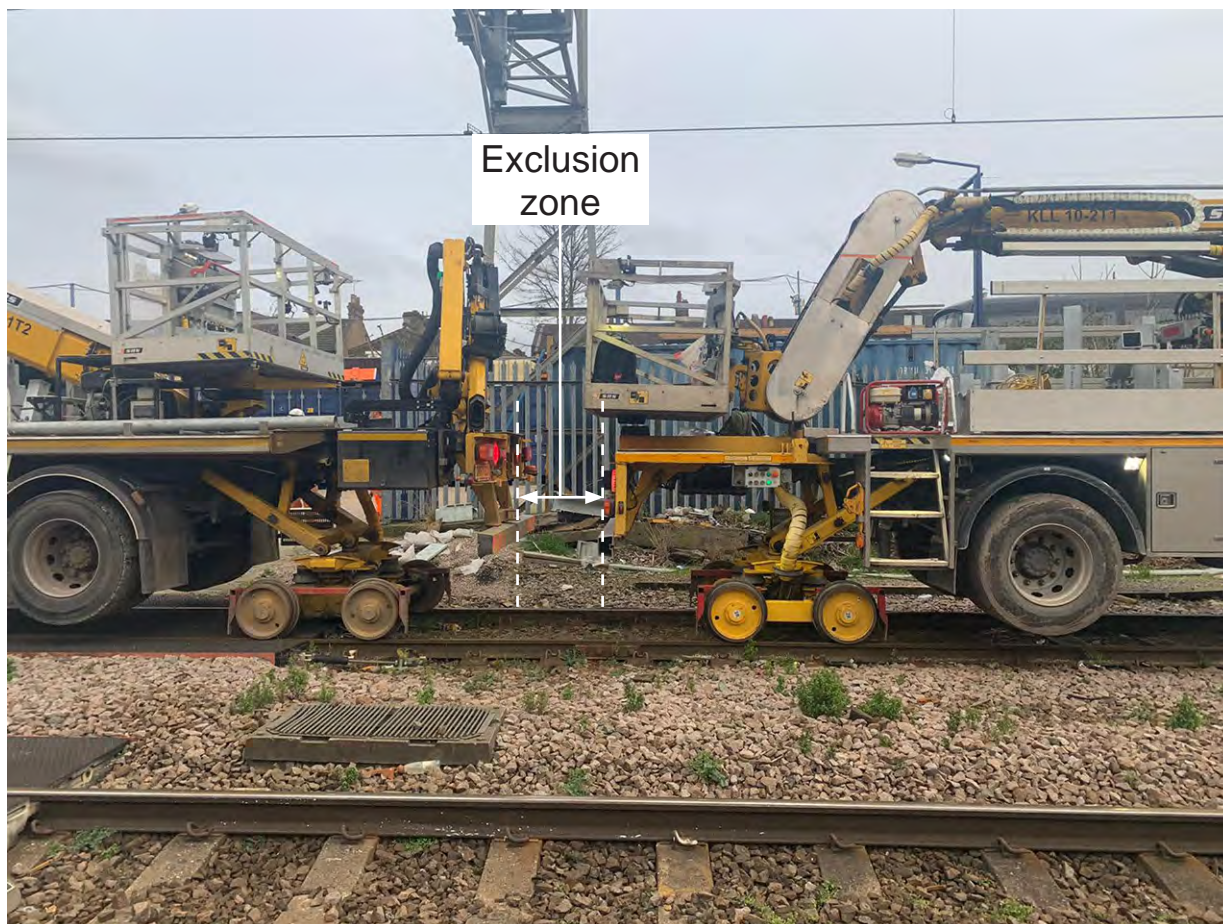
### Identification of causal factors

Figure 14: Image showing where the COSS was injured at Manor Park
