SERIOUS INCIDENT

Aircraft Type and Registration:	Boeing 737-8K5, G-TAWG	
No & Type of Engines:	2 CFM CFM56-7B27E turbofan engines	
Year of Manufacture:	2012 (Serial no: 37266)	
Date & Time (UTC):	24 December 2019 at 0048 hrs	
Location:	Manchester Airport	
Type of Flight:	Commercial Air Transport (Passenger)	
Persons on Board:	Crew - 6	Passengers - 181
Injuries:	Crew - None	Passengers - None
Nature of Damage:	Bearing failure, separation of No 4 (right outer) mainwheel and severe damage to the associated brake unit	
Commander's Licence:	Airline Transport Pilot's Licence	
Commander's Age:	41 years	
Commander's Flying Experience:	6,709 hours (of which 246 were on type) Last 90 days - 68 hours Last 28 days - 27 hours	
Information Source:	AAIB Field Investigation

Synopsis

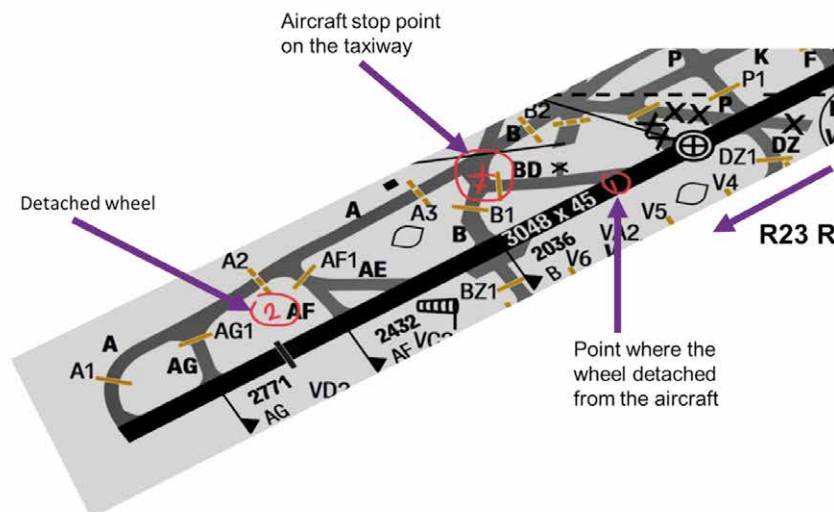
Figure 1

Marks and debris on the runway indicated that the wheel detached approximately 1,800 m from the threshold and continued for a further 700 m before coming to rest on the grass to the right of Runway 23R, between Taxiway AF and AG. A runway inspection carried out immediately after the landing found metallic debris from the wheel hub, bearings and brake pack strewn along the runway from point P to an area where most of the debris was found, abeam Taxiway BD (Figure 1).

Final location of aircraft, debris and wheel as plotted by airport authorities

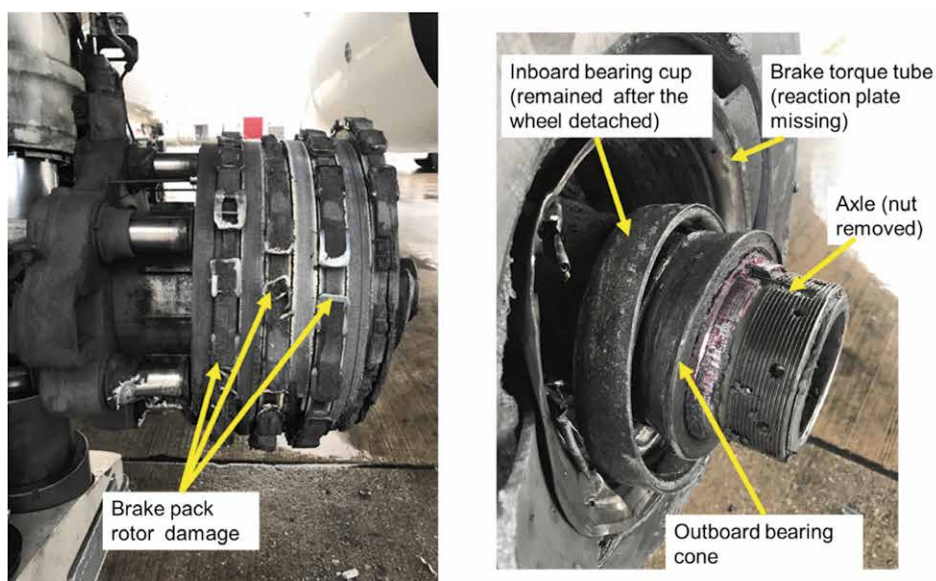
Prior to moving the aircraft, an inspection was carried out by the operator's engineers who found significant damage on the brake pack and to the wheel bearing cones, which were still attached to the axle. The tracks were heavily scored, exhibited heat damage and the remains of some of the rollers were smeared onto the bearing tracks. The inboard bearing cup had detached from the hub and was loosely hanging on the axle (Figures 5 and 6). The nut and washer were still in place on the axle and were relatively undamaged. The brake pack reaction plate was found on the runway.

Figures 5 and 6
Brake pack and bearing damage

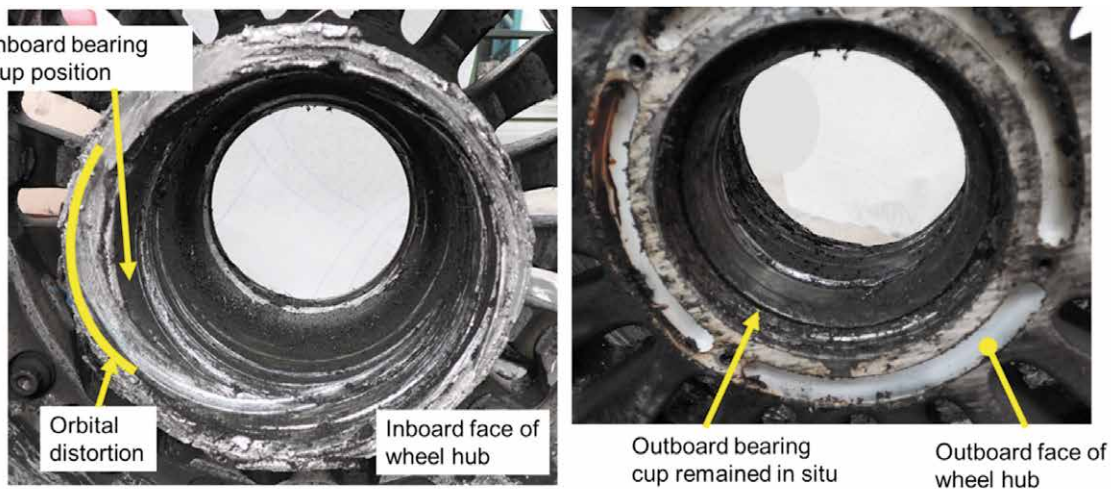
Figures 7 and 8

All but one of the brake rotor drive keys had detached and the inner face of the hub was heavily scored over its entire surface. The outboard bearing cup was in place, but the inboard bearing cup had detached. The hub, where the inboard cup had been fitted, was badly distorted and had taken on an offset elliptical shape (Figures 7 and 8).

Hub damage around the inboard and outboard bearing cup area

The elliptical damage to the hub, and the area where the inboard bearing cup is located, is consistent with the inboard bearing becoming loose allowing the wheel to wobble about its axle.

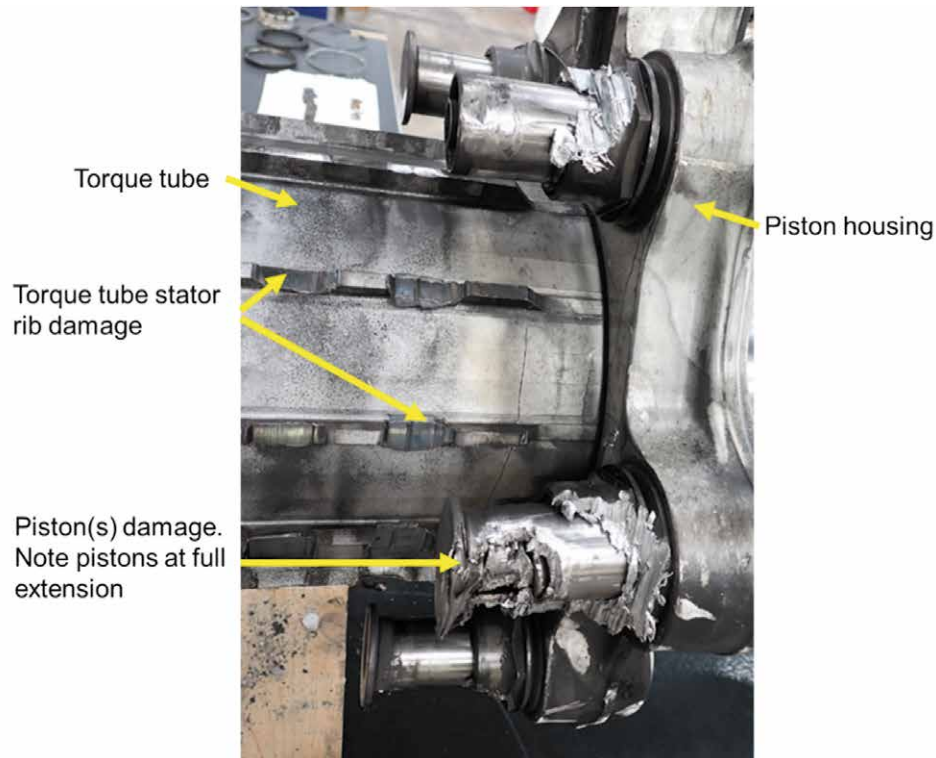
The brake pack rotors and stators were all present, although they had been pushed outwards by the brake pistons which had travelled to their full extension. There was no evidence of hydraulic fluid leakage. The outer reaction plate had detached along with a large portion of the brake torque tube. Some of the lower-most pistons had deep gouges in their outer surfaces. Most of the rotors and stators were distorted and had various cracks and fissures across their surfaces. Figure 9 shows the damage to the brake pack torque tube and pistons.

Damage to the torque tube and pistons

With a loss of wheel alignment, the outboard bearing would have deteriorated until the rollers and cage were released. Damage to the brake components show that as the bearings failed, the wheel loads were imparted into the brake components leading to the torque tube failure. The brake pistons then had nothing to react against, so fully extended under hydraulic brake system pressure. The damage to the hub and bearings was such that the wheel was able to move outwards over the outboard bearing cone, washer and nut until the wheel eventually came off the axle.

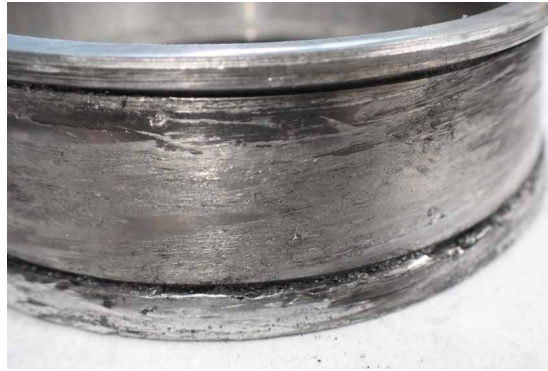
Only 20% of the outboard and 50% of the inboard bearings were recognisable. The outboard bearing cone, which was still fitted to the axle, was scored and showed evidence of metallic smearing on its bearing track. None of the rollers or the cage were in place. The remains of the rollers were found on the runway and showed signs of skidding welding and overheating. The outboard bearing cup remained within the wheel hub and exhibited similar damage to the bearing cone.

Figure 10
Outboard bearing cone

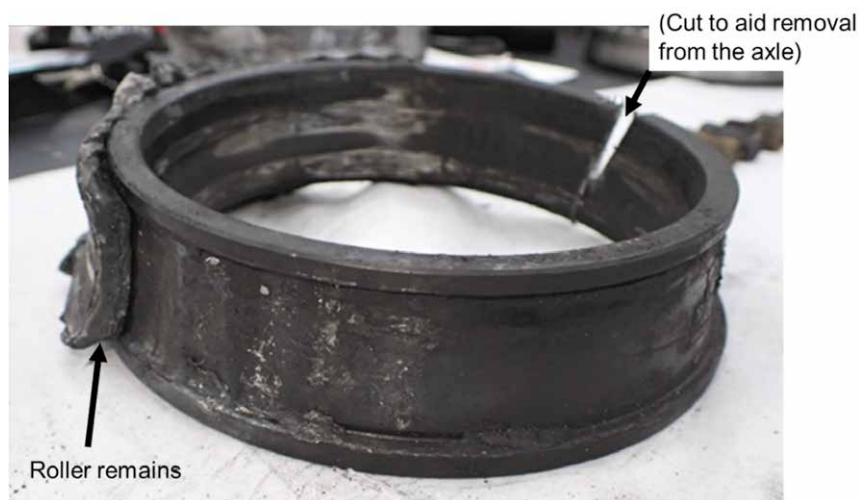
The damage to the inboard bearing was far worse than on the outboard bearing components. The inboard cone was severely overheated, its bearing track was worn and misshapen and the remains of several rollers were smeared and welded to its surface. The inboard bearing cup exhibited very similar damage to the cup on its bearing track. Figures 10 and 11 show the condition of the outboard and inboard bearing cones.

Figure 11
Inboard bearing cone

The inboard bearing was more severely damaged than the outboard bearing indicating that the inboard bearing failed first, causing secondary damage to the outboard bearing. The severity of the damage to the inboard bearing indicates that it may have been running for a period of time in a distressed condition during which large amounts of heat were generated.
