ACCIDENT

Aircraft Type and Registration:	Colibri MB2, G-BUDW	
No & Type of Engines:	1 Volkswagen 1834cc piston engine	
Year of Manufacture:	1992 (Serial no: PFA 043-10644)	
Date & Time (UTC):	15 December 2019 between 1228 and 1328 hrs	
Location:	Northfield Farm, Spilsby, Lincolnshire	
Type of Flight:	Private	
Persons on Board:	Crew - 1	Passengers - None
Injuries:	Crew - 1 (Fatal)	Passengers - N/A
Nature of Damage:	Aircraft destroyed	
Commander's Licence:	Private Pilot's Licence	
Commander's Age:	55 years	
Commander's Flying Experience:	1,300 hours (of which 221 were on type) Last 90 days - 11 hours Last 28 days - 1 hour	
Information Source:	AAIB Field Investigation

Synopsis

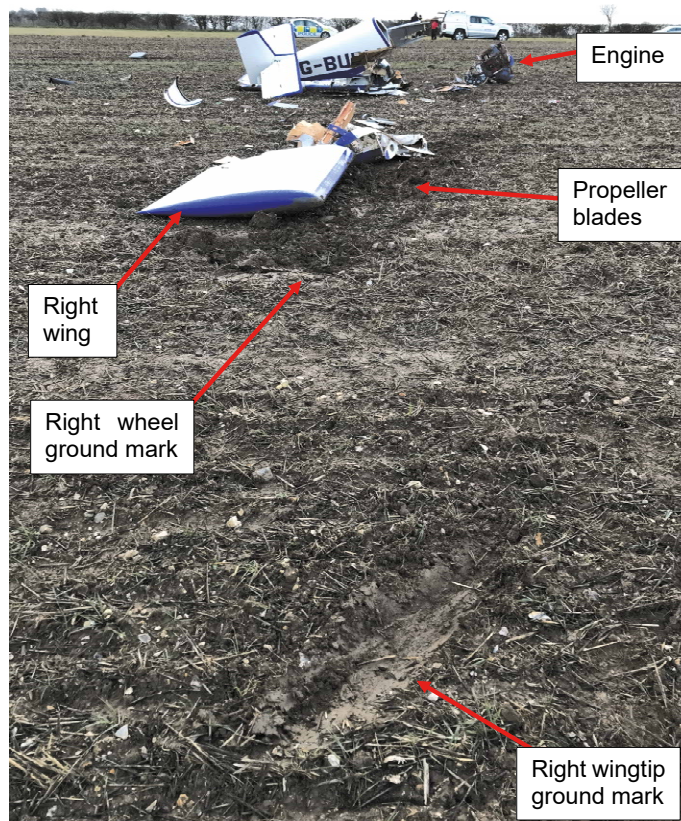
Figure 3

The aircraft wreckage was discovered approximately 50 m to the north of the grass runway and from the ground marks it was apparent that the aircraft was heading in a south-south-westerly direction. The accident site was hidden from the grain shed due to the ground rising and falling around the midpoint of the runway.

The right wing and landing gear had detached from the aircraft during the impact sequence. Ground markings showed that the right wingtip and wheel were the first points to contact the soft, sticky, clay soil (Figure 3). Both blades of the wooden propeller had detached and were found, embedded in the ground where the engine had first struck the ground. The engine was detached from the fuselage. The fuselage was relatively intact and had come to rest 2-3 m from the right wing, adjacent to the left wing, which had also detached. The cockpit area had been severely disrupted. The fuel tank had been moved away from the aircraft by the first responders to minimise the risk of fire as they stated there was still fuel in the tank. No fuel remained in the tank when it was recovered by the AAIB. The wreckage was removed and taken to the AAIB facilities for further examination.

Accident site with ground marks

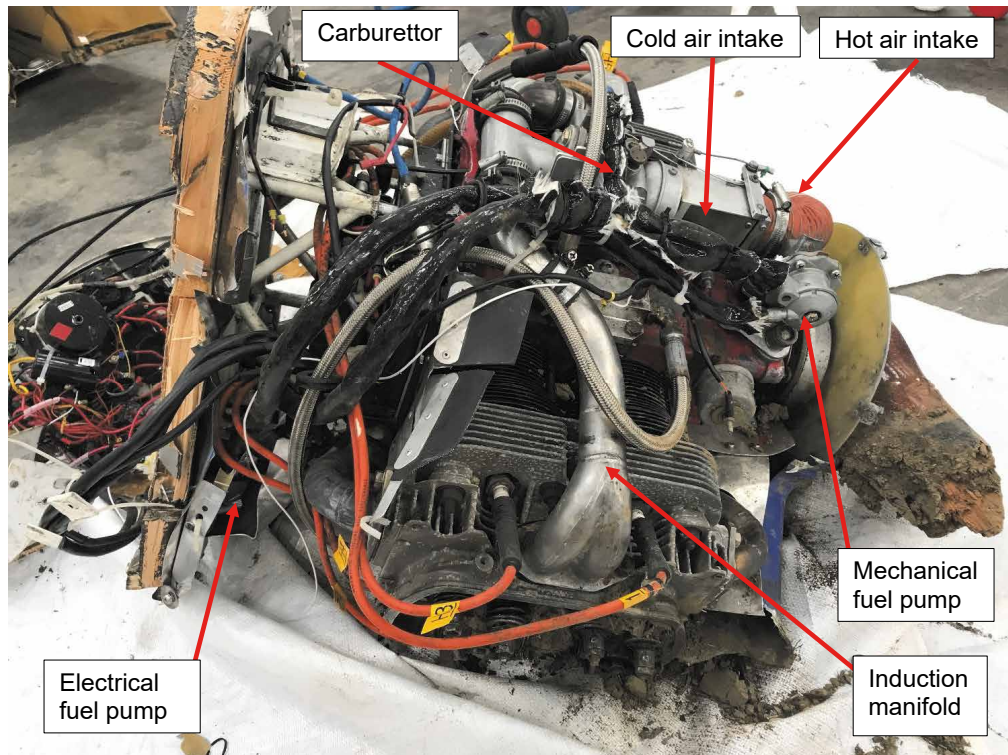
Figure 4

to a filter / drain assembly attached to the bulkhead and fuel was fed to a Minnow Fish carburettor, positioned on top of the engine, by the fuel pumps. Non-return valves were fitted between the pumps and the carburettor inlet. The air intake to the carburettor was unfiltered and was fitted with a manually operated, carburettor heating system on the exhaust silencer. The intake manifold split the fuel air mixture to both cylinder heads and had flexible joints to allow for alignment and vibration (Figure 4).

Engine at AAIB facilities

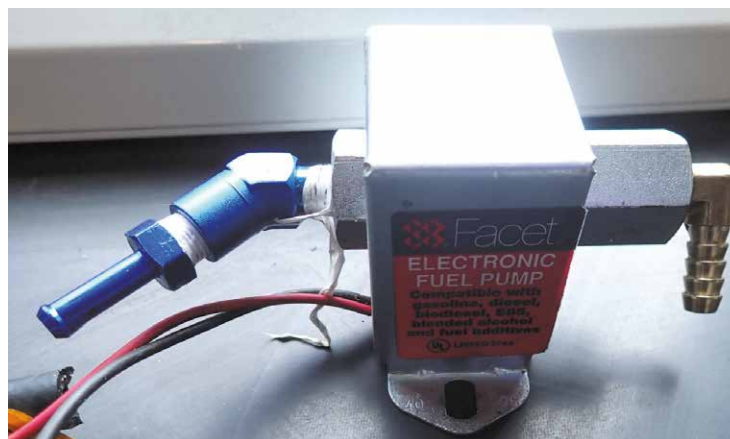
Figure 5

A non-return valve was fitted into the outlet pipe from each pump to ensure fuel flow to the carburettor. The electrical fuel pump² was a Facet Cube 40106 solid state 12v fuel pump (Figure 5). The manufacturer's datasheet states it is compatible with '*gasoline, diesel, biodiesel, blended alcohol fuels and fuel additives*' and is capable of 32 US Gallons per hour and between 4-7 psi. The manufacturer's data sheet also states that it is not intended for aircraft use however this is probably due to certification requirements rather than its functionality.

Additional electrical fuel pump

There are a wide variety of pump capacities available and there was no evidence that any calculations had been made to size the pump. If the owner had applied to the LAA for a modification he would have been required to present a rationale for the choice of pump. The pump was tested and operated normally.

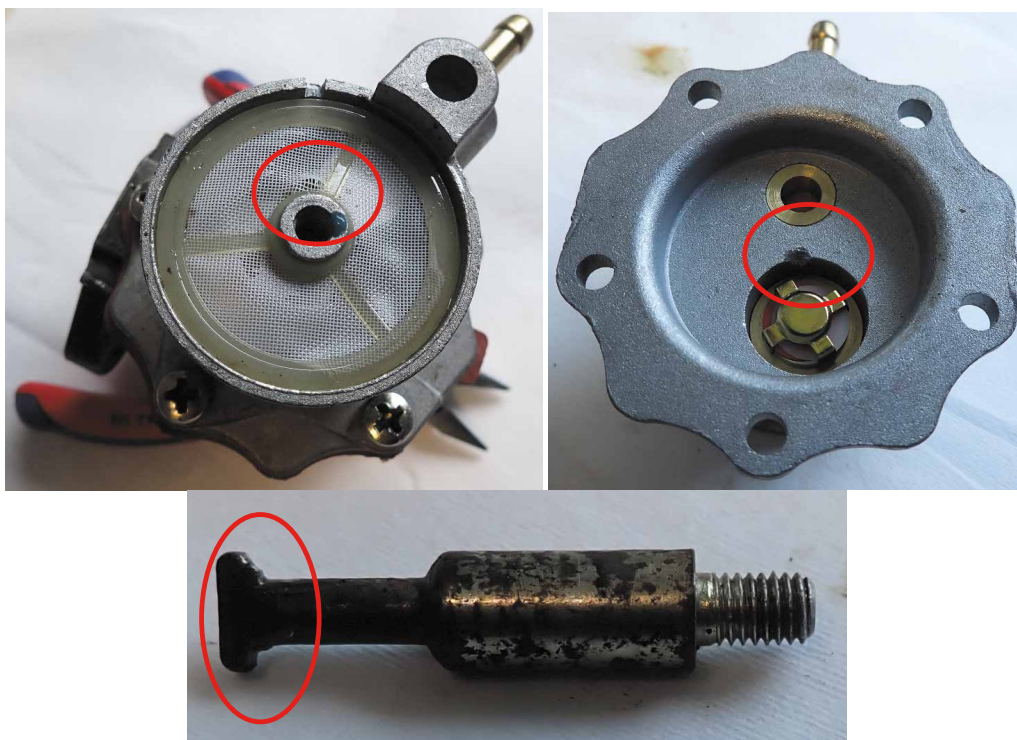
Figure 6

The mechanical fuel pump was driven by an auxiliary engine shaft and quill drive. It was a diaphragm pump and records show that the diaphragm and springs were replaced in August 2018. The pump and the fuel priming system functioned correctly and there was a small quantity of fuel remaining in the pump. An internal filter mesh had a small tear (Figure 6 left), it is thought probable that this happened during removal of the mesh when the pump was overhauled. The drive components were examined and found to be worn (Figure 6 lower) to the extent that part of the pump had clashed with the housing (Figure 6 right). This would have limited the volume of fuel pumped on each stroke.

Mechanical fuel pump –
Filter damage, housing damage and drive component wear

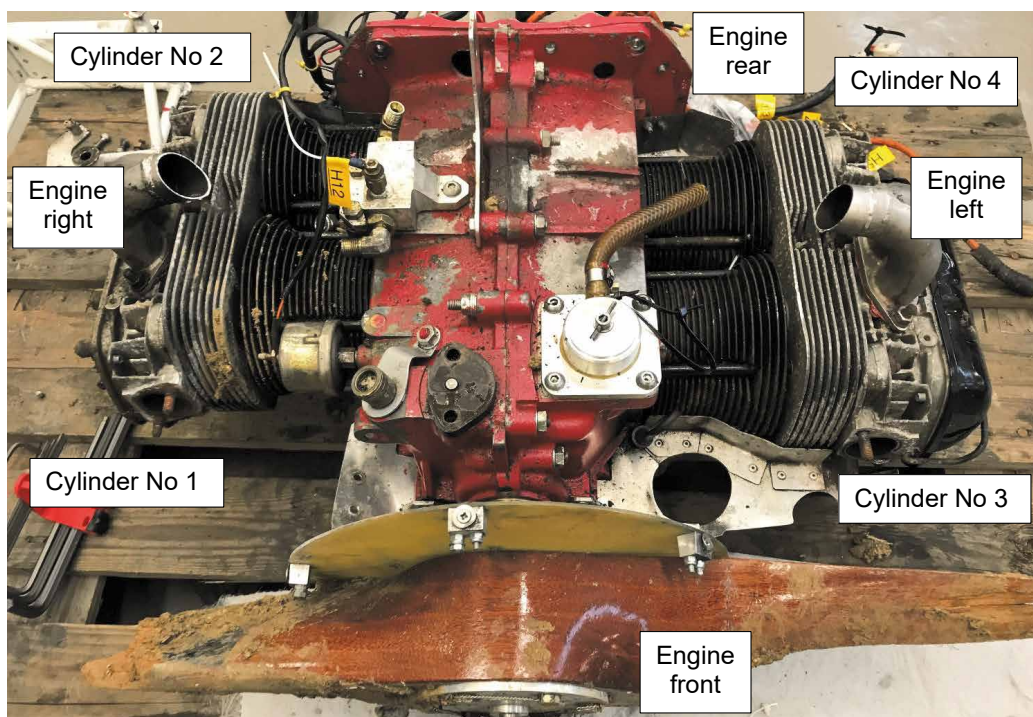
Figure 8

An external inspection of the engine (Figure 8) revealed that the right side had struck the ground, the right rocker cover was missing and the two push rod guide tubes for cylinder 1 were crushed. The rocker cover was found on the accident site and, although covered with soil, was not visibly damaged. The left rocker cover and rocker assembly were removed, and it was noted that the thread on one of the rocker attachment studs differed from the other three suggesting it had been replaced. Furthermore, the nut had been cross threaded onto the stud damaging the thread profile, but it is not considered that this impaired the function of the rocker assembly. All the rocker valve clearance adjusters showed signs of wear. The engine logbooks showed that the valve clearances were checked and adjusted by the owner approximately every 50 hours. The spark plugs were examined, and they all showed signs of use with some build-up of black and light brown coloured deposits.

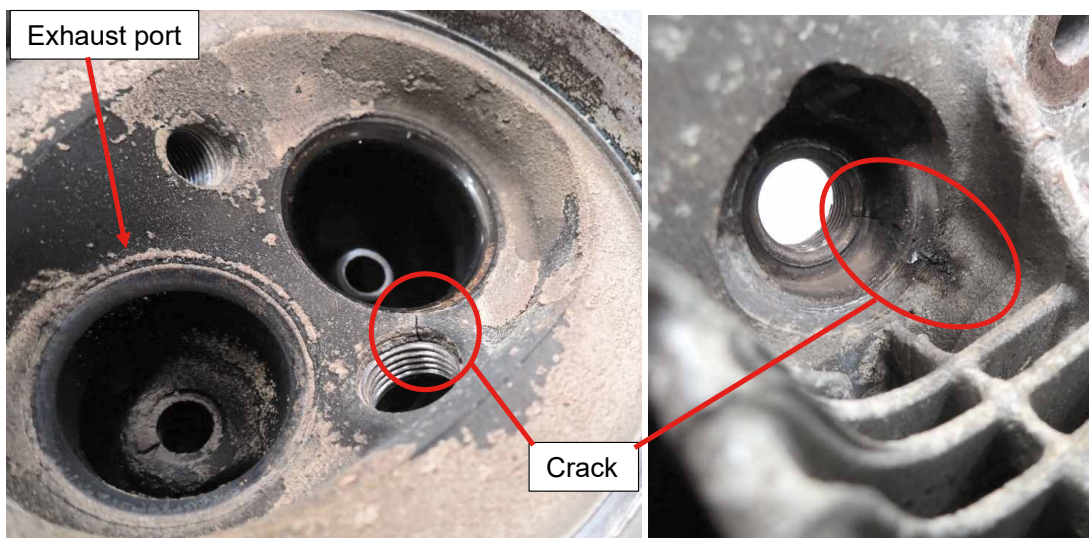
Figure 12

The valve seats were examined, and it was noted in cylinder 2 there were crushed light brown deposits on the valve seat sealing face and in the exhaust port. A crack was identified between the inlet port and the larger spark plug hole (Figure 12) with carbon deposit on the exterior surface. All spark plug holes had a helical threaded insert fitted.

Deposits and crack in cylinder 2

The long-term engine problems are likely to have been caused by the crack in the head of cylinder 2 and the split in the inlet manifold joint. However, it is believed that on the accident flight, a detached carbon flake caught under the exhaust valve of cylinder 1 further reducing the engine's performance to a point where flight could not be sustained.

Had the checks and servicing been carried out using the LAA guidance in TL 2.19 and TL 2.23 it is likely the crack in Cylinder 2 and the inlet manifold leak would have been identified.

While there was no defined overhaul period for G-BUDW's engine its poor condition indicated that it required a top-end overhaul.

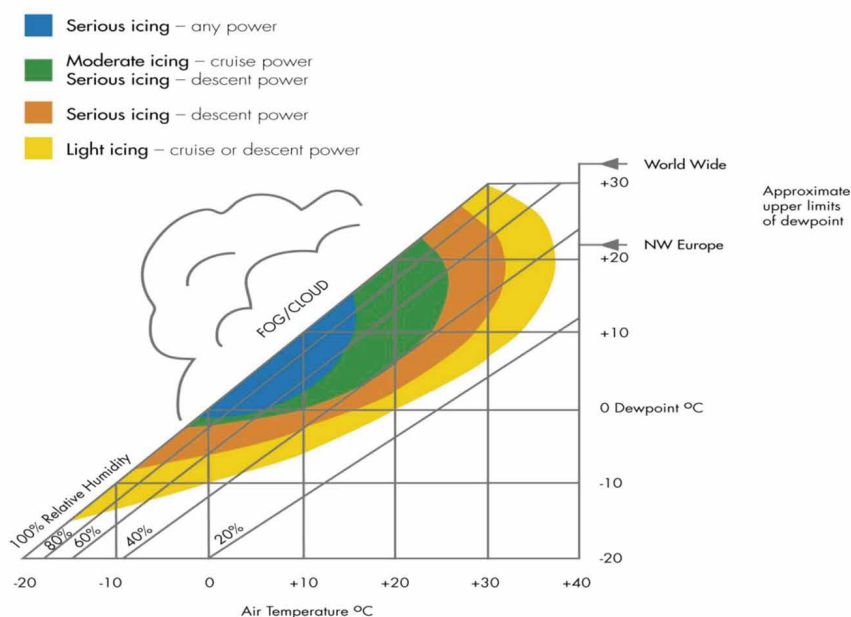
Figure 13 is extracted from the CAA Safety Sense Leaflet 14 about carb icing⁶, it shows that for the air temperature and dew point on the day of the accident serious carb icing was likely at any power setting. The grass runway was wet with dew which would have increased the likelihood for carb ice forming during the taxi along the runway. Selecting carburettor heat ON before takeoff, including as part of a power check, may reveal the presence of carburettor ice that might then be removed by more prolonged application. It is not known if the pilot did this prior to takeoff or if the engine temperature would have been high enough for the carb heat system to melt any ice that may have accumulated.

Figure 13
Carburettor icing conditions

The original power output of the engine was not known but with the defects identified during the examination its power would have been severely reduced. The weather conditions on the day were also conducive to carburettor icing and following the long taxi over wet grass, this may have further reduced engine power.
