SERIOUS INCIDENT

Aircraft Type and Registration:	DHC-8-402, G-FLBE
No & Type of Engines:	2 Pratt & Whitney Canada PW150A turboprop engines
Year of Manufacture:	2009 (Serial no: 4261)
Date & Time (UTC):	14 November 2019 at 1950 hrs
Location:	In-flight from Newquay Airport to London Heathrow Airport
Type of Flight:	Commercial Air Transport (Passenger)
Persons on Board:	Crew - 4 Passengers - 59
Injuries:	Crew - None Passengers - None
Nature of Damage:	Aileron cable broke
Commander's Licence:	Airline Transport Pilot's Licence
Commander's Age:	51 years
Commander's Flying Experience:	8,778 hours (of which 5,257 were on type) Last 90 days - 150 hours Last 28 days - 33 hours
Information Source:	AAIB Field Investigation

Synopsis

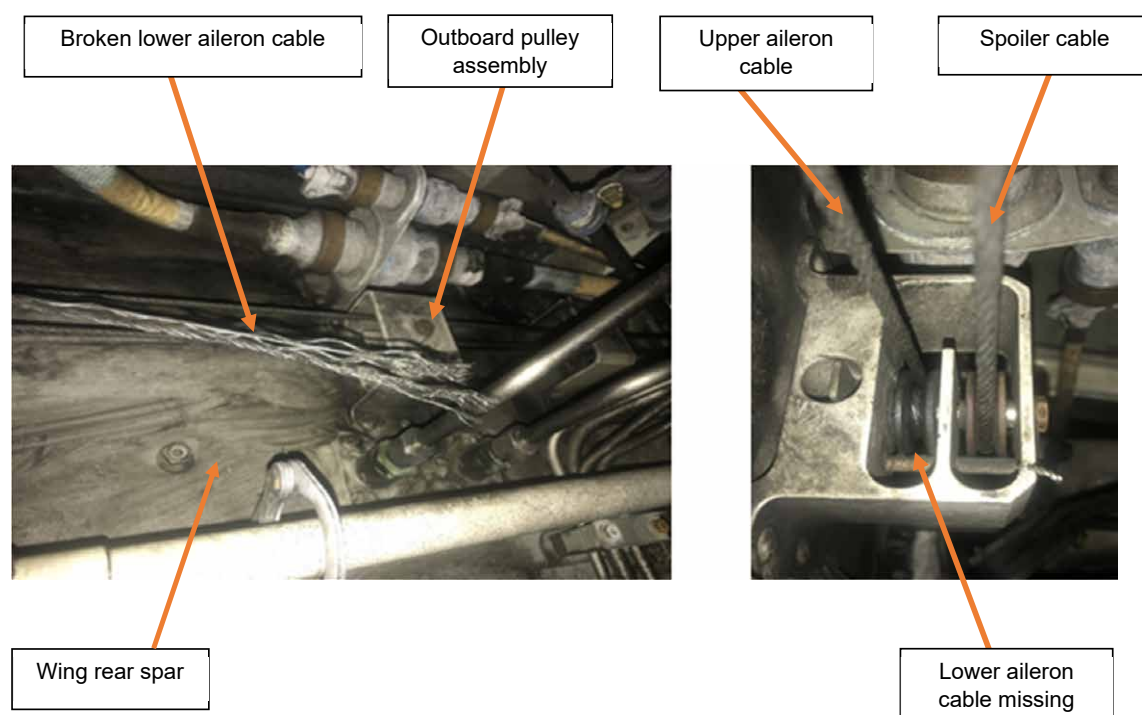
Figure 1

Post-flight examination revealed that the lower left aileron cable broke just outboard of the engine where it passed over a pulley to accommodate a change in the wing dihedral (Figure 1). There was no other damage to the aircraft.

Broken aileron cable and associated pulley

The lower left aileron cable failed where it passed over a pulley mounted on the rear wing spar. The pulley was found to rotate freely on its bearing.

The cable and its associated pulley were examined using optical and scanning electron microscopes. Individual wires showed a variety of features including ductile (tensile overload) failure, wear between wires in adjacent strands, wear between wires in the same strand and wear from an external source. There was no evidence of manufacturing anomalies, corrosion or fatigue.

The pulley was found to be worn with a pronounced imprint of the cable around the entire circumference of the groove. Small particles of metallic debris were found embedded in the pulley and it was concluded that these originated from the control cable. Apart from the wear, dimensional checks of the pulley found it to be compliant with the drawing requirements.

The lower left aileron cable failed due to a combination of internal and external wear. Following the failure, the tension in the upper cable would have caused the aileron to deflect upwards inducing a roll to the left. From the FDR data, it was established that the cable failed between the aircraft landing at Newquay and during the subsequent takeoff.

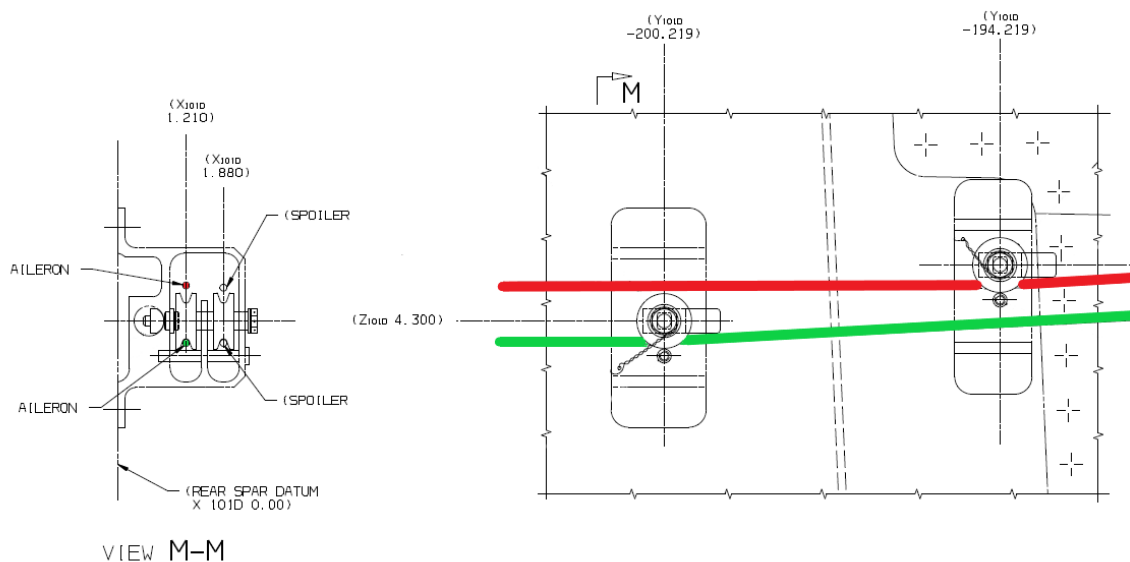
Figure 2

Immediately outboard of the engine, small pulleys direct the cables by approximately three degrees to accommodate a change in the wing dihedral. The spoiler cables are routed aft of the aileron cables (Figure 2).

Pulley and cable arrangement to accommodate a change in the wing dihedral

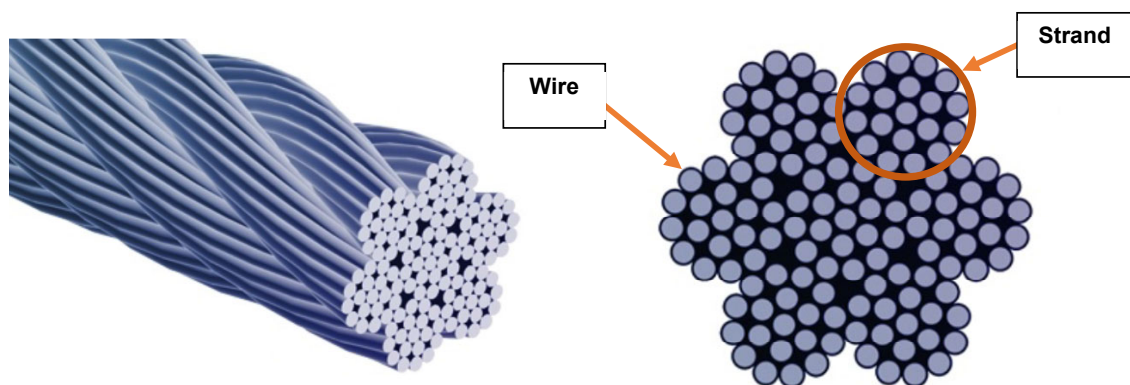
Figure 3

The control cables have a diameter of $\frac{1}{8}$ inch and are constructed from 7 strands, each consisting of 19 wires. Six of the strands are wound concentrically around a central strand (Figure 3).

Construction of the control cable

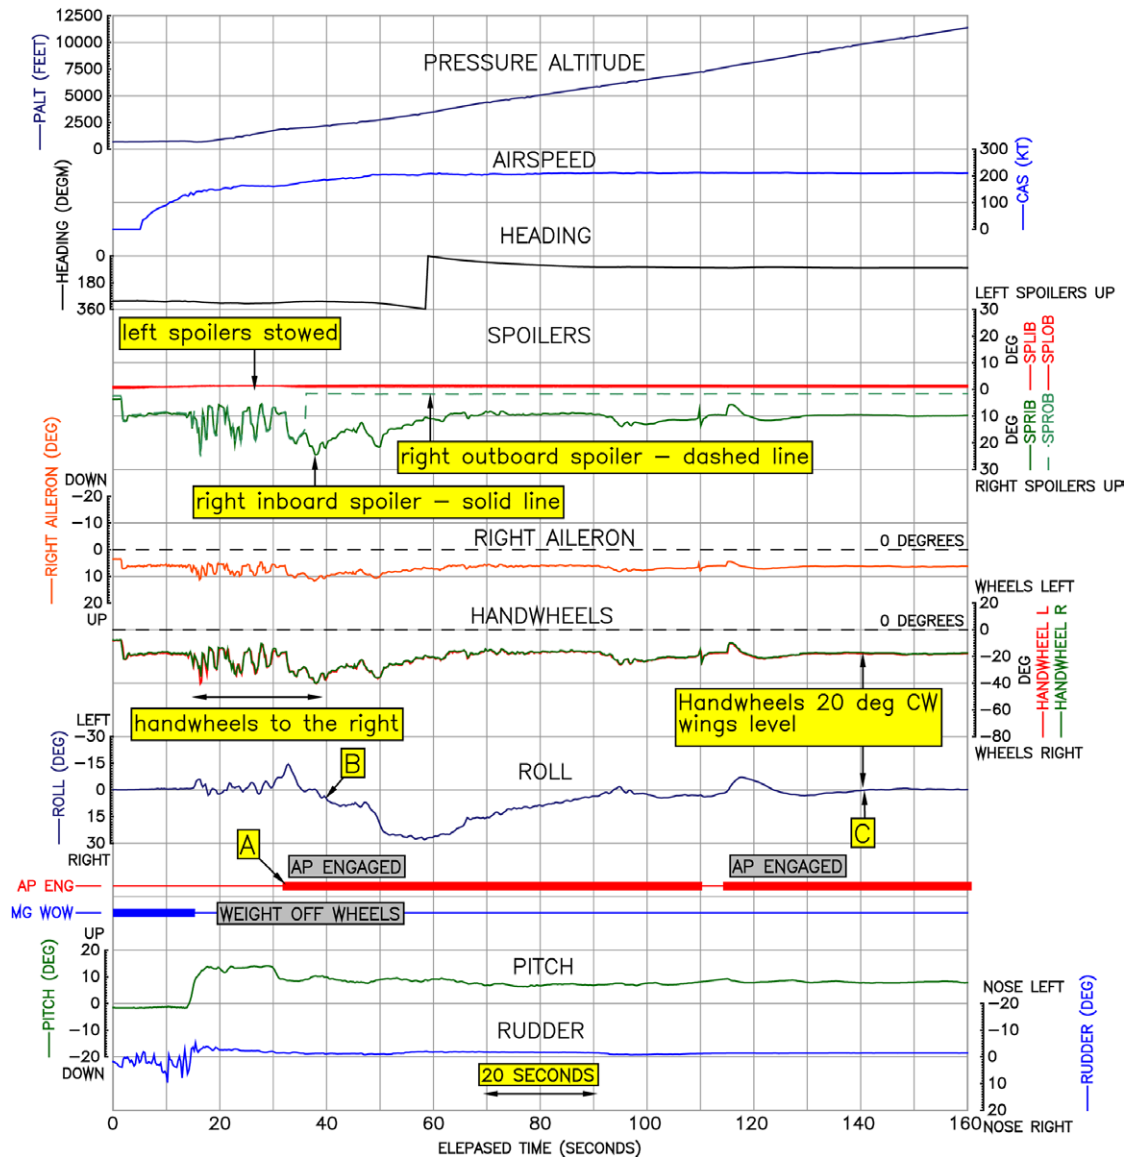
Figure 5

intact cable would reduce and the aileron would be moved by aerodynamic loads. The manufacturer confirmed that the aircraft had sufficient roll authority with the left aileron in the most adverse position.

Handwheel offset after departing Newquay

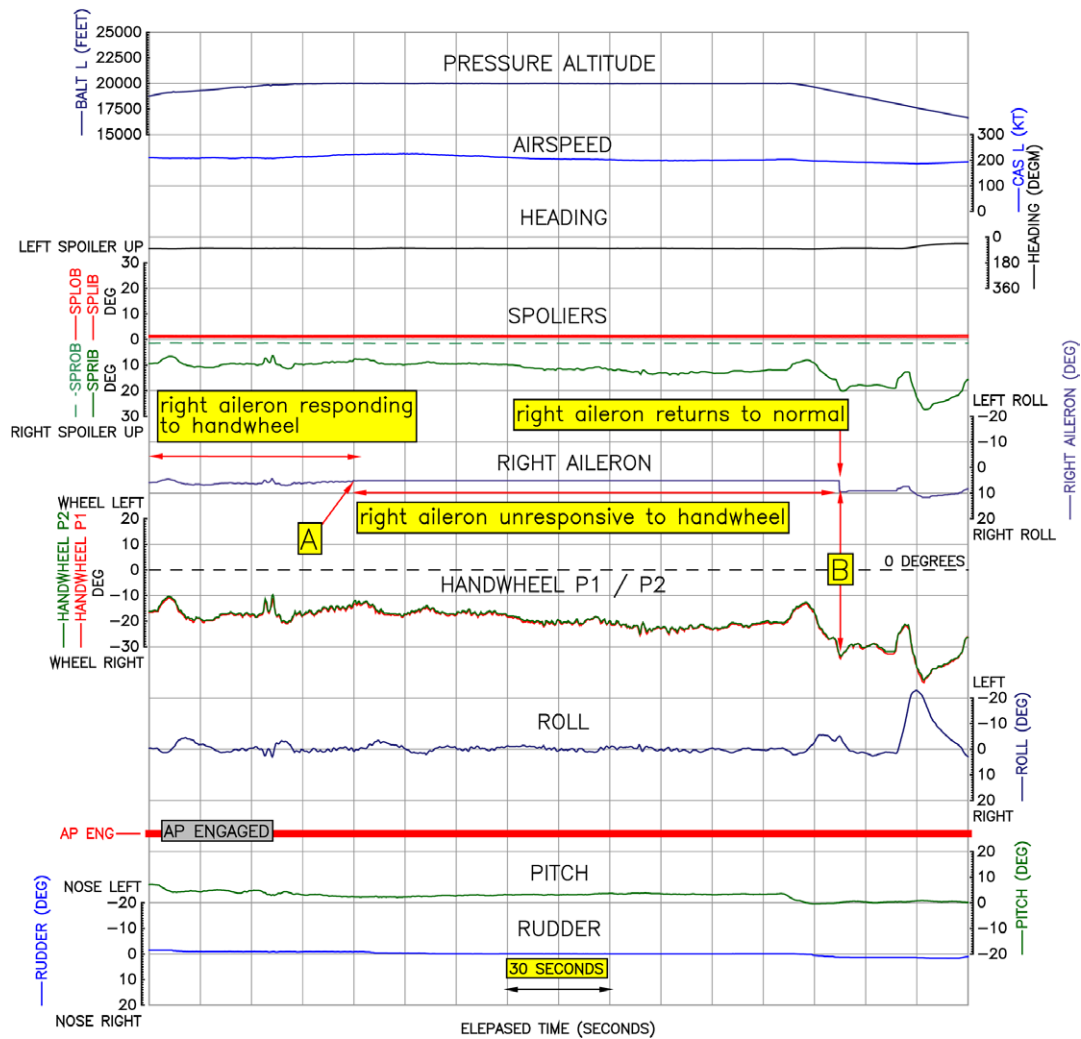
Figure 6

During this investigation an issue, unrelated to the cable failure, was identified with the movement of the right aileron in-flight. Data from the FDR showed that shortly after G-FLBE levelled at FL200, the aileron stopped responding to movement of the handwheels (Point A Figure 6). This lasted for about five minutes, with the aileron remaining in an almost fixed position of +5°. During this period, the AP continued to maintain wings level with handwheel positions between 13° CW and 27° CW. The inboard spoilers continued to operate normally during the flight.

Unresponsive right aileron
