SERIOUS INCIDENT

Aircraft Type and Registration:	Mooney M20K, G-OSUS	
No & Type of Engines:	1 Teledyne Continental TSIO-360-LB1 piston engine	
Year of Manufacture:	1980 (Serial no: 25-0429)	
Date & Time (UTC):	30 May 2020 at 1255 hrs	
Location:	Membury Airfield, Berkshire	
Type of Flight:	Private	
Persons on Board:	Crew -1	Passengers -1
Injuries:	Crew - None	Passengers - None
Nature of Damage:	Damage to baggage door, rear fuselage and tailplane	
Commander's Licence:	Private Pilot's Licence	
Commander's Age:	28 years	
Commander's Flying Experience:	165 hrs (of which 50 were on type) Last 90 days - 15 hours Last 28 days - 4 hours	
Information Source:	AAIB Field investigation

Synopsis

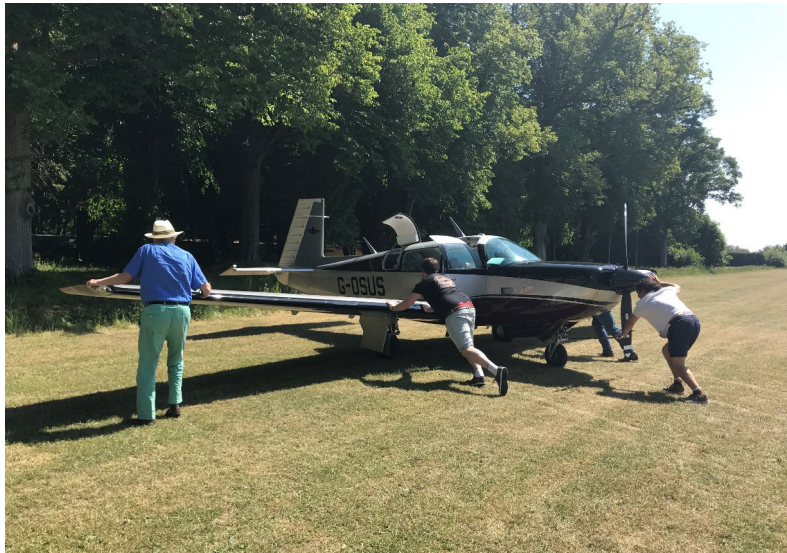
Figure 1

The pilot had flown the aircraft to Charlton Park Airstrip and whilst there the baggage door had been opened from the outside to allow access to a picnic basket. As it was a hot day, it was left open for the duration of the stay to keep the cabin area cool (Figure 1).

G-OSUS being pushed into a parking position showing open baggage door

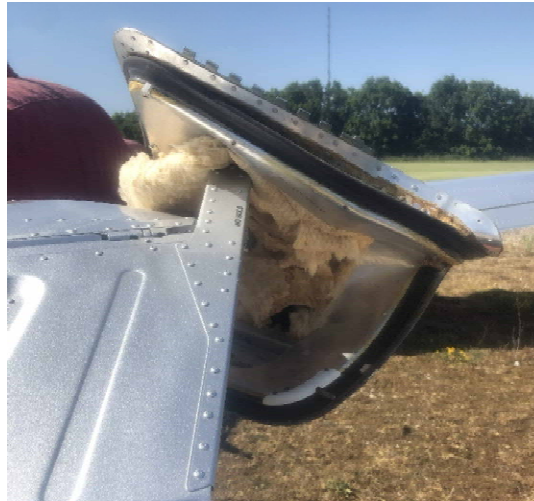
Figure 2

Baggage door on the tailplane right tip, as found after landing, looking forward

The aircraft sustained considerable damage to the right side of the tailplane. The force of the impact twisted the right side of the tailplane rearwards and the left side forwards to such an extent that it was touching the fuselage where normally there is a gap. Several rivets around the tail assembly attachment to the fuselage were 'popped'.

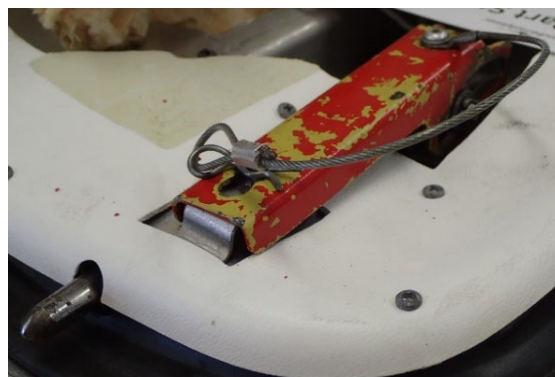
Figure 3

The internal emergency handle is fitted with a secondary locking clip to prevent inadvertent operation and there is a cover over the whole mechanism along with a placard providing operating instructions (Figure 3). This secondary locking clip was introduced by the manufacturer in a service bulletin (SB) SB M20-239A, issued in 1988 and mandated by Airworthiness Directive (AD) 88-25-11 which became effective 5 January 1989. This aircraft had this SB/AD embodied.

Internal emergency handle correctly closed and secured by secondary locking clip
(Image shows accident door, placard and cover are missing)

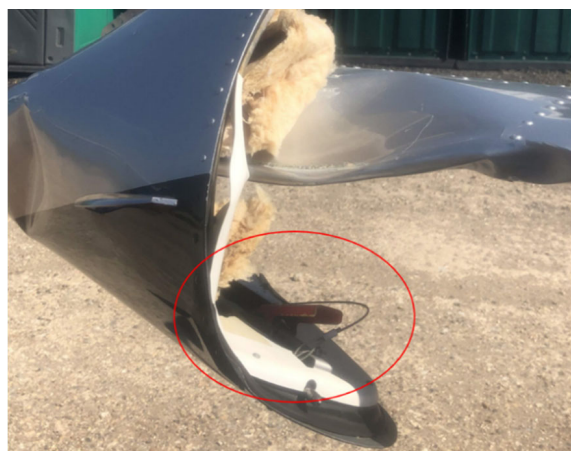
Figure 5

Position of internal operating handle after emergency landing

The internal handle features a slot which allows the handle to be opened partly before it starts to move the shoot bolts from the fully extended position. The handle position in the images taken before and after the flight (Figures 4 and 5), show the internal handle approximately in a position where the shoot bolts would not yet have moved and they can be seen extended.

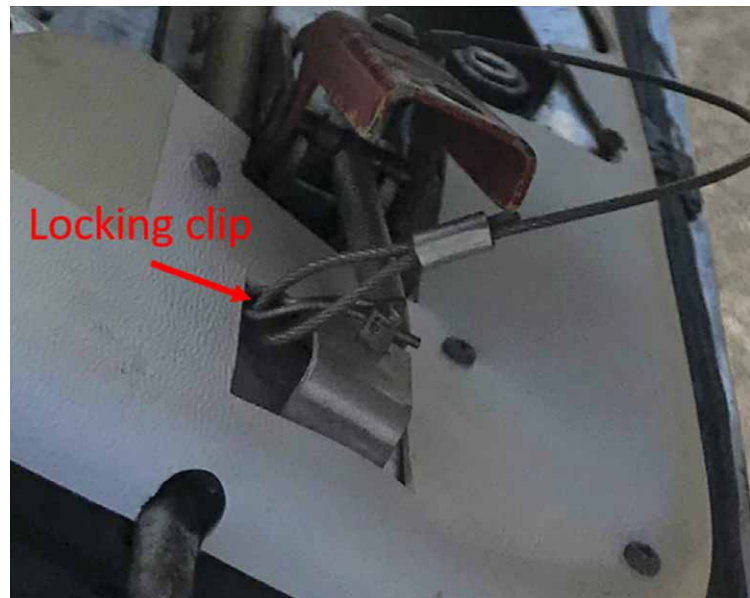
Figure 6

The internal handle had the secondary locking clip installed in the clevis pin, but this was installed under the handle rather than over it, so it did not provide a secondary locking feature. The locking clip is also bent suggesting the handle had been forced down on to the locking clip onto the locking clip (Figure 6). This may have made it appear as though the operating handle was in the correct closed position.

Closer inspection of the clevis pin found that it was loose in its mounting plate rather than the push fit specified. This meant that it was free to drop down which made it impossible to install the locking clip until it had been lifted to the correct position.

Bent locking clip and partially open internal handle

Inspection of the internal emergency handle showed that it had been incorrectly assembled; the safety clip was fitted under the operating handle rather than above it. The safety clip appeared to be bent, possibly as a result of the operating handle being forced into its closed position over it. This meant the handle was not in the fully closed position and it would have been held slightly open by the safety clip, although the available images suggest it had moved further open than this.
